Summary of LaSalle SIT exit (the team made it clear to the licensee that info presented was based upon management review)

Operating Experience Spring 2017 Counterparts Briefing

LaSalle 2 – HPCS Injection Valve Failure – Stem-Disc Separation

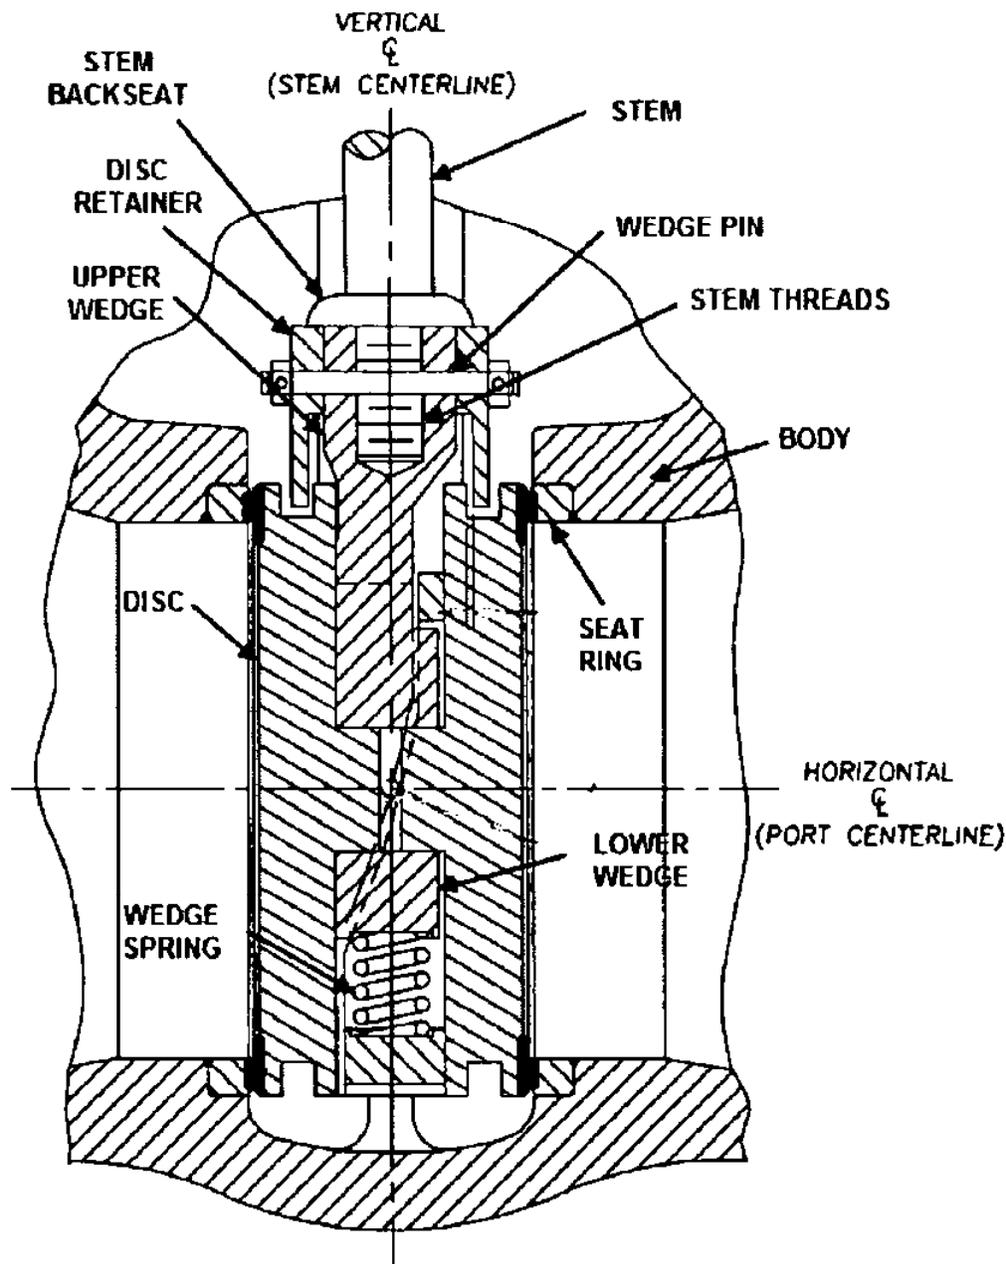
These valves are used on numerous plants, and there has been recent operating experience. On February 11, 2017, the LaSalle Unit 2 HPCS injection valve stem was found to be separated from the upper wedge/disc assembly during a fill and vent activity¹. Prior to the failure, the valve

had successfully passed a local leak rate test where the valve had cycled successfully several times. Valve disassembly and inspection revealed the wedge pin had sheared and the valve stem threads were damaged. This valve was an Anchor/Darling 12 inch Double Disc Gate Valve (ADDDGV) and was included in those valves associated with the Flowserve and Browns Ferry Part 21 reports submitted in 2013 (ADAMS ML13008A321 and ML13064A012). The licensee was addressing the Part 21 reports by using industry guidance provided by the Boiling Water Reactor Owners Group (BWROG) prior to the failure.

On February 11, 2017, the LaSalle Unit 2 HPCS injection valve stem was found to be separated from the upper wedge/disc assembly during a fill and vent activity. Prior to the failure, the valve had successfully passed a local leak rate test where the valve had cycled successfully several times. Valve disassembly and inspection revealed the wedge pin had sheared and the valve stem threads were damaged. This valve was an Anchor/Darling 12 inch Double Disc Gate Valve (ADDDGV) and was included in those valves associated with the Flowserve and Browns Ferry Part 21 reports submitted in 2013 (ADAMS ML13008A321 and ML13064A012). The licensee was addressing the Part 21 reports by using industry guidance provided by the Boiling Water Reactor Owners Group (BWROG) prior to the failure. Following the identification of the separation, the licensee redesigned and repaired the failed Unit 2 HPCS Injection valve.
