UNITED STATES  
NUCLEAR REGULATORY COMMISSION  
REGION II  
101 MARIETTA ST., N.W.  
ATLANTA, GEORGIA 30323

Report No.: 50-259,-260,-296/89-04

Facility Name: Browns Ferry Units 1, 2, and 3

Inspection Conducted: January 4-12 1989

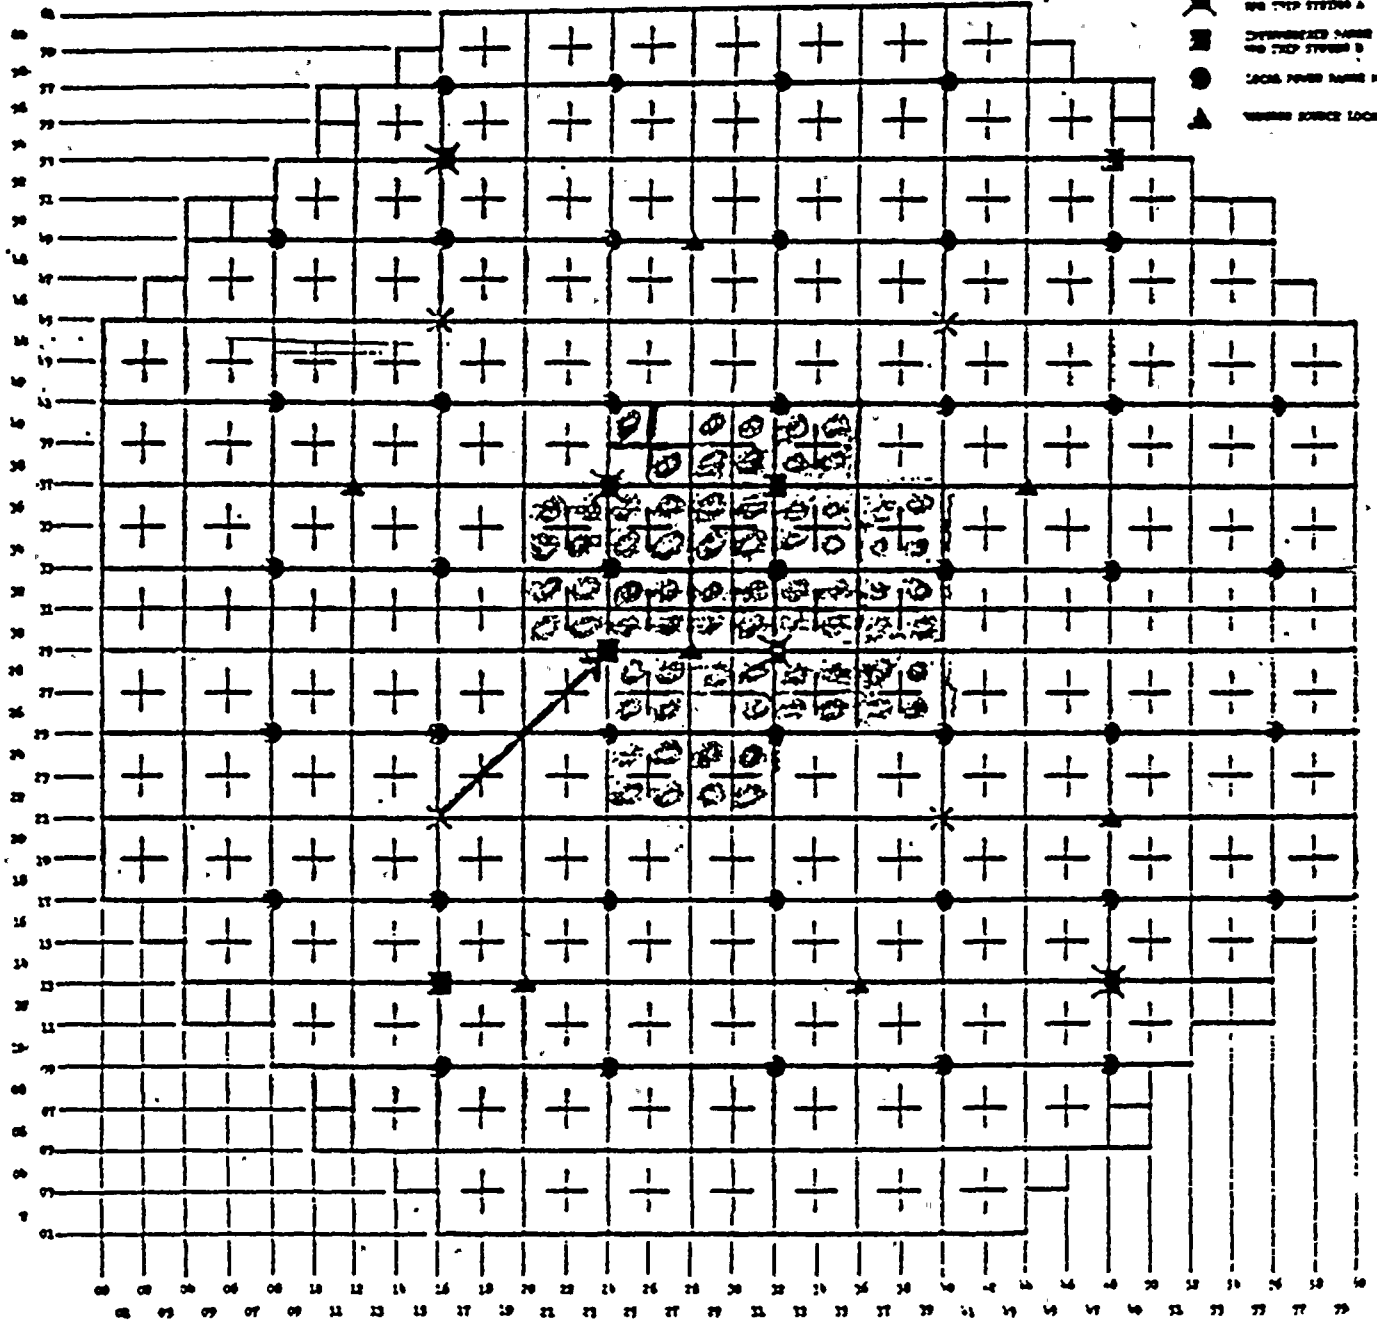
## CORE POSITION MAP

X → ■ SRM D in IRM F

⊗ Core locations with fuel
