FACIL: 50-259 Browns Ferry Nuclear Power Station, Unit 1, Tennessee 05000259

SUBJECT: Responds to NRC 890130 ltr re violations noted in Insp Repts
 50-259/89-04, 50-260/89-04 & 50-296/89-04.

MAR 01 1989

BROWNS FERRY NUCLEAR PLANT (BFN) - RESPONSE TO NRC INSPECTION REPORT
NUMBERS 50-259/89-04, 50-260/89-04, AND 50-296/89-04

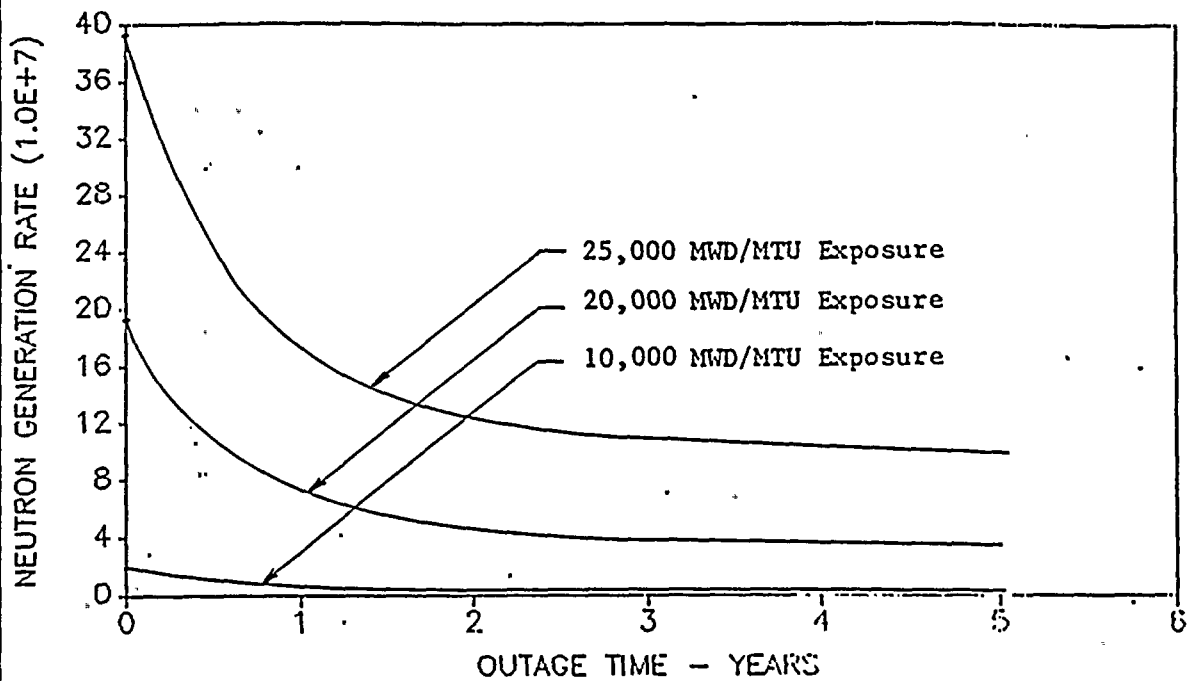
FIGURE 1
 NEUTRON GENERATION RATE / MTU
 BWR REACTOR - GE 8X8 FUEL

The sources of neutrons in irradiated fuel due to spontaneous fission and alpha-n reactions have been estimated as a function of fuel burnup and time after shutdown using the ORIGIN code (reference 3). ORIGIN results for BWR fuel are depicted in figure 1. From this figure it can be seen that the source of neutrons in irradiated fuel is influenced strongly by the exposure

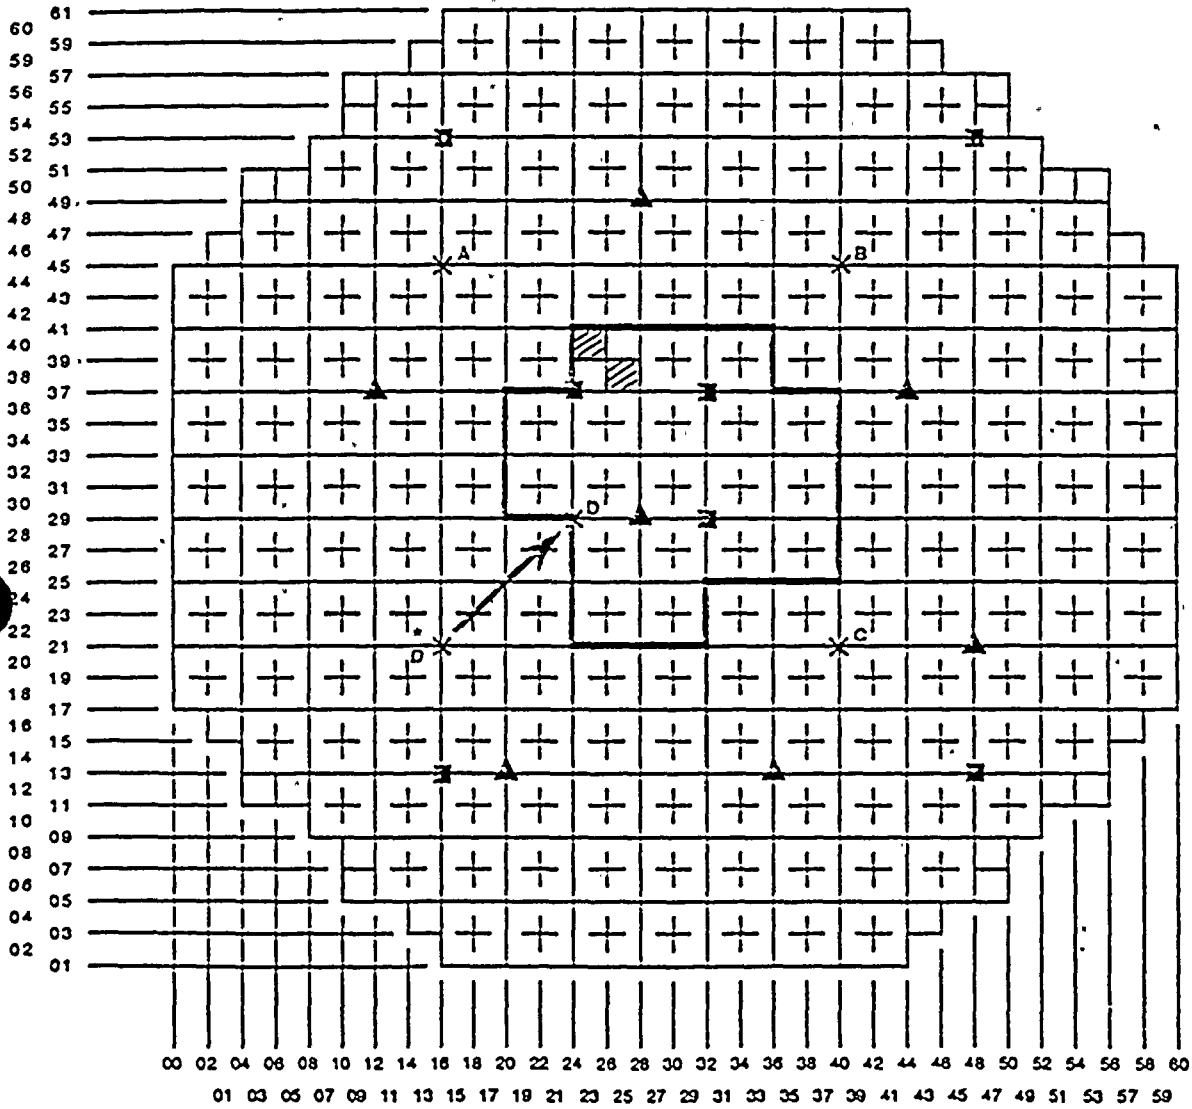
BROWNS FERRY UNIT 2
 CORE CONFIGURATION AS OF 1/05/89
 74 BUNDLES LOADED

As stated earlier, the failure of the SRMs to obtain readings of 3 cps or greater was due to the location of SRMs with respect to the loaded fuel bundles rather than an inadequate neutron source. Up to the time fuel loading was halted with 74 fuel assemblies in the core, none of the SRMs were closer than a foot, and two of the four detectors were more than 2 feet from the nearest fuel bundle.

Detector not connected

Empty Fuel Locations after 74 Bundles Loaded

TVA requested GE to recommend a loading and instrumentation strategy. A team of GE experts arrived onsite Saturday, January 7 and developed a reload sequence to recommence fuel load. The fuel loading procedures were revised to incorporate the GE recommendations, to allow the use of fuel loading chambers, and to ensure that fuel loading practices were comparable to the best practices in the industry.
