SUBJECT: Forwards table entitled "NMP-1 Guidelines for Repair of Leaking CRD Penetrations," per 851118 request. Basis for leakage limits in guideline include available test info on rolled tube-to tube sheet joints in steam generators.

Re: Nine Mile Point Unit 1
Docket No. 50-220
.....DPR-63.....

TABLE I
NMP-1
GUIDELINES FOR REPAIR OF LEAKING
CONTROL ROD DRIVE (CRD)
PENETRATIONS

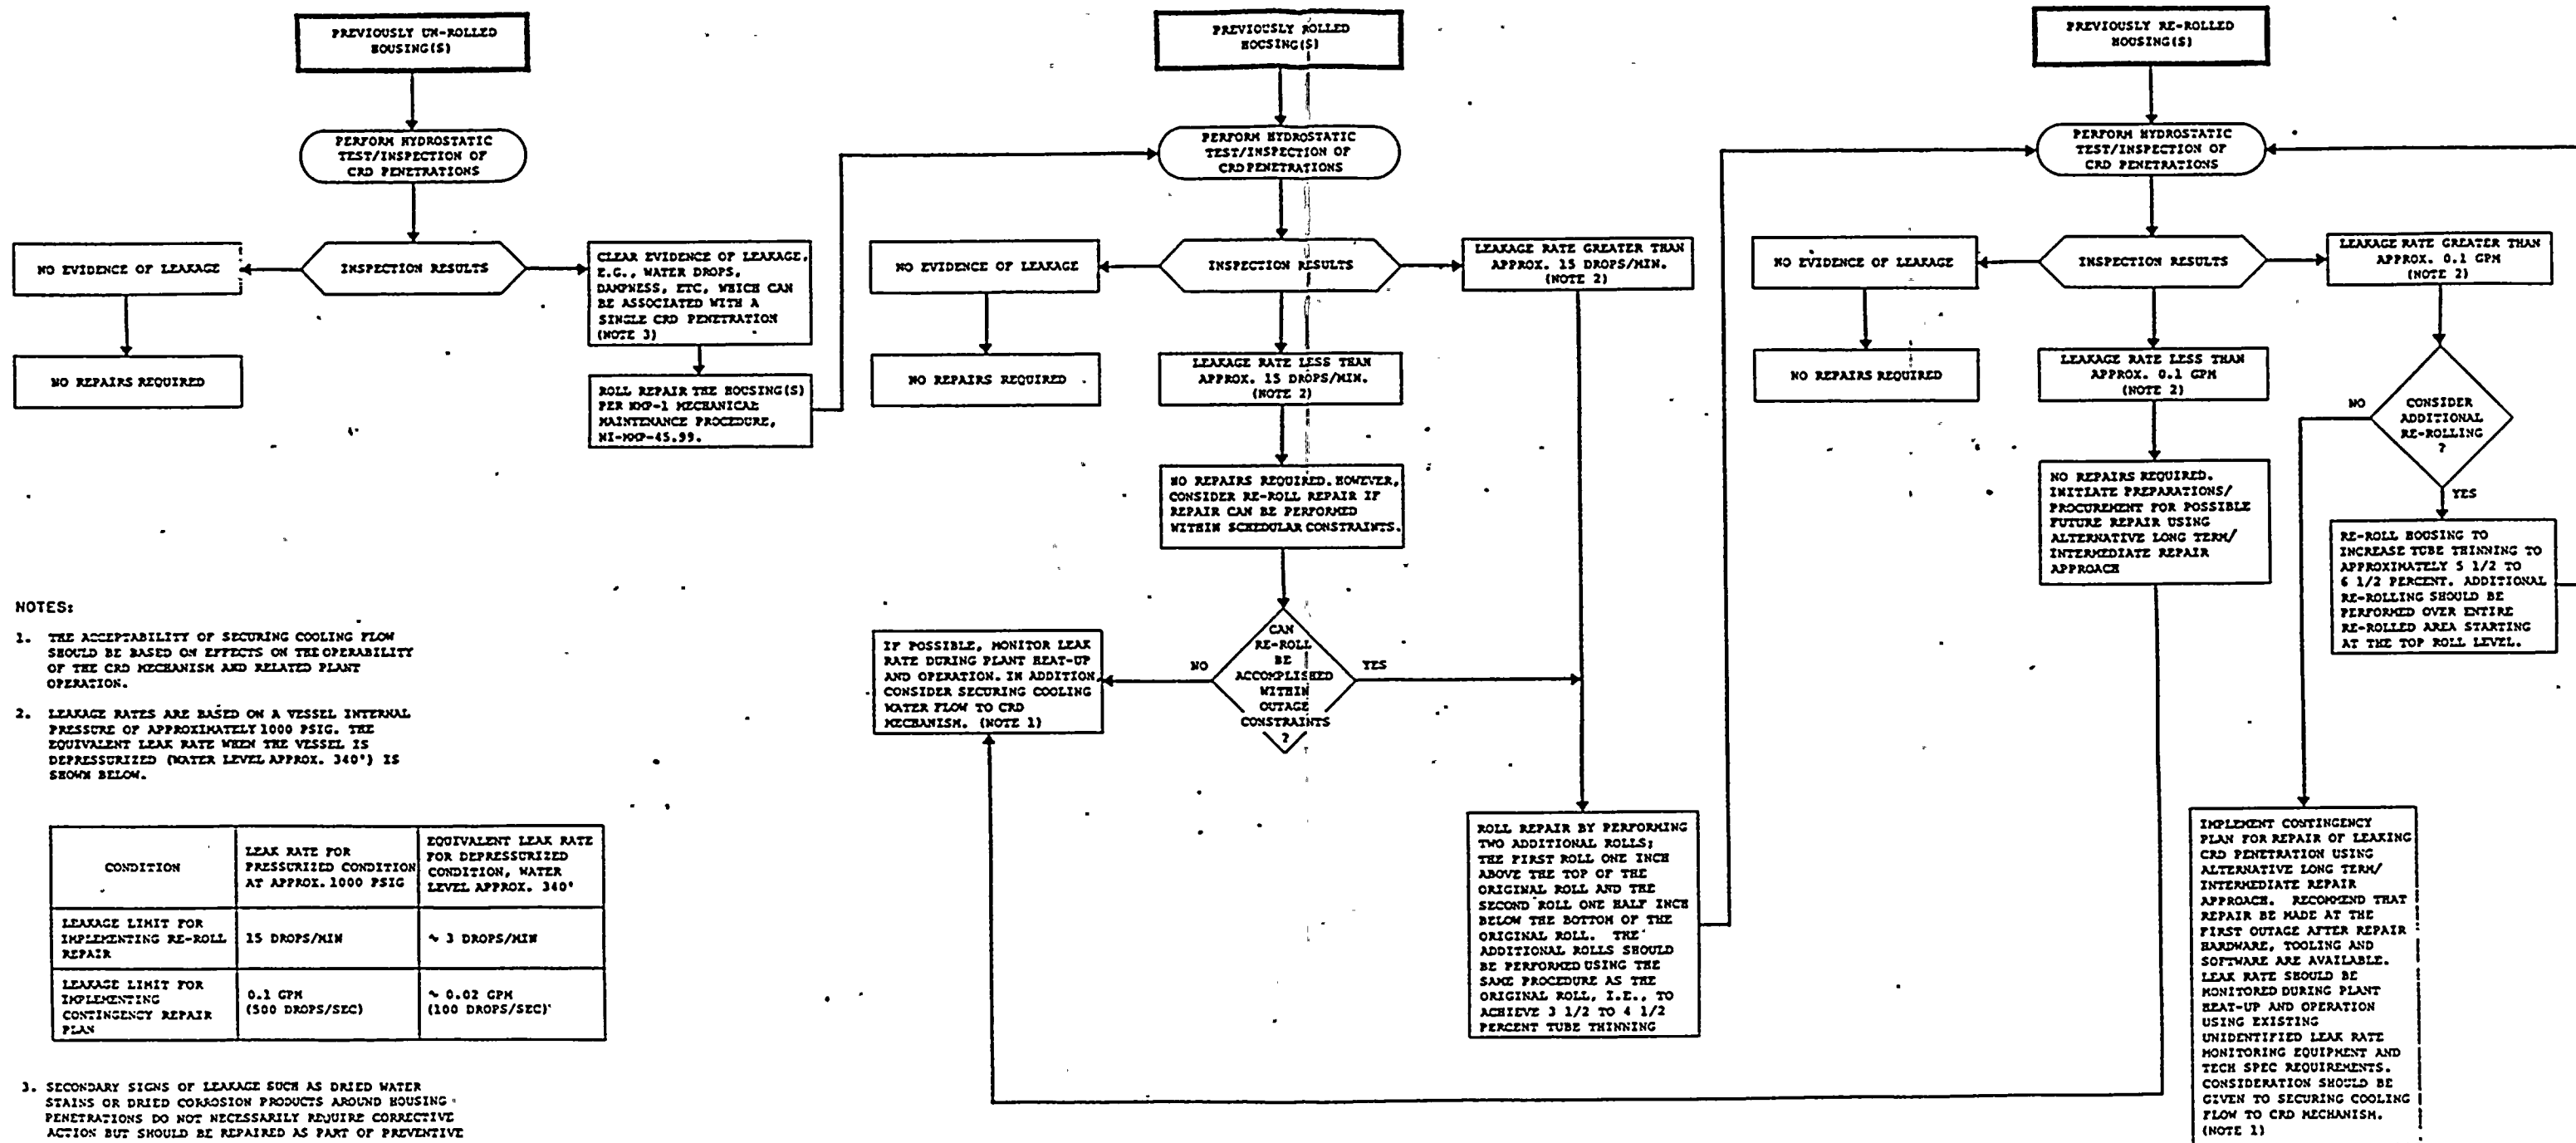
1. THE ACCEPTABILITY OF SECURING COOLING FLOW SHOULD BE BASED ON EFFECTS ON THE OPERABILITY OF THE CRD MECHANISM AND RELATED PLANT OPERATION.
2. LEAKAGE RATES ARE BASED ON A VESSEL INTERNAL PRESSURE OF APPROXIMATELY 1000 PSIG. THE EQUIVALENT LEAK RATE WHEN THE VESSEL IS DEPRESSURIZED (WATER LEVEL APPROX. 340") IS SHOWN BELOW.

CONDITION	LEAK RATE FOR PRESSURIZED CONDITION AT APPROX. 1000 PSIG	EQUIVALENT LEAK RATE FOR DEPRESSURIZED CONDITION, WATER LEVEL APPROX. 340"
LEAKAGE LIMIT FOR IMPLEMENTING RE-ROLL REPAIR	15 DROPS/MIN	~ 3 DROPS/MIN
LEAKAGE LIMIT FOR IMPLEMENTING CONTINGENCY REPAIR PLAN	0.1 GPM (500 DROPS/SEC)	~ 0.02 GPM (100 DROPS/SEC)

3. SECONDARY SIGNS OF LEAKAGE SUCH AS DRIED WATER STAINS OR DRIED CORROSION PRODUCTS AROUND HOUSING PENETRATIONS DO NOT NECESSARILY REQUIRE CORRECTIVE ACTION BUT SHOULD BE REPAIRED AS PART OF PREVENTIVE MAINTENANCE AS LONG AS THE REPAIR DOES NOT CONFLICT WITH OUTAGE CONSTRAINTS.
