**ROOT CAUSE REPORT FOR THE
EXIDE UPS 1A, B, C, D, G
TRIP EVENT OF AUGUST 13, 1991**

SEPTEMBER 9, 1991

FILE CODE: NMP77748

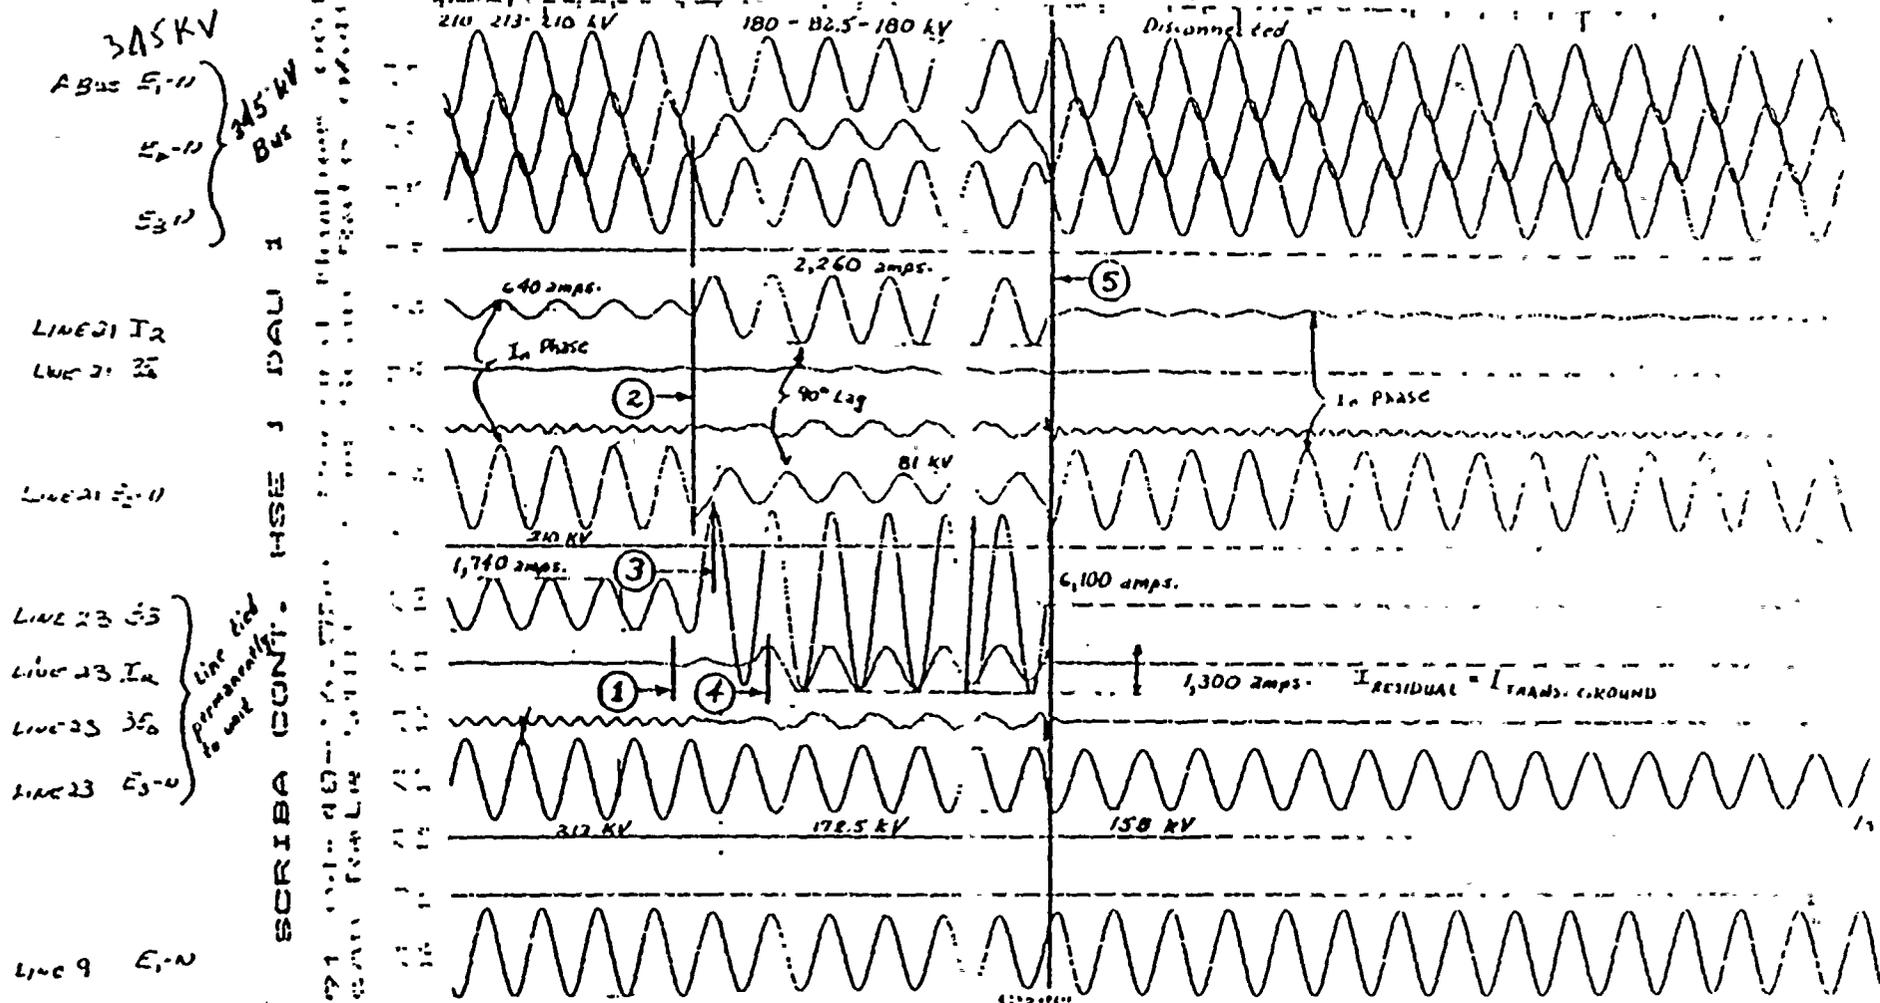
FIGURE A
 Notations by
 M.L. Crenshaw

On August 13, 1991, at 5:48 AM the Unit 2 phase B generator step-up transformer failed. Oscillographic records of the event are available from a digital data recorder at the Scriba Substation. They show various 345 kV and 115 kV system voltages and currents. Figure A with notations is attached.

The four cycles preceding the fault show no signs of a gradual degradation or a developing disturbance. The oscillographic traces and station protective relay targets reported, indicate a ground fault occurred on the high voltage winding. Depression of the 345 kV phase B bus voltage to about 39% of the prior value was observed from the oscillographic trace. This suggests the involvement of only a portion of the entire winding. The 345 kV line currents and voltages show rapid development of the ground fault beginning at point 1 with the ground current reaching a constant value of 1,300 amperes in 1 1/2 cycles at point 4. The flashover in the faulted transformer occurs just preceding a maximum in phase 2 to neutral voltage (as would have been expected) at point 2. The 345 kV line current in an unfaulted phase increases in step function manner to 350% of the pre-fault value at point 3.

Following isolation of the generator and failed transformer from the power grid, marked 5 on Figure A, only a single 345 kV phase to ground voltage record is available. The magnitude of this voltage on an unfaulted phase is 74% of the pre-fault value. Since generator neutral current is limited to less than 8 amperes, it is known that the faulted transformer appears as a line to line fault with some impedance to the generator. By trial and error calculation, generator line currents are found to be 0, 1.9 and 1.9, multiples of the rated value of 31,140 amperes. The line-to-line voltages have magnitudes 74% 74%, and 25% of the rated value of 25,000 volts. The decay of this voltage for 0.25 seconds of the recording has a measured time constant of 2.7 seconds. The calculated value of the impedance of the faulted transformer as seen by the generator is 0.23 per unit.

Conditions prevailing during the six cycle time period following the fault, marked 2 on Figure A, cannot be determined with certainty. The exact nature of the fault within the transformer is not known and the physical evidence will be strongly affected by the continued flow of energy from the generator due to the inherent time constant. The flashover of only a portion of the HV winding is evident since the 345 line voltages to neutral remain at 39%, 86% and 86% of the pre-fault values. The presence of "residual" in the measured 345 kV line currents provides the evidence of transformer neutral to ground current. This requires that the fault involves a path for current to ground from the high voltage winding. Recorded voltages and currents show a step change to new values and no dramatic change during the time period of the record, which totals somewhat less than 1/2 second. It could be said they are "cleaner" and less distorted than commonly seen oscillograph recordings of faults.
