SUBJECT: LER 88-051-01: on 870813, shutdown cooling sys isolated & Tech Specs 3.4.9.2 exceeded. Caused by equipment failure, personnel error & procedural & design deficiencies. Shutdown cooling sys manually restored. W/880822 ltr.

FACILITY NAME (1)	DOCKET NUMBER (2)	PAGE (3)
Nine Mile Point Unit 2	0 5 0 0 0	1 OF 08

TITLE (4) Shutdown Cooling Isolation and LCO Exceeded due to Design Deficiency and a Lack of Support for Pre-Job Review

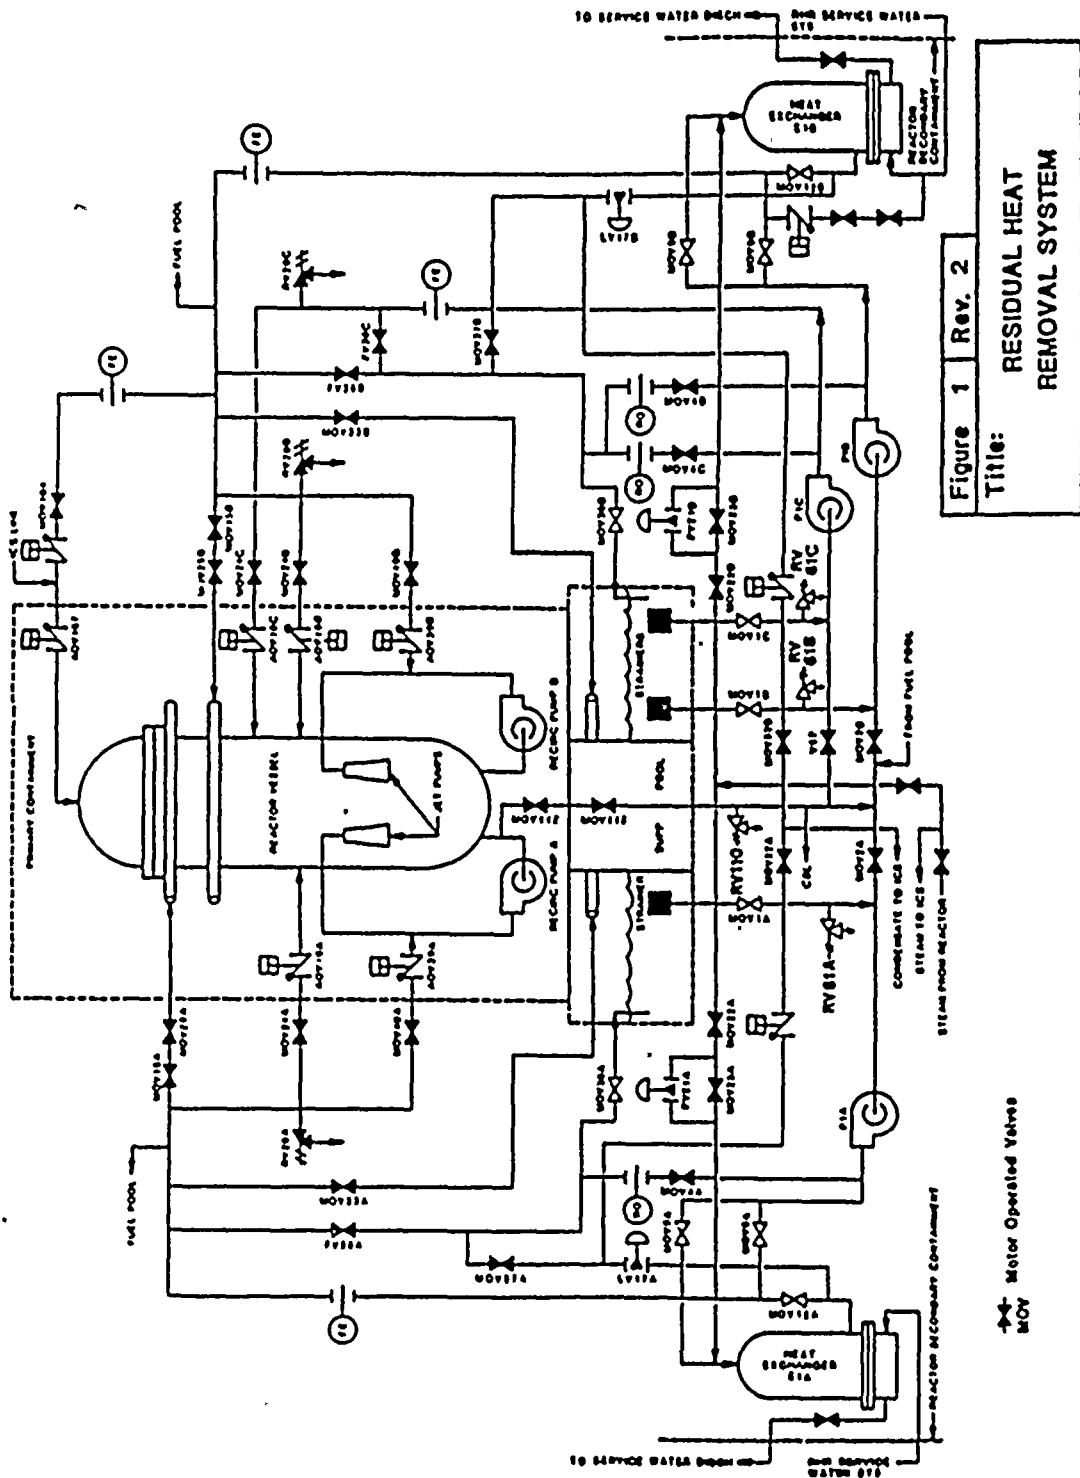
Refer to Attachment 1 for the Residual Heat Removal System (RHR/RHS)-SDC subsystem configuration. Refer to Attachment 2 for RPS logic power supply configuration.

At 0322 hours, EPA 1A was tripped by Niagara Mohawk Power Corporation (NMPC) Meter and Test (M&T) personnel in accordance with the surveillance procedure to perform the necessary channel calibrations. The expected Division 1 half scram and primary containment isolations (outboard containment isolation valves) were received. However, an unexpected result was the receipt of a Division 2 SDC isolation. Consequently, the inboard SDC suction isolation (2RHS*MOV112) and SDC Loop B injection (2RHS*MOV40B) valves closed. The other Division 2 SDC valves were already closed. Subsequently, the running SDC pump (2RHS*PIB) tripped due to the suction valve closure, and normal SDC was interrupted at 0323 hours.

Prior to tripping the EPA, NMPC licensed control room operators and the Station Shift Supervisor (SSS) made a conscientious effort to take the necessary measures to prevent isolation of systems such as SDC, Reactor Water Cleanup (WCS) and normal Reactor Building Ventilation (HVR). In addition, measures were taken to prevent auto initiation of Engineered Safety Features (ESF) systems such as Standby Gas Treatment (GTS). Except for the Main Steam Isolation Valves (MSIVs), the Nuclear Steam Supply Shutoff System (NSSS) isolation circuits are designed to isolate one of the two isolation valves on a loss of either divisional power supply (i.e. Division 1 isolates outboards and Division 2 isolates inboards). However, the SDC isolation circuit is also an exception to this general design. A loss of any divisional power supply will result in a complete isolation of the SDC system (both inboard and outboard valves). The purpose for this unique design feature is to protect the SDC system from overpressurization. Due to procedural deficiencies and a lack of knowledge of this unique feature of the SDC isolation circuit, the operators' measures to prevent SDC isolations did not include preventing closure of 2RHS*MOV112 or 40B. Thus, SDC isolated when the EPA was tripped.

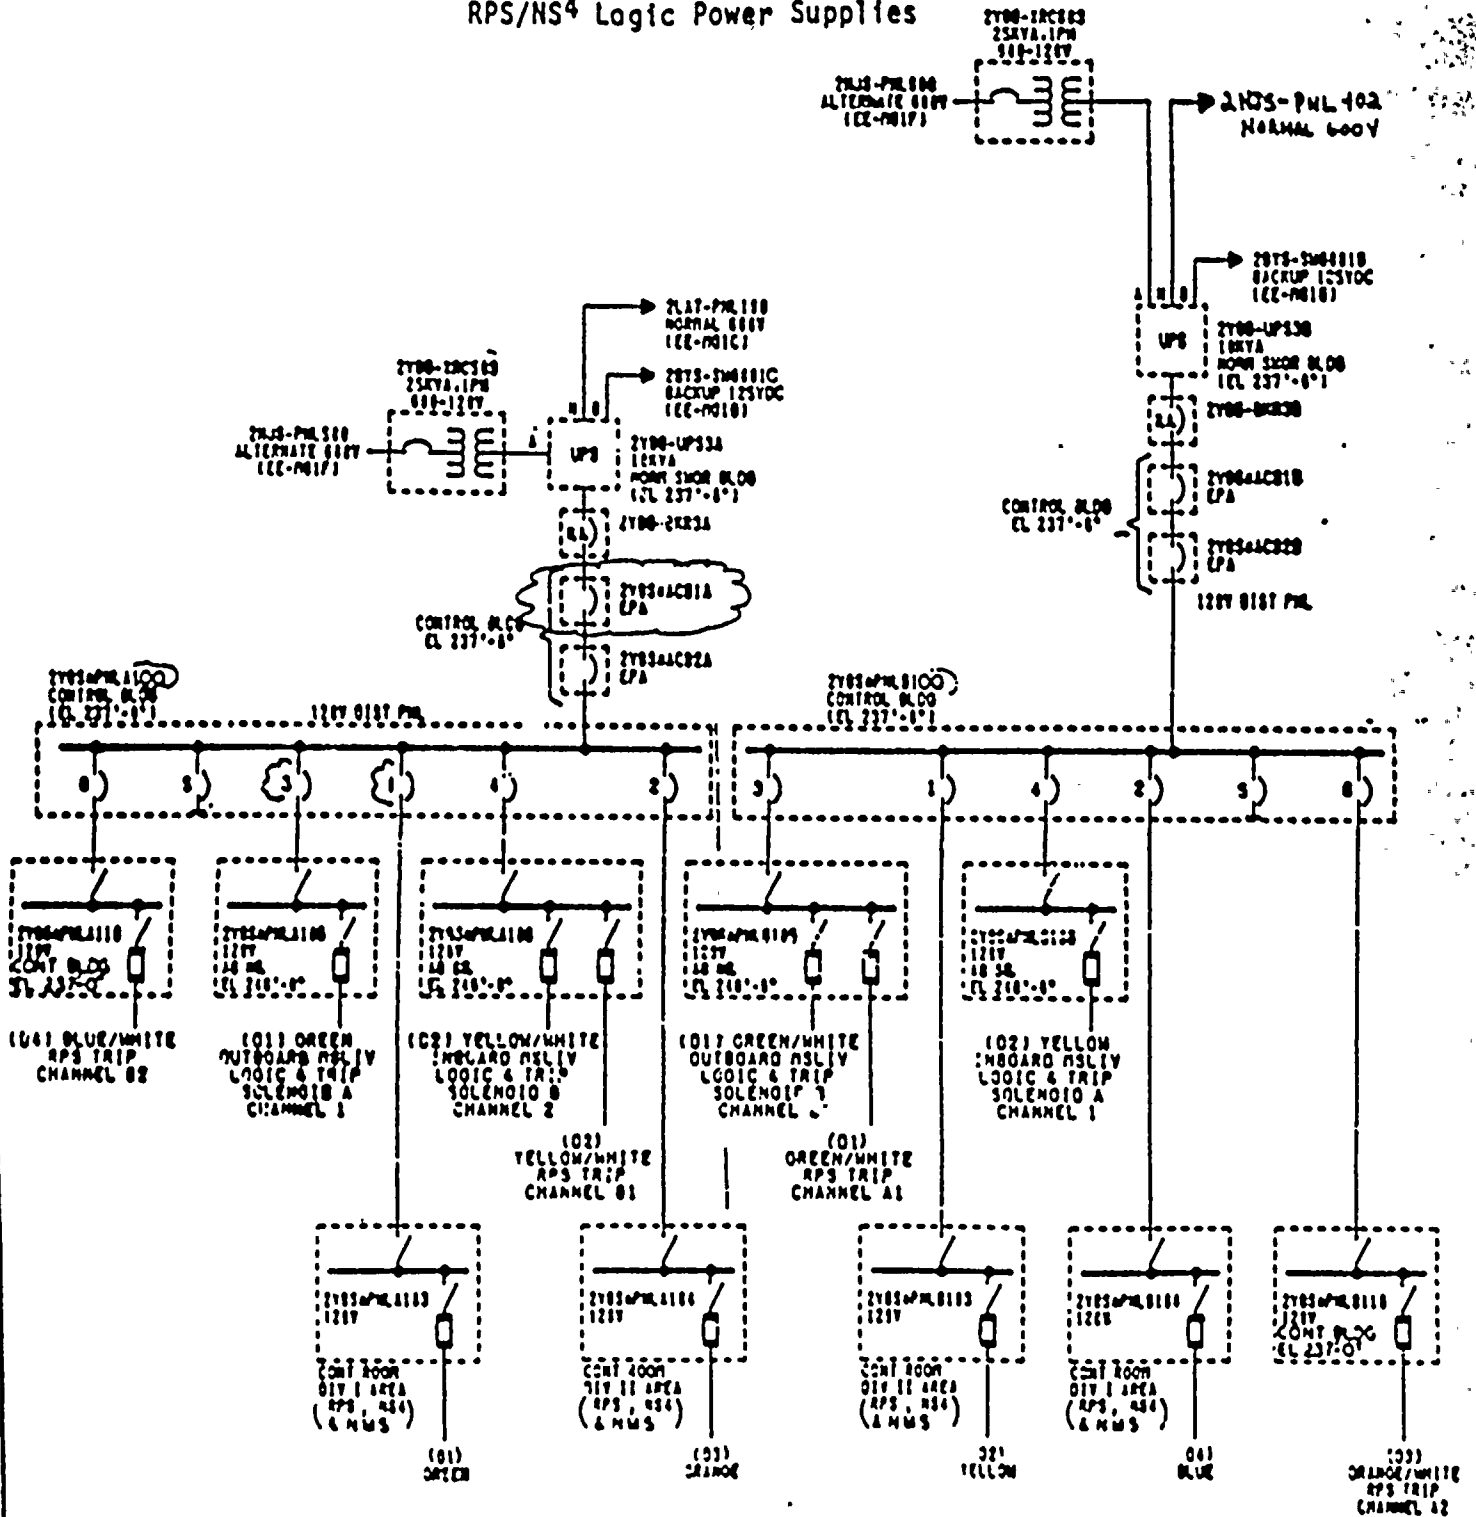
ATTACHMENT 2

Another root cause is the inability to test the EPAs without power interruptions. If this design feature existed, this event would not have occurred. A loss of power to a single power supply of the RPS/NS⁴ logic results in a half scram and in numerous Engineered Safety Features (ESF) actuations such as primary containment isolation, secondary containment isolation and automatic initiation of GTS.

The inadvertent failure of the EPA output breaker resetting mechanism or an unanticipated trip of an EPA has the potential to create a serious transient during power operation. The loss of a single power supply to RPS/NS⁴ logic has the following plant impact:
