EXECUTIVE SUMMARY
INSPECTION REPORT 50-220/88-201
NINE MILE POINT UNIT 1

U.S. NUCLEAR REGULATORY COMMISSION
OFFICE OF NUCLEAR REACTOR REGULATION

Division of Reactor Inspection and Safeguards

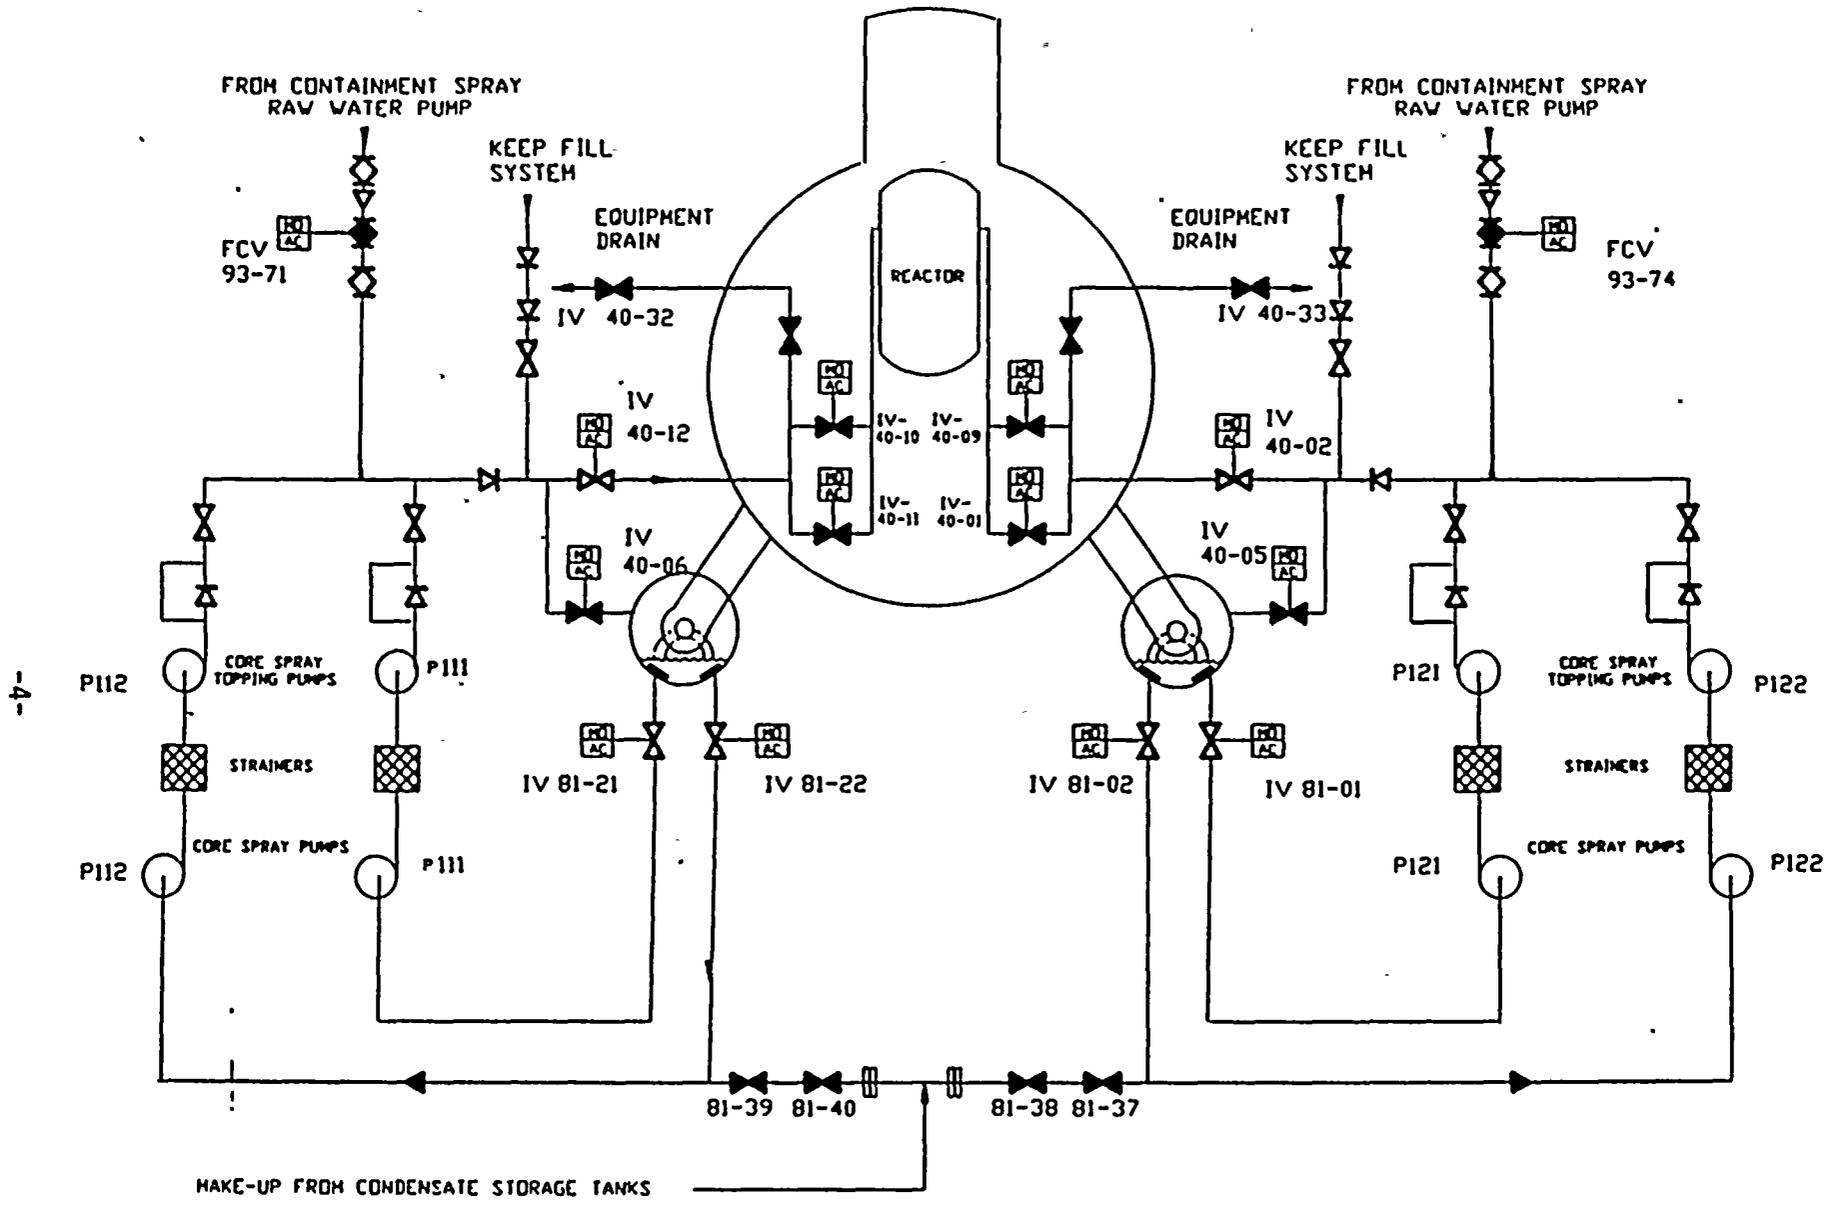
FIGURE 1

NMP-1 CORE SPRAY SYSTEM
