**BROWNS FERRY NUCLEAR PLANT (BFN) - EVALUATION OF EPOXY
COATING ON STAINLESS STEEL COMPONENTS INSIDE THE UNIT 2
SUPPRESSION CHAMBER**

TENNESSEE VALLEY AUTHORITY
BROWNS FERRY NUCLEAR PLANT (BFN)
UNIT 2

EVALUATION OF EPOXY COATING ON STAINLESS STEEL COMPONENTS
INSIDE THE UNIT 2 SUPPRESSION CHAMBER

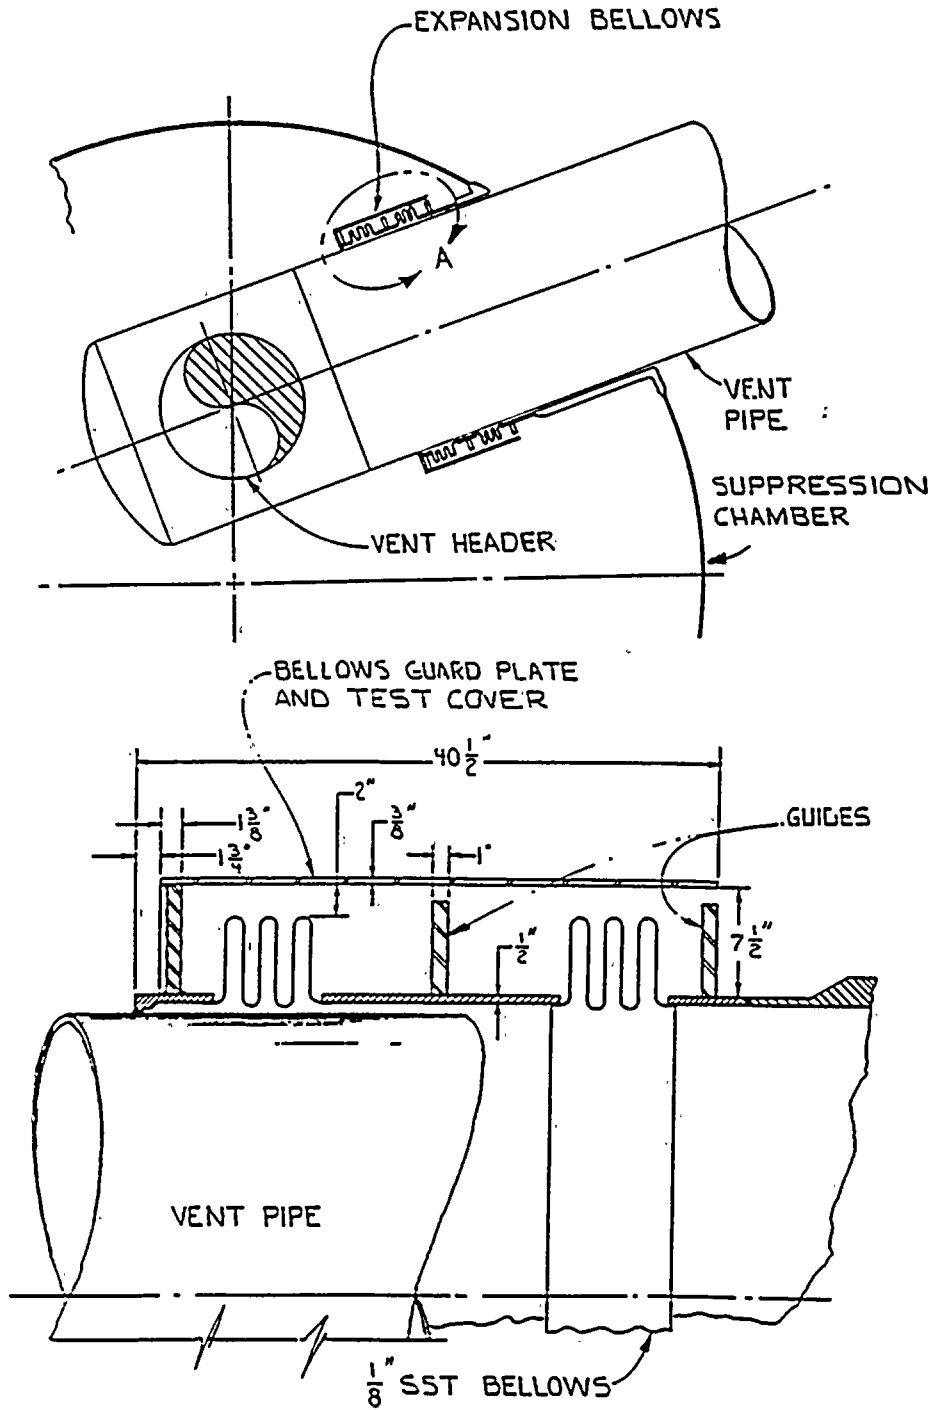
FIGURE 1
DRYWELL VENT PIPE EXPANSION BELLOWS

The bellows are flexible expansion joints that allow movement of the main vent pipes through the torus wall, while maintaining the required pressure boundary. Sketches of the drywell vent pipe expansion bellows are provided in Figure 1 (Please note that the cover plates shown on the sketches were for the purposes of leak rate testing and were removed prior to installation). The movement of these bellows was previously analyzed as part of the Long Term Torus Integrity Program (Reference 8), which was performed in order to resolve Generic Technical Activity A-7 (NUREG-0661).

As previously discussed, the movement of these bellows during a design basis accident large break LOCA scenario was analyzed. The dynamic and static stresses were determined not to be significant. Fatigue life was the dominant concern. A fatigue evaluation showed thermal stresses to be the most significant. The combined axial displacement of the bellows and the suppression chamber was calculated to be 1.16 inches and the combined lateral displacement was 0.48 inches. The deflection of the bellows due to these analyzed thermal stresses is concentrated on the twelve "peaks" and eight "valleys" of the bellows. The maximum deflections are distributed equally across the entire surface area of all the peaks and valleys by the rounded shape of the bellows. The maximum movement at any of these peaks and valleys is well within the flexural resistance of the coating.

TVA has determined, based on engineering judgement, that when this type of epoxy coating is exposed to flexural stresses, the typical failure mode is cracking of the coating to the extent necessary to relieve the stresses. Should disbonding develop, it typically occurs only at the cracks. The coating that disbonds at the cracks is typically in the form of very small flakes (less than $\frac{1}{8}$ " diameter) and powder-like particles, which do not pose a threat to suction strainer blockage or to the ECCS equipment downstream of the strainers.

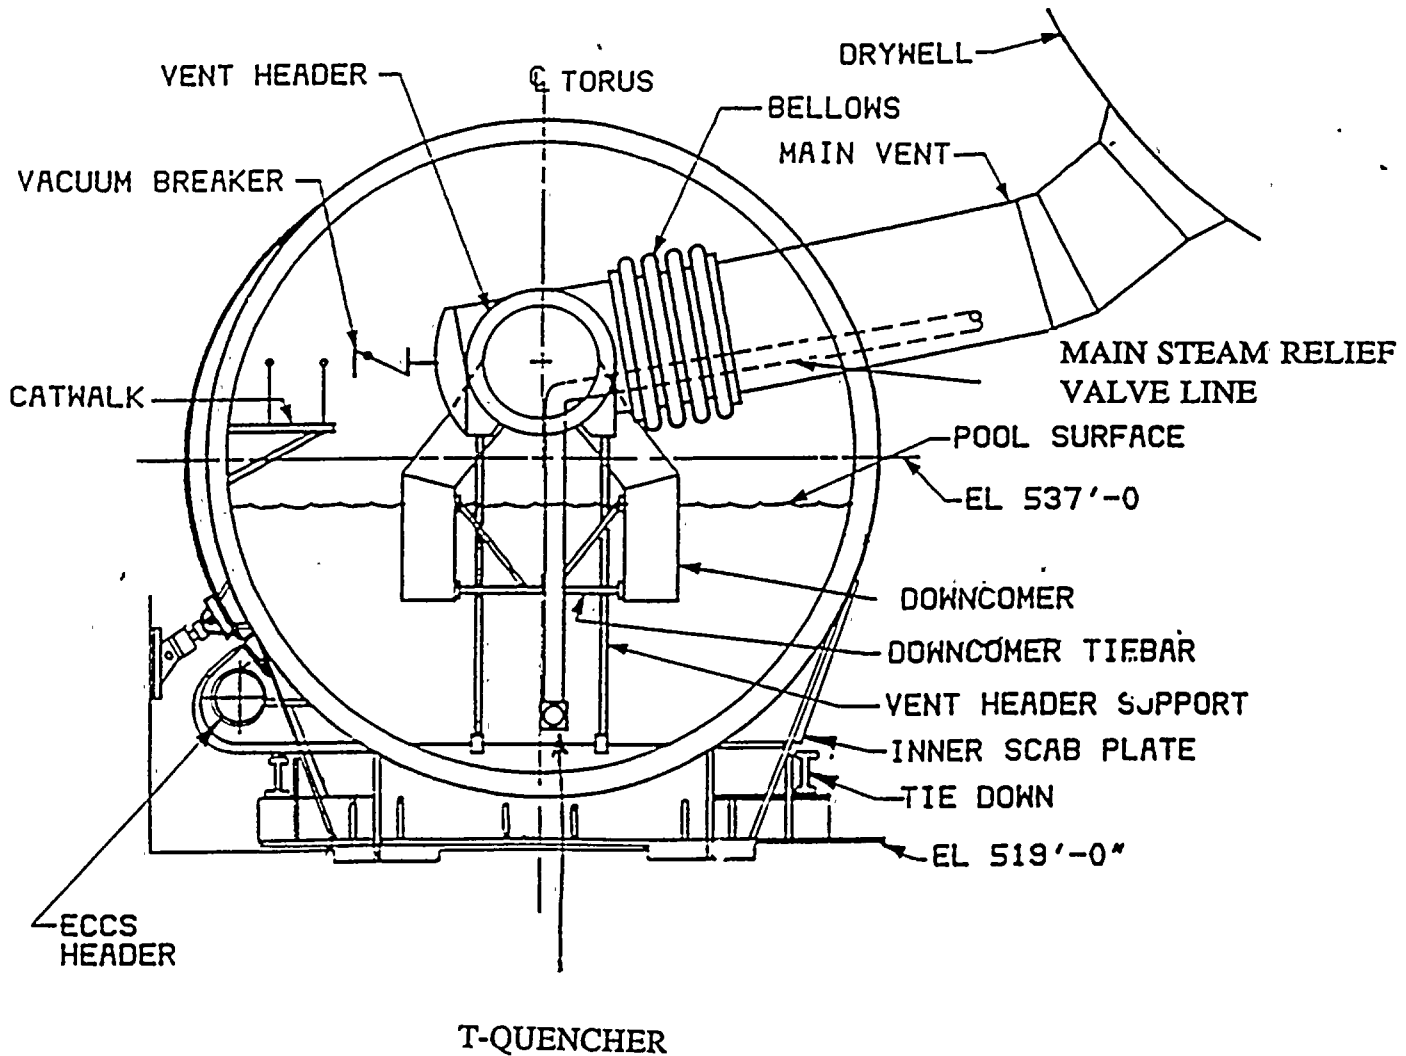
FIGURE 2
 CROSS-SECTION OF THE SUPPRESSION CHAMBER

Projecting downward from the vent header are 96 downcomer pipes, 24 inches in diameter, and terminating approximately 3 feet below the water surface of the pool. Each BFN unit is equipped with 13 Main Steam Relief Valves (MSRVs). Each valve discharges into the torus through a perforated sparger called a T-quencher discharge device. Each T-quencher is made of 12-inch diameter schedule 80 stainless steel pipe and consists of two arms, which contain numerous perforations to allow the controlled discharge from the MSRVs to the suppression chamber. Figure 2 provides a cross-section of the suppression chamber and shows the relative locations of these components.

The T-quenchers are normally submerged in the suppression chamber. The other coated stainless steel components inside the suppression chamber (i.e., the bellows of the main vent, catwalk support plates, conduits, junction boxes, small piping, valve bodies, and miscellaneous other small components) are all located above the normal suppression pool water level.

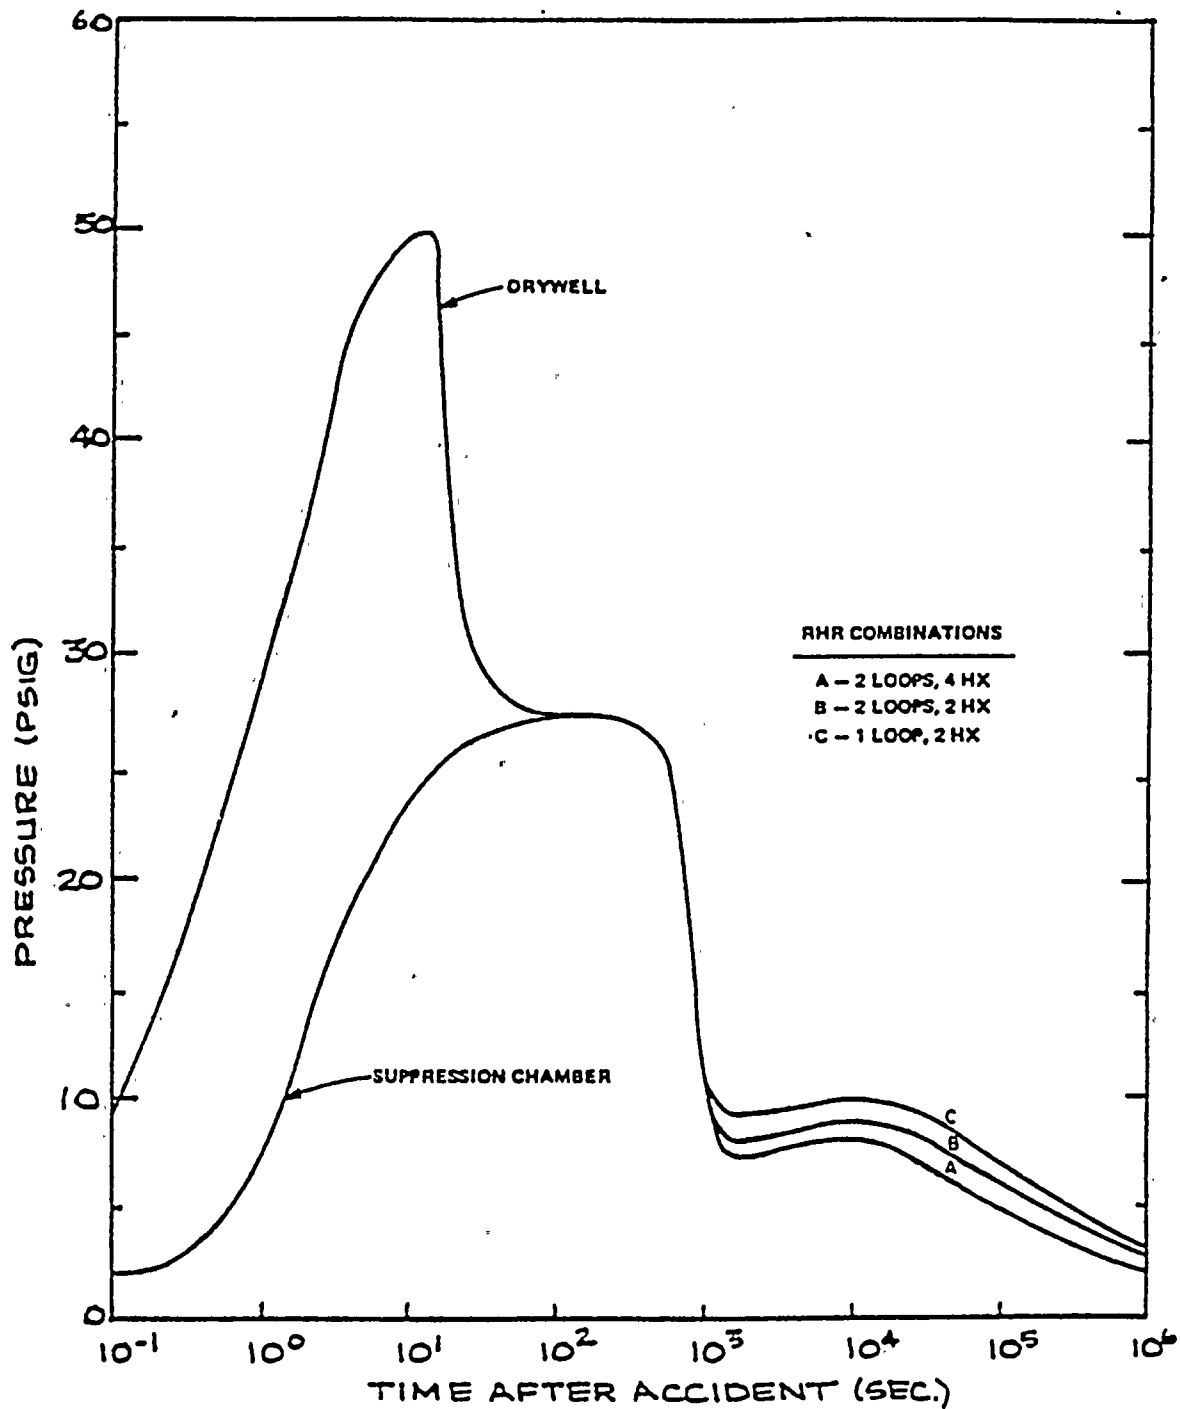
FIGURE 3
PRIMARY CONTAINMENT PRESSURE RESPONSE
AFTER A LOSS OF COOLANT ACCIDENT

During the large break LOCA scenario, water, air and steam are released from the drywell atmosphere. The resulting primary containment pressure response is shown in Figure 3. The peak drywell pressure of approximately 50 psig forces the water, air and steam through the 96 downcomers to the suppression chamber water. The downcomers are over 6 feet away, and offset from, the submerged T-quenchers. The bellows of the main vent, catwalk support plates, conduits, junction boxes, small piping, valve bodies, and miscellaneous other small components are all located above the normal suppression pool water level and would only experience occasional and short-lived dousing by pool swell.

The suppression chamber pressure builds gradually to a peak of approximately 28 psig. The downward force on the T-quencher coating from the blowdown force and the subsequent turbulence around the T-quenchers due to the hydro-dynamic effects of the blowdown are significantly less severe than the forces produced during the MSR/V blowdown, which was previously discussed. The occasional and short-lived dousing by pool swell on the other coated stainless steel components are also expected to be less severe than the forces produced on the T-quenchers during the MSR/V blowdown.
