BROWNS FERRY NUCLEAR PLANT (BFN) - UNIT 2 - RESULTS OF CORE SHROUD INSPECTION (TAC NO. M90082)

TENNESSEE VALLEY AUTHORITY BROWNS FERRY NUCLEAR PLANT (BFN) UNIT 2

BFN UNIT 2 REACTOR CORE SHROUD INSPECTION RESULTS AND ANALYSIS

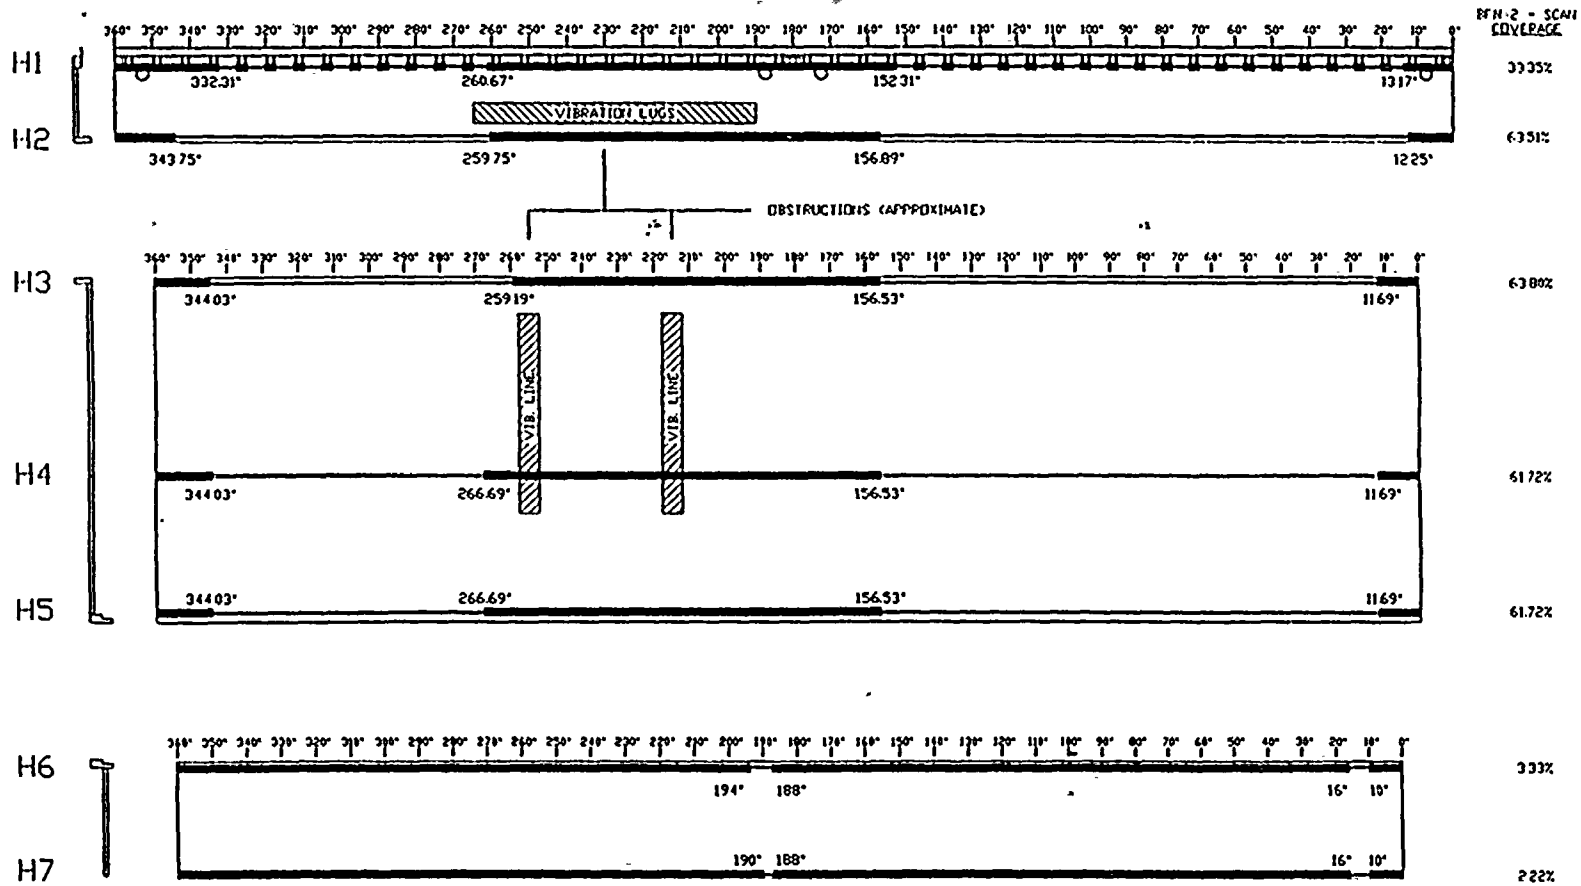
FIGURE E-2
UNIT 2 INSPECTION RESULTS
(SHADED AREAS INDICATE LOCATIONS NOT SCANNED)

The results of the Unit 2 inspection indicate that severe cracking of the core shroud welds is not occurring. During UT inspections, surface connected planar indications were found in three welds (H2, H3, and H5). The flaws were dispersed around the circumference of each weld. There were no through-wall cracks identified. A summary of the Unit 2 inspection results is provided below. The individual Examination Summary Sheets for shroud welds H1 through H7 are provided on pages E-6 through E-12.

<u>WELD NUMBER</u>	<u>INSPECTION TYPE</u>	<u>RESULTS</u>	<u>FLAW TYPE</u>
H1	UT	No reportable indications	N/A
H2	UT	(1) indication 1.34" total length	Planar
H3	UT	(3) indications 9.41" total length	Planar (3)
H4	UT	No reportable indications	N/A
H5	UT	(6) indications 9.09" total length	Planar (6)
H6	UT	No reportable indications	N/A
H7	UT	No reportable indications	N/A
