Final ASP Program Analysis – Precursor

Accident Sequence Precursor Program – Office of Nuclear Regulatory Research			
Turkey Point Nuclear Generating Station, Unit 3		Loss of 3A 4kV Vital Bus Results in Reactor Trip, Safety System Actuations, and Loss of Safety Injection Function	
Event Date: 3/18/2017		LER: 250-2017-001 IRs: 05000250/2017008 and 05000250/2017002	CCDP = 3×10^{-6}
Plant Type: Westinghouse 3-Loop Pressurized-Water Reactor (PWR) with Dry, Ambient Pressure Containment			
Plant Operating Mode (Reactor Power Level): Mode 1 (100% Reactor Power)			
Analyst: Chris Hunter	Reviewer: Ian Gifford	Contributors: N/A	Approval Date: 02/12/2018

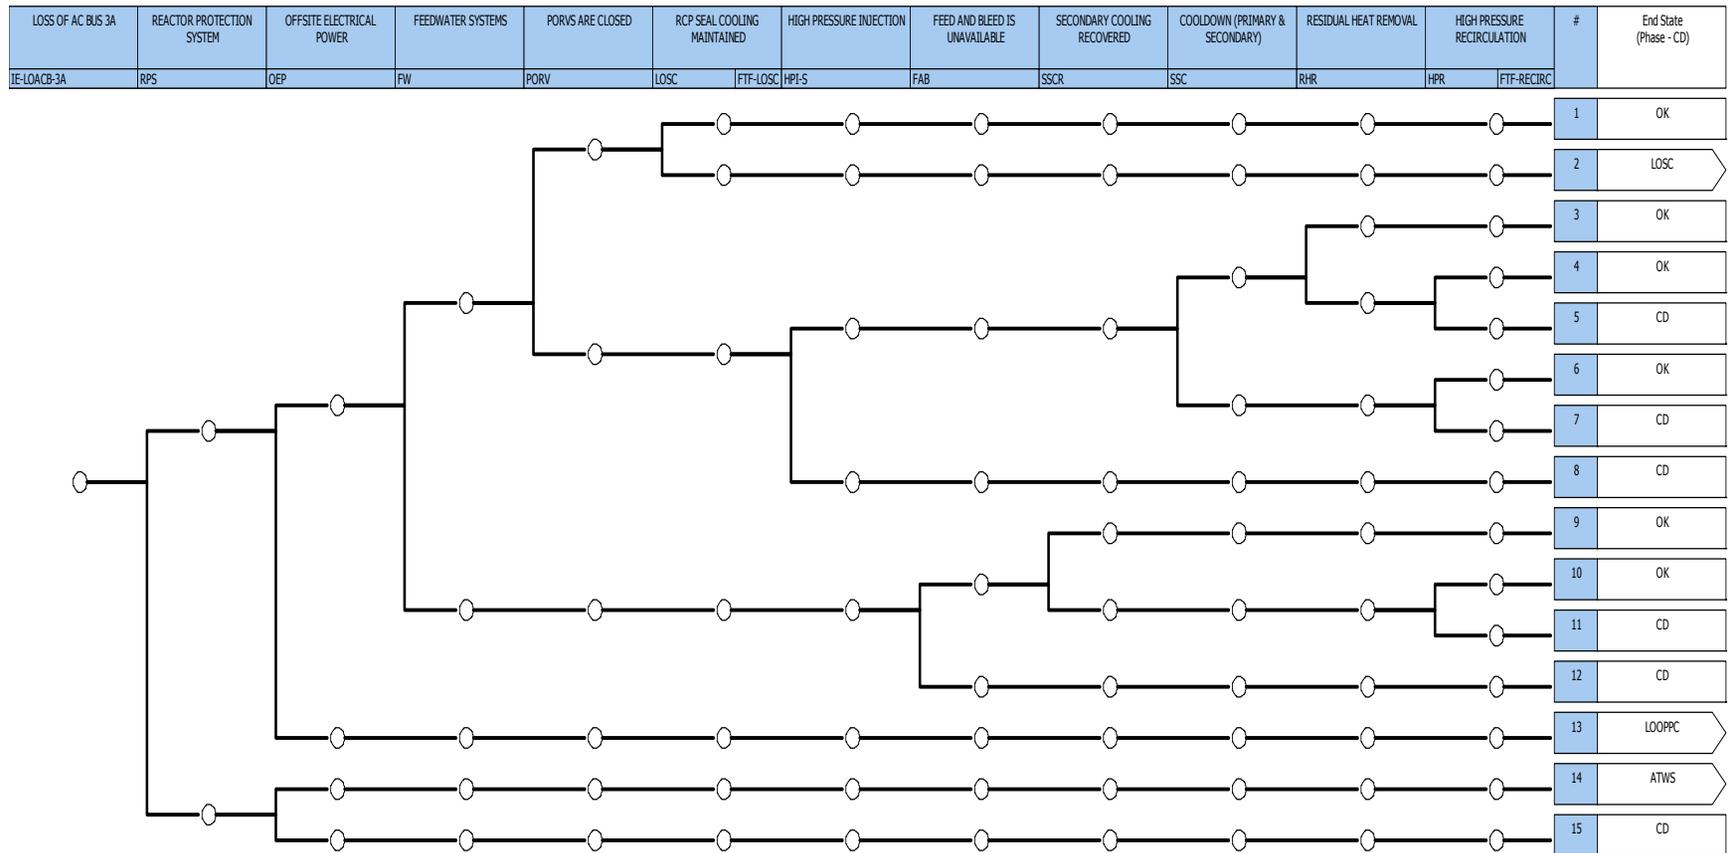
Figure A-1. Turkey Point Loss of 4.16kV Safety-Related Bus 3A Event Tree

Dominant Sequence. The dominant accident sequence is LAC3A sequence 13-16-22 (CCDP = 2.30×10^{-6}), which contributes approximately 71 percent of the total internal events CCDP. The dominant sequences that contribute at least 1.0 percent to the total internal events CCDP are provided in the following table. The dominant sequence is shown graphically in Figures A-1 through A-4 in [Appendix A](#).

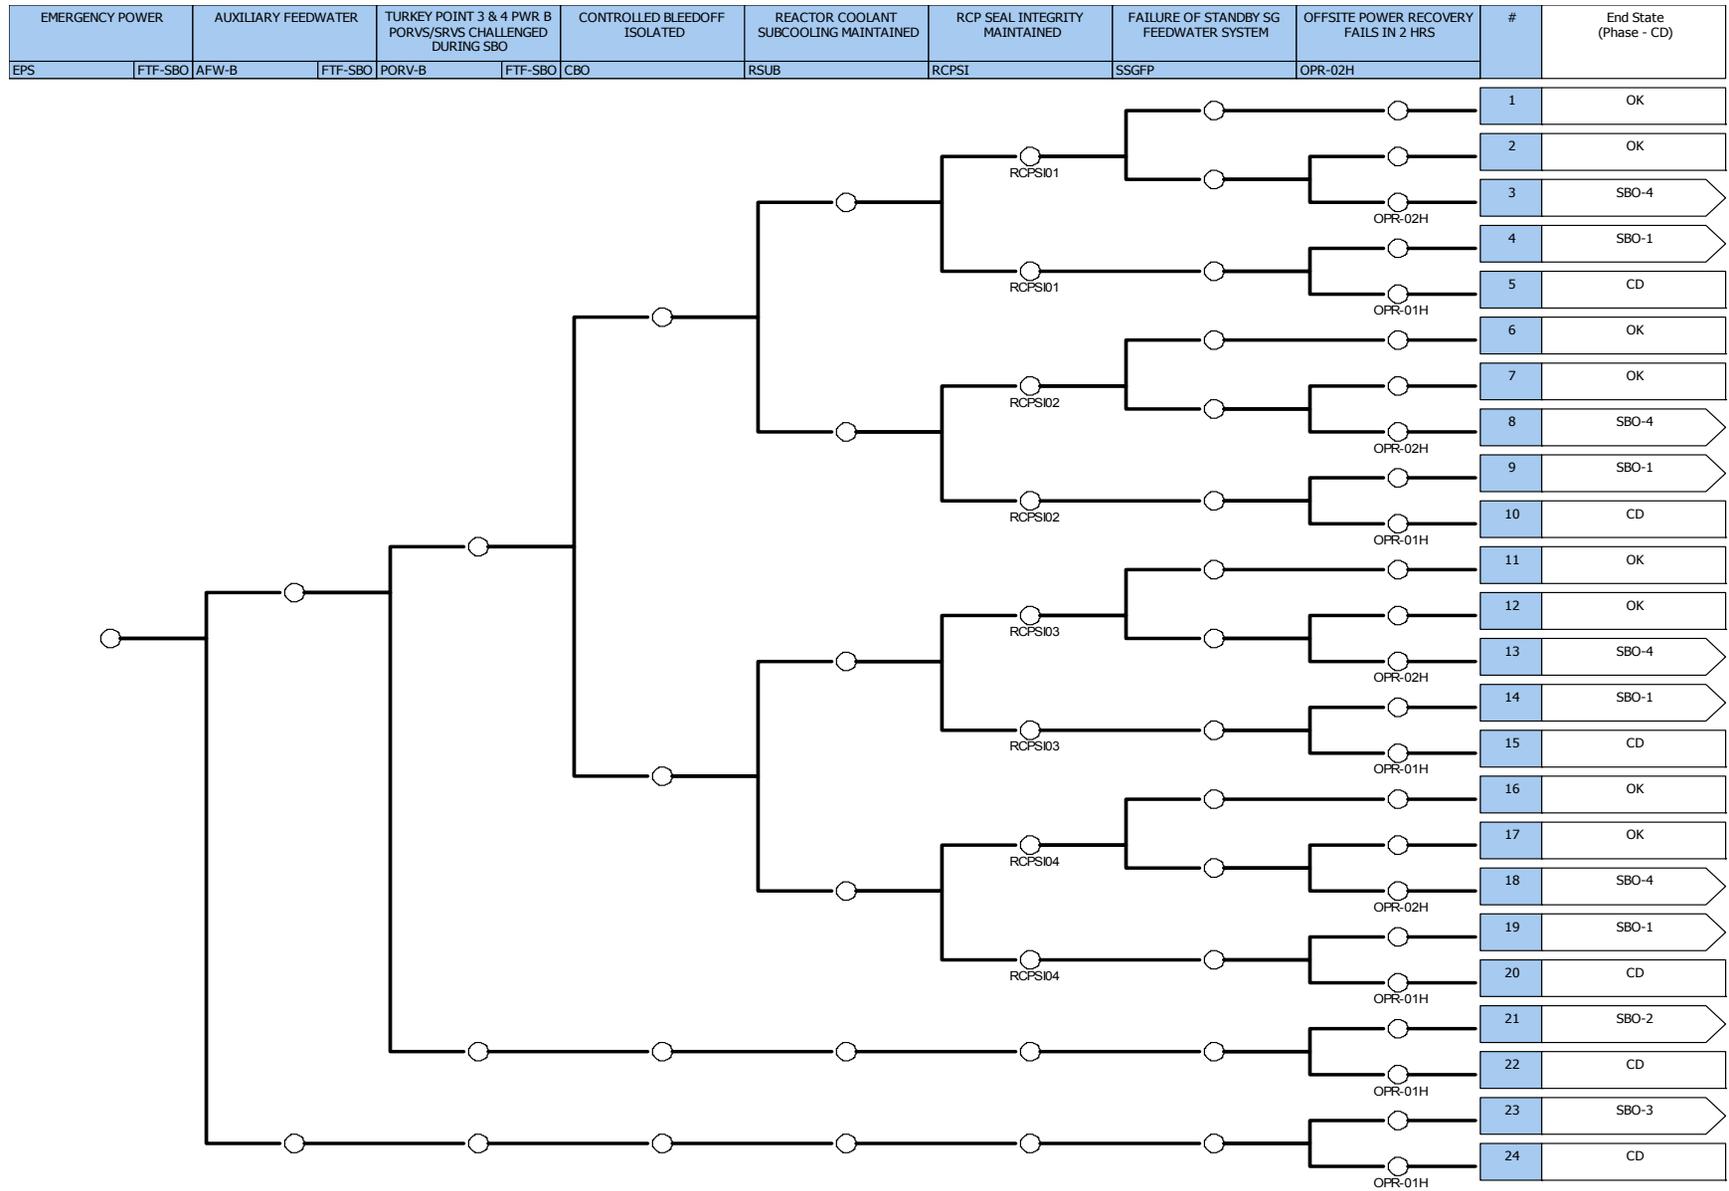
Figure A-3. Modified Turkey Point SBO Event Tree

- In ASP analyses, recovery credit for EDG failures is limited to cases where event information supports credit for EDG recovery. Therefore, the DGR-02H (*diesel generator recovery in 2 hours*) top event (including applicable event tree branching) was eliminated from the station blackout (SBO) event tree. The modified SBO event tree is shown in [Figure A-3](#).

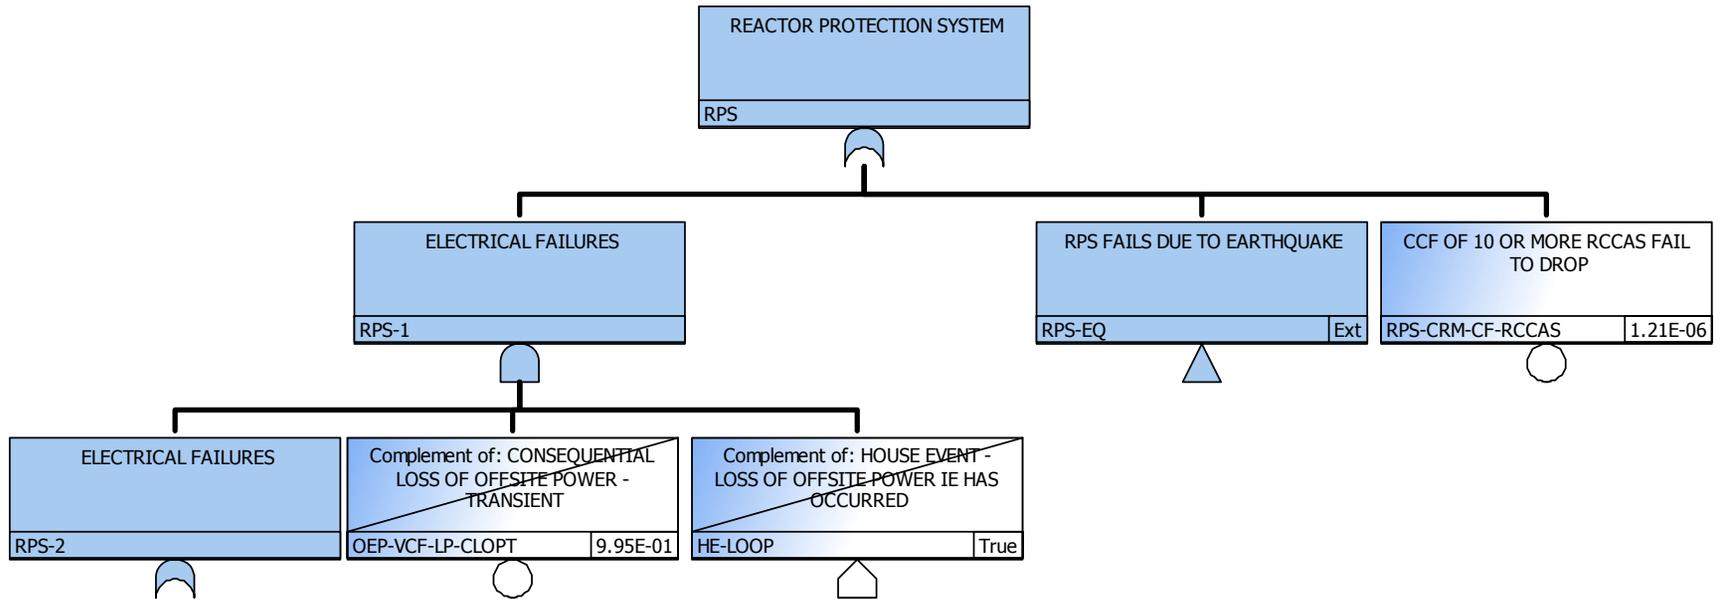
Figure B-1. Modified Turkey Point RPS Fault Tree

- To prevent risk contributions from certain anticipated transient without scram (ATWS) cut sets that do not apply to this assessment, the complement basic event OEP-VCF-LP-CLOPT (*consequential loss of offsite power—transient*) was inserted under gate RPS-1 (*electrical failures*) in the RPS (*reactor protection system fault tree*). An ATWS is only possible during a consequential loss of offsite power (LOOP) if the rods fail to insert into the reactor (i.e., they are mechanically stuck). The modified RPS fault tree is shown in [Figure B-1](#).

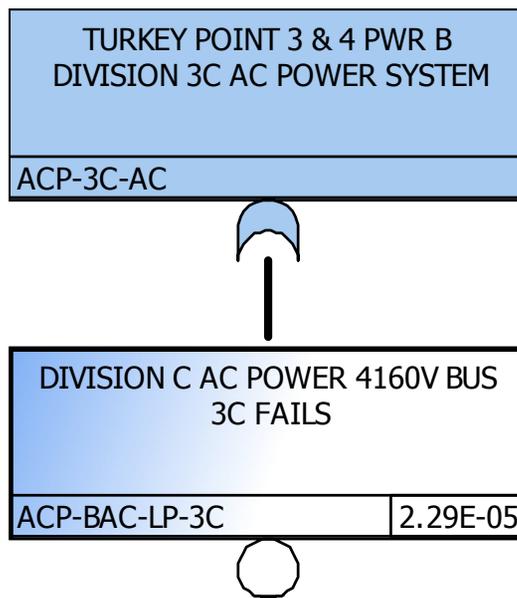
Figure B-2. Modified Turkey Point ACP-3C-AC Fault Tree

- During the event, nonsafety-related AC bus 3C remained energized and, therefore, the motor-driven standby SG feedwater pump was available to provide inventory makeup to the SGs. This pump would also be available for the dominant (postulated) scenarios in this analysis (i.e., loss of all safety-related 4.16 kV power). To ensure that credit for this pump is provided in this analysis, basic events HE-LOOP (*house event—loss of offsite power initiating event has occurred*) and HE-LOSP-3C (*loss of division 3C offsite power flag*) were deleted from the ACP-3C-AC (*Turkey Point 3 and 4 PWR B division 3C AC power system*) fault tree. The modified ACP-3C-AC fault tree is shown in [Figure B-2](#).
