Final ASP Program Analysis – Precursor

Accident Sequence Precursor Program – Office of Nuclear Regulatory Research			
Turkey Point Nuclear Generating Station, Unit 3		Loss of 3A 4kV Vital Bus Results in Reactor Trip, Safety System Actuations, and Loss of Safety Injection Function	
Event Date: 3/18/2017		LER: 250-2017-001 IRs: 05000250/2017008 and 05000250/2017002	CCDP = 3×10^{-6}
Plant Type: Westinghouse 3-Loop Pressurized-Water Reactor (PWR) with Dry, Ambient Pressure Containment			
Plant Operating Mode (Reactor Power Level): Mode 1 (100% Reactor Power)			
Analyst: Chris Hunter	Reviewer: Ian Gifford	Contributors: N/A	Approval Date: 02/12/2018

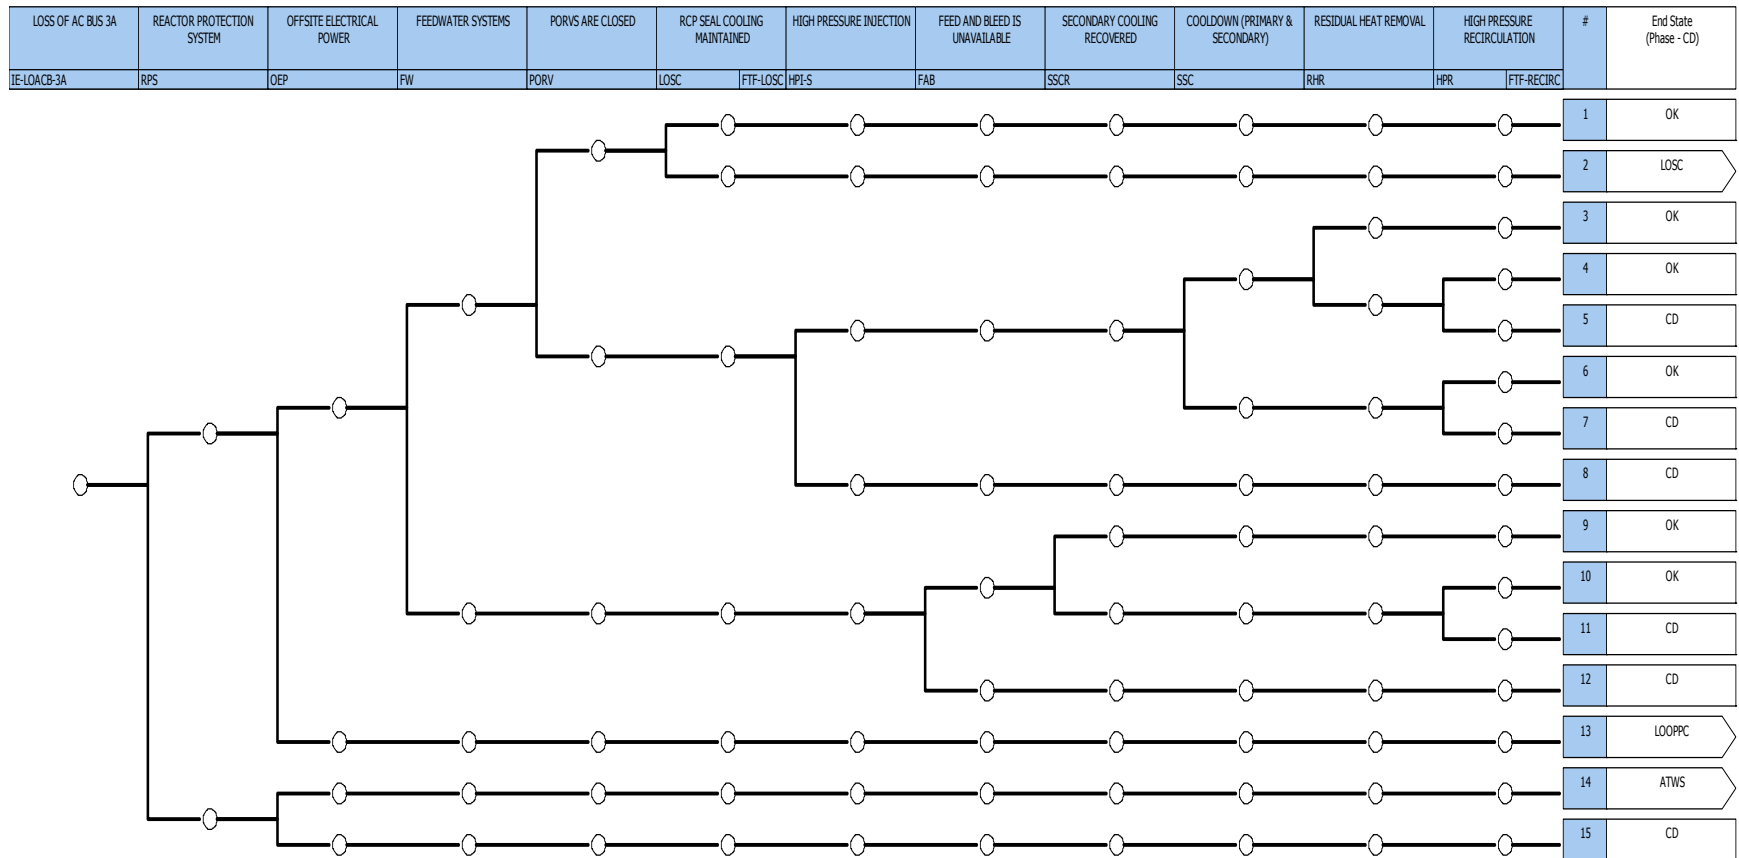
Figure A-1. Turkey Point Loss of 4.16kV Safety-Related Bus 3A Event Tree

Dominant Sequence. The dominant accident sequence is LAC3A sequence 13-16-22 (CCDP = 2.30×10^{-6}), which contributes approximately 71 percent of the total internal events CCDP. The dominant sequences that contribute at least 1.0 percent to the total internal events CCDP are provided in the following table. The dominant sequence is shown graphically in Figures A-1 through A-4 in [Appendix A](#).

Sequence	CCDP	Percentage	Description
LAC3A 13-16-22	2.30E-6	71.4%	Loss of safety-related bus 3A initiating event; successful reactor trip; subsequent loss of bus 3B results in a loss of all safety-related AC power; AFW succeeds; a PORV fails to reclose resulting in a LOCA; all HHSI pumps are unavailable due to no electrical power (Unit 3) or maintenance (Unit 4), which results in core damage
LAC3A 13-16-20	2.68E-7	8.3%	Loss of safety-related bus 3A initiating event; successful reactor trip; subsequent loss of bus 3B results in a loss of all safety-related AC power; AFW succeeds; RCP seal injection/cooling is lost and a subsequent RCP seal LOCA occurs; all HHSI pumps are unavailable due to no electrical power (Unit 3) or maintenance (Unit 4), which results in core damage
LAC3A 02-9-05	1.21E-7	3.8%	Loss of safety-related bus 3A initiating event; successful reactor trip; AFW succeeds; RCP seal injection/cooling is lost and a subsequent RCP seal LOCA occurs due operators failing to trip the RCPs; high-pressure injection succeeds; accumulators successfully inject in the reactor coolant system; secondary-side cooldown fails, and high-pressure recirculation fails resulting in core damage

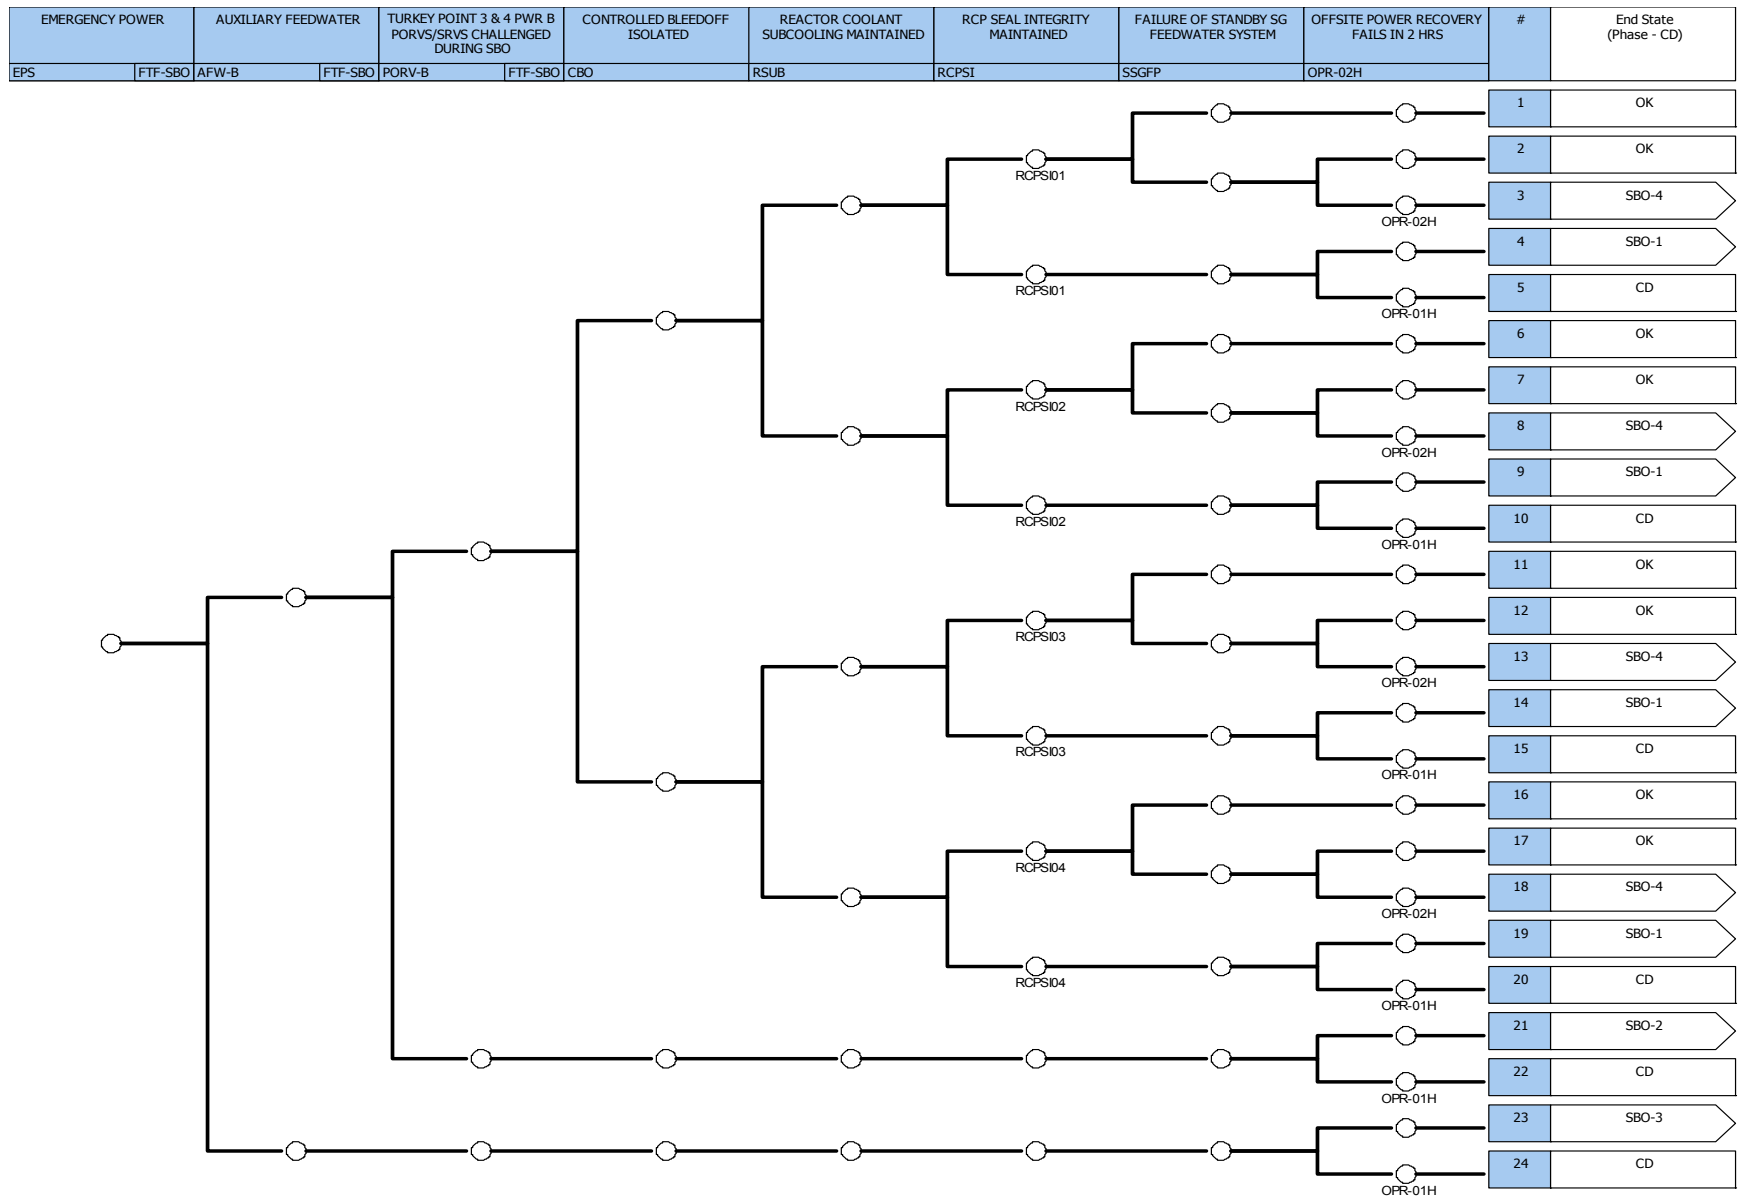
Figure A-3. Modified Turkey Point SBO Event Tree

- In ASP analyses, recovery credit for EDG failures is limited to cases where event information supports credit for EDG recovery. Therefore, the DGR-02H (*diesel generator recovery in 2 hours*) top event (including applicable event tree branching) was eliminated from the station blackout (SBO) event tree. The modified SBO event tree is shown in [Figure A-3](#).

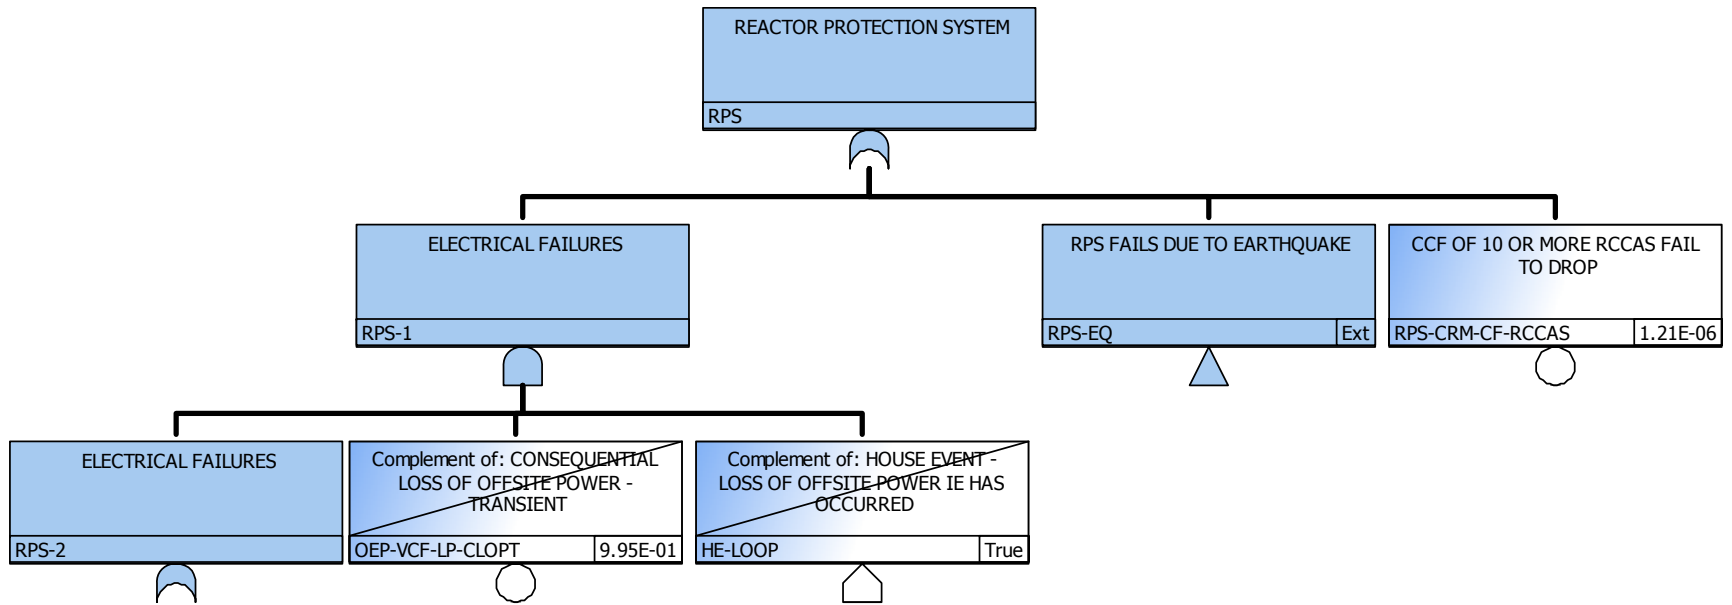
Figure B-1. Modified Turkey Point RPS Fault Tree

- To prevent risk contributions from certain anticipated transient without scram (ATWS) cut sets that do not apply to this assessment, the complement basic event OEP-VCF-LP-CLOPT (*consequential loss of offsite power—transient*) was inserted under gate RPS-1 (*electrical failures*) in the RPS (*reactor protection system fault tree*). An ATWS is only possible during a consequential loss of offsite power (LOOP) if the rods fail to insert into the reactor (i.e., they are mechanically stuck). The modified RPS fault tree is shown in [Figure B-1](#).

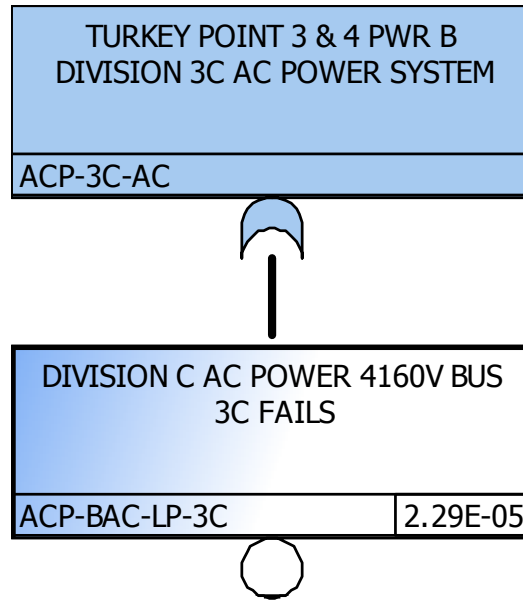
Figure B-2. Modified Turkey Point ACP-3C-AC Fault Tree

- During the event, nonsafety-related AC bus 3C remained energized and, therefore, the motor-driven standby SG feedwater pump was available to provide inventory makeup to the SGs. This pump would also be available for the dominant (postulated) scenarios in this analysis (i.e., loss of all safety-related 4.16 kV power). To ensure that credit for this pump is provided in this analysis, basic events HE-LOOP (*house event—loss of offsite power initiating event has occurred*) and HE-LOSP-3C (*loss of division 3C offsite power flag*) were deleted from the ACP-3C-AC (*Turkey Point 3 and 4 PWR B division 3C AC power system*) fault tree. The modified ACP-3C-AC fault tree is shown in [Figure B-2](#).
