UNITED STATES
NUCLEAR REGULATORY COMMISSION
WASHINGTON, D.C. 20555-0001

SUBJECT: TRIP REPORT - AUDIT OF BROWNS FERRY UNIT 3 USI A-46/IPEEE
IN-PROGRESS SEISMIC WALKDOWN, OCTOBER 16-20, 1995

BROWNS FERRY IN-PROGRESS SEISMIC WALKDOWN AUDIT REPORT

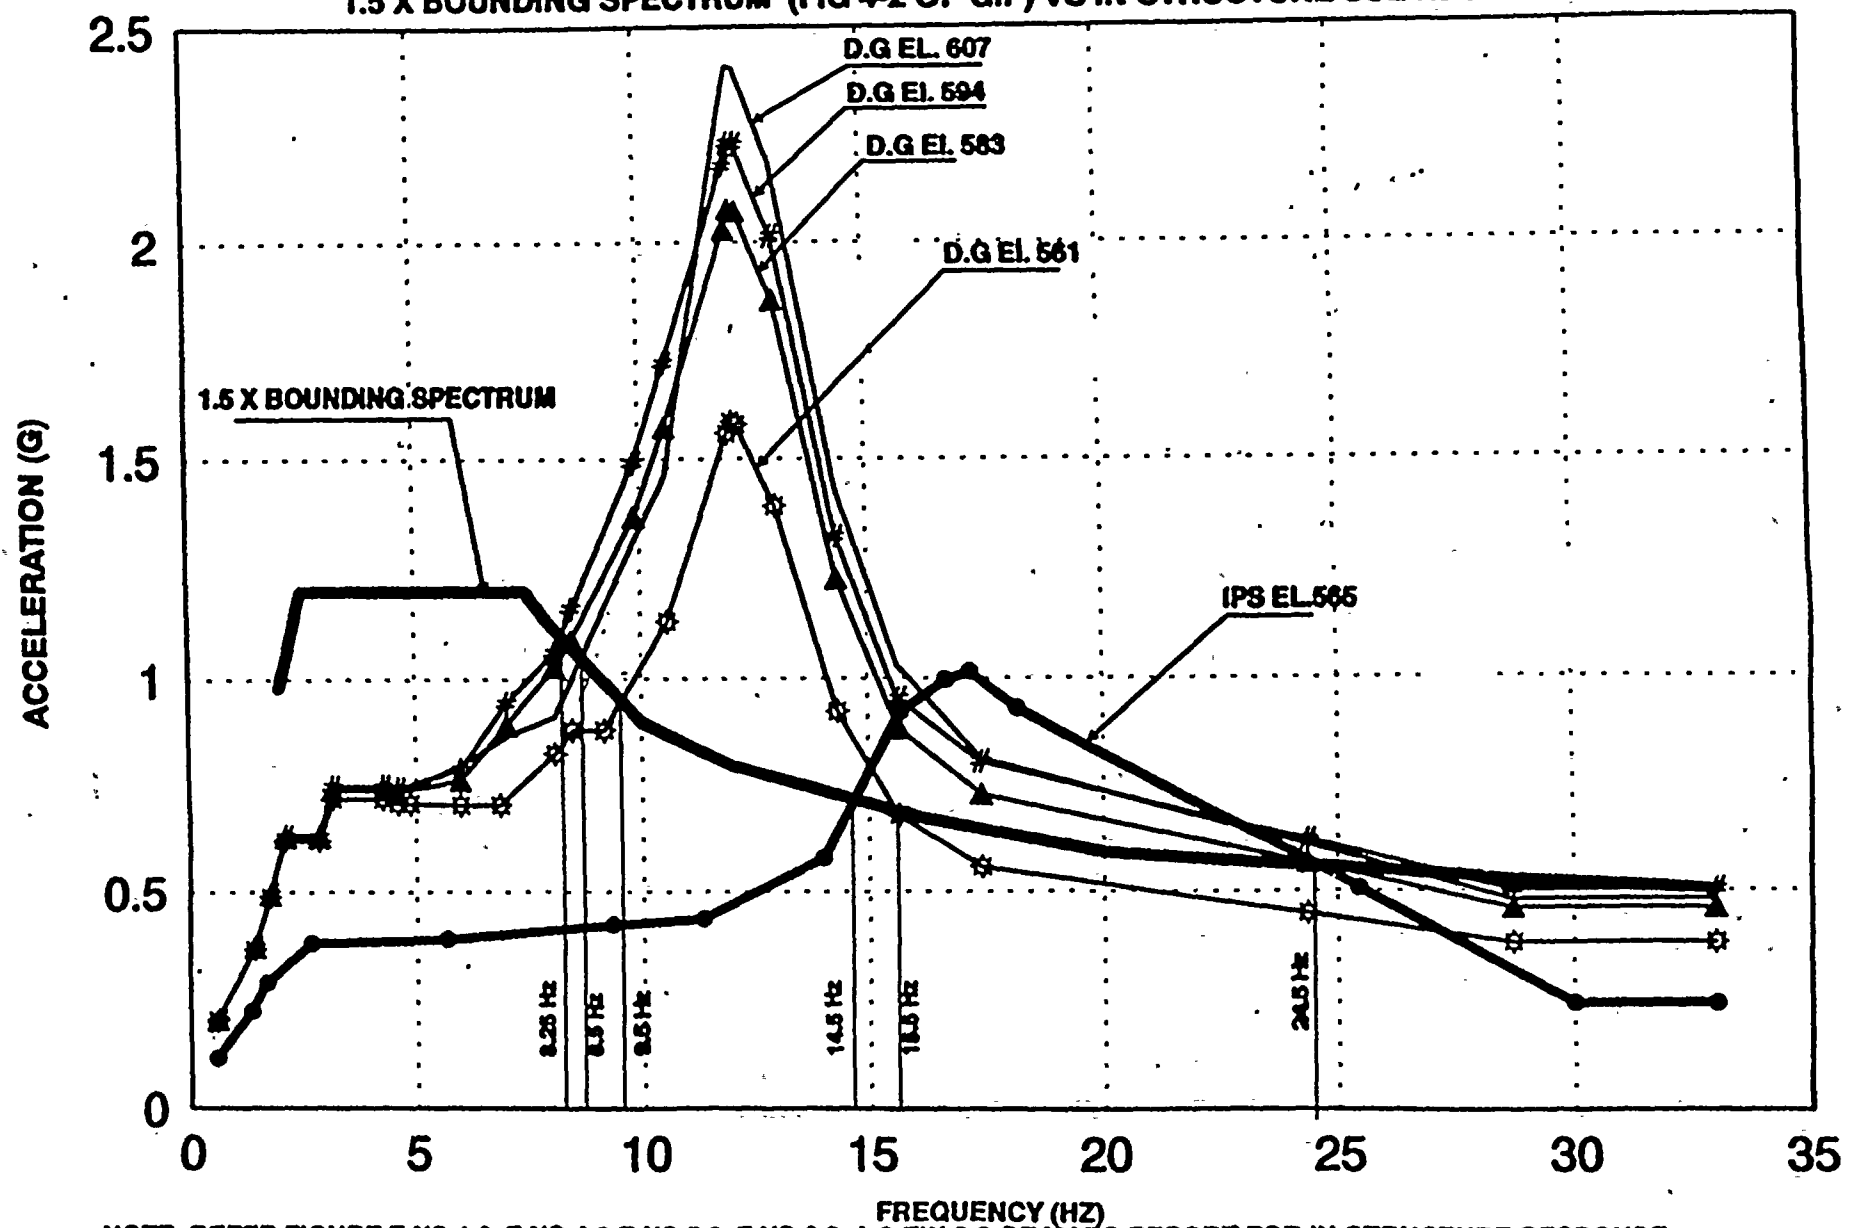
FIG B.1.1 (DG & IPS)
SEISMIC CAPACITY VS SEISMIC DEMAND
SPECTRA COMPARISON FOR DG AND IPS BLDG 5% DAMPING
1.5 X BOUNDING SPECTRUM (FIG 4-2 OF GIP) VS IN-STRUCTURE SSE RESPONSE

The Browns Ferry site SSE ground motion spectrum (approximately 0.3g spectral acceleration for a critical damping value of 5% and 0.2g ZPA) is substantially below the GIP-2 "Bounding Spectrum" (0.8g spectral acceleration for critical damping value of 5% and 0.33g ZPA). Therefore, in accordance with GIP-2, equipment items located at an elevation of up to 40-feet above effective grade may be adequate, provided that they satisfy the fundamental frequency requirement of about 8 Hz or higher. Alternatively, the GIP-2 also allows a comparison of the in-structure response spectrum with the equipment capacity spectrum, i.e., "Reference Spectrum." During the staff's audit, it was noted that if this second alternative is used, the licensing-basis seismic demands for some equipment items installed in the Diesel Generator (DG) Building and the Intake Pumping Station (IPS) will substantially exceed the "Reference Spectrum," i.e., the seismic demand measured by the in-structure response spectrum exceeds the seismic capacity of some equipment at certain elevations. Attachment 3 (Fig B.1.1), that was provided by the licensee during the audit, depicts curves representing seismic capacity vs. seismic demand for DG and IPS buildings. The figure signifies the magnitude of exceedence above the reference spectrum (1.5 x Bounding Spectrum) at various frequencies for various floor elevations in these buildings.

The staff does not consider the licensee's choice of the first alternative in the GIP-2 acceptable, since it results in a deviation from the licensing basis for the plant.

For Browns Ferry, it appears that the unexpected amplifications in-structure response spectra are due to large amplifications through the soil and the structures, especially at high frequencies for the DG Building and the IPS. In general, however, the staff contends that the use of the first method in the GIP-2 is only appropriate for facilities that do not have in-structure response spectra in their respective licensing basis documents. The staff believes that the lack of specificity in the GIP-2 with regard to the selection of the appropriate method for determining equipment seismic adequacy, has led to the identified non-conformance. The staff is pursuing this issue with the SQUG Steering Group.

NOTE: REFER FIGURE F-NS-1.6, F-NS-4.6, F-NS-5.6, F-NS-6.6, A.2-EW-5.6 OF MARS REPORT FOR IN-STRUCTURE RESPONSE SPECTRA (DG BLDG UNBROADENED BY 15% & IPS UNBROADENED BY 10%)
