**BROWNS FERRY NUCLEAR PLANT (BFN) - UNIT 3 - RESPONSE TO
REQUEST FOR ADDITIONAL INFORMATION REGARDING CORE SPRAY WELD
FLAW EVALUATION (TAC NO. M98059)**

ENCLOSURE
BROWNS FERRY NUCLEAR PLANT - UNIT 3
RESPONSE TO REQUEST FOR ADDITIONAL INFORMATION REGARDING
CORE SPRAY WELD FLAW EVALUATION

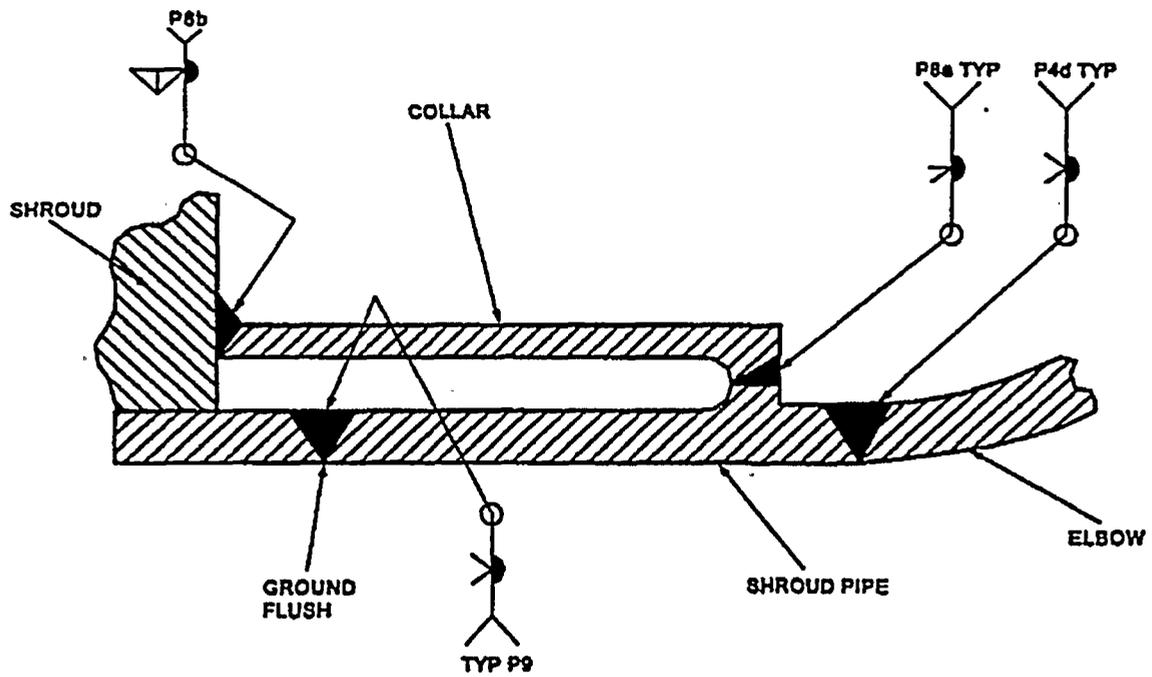
FIGURE 1
DIAGRAM OF ATTACHMENT OF CORE SPRAY PIPE TO SHROUD

With respect to the structural integrity of weld P8b, as discussed in TVA's March 9, 1997 letter (Reference 2), the ultrasonic testing (UT) data show the indications on weld P8b (See Figure 1) to be located in the heat affected zone of the core shroud itself, rather than in the collar. Only for the purposes of conservatively evaluating the capability of the core spray piping for continued operation, was a bounding assumption made that the indications are located in the collar. The projected remaining ligament for weld P8b at the end of the cycle of operations showed a projected remaining ligament of 2.5 inches, which would provide axial load carrying capability. With this amount of ligament remaining, the weld would not have any significant moment carrying capability. However, it is likely axial forces would be resisted up to the capacity of the remaining weld.

Finite element modeling was performed by assuming that the connection of the line to the shroud had no moment carrying capability. For the most limiting load cases, the safety factor was found to be greater than five as defined by load capacity/axial load.

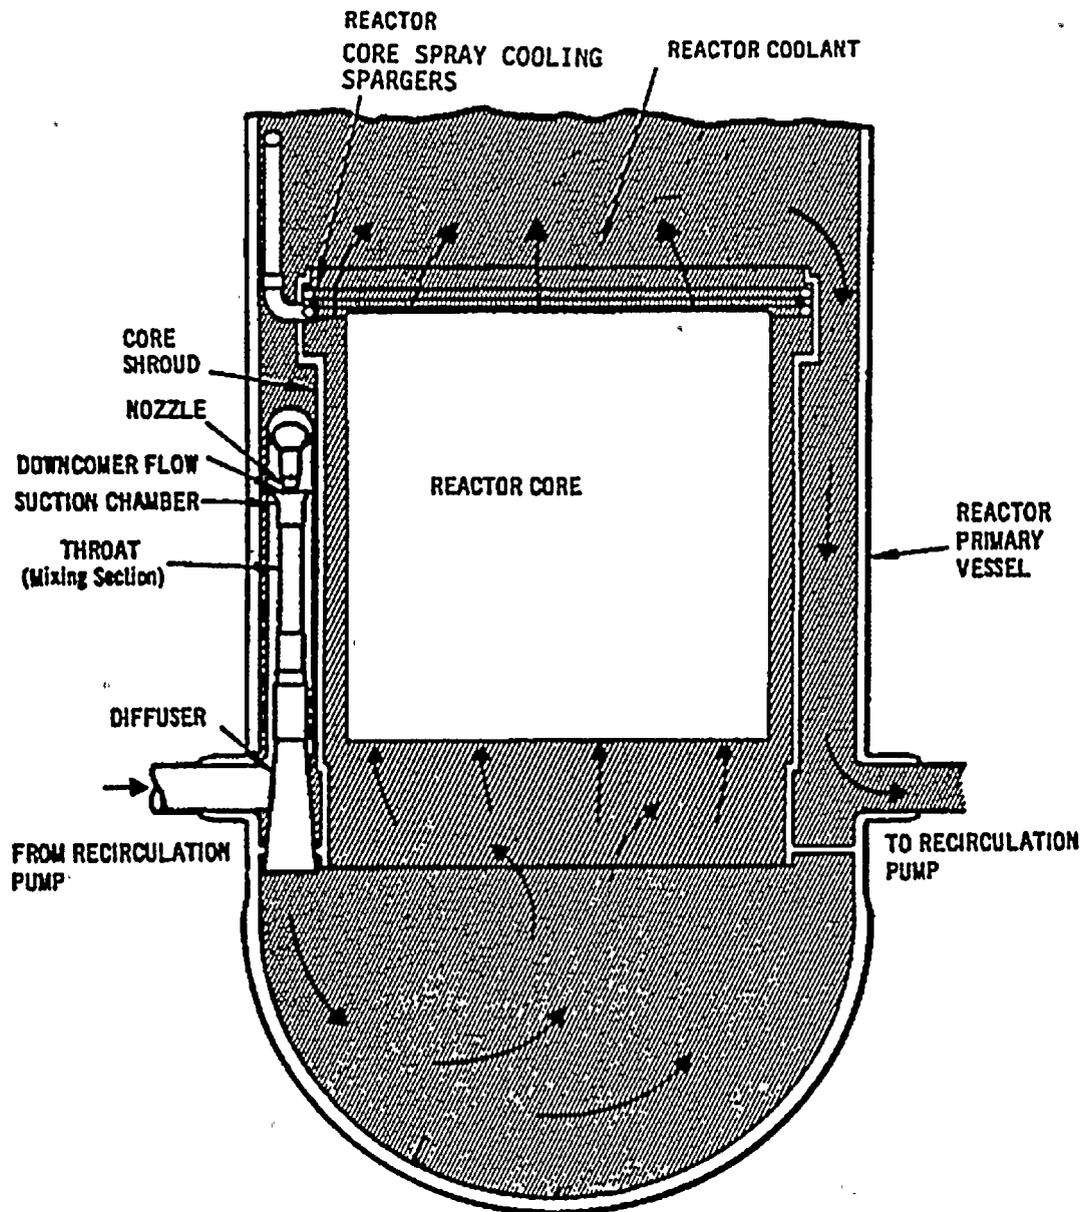
FIGURE 2
SCHEMATIC OF TYPICAL REACTOR VESSEL INTERNAL FLOW

- The piping at the subject weld joint is assumed to totally separate from the sparger nozzle; whereas it is more likely to crack and leak.
- No credit was taken for core cooling from the failed or cracked core spray loop. Realistically, some flow from that loop would contribute to flooding the reactor vessel (Figure 2) even with both welds P8b and P9 in a fully degraded condition.
- The recirculation discharge line break is assumed on Division II to match the core spray loop failure in Division II, which maximizes the effects of single failures in Division I.
- A worst case single failure occurs.
