SUBJECT: Forwards info requested in NRC 960328 RAI re util 951116  
response to NRC Bulletin 95-002, "Unexpected Clogging of RHR  
Pump Strainer While Operating in Suppression Pool Cooling  
Mode."

RE: Nine Mile Point Unit 1  
Docket No. 50-220  
DPR-63

**Subject:** *NRC Bulletin 95-02, "Unexpected Clogging of a Residual Heat Removal (RHR) Pump Strainer While Operating in Suppression Pool Cooling Mode"*

#### ***UNEXPECTED CLOGGING OF A RESIDUAL HEAT REMOVAL (RHR) PUMP STRAINER WHILE OPERATING IN SUPPRESSION POOL COOLING MODE***

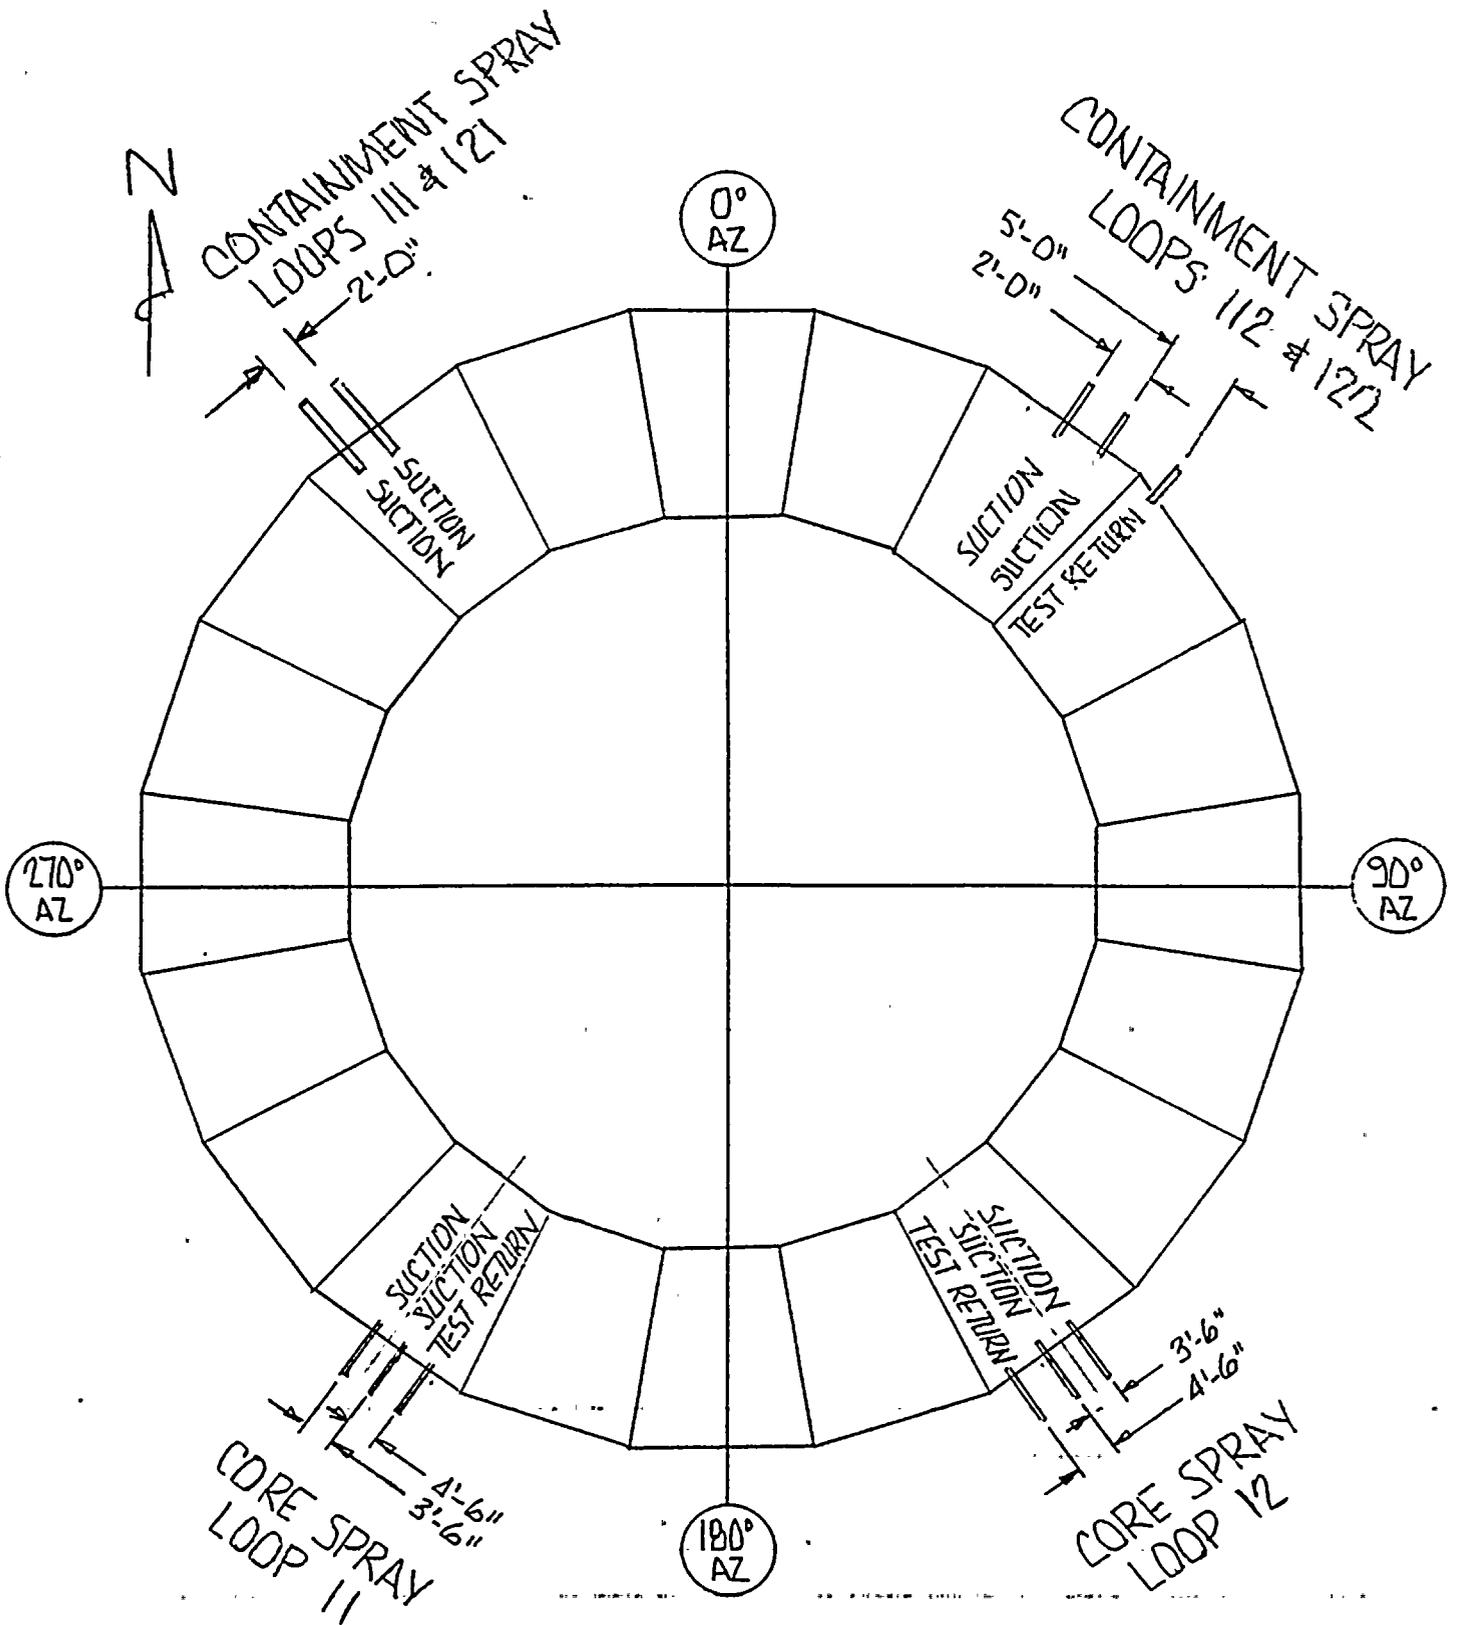
CORE & CONTAINMENT SPRAY PLAN

Concerning the orientation of the return lines, they enter the torus approximately 60° apart, perpendicular to the torus (i.e., directing flow towards the center of the torus). Accordingly, they do not direct flow in a circular motion around the torus. The configuration of the torus suction and return lines for the Core Spray and Containment Spray System are shown in the attached figure.
