NIAGARA MOHAWK POWER CORPORATION

NINE MILE POINT 1

SHROUD CRACKING SAFETY ASSESSMENT

REPORT NO. NER-1M-014

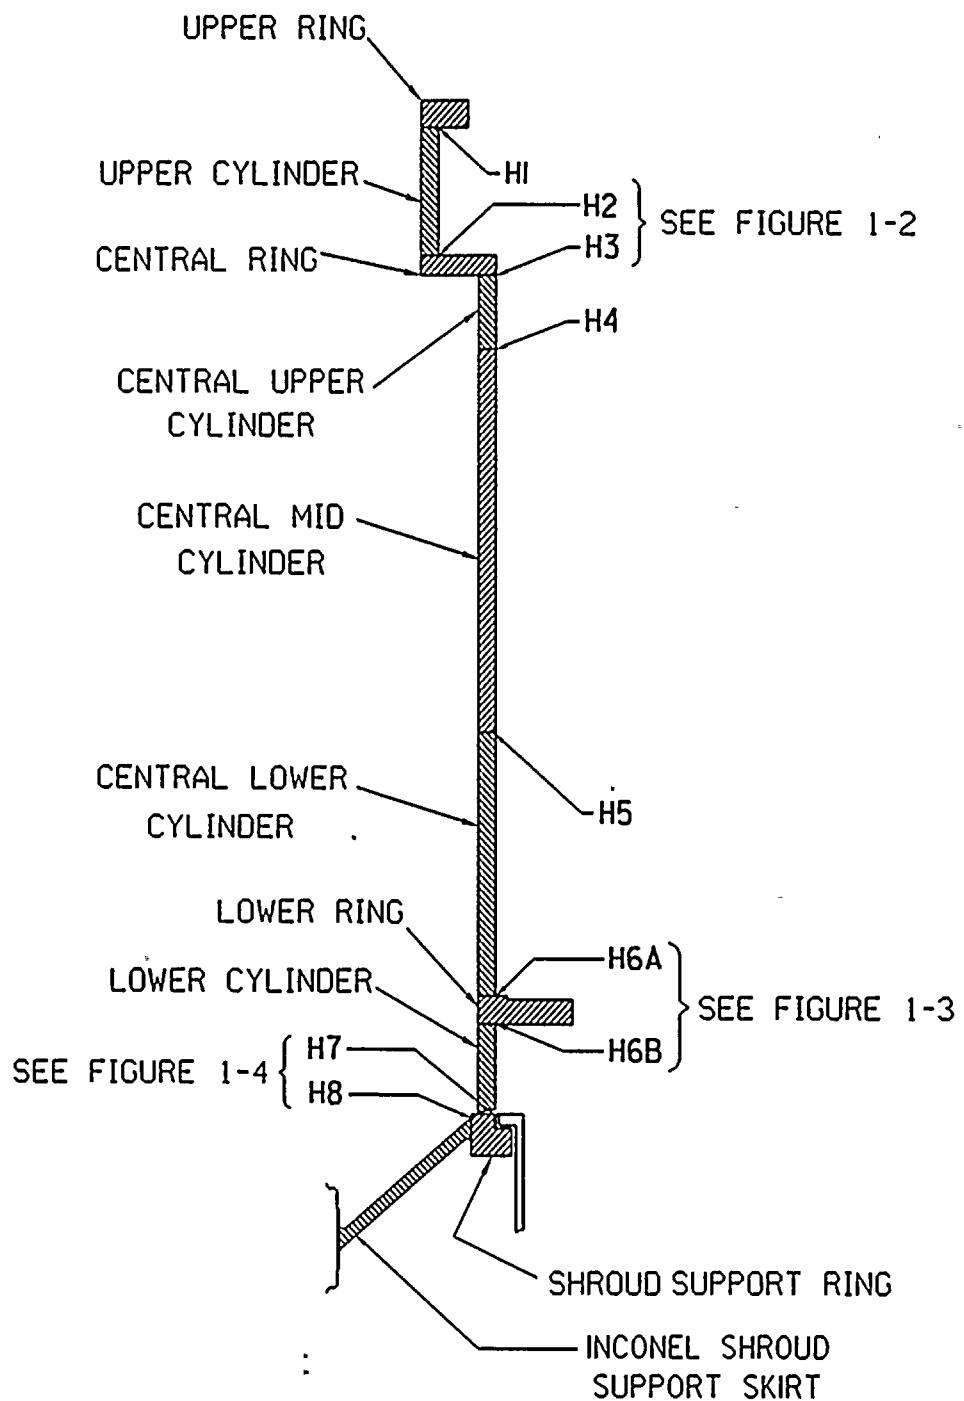
FIGURE I-I NINE MILE POINT I SHROUD WELDS

The following are the Nine Mile Point 1 shroud weld designations, also shown in Figures 1-1, 1-2, 1-3 and 1-4.

- H1, H2: Upper welds, with H1 above and H2 below the emergency core cooling system (ECCS) injection.
- H3: Upper weld located below the bottom of the top guide support ring
- H4, H5: Mid-plane welds located above the core plate
- H6A, H6B: The welds located just above and below the core plate
- H7: Lower shroud to shroud support ring weld
- H8: Inconel 182 weld between 304 SS shroud support ring to inconel shroud support cone
- H9: Shroud Support Cone to Vessel Weld

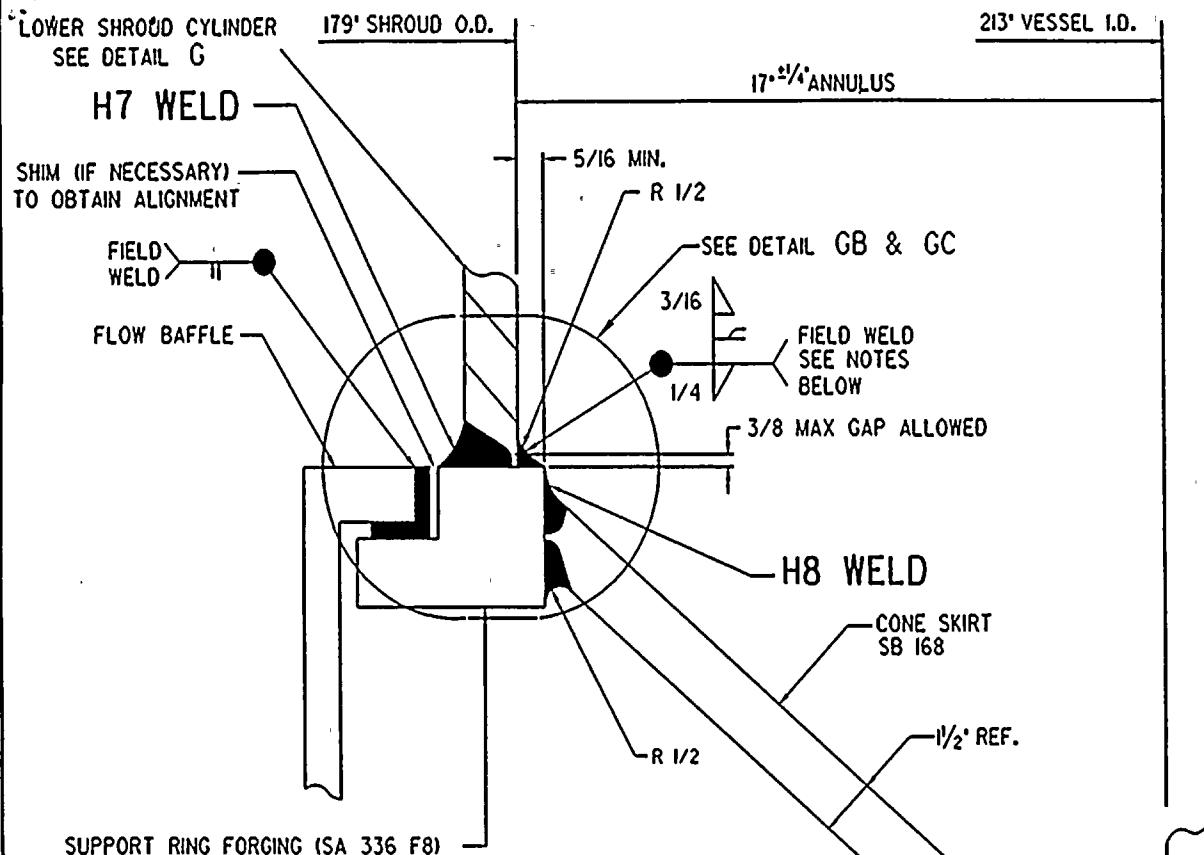
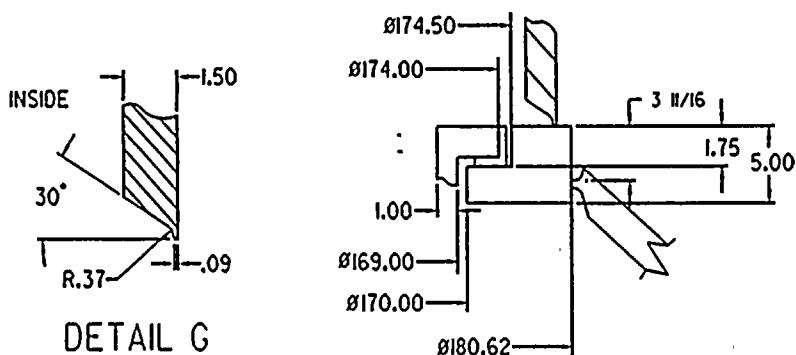
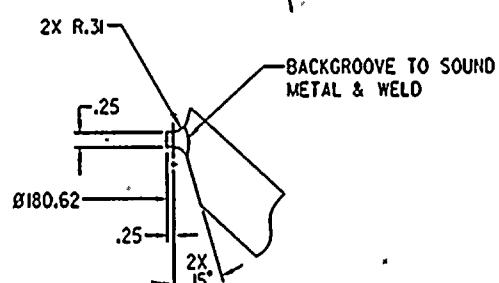
FIGURE I-4 DETAIL SHROUD TO SHROUD SUPPORT JOINT

The shroud support ring is a forged 304 SS ring, however, for Nine Mile Point 1 the H7 and H8 welds to the forged ring have a plant specific susceptibility because the shroud support ring forging was sensitized during the initial vessel heat treatment. The H7 weld is a field weld which was not stress relieved and therefore is considered to be susceptible to IGSCC cracking due to higher weld stresses and sensitized base material. The susceptibility to crack initiation and crack growth rate for the H7 weld is considered similar to that used for the welded plate ring evaluations (H1 through H6). The H8 location susceptibility is discussed in detail in Appendix A. The Appendix A analysis concludes that IGSCC through the heat affected zone (HAZ) of the H8 weld is extremely unlikely because the residual stresses were relieved for this weld during the initial vessel heat treatment, and because the H8 weld is generally compressive during operation. In addition, the Appendix A analysis predicts that IGSCC cracking at H8 would initiate at the OD surface due to the highest tensile stresses being located on the OD. The ASME XI inspection of the OD of H8 revealed no indications.

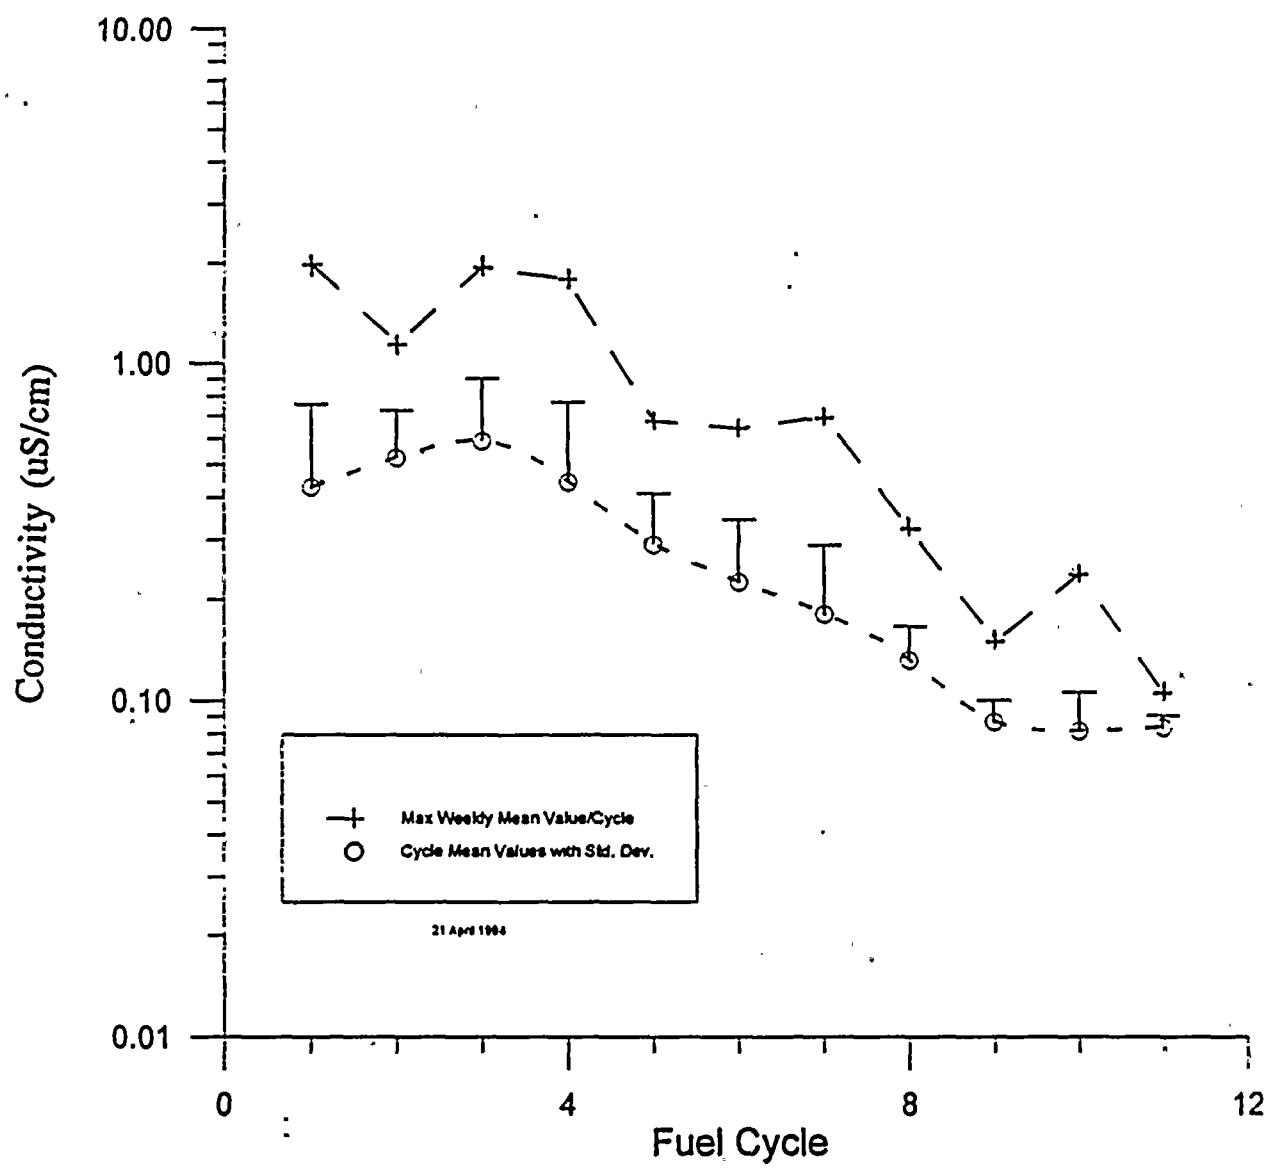
Figure 2-1 Reactor Water Conductivity Mean Values

The generic assessment¹ identifies the mean conductivity for the first five cycles as a factor for susceptibility grouping. Figure 2-1 and Table 2-2 provide the Nine Mile Point 1 specific cycle mean conductivities. This conductivity places Nine Mile Point 1 in the susceptible category for which IGSCC cracking in welded plate ring welds is likely to occur.

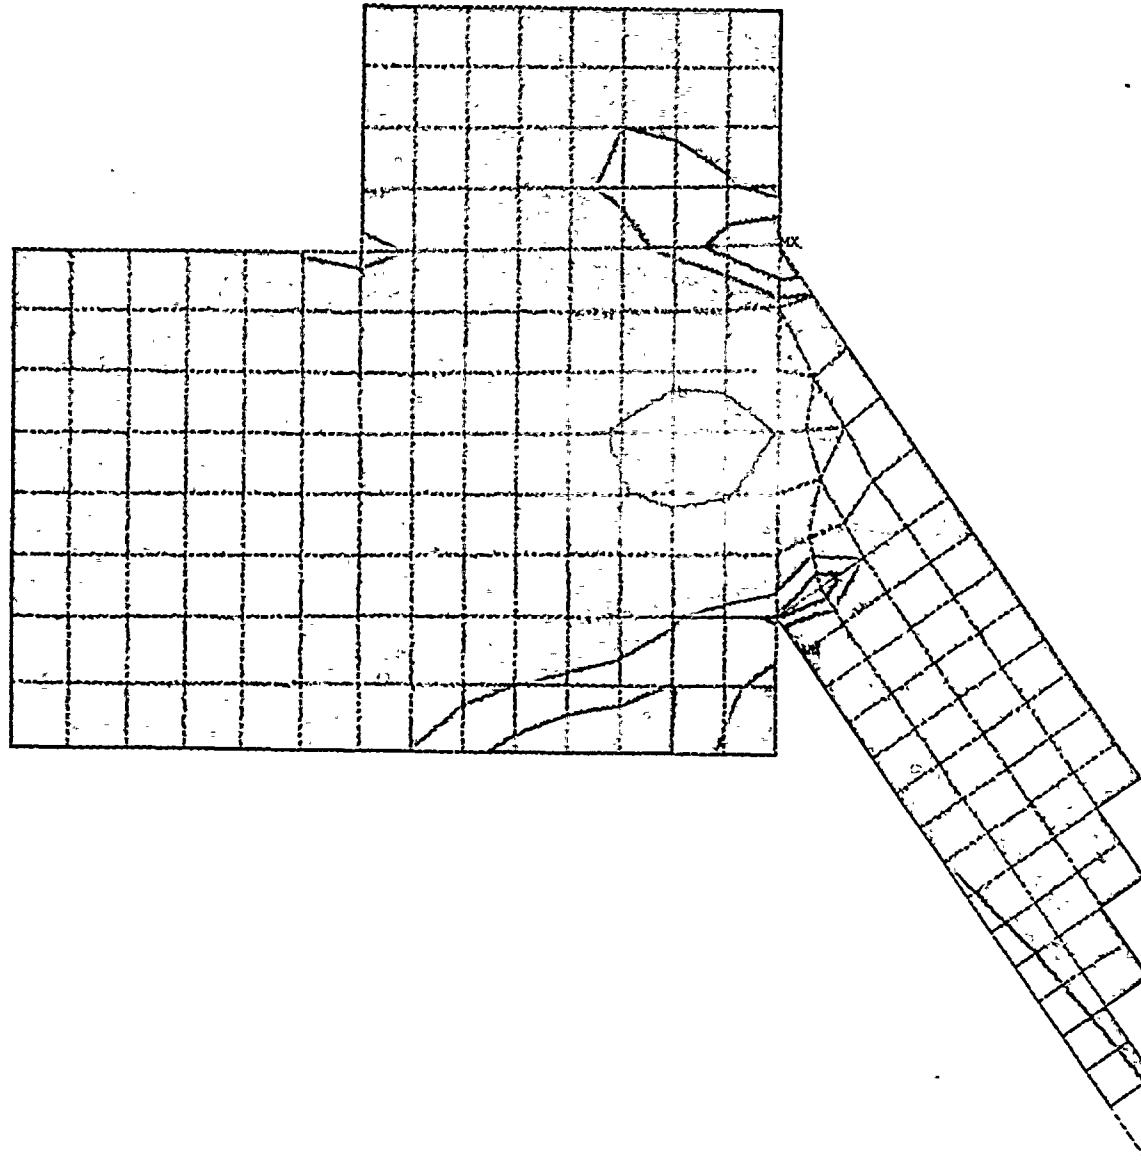
Figure 2. Radial Stress During PWHT

Stress contour plots for the radial stress component during the original stress relief and under normal operating conditions are shown in Figures 2 and 3. The principal load during stress relief is the thermal load, during which time the shroud is not attached. During normal operation, the loads include thermal, pressure, deadweight and hydraulic uplift forces.

induced tensile thermal stresses, combined with the reduced yield strength at the 1150°F temperature, reduced the weld residual stresses to a low value, about 7 ksi. During normal operation, these stresses add to the normal operating stresses for a total stress of about 13 ksi at the top of weld H-8 in the ring.

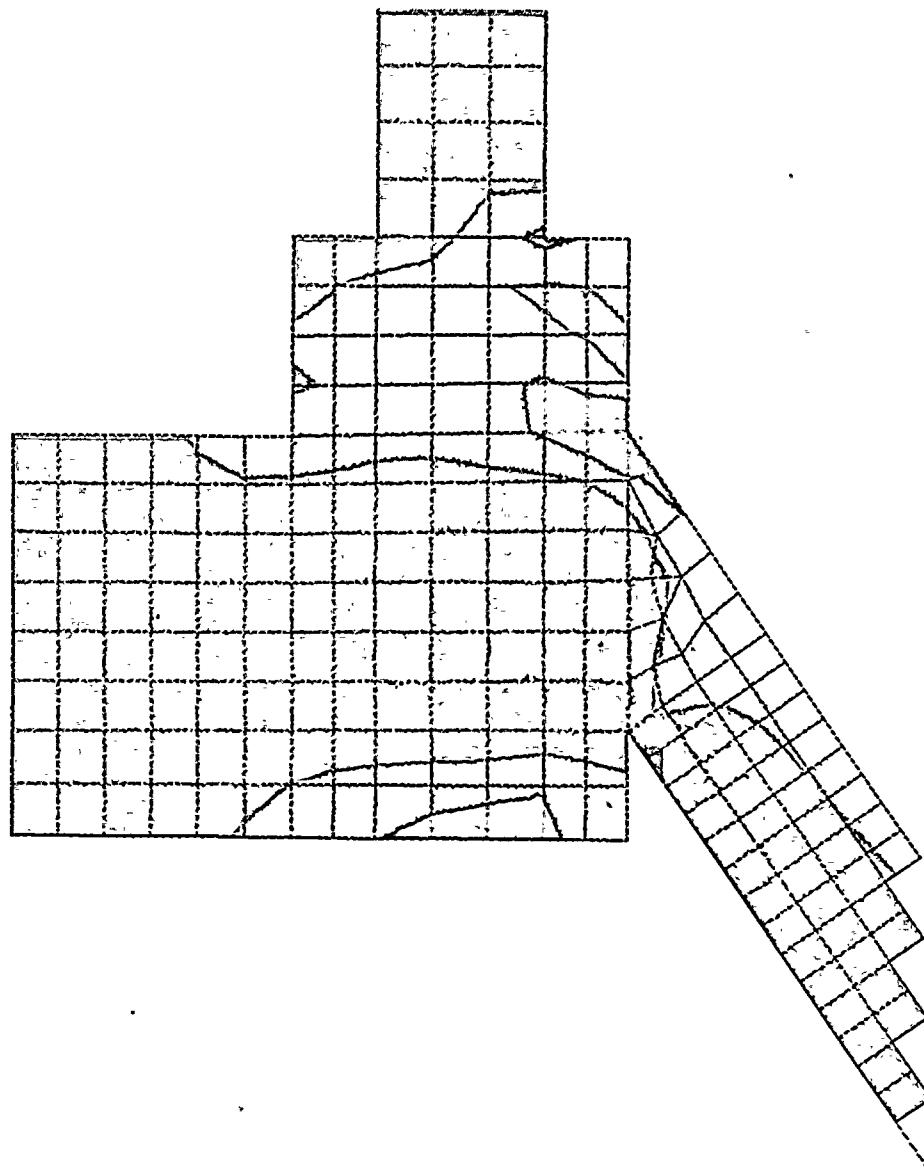
Figure 3. Radial Stress During Normal Operation

Inspection of Figure 3 reveals that the highest tensile radial stresses exist at the top of weld H-8 in the ring. This is considered to be the limiting location for possible crack initiation. It is presumed that local tensile weld residual stresses existed at this location after welding, and they were at the yield stress level. During stress relief (see Figure 2),

While it is unlikely that cracking would initiate in a 13 ksi stress field, we note that the location of highest tensile stress is an area that is inspectable. Further, cracking in the heat affected zone of the support ring adjacent to weld H-8 would grow very slowly, if at all, because: (1) it would have to grow into an area of applied compressive stresses, and (2) weld residual stresses are also expected to become compressive in the ring at the center of weld H-8.
