NIAGARA MOHAWK POWER CORPORATION

ANNUAL ENVIRONMENTAL OPERATING REPORT

January 1, 1996 - December 31, 1996

NINE MILE POINT NUCLEAR STATION UNIT 2

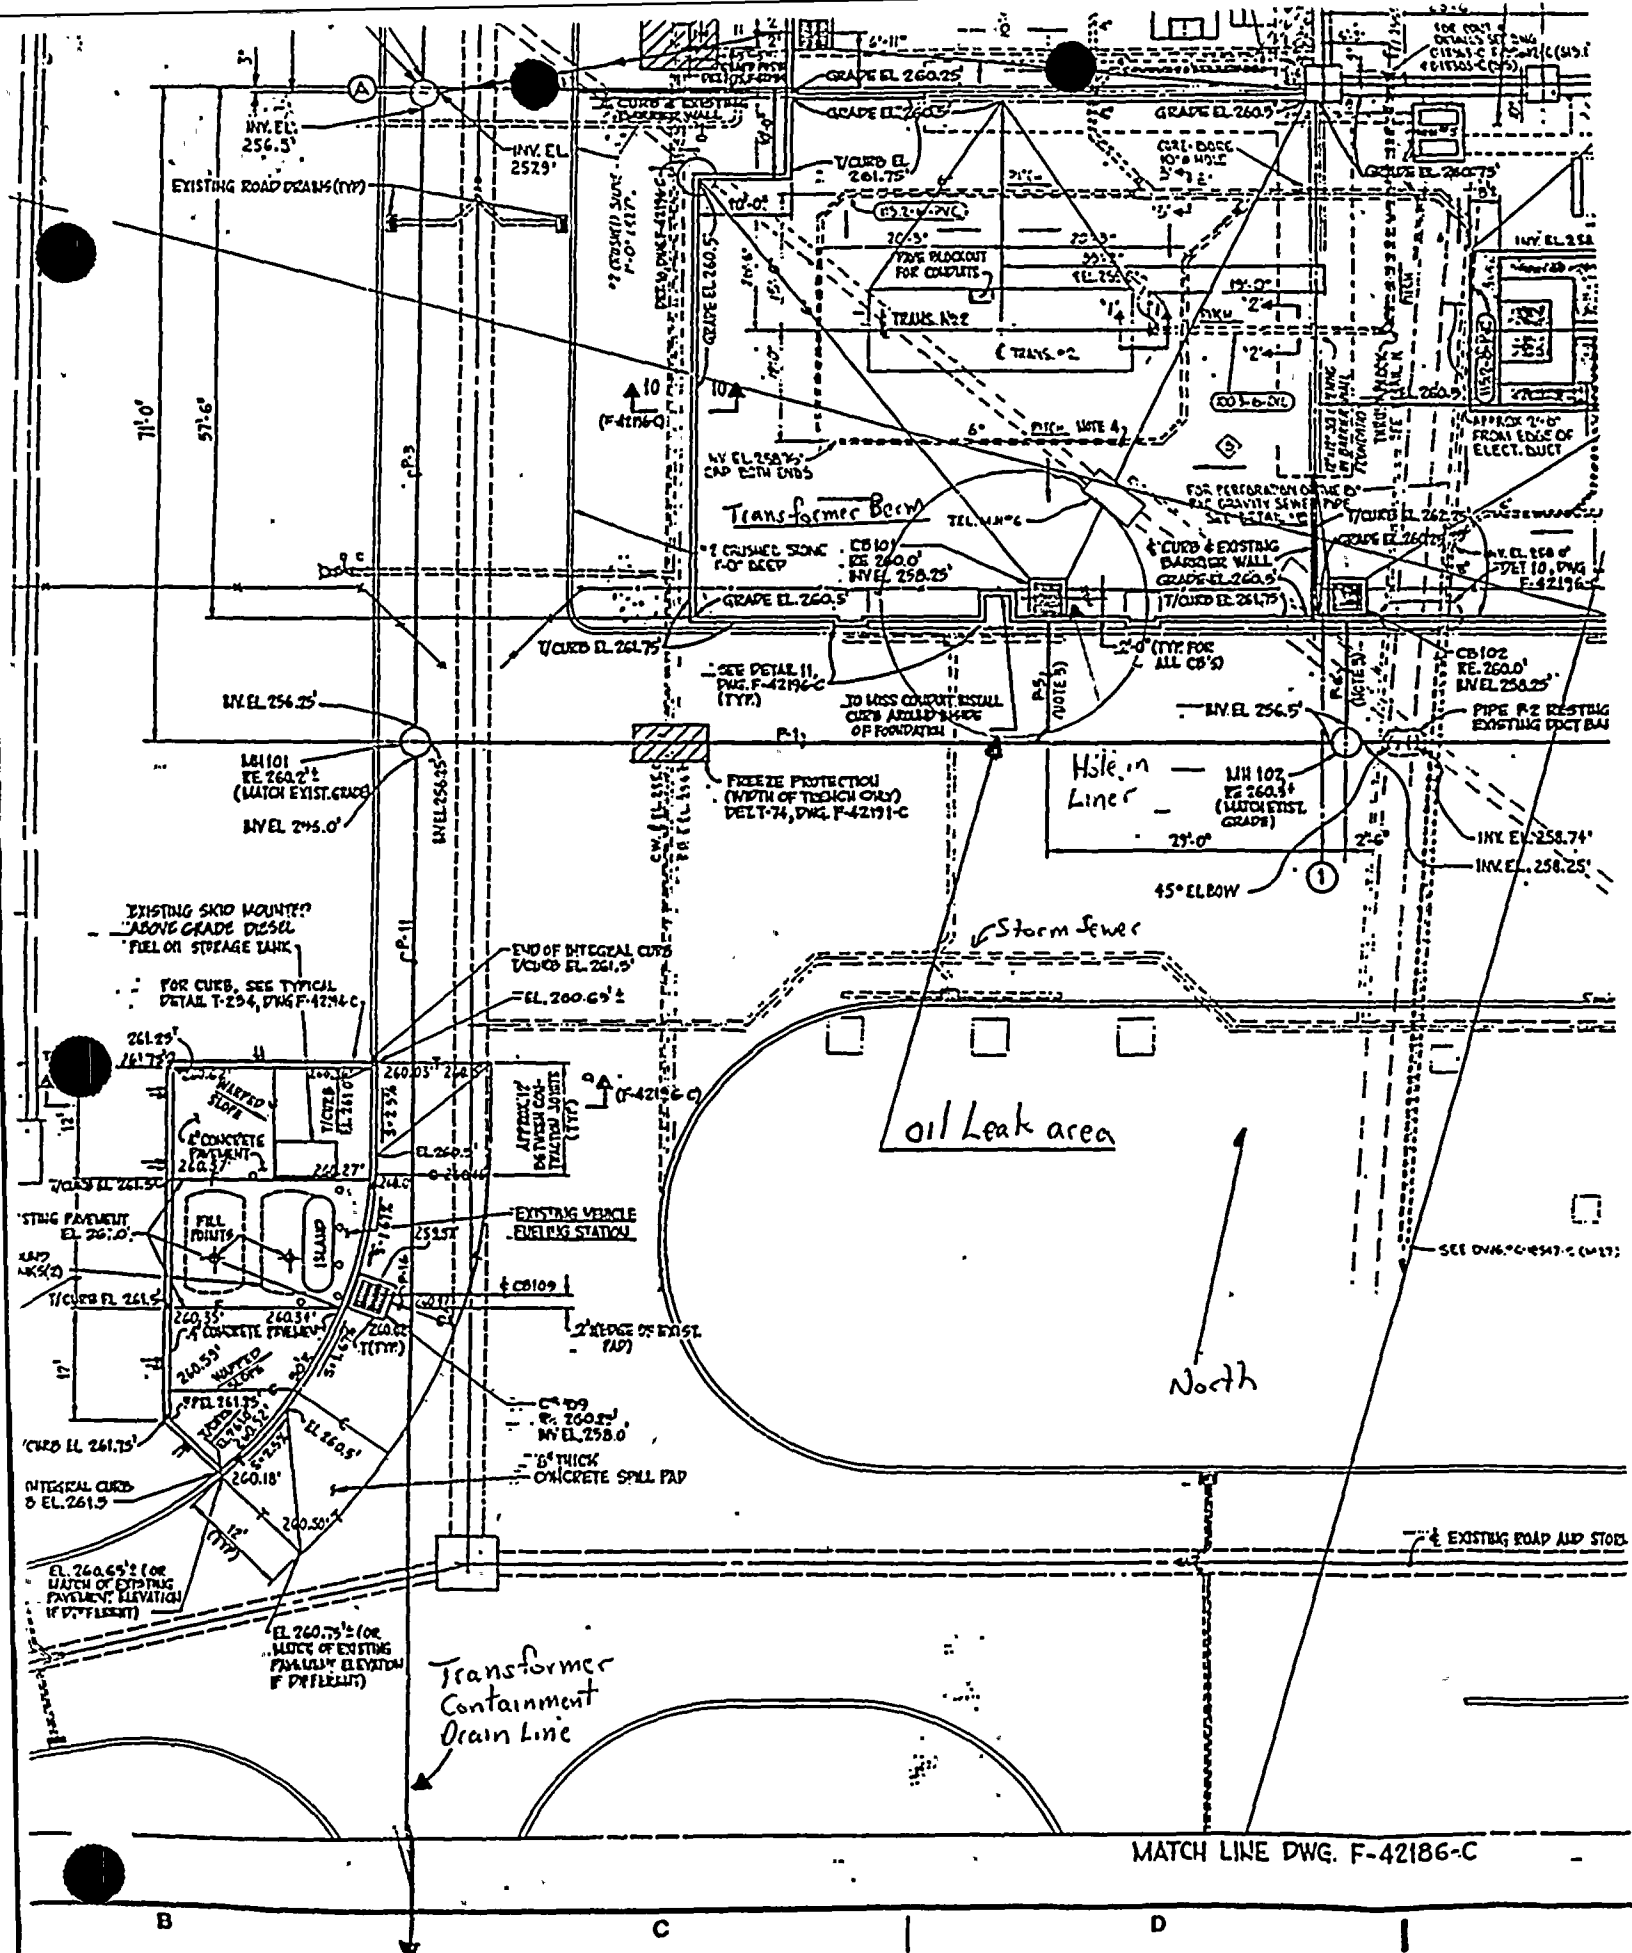
FIGURE 5

Figure 5 shows the proximity of the transformer, storm sewer, and Unit 1 Oil Spill Retention Basin.

The cause of oil entering the storm sewers is a breach in the integrity of the transformer containment berm. A thumb-size hole and dislodged section of liner seam allowed oily water to exit the containment area and enter directly into the storm sewer drainage system. As shown in Figure 5, the hole in the containment liner is in very close proximity to the storm sewer.

The ground/stones around and under the storm sewer were excavated and will be replaced with virgin gravel and stones. The transformer containment liner was repaired including new support material packed in around the area the puncture was located.
