**LICENSEE:** Niagara Mohawk Power Corporation  
**FACILITY:** Nine Mile Point Nuclear Station, Unit No. 1  
**SUBJECT:** SUMMARY OF MEETINGS WITH LICENSEE AND PUBLIC ON APRIL 14, 1997,  
REGARDING CORE SHROUD (TAC NO. M98170)

# MEETING ON CORE SHROUD CRACKING AT NINE MILE POINT UNIT 1

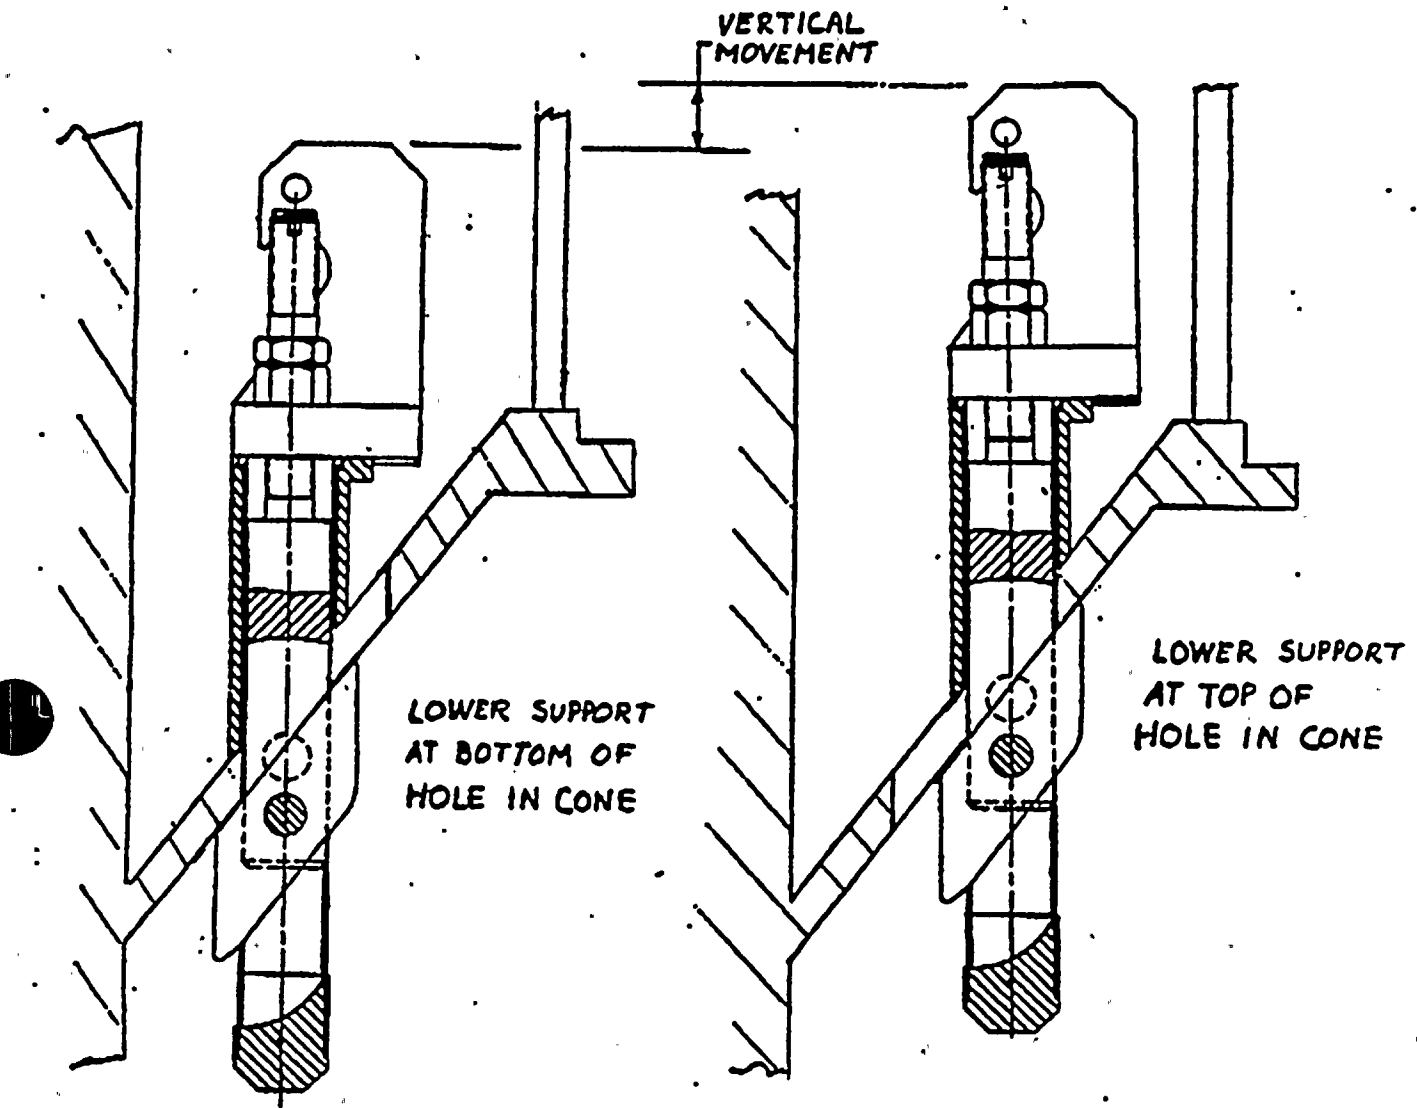
Figure 3

Toggle Bolt Movement in Shroud Support Cone

- Removed clearance between the lower support toggle bolts and the shroud side of the cone holes.
- Re-torqued the tie rods to their original design installation torque.
- Installed new modified latches which are more tolerant of differential vertical displacement.

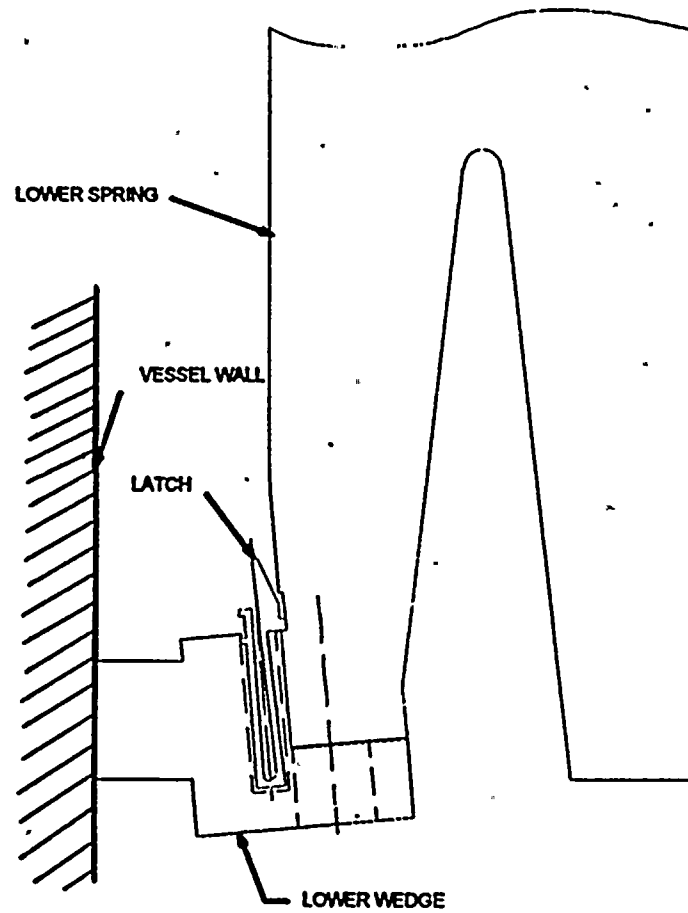
ORIGINAL LATCH

- The evaluation of the as-found condition shows that both the latch failure and the loss of tie rod preload were related.
- The design of the lower spring contact implicitly assumed that the lower spring contact would slide along the Reactor Pressure Vessel (RPV) wall.
- There were two conditions causing differential movement that were not expected:
  - The lower support assemblies were able to shift up the shroud cone toward the shroud due to original installation clearances between the toggle bolts and the cone holes. The impact of the clearances was not recognized.
  - Differential motion could also be caused by the deflection of the C-spring under tie rod load for heat up. This could also cause stresses in the latch, although somewhat less than in the previous case.

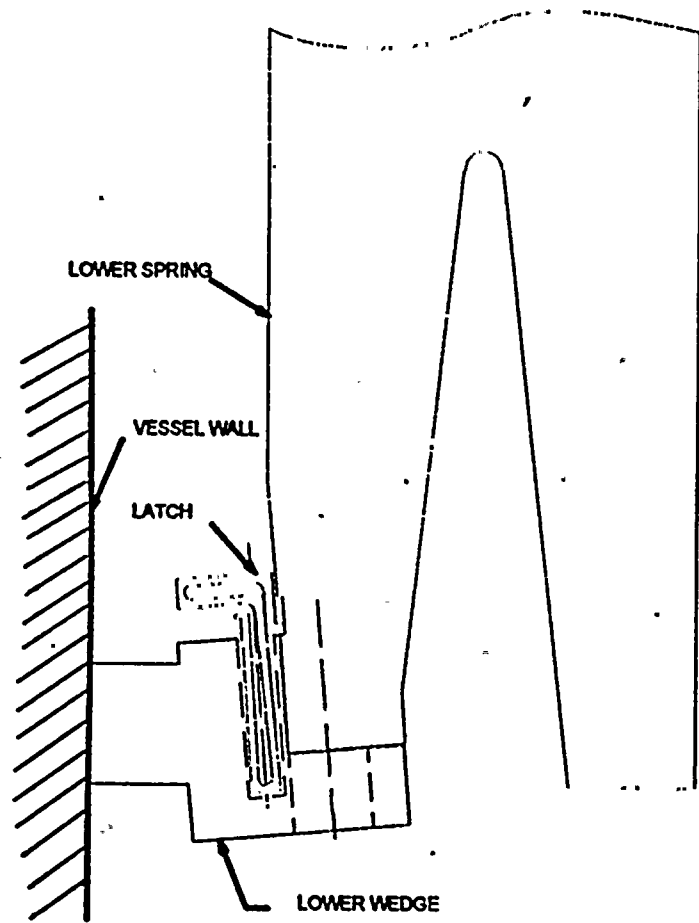
NEW LATCH

- The improved latch design stresses are 8 to 12 times lower than the original design
  - membrane + bending  
ratio = 8.6
  - membrane + bending + peak  
ratio = 12.8
- No permanent deformation in new latch design even under worst case conditions

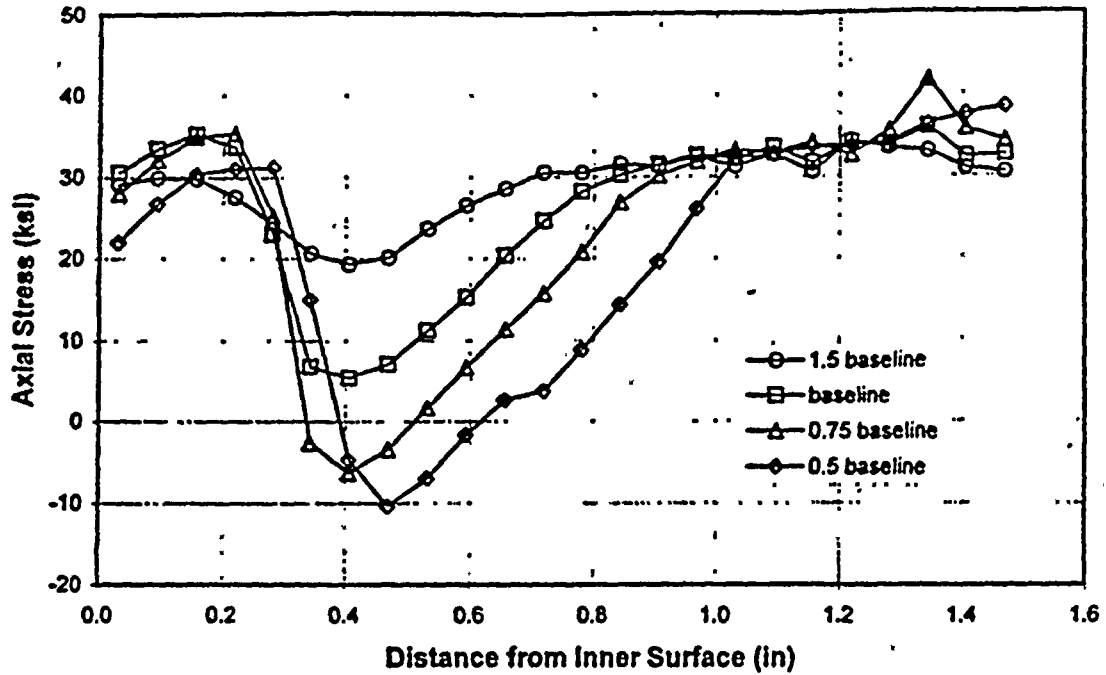
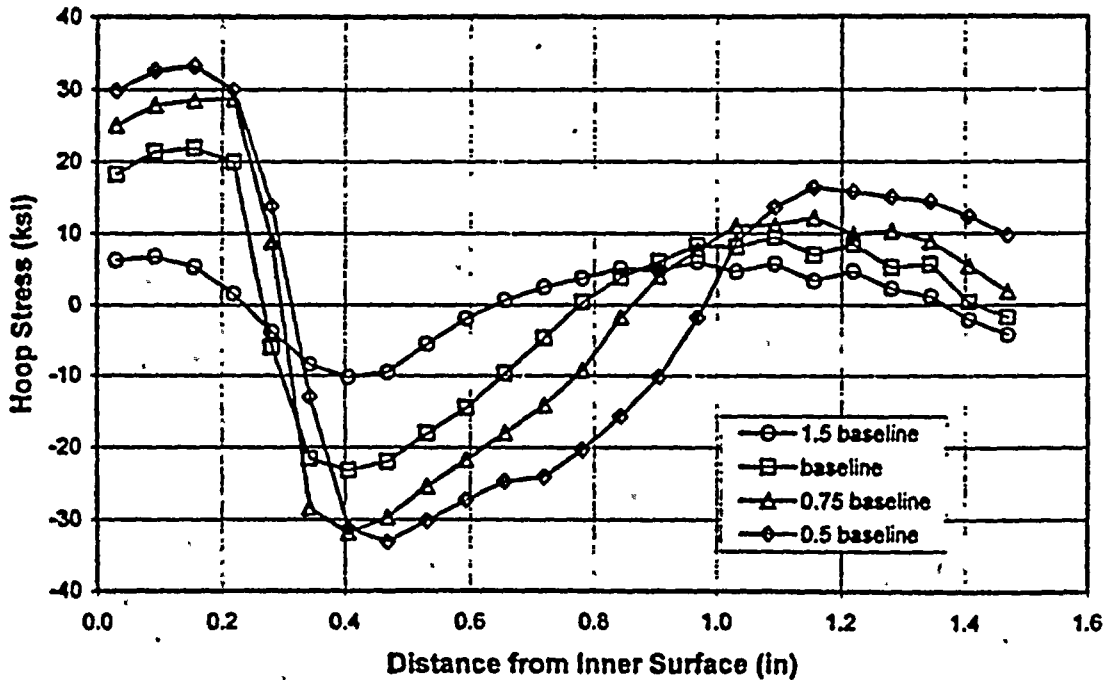
Conclusion: It can be demonstrated that a combination of low heat input and a diametral squeeze (dead weight and/or jacking) produce a stress field which would explain the cracking behavior.

**Axial and Hoop Stresses at Operating Temperature for the V9/V10 Welds as a Function of Heat Input During Welding**

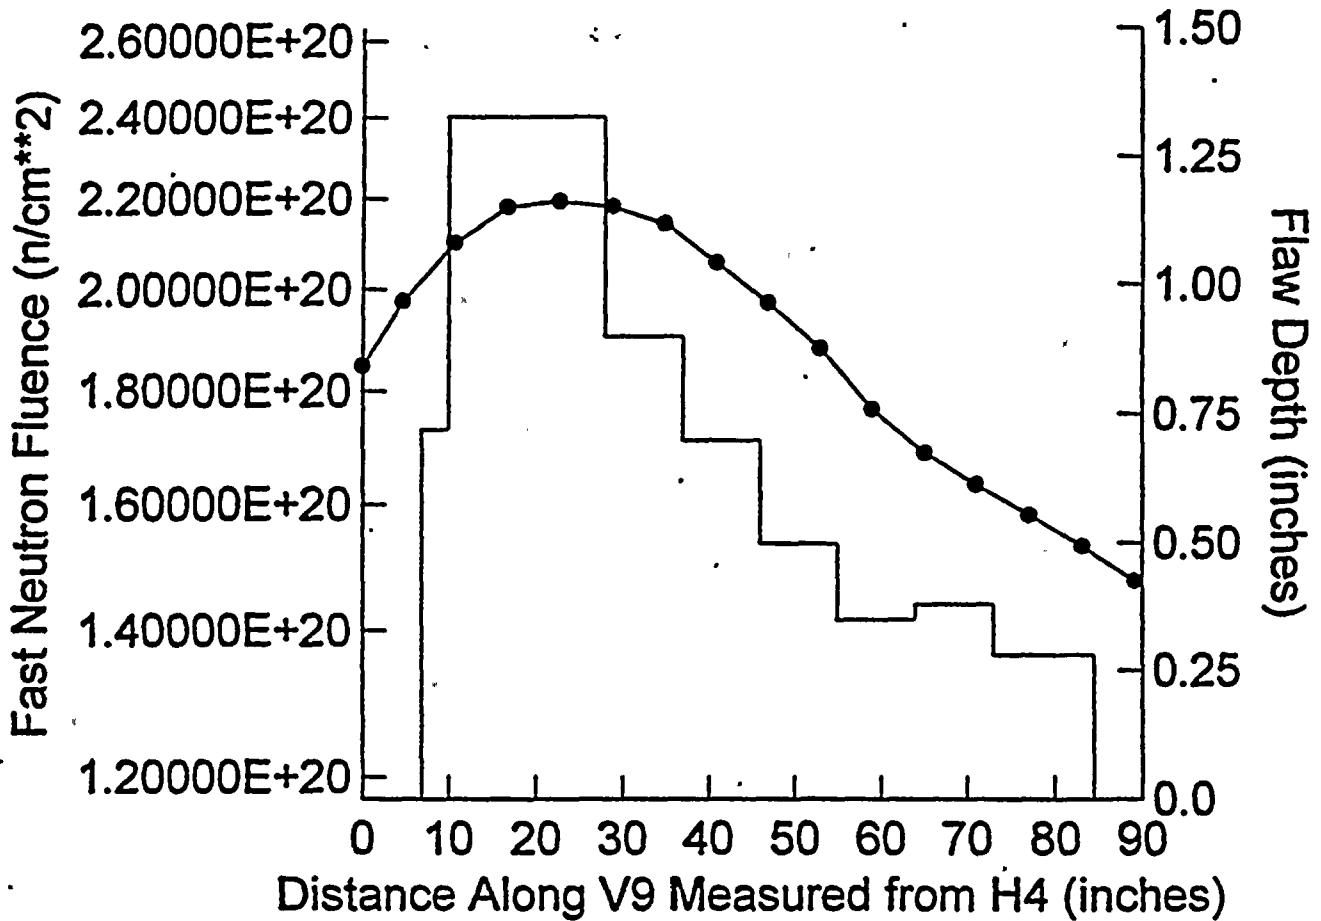
- The cracking is almost exclusively on the OD side of the weld within the HAZ
- Most of the cracks run longer in the axial direction and are connected to a short horizontal crack segment
- The axial cracks (driven by hoop stress) are deepest near the H4 weld where the fast neutron flux is highest
- Both the left and right sides of V10 are cracked
- The left side of V9 is cracked with little cracking on the right side
- The depth of cracking correlates with fast ( $E > 1$  MeV) neutron fluence

**Correlation Between Fast Neutron Fluence and Crack Depth at NMP-1 Vertical Weld V9**

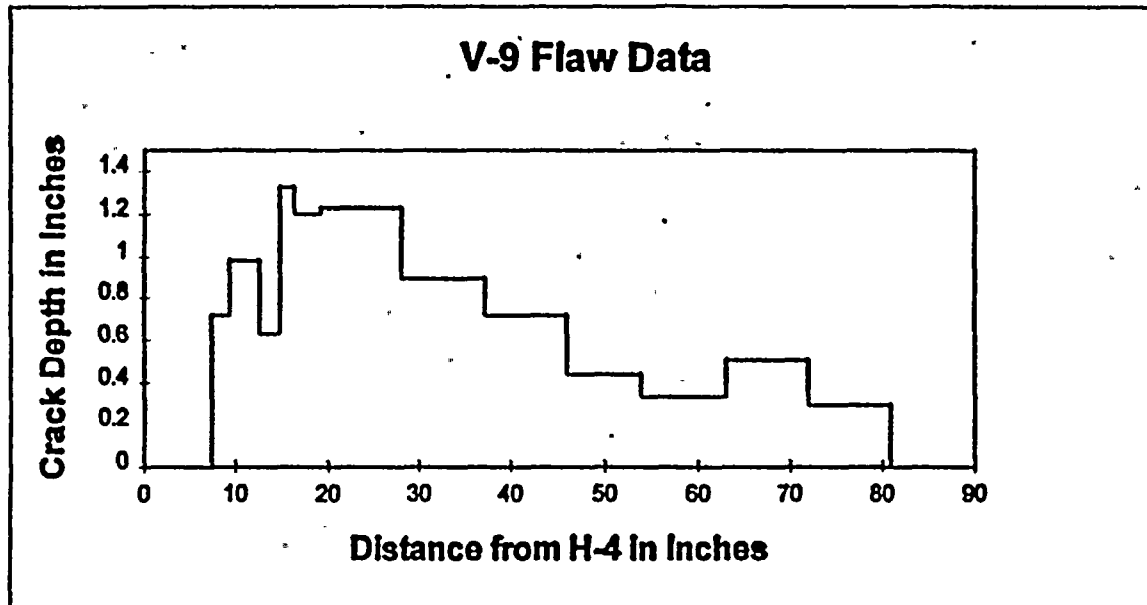
# Weld V-9 UT Data

Performed ultrasonic examination from the shroud OD surface for approximately the entire length of both the left and right HAZs as well as EVT from both the ID and the OD. Visual cracking was detected over greater than 90% of the right HAZ on the OD and minimal cracking was detected on the ID in both the left and right HAZs. Minor cracking was also detected on the OD in the left HAZ. The cracks detected visually on the shroud ID surface were found to be predominantly transverse to the weld whereas the cracking detected visually on the shroud OD surface was mostly parallel to the weld with components that branched transverse to the weld. Ultrasonic examinations of essentially the entire length of the weld was performed from the shroud OD surface and detected numerous flaws over the length of the left HAZ emanating from the shroud OD surface. Two small flaws on the ID surface were detected in the right HAZ.

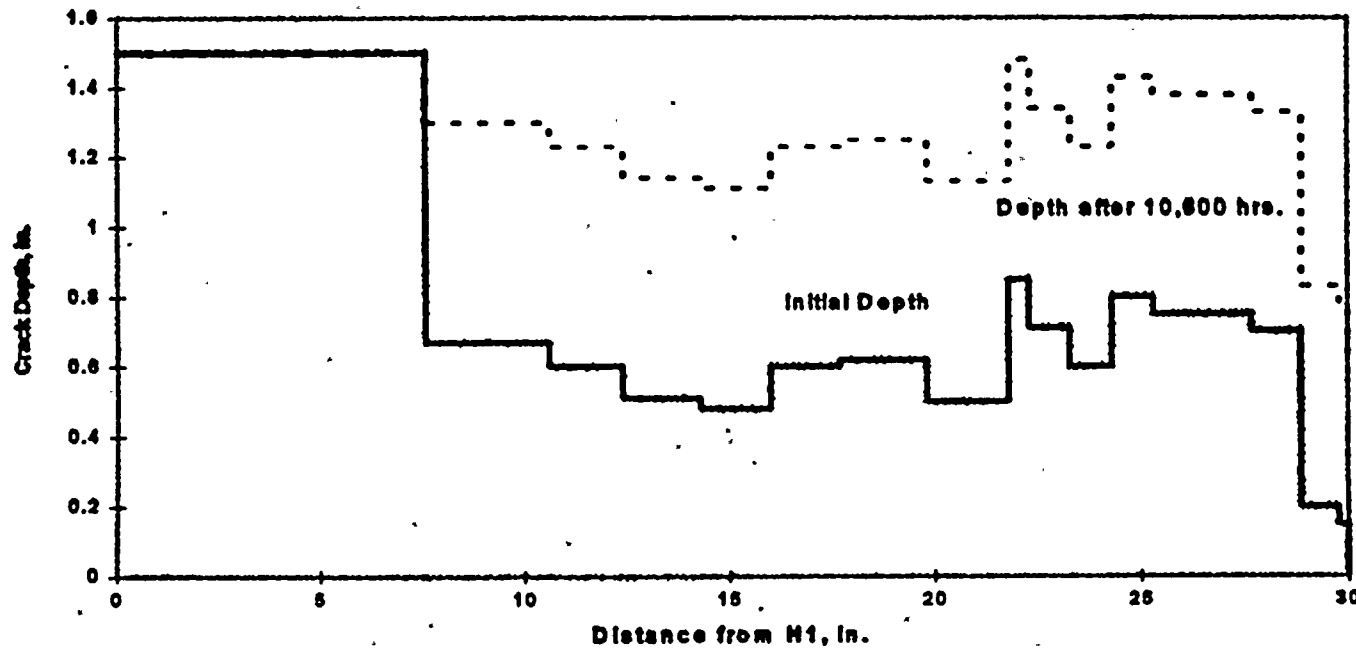
# V-4 Depth and Depth after 10,600 hours

- Detailed evaluations for the V9, V10, and V4 indications
  - Credit for remaining ligament after crack growth of  $5 \times 10^{-5}$  in/hr and inspection uncertainty factors
  - LEFM and limit load analysis with ASME code safety factors
  - Covers normal/upset and accident conditions
  - Acceptable period for continued operation determined
- Analysis shows that continued operation is justified for at least 10,600 hours

V4 - Initial Depth & Depth after 10,600 hrs
