Attachment to LER 79-042/01-T-0
Consumers Power Company
Palisades Nuclear Plant
Docket 50-255

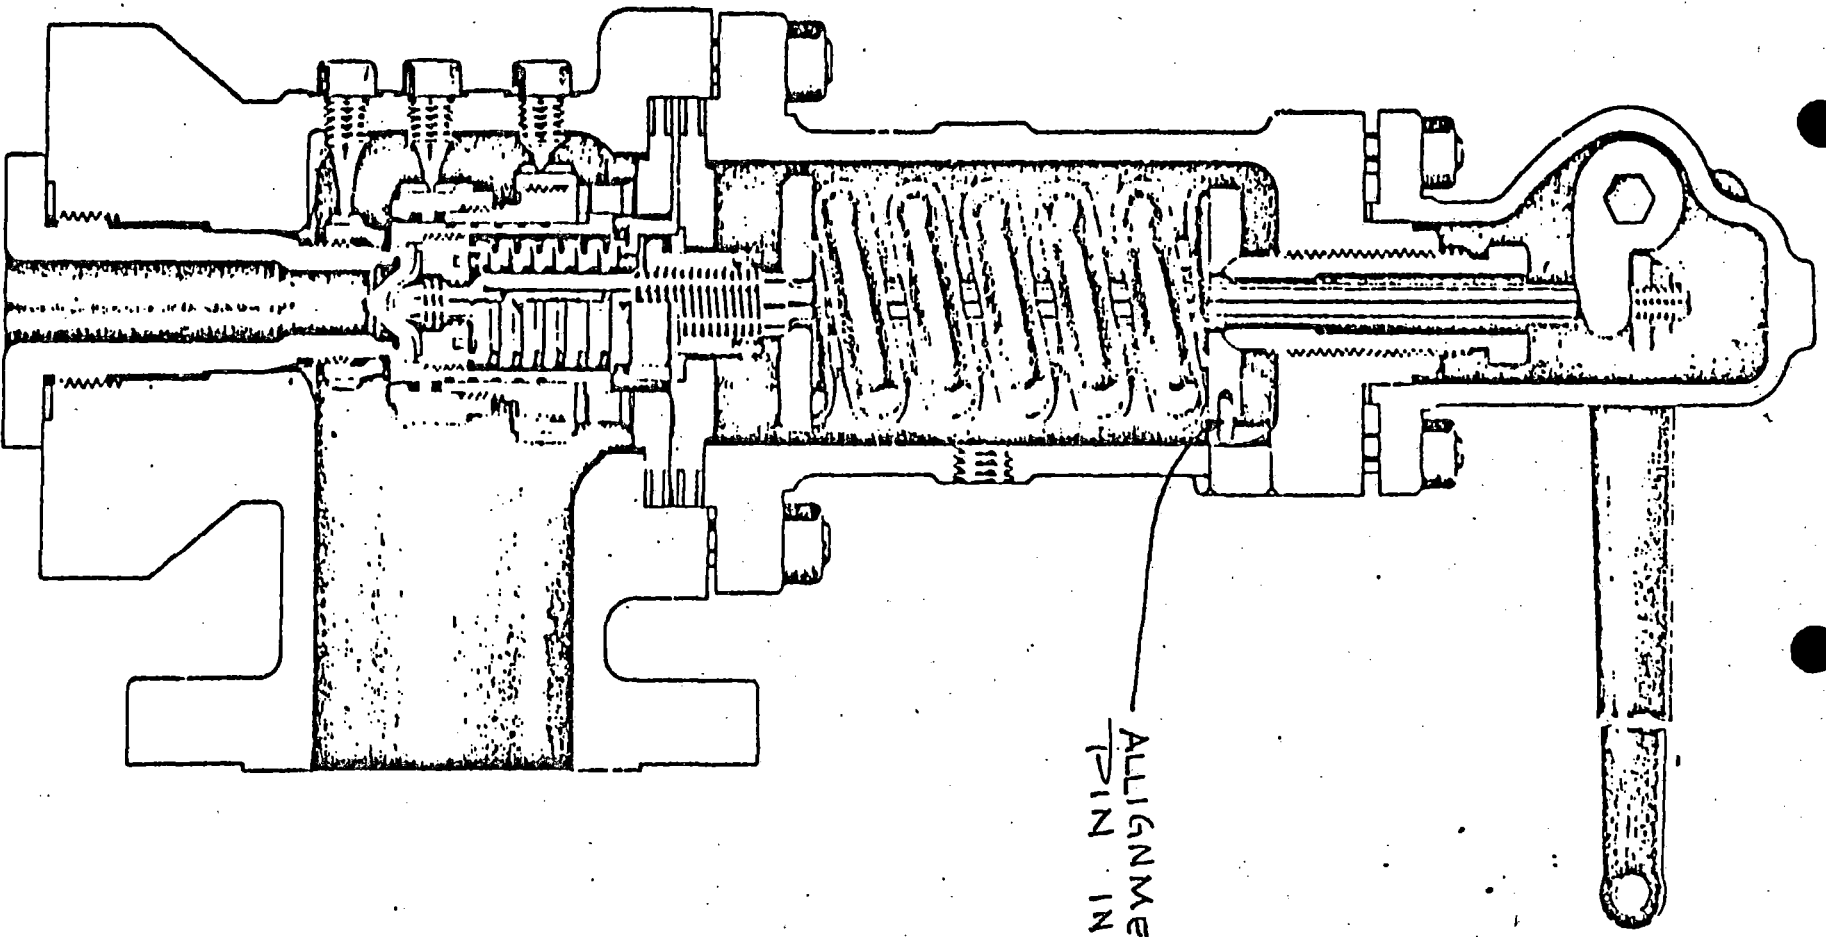
ALIGNMENT
PIN IN SLOT

The valves were disassembled, inspected, refurbished and retested satisfactorily with steam. Inspection of RV 1039 revealed that the alignment pin on the upper spring washer was out of its slot, and was bound on the land under the slot (see attached figure). It is probable that the mispositioning of the alignment pin occurred during the previous rebuilding of the valve in March, 1976. It is noted; however, that subsequent to the rebuilding of the valve in March, 1976, it was tested satisfactorily by checking the lift setting four times with cold nitrogen. Inspection of RV 1040 revealed no apparent deficiencies.

To avoid future errors in the lift settings of the Palisades pressurizer code safety valves, these valves will continue to be tested with steam as long as there exists no other practical means of testing which will provide acceptable results.
