UNITED STATES
NUCLEAR REGULATORY COMMISSION
OFFICE OF INSPECTION AND ENFORCEMENT
WASHINGTON, D.C. 20555

IE Bulletin No. 79-13
Revision 2

CRACKING IN FEEDWATER SYSTEM PIPING

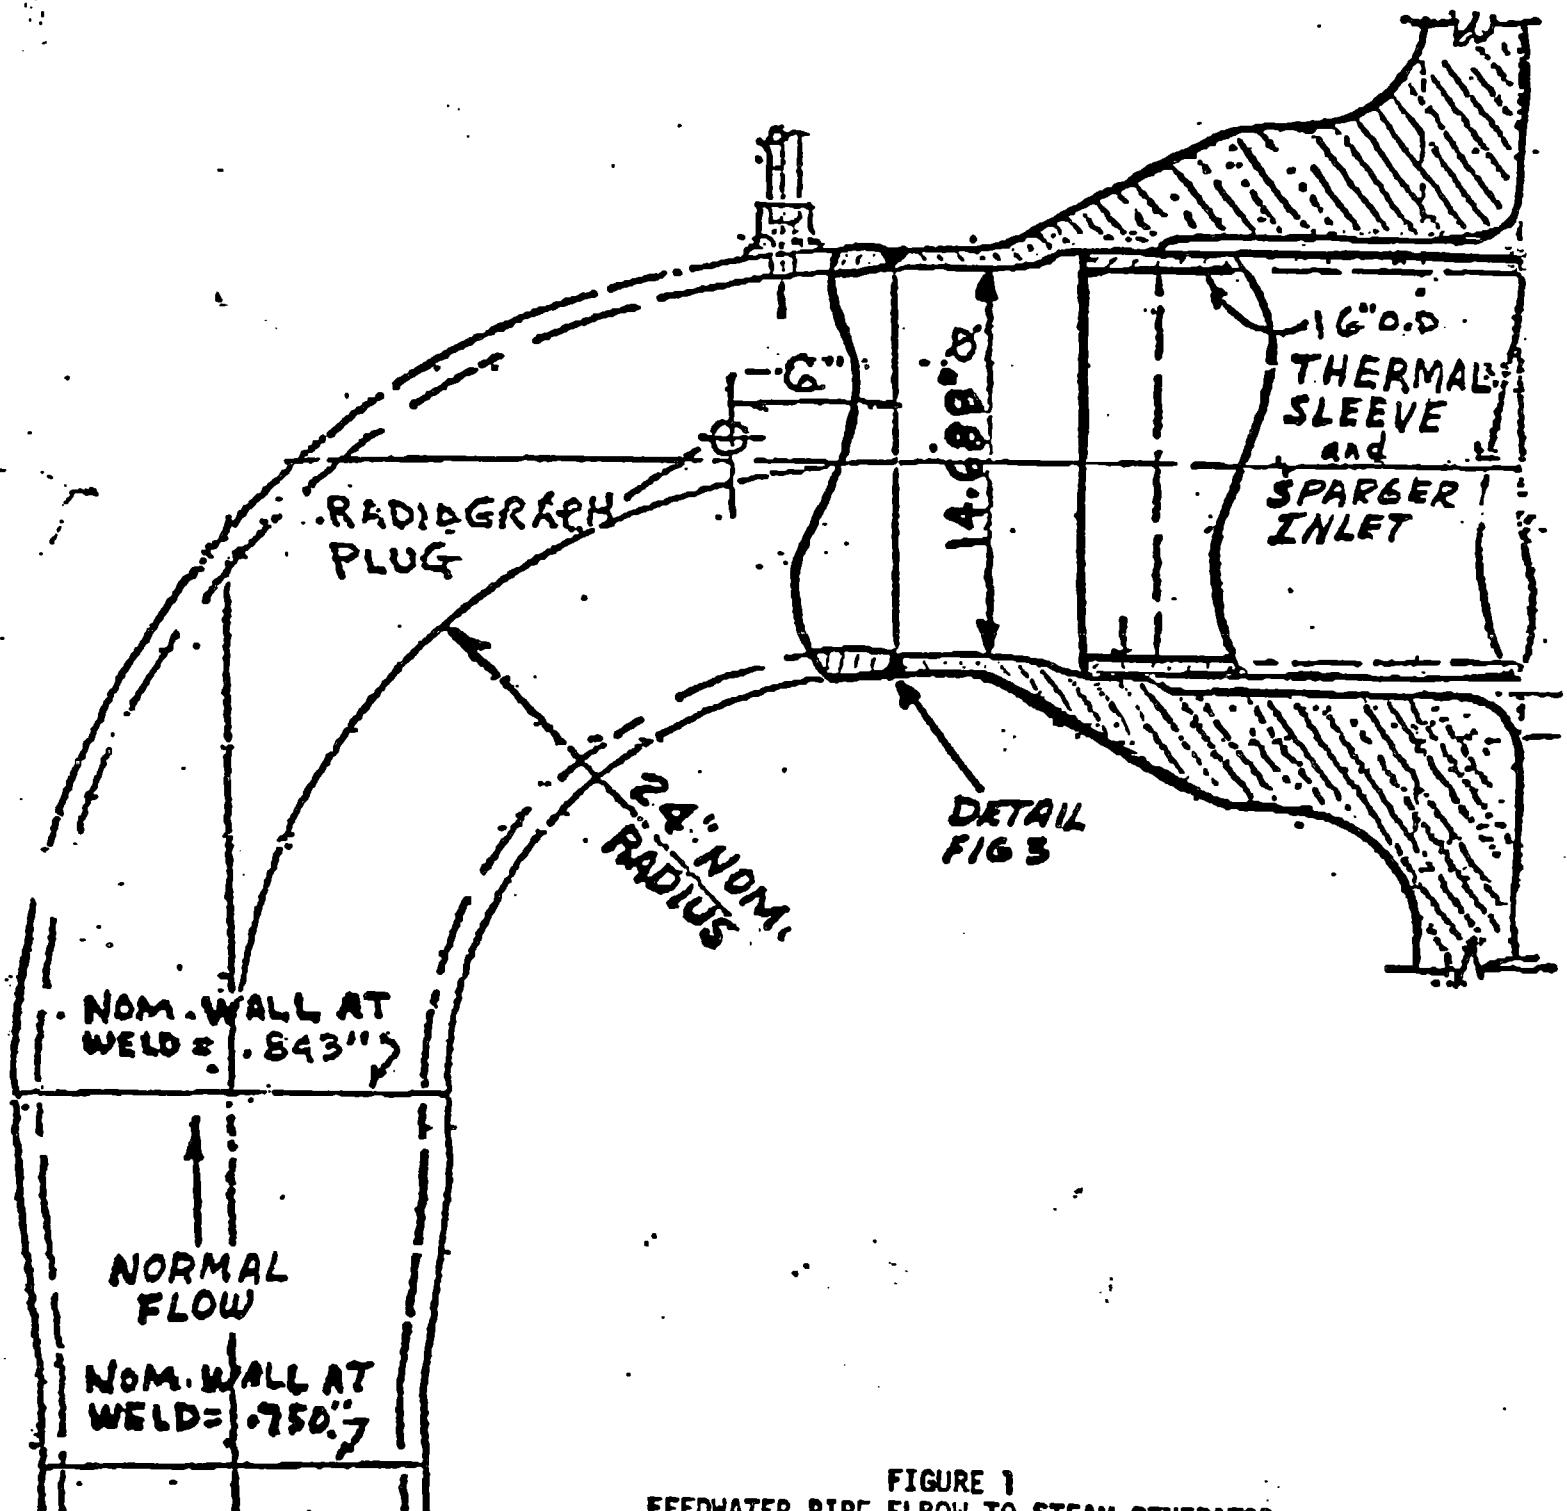
FIGURE 1
FEEDWATER PIPE ELBOW TO STEAM GENERATOR
NOZZLE INSTALLATION (DC COOK)

On May 20, 1979, Indiana and Michigan Power Company notified the NRC of cracking in two feedwater lines at their D. C. Cook Unit 2 facility. The cracking was discovered following a shutdown on May 19 to investigate leakage inside containment. Leaking circumferential cracks were identified in the 16-inch feedwater elbows adjacent to two steam generator nozzle elbow welds. Subsequent radiographic examination revealed crack indications in all eight steam generator feedwater lines at this location on both Units 1 and 2.

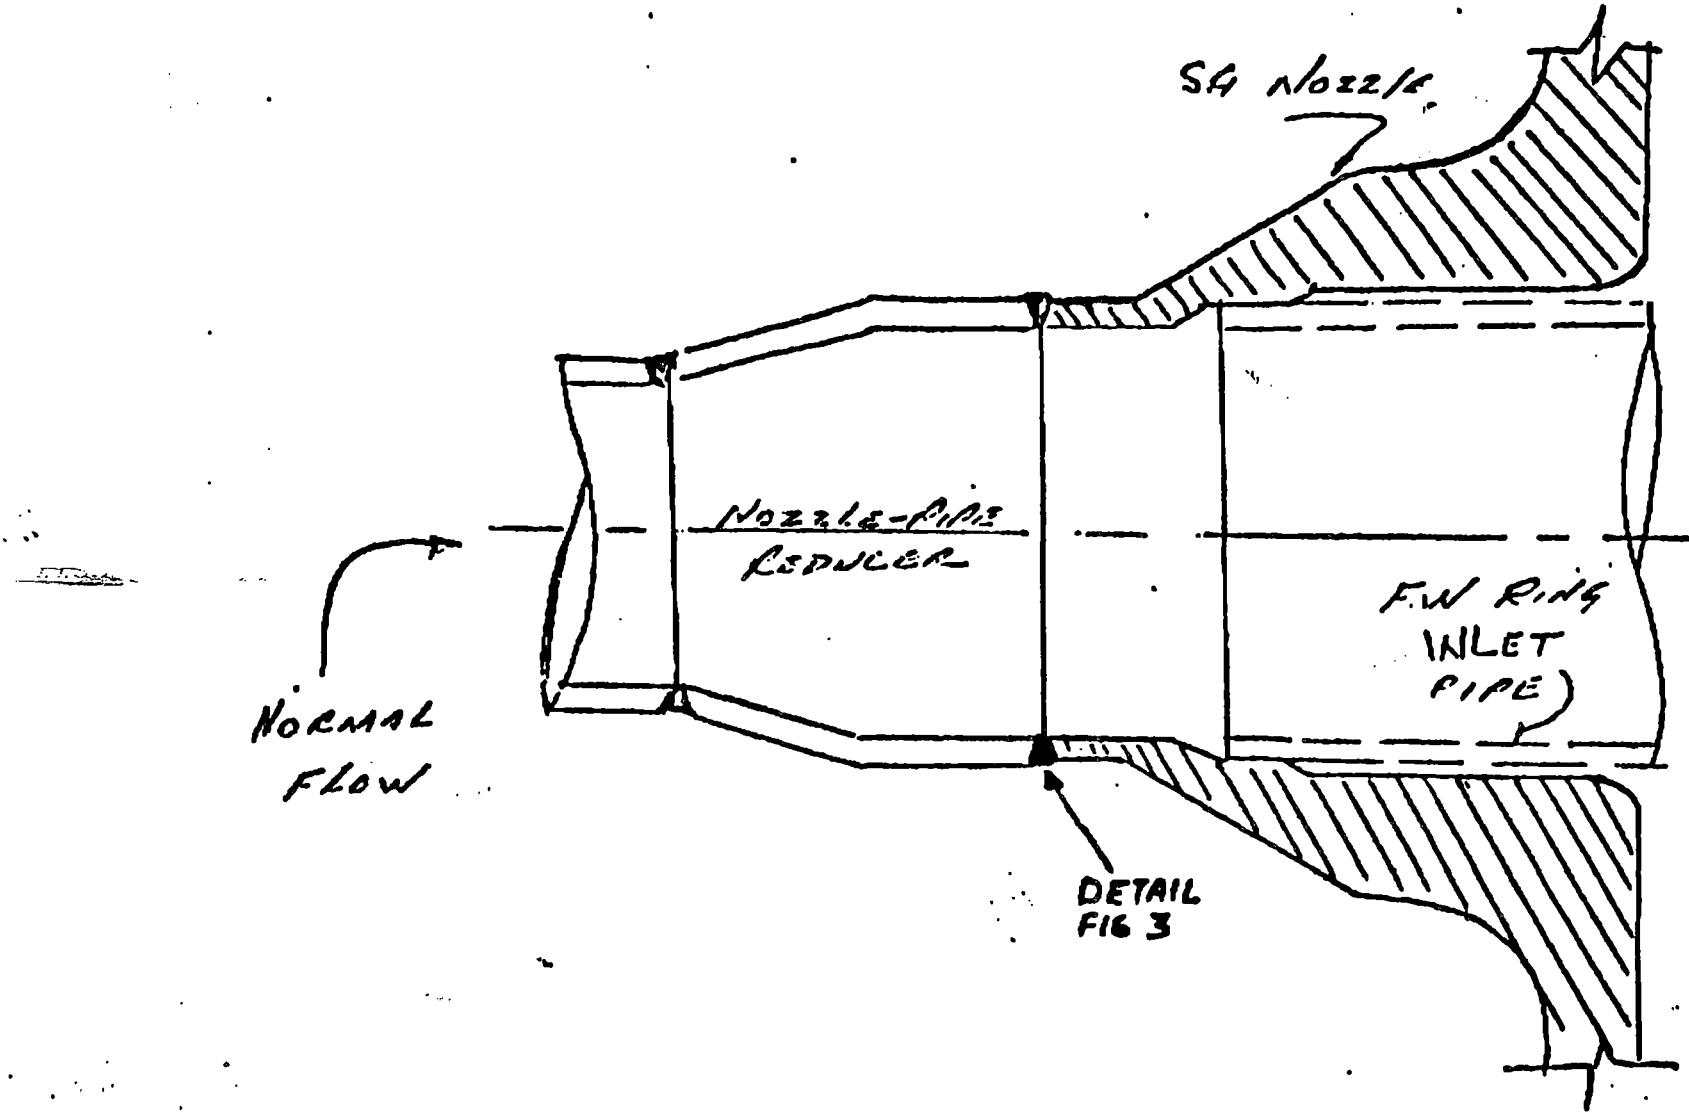
FIGURE 2
FEEDWATER PIPE REDUCER TO STEAM GENERATOR
NOZZLE INSTALLATION (SAN ONOFRE)

As a result of these actions, several other licensees with Westinghouse steam generators reported crack indications. Southern California Edison reported on June 5, 1979, that radiographic examination revealed indications of cracking in feedwater nozzle-to-pipe welds on two of three steam generators of San Onofre Unit 1. On June 15, 1979, Carolina Power and Light reported that radiography showed crack indications in similar locations at their H. B. Robinson Unit 2. Duquesne Power and Light confirmed on June 18, 1979, that radiography has shown cracking in their Beaver Valley Unit 1 feedwater piping-to-vessel nozzle weld. Public Service Electric and Gas Company reported on June 20, 1979 that Salem Unit 1 also has crack indications. Wisconsin Public Service company decided on June 20, 1979 to cut out a feedwater nozzle-to-pipe weld which contained questionable indication, for metallurgical examination. As of June 22, 1979 and since May 25, 1979 seven other PWR facilities have inspected the feedwater nozzle-to-pipe welds without finding cracking indications.

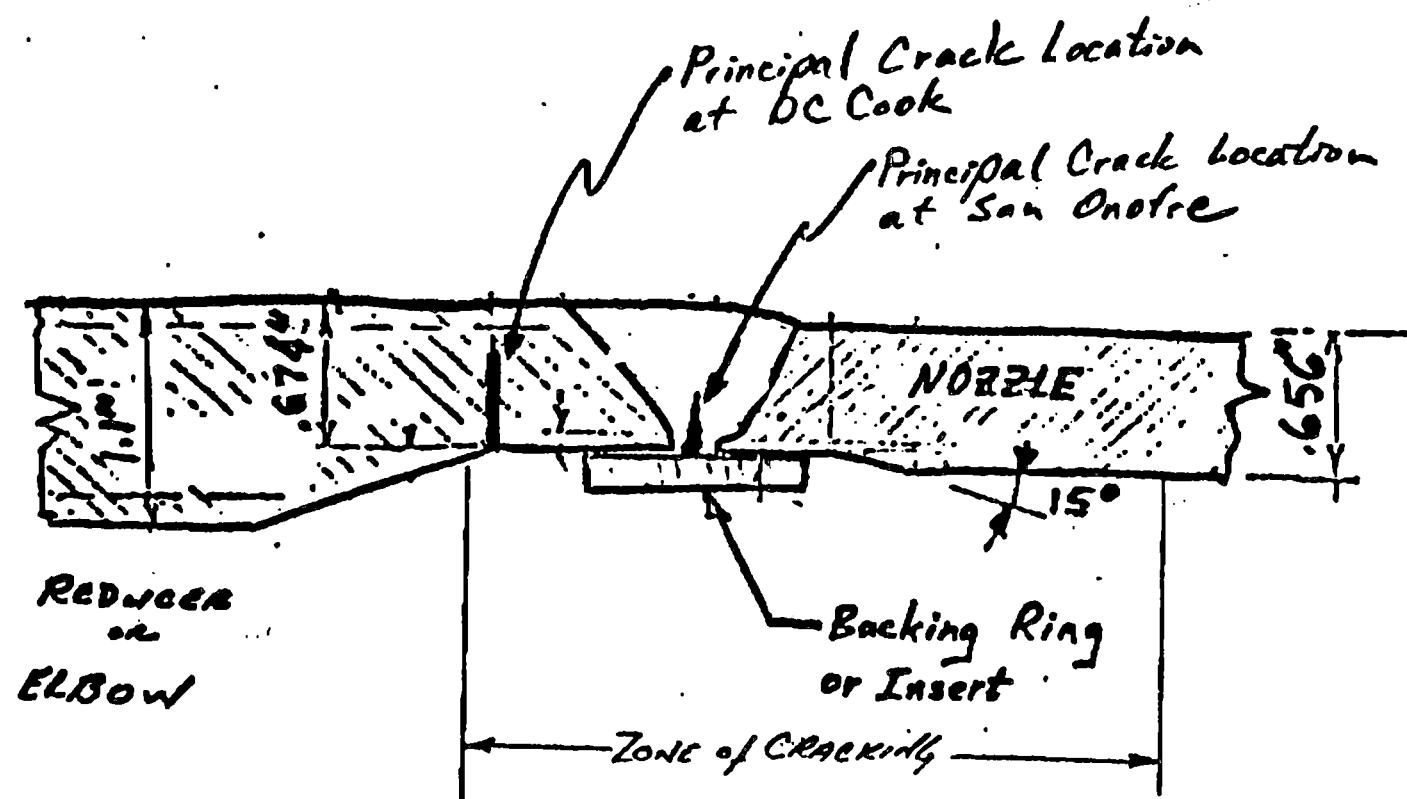
FIGURE 3
TYPICAL FEEDWATER PIPE TO NOZZLE
WELD JOINT DETAIL
(N .CE)

The feedwater nozzle-to-pipe configurations for D. C. Cook and for San Onofre are shown on the attached figures 1 and 2. A typical feedwater nozzle-to-pipe weld joint detail showing the principal crack locations for D. C. Cook and San Onofre are shown on the attached figure 3.

An extensive metallurgical investigation has been conducted by Westinghouse on a substantial number of cracked weldments removed from the above plants. Results of the metallurgical analysis lead to the conclusion that a corrosion fatigue phenomenon is the probable failure mechanism, except for the San Onofre piping which has been characterized as stress assisted corrosion.

- a. Perform radiographic examination, supplemented by ultrasonic examination as necessary to evaluate indications, of all feedwater nozzle-to-pipe welds and of adjacent pipe and nozzle areas (a distance equal to at least two wall thicknesses). Evaluation shall be in accordance with ASME Section III, Subsection NC, Article NC-5000. Radiography shall be performed to the 2T penetrometer sensitivity level, in lieu of Table NC-5111-1, with systems void of water.
