RE: LQD 2016-2017 Annual Inspection Report, Uranium One, Willow Creek ISR Project, Permit No. 478

IN SITU MINE INSPECTION REPORT

Permit Number:	PT0478	Permittee:	URANIUM ONE USA INC
Inspection Date:	11/29/2017	Inspector(s):	Luke McMahan
Report Date:	1/9/2018	Participant(s):	Scott Schierman, Kevin Filbert
Last Inspection:	10/18/2016	Current Bond:	\$21,707,323
Inspection Reason(s):	Annual	Field Conditions:	Clear, windy, dry, all areas accessible, ~55° F
		Approval Date:	4/18/1978

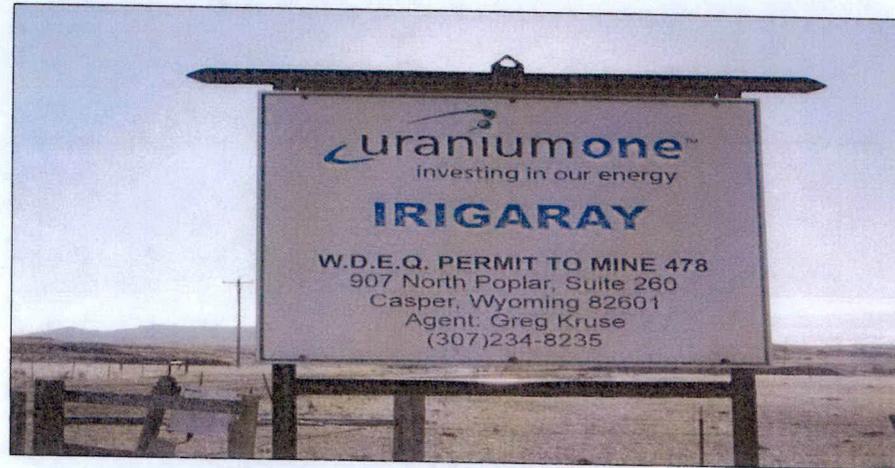
Photo #1: Irigaray Site Permit Sign.

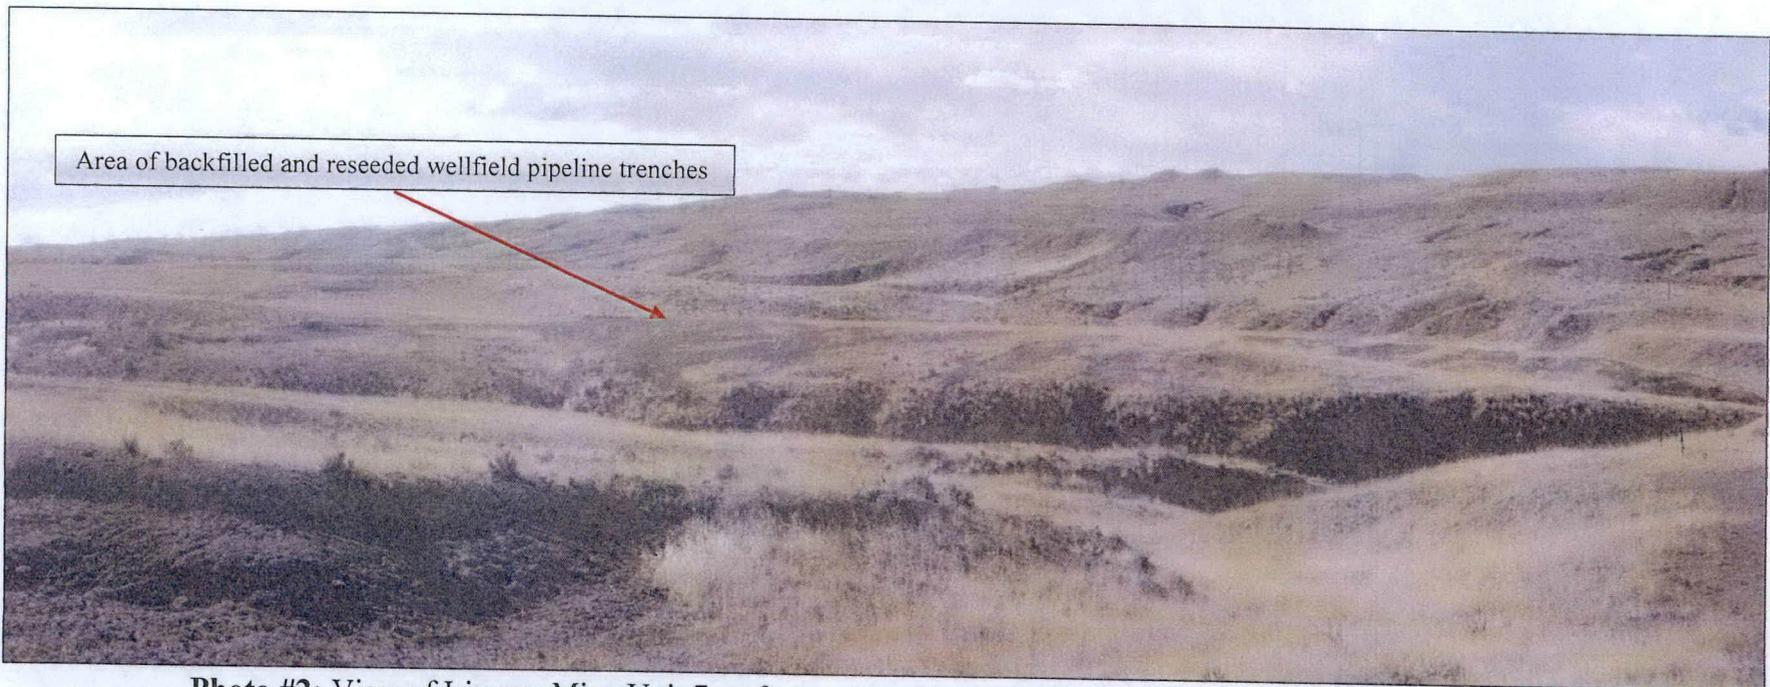
Photo #2: View of Irigaray Mine Unit 7 surface reclamation following removal of wellfield infrastructure.

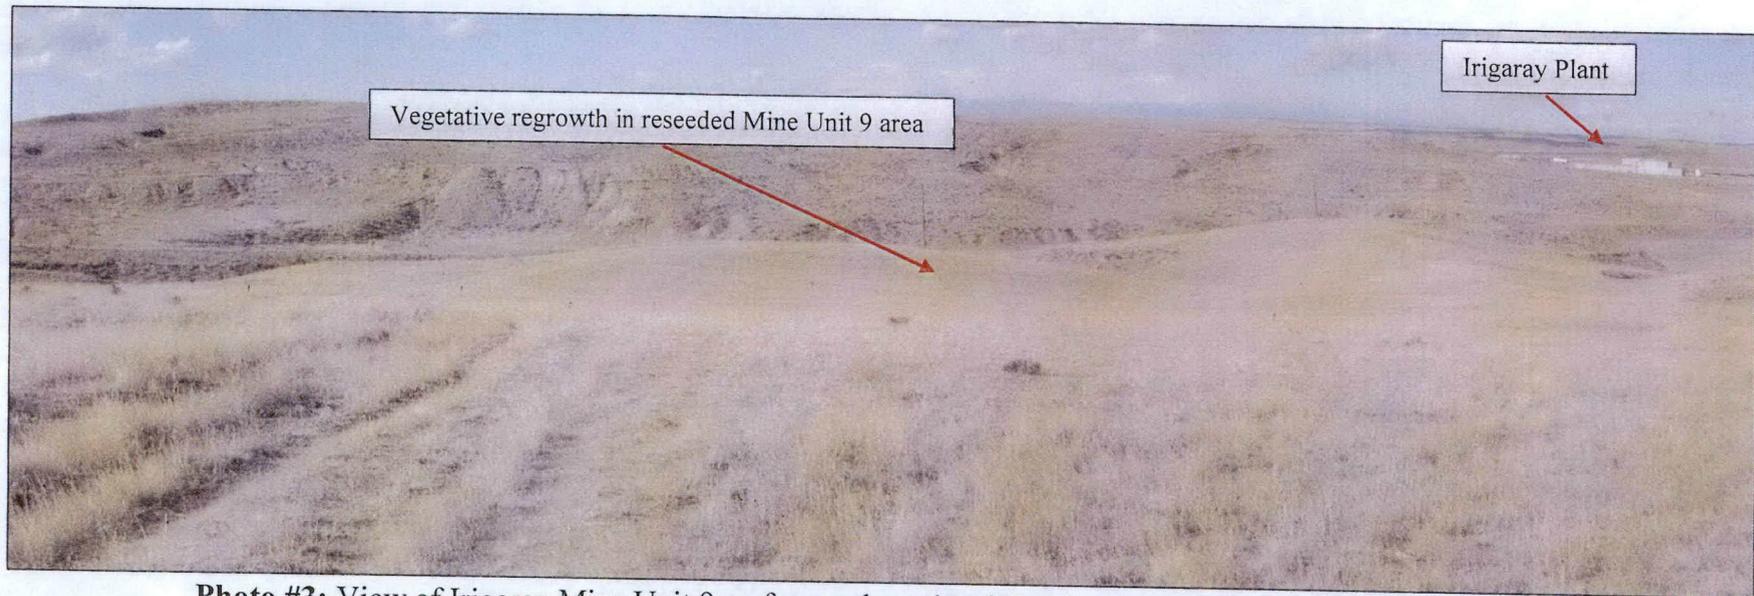
Photo #3: View of Irigaray Mine Unit 9 surface reclamation following removal of wellfield infrastructure.

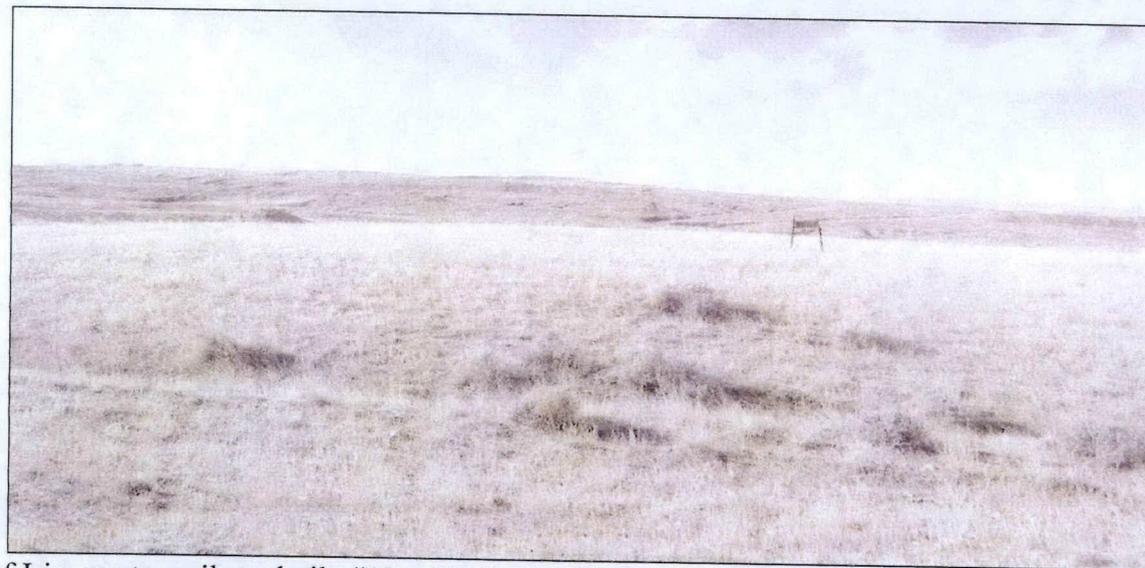
Photo #4: View of Irigaray topsoil stockpile #12 with ID sign, vegetative growth and signage typical of IR stockpiles viewed.

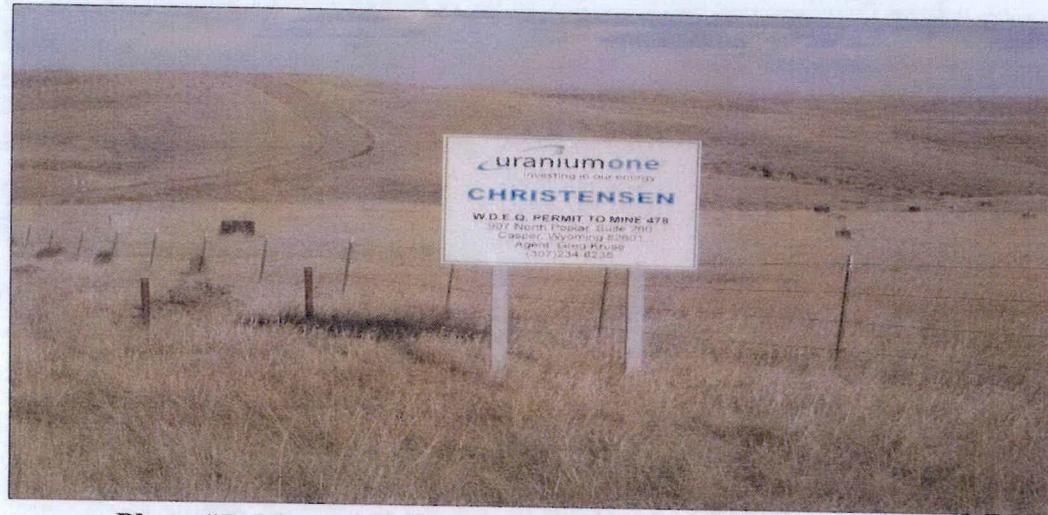
Photo #5: View of Christensen Ranch Site Permit Sign.

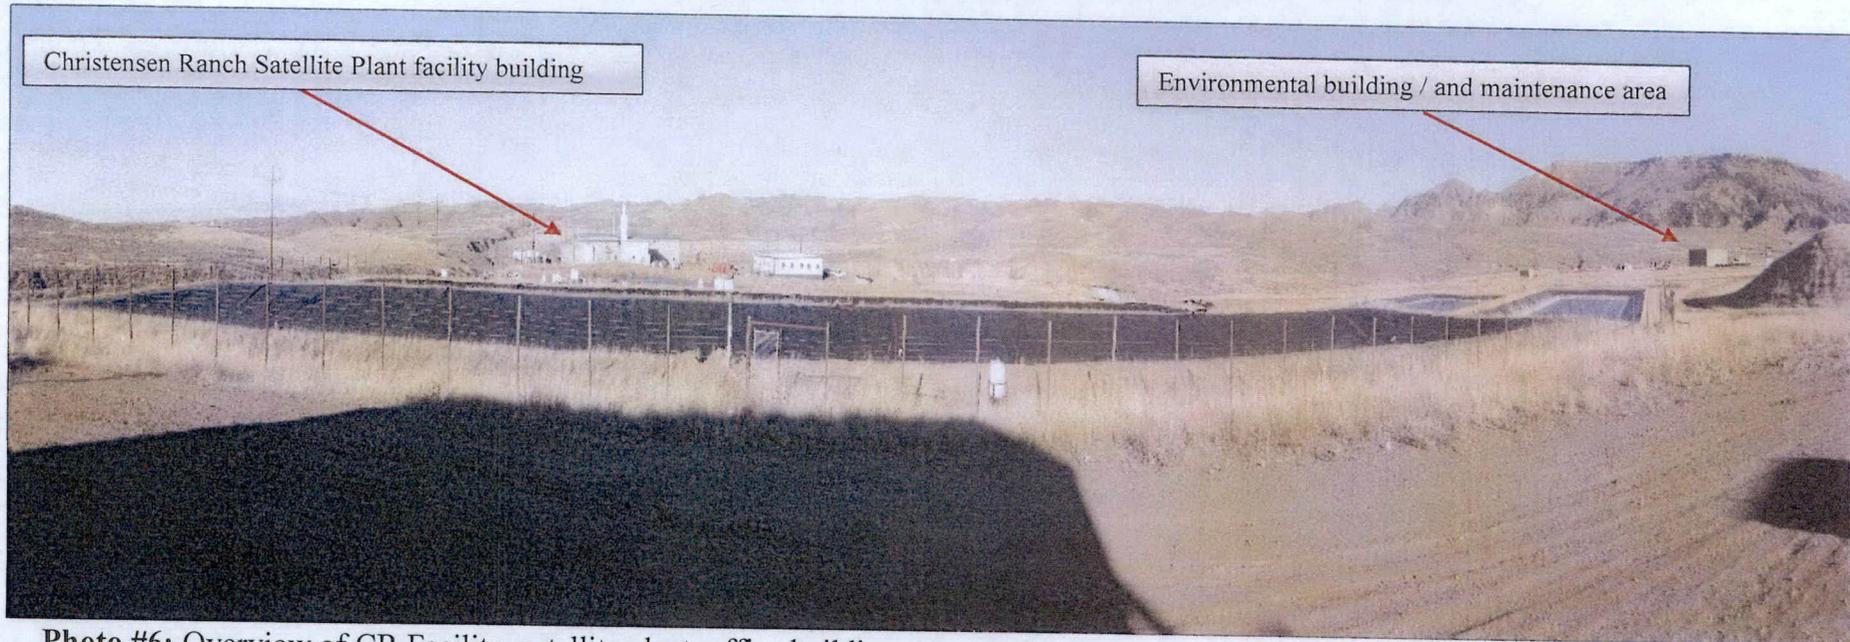
Photo #6: Overview of CR Facility; satellite plant, office building, evaporation ponds and maintenance area, looking NE from DDW site.

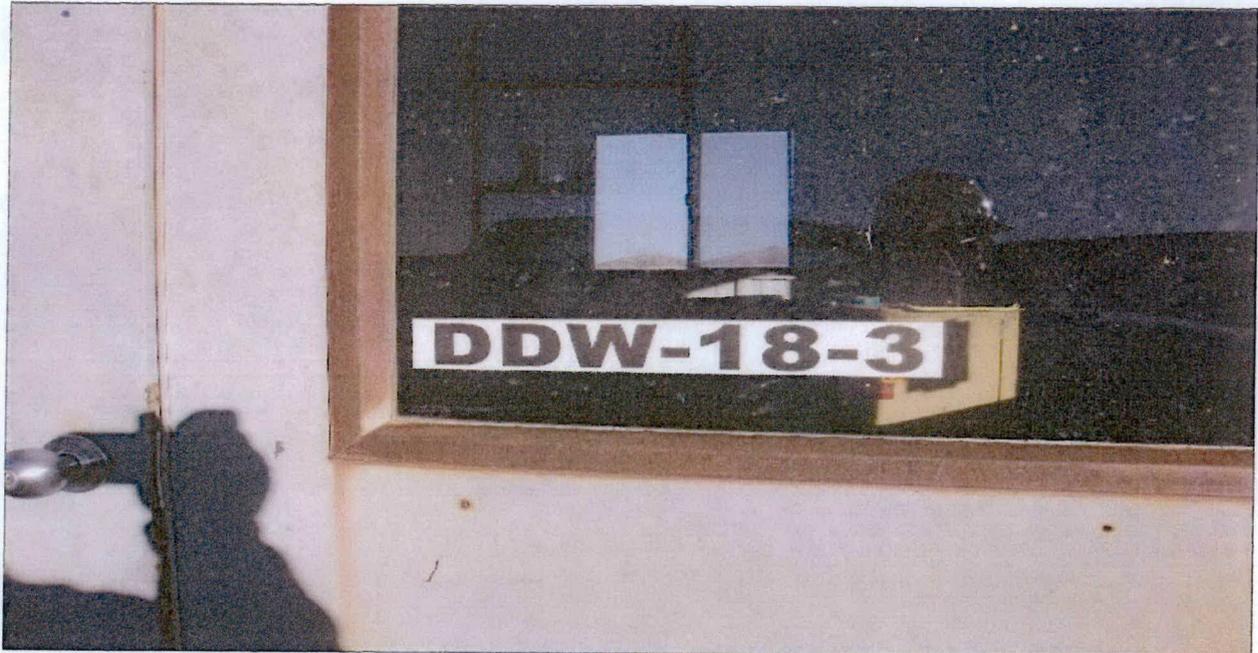
• Deep Disposal Wells	Yes
<p>The Willow Creek Mine has two (2) Class I Deep Disposal Wells, Christensen Ranch DW-1 and Christensen Ranch 18-3. Both wells are located at the Christensen Ranch Facilities area. The wells are permitted for injection of industrial wastes under the WDEQ Water Quality Division (WQD) Permit UIC 10-219. Construction, operation, mechanical integrity testing standards and the cost of reclamation are under the purview of the WQD UIC permit. However, the bond amount posted by Uranium One for reclamation of the wells is held by LQD in accordance with the LQD permit to mine for Willow Creek. Both wells were operational at the time of the inspection. No evidence of significant leakage or spills around the wellheads or around the well facilities was observed (Photos #7 & #8).</p>

Photo #7: View of Christensen Ranch Facility DDW-18-3.

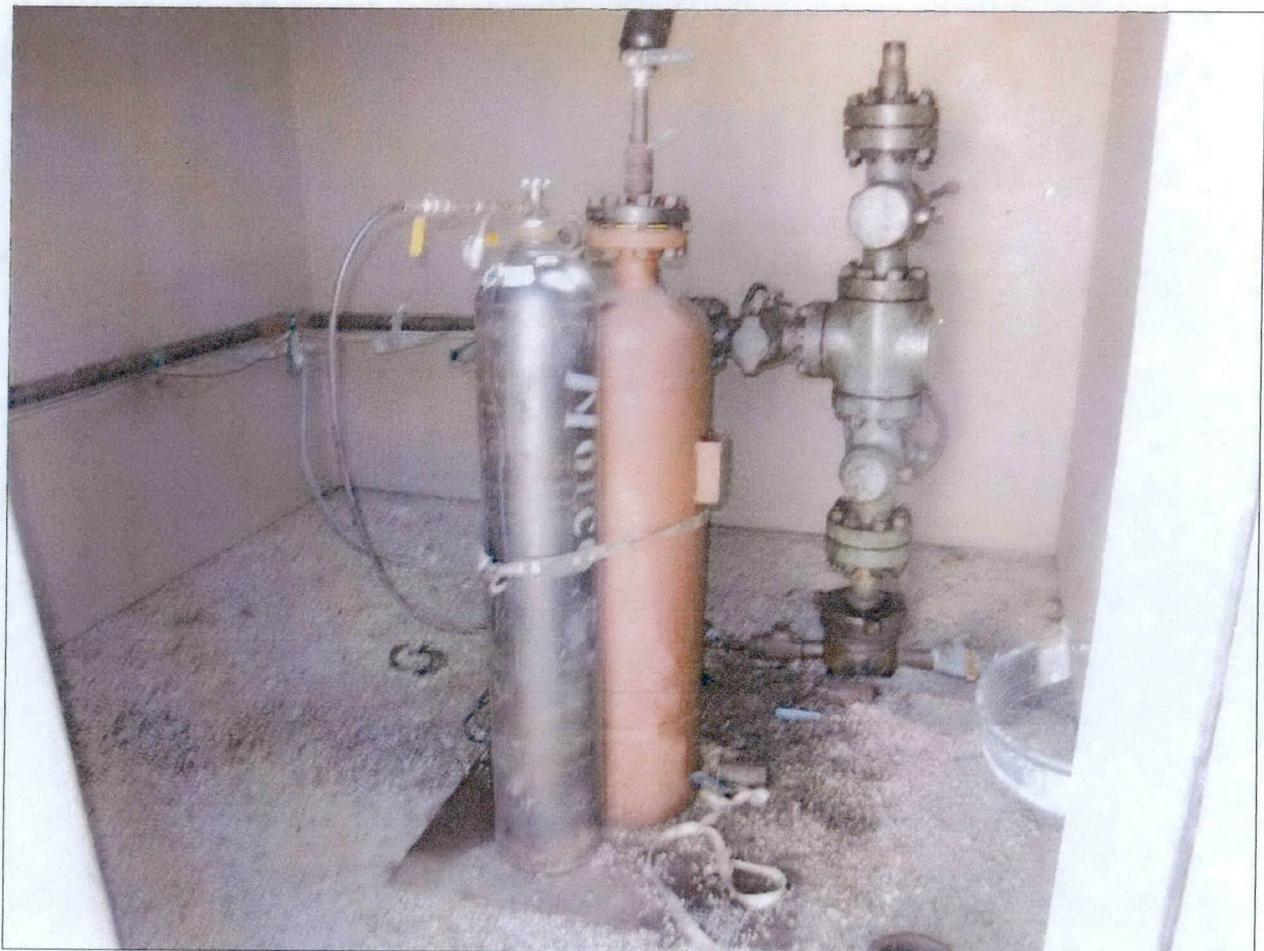
Photo #8: View of Christensen Ranch Facility DDW-18-3.

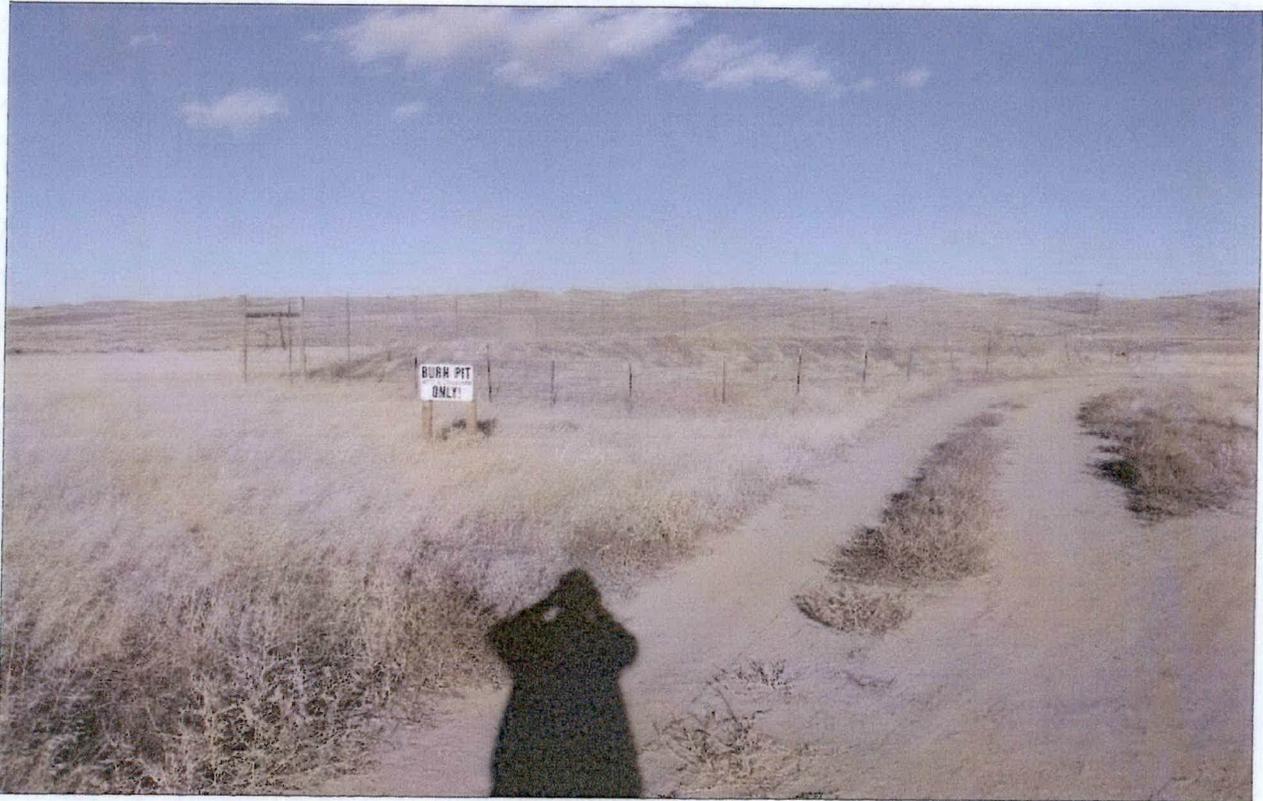
• Facilities	Yes
<p>Both the Irigaray Plant and Christensen Ranch Plant facilities were viewed in passing, however, the inspector did not enter the plant facilities during this inspection. The solid waste disposal area for common trash at the Christensen Ranch site was viewed. Although a minor amount of wind-blown trash was observed in the area, the containment fencing above and around the trash bins appeared to be effectively preventing wind-blown trash from migrating away from the trash bin location (Photo #10).</p> <p>The burn pit located adjacent to the maintenance area at the Christensen Ranch site was also viewed and found to have appropriate signage and fencing. There was no wind-blown debris observed to be around or migrating away from the pit location (Photo #9).</p>

Photo #9: View of Christensen Ranch Facility burn pit.

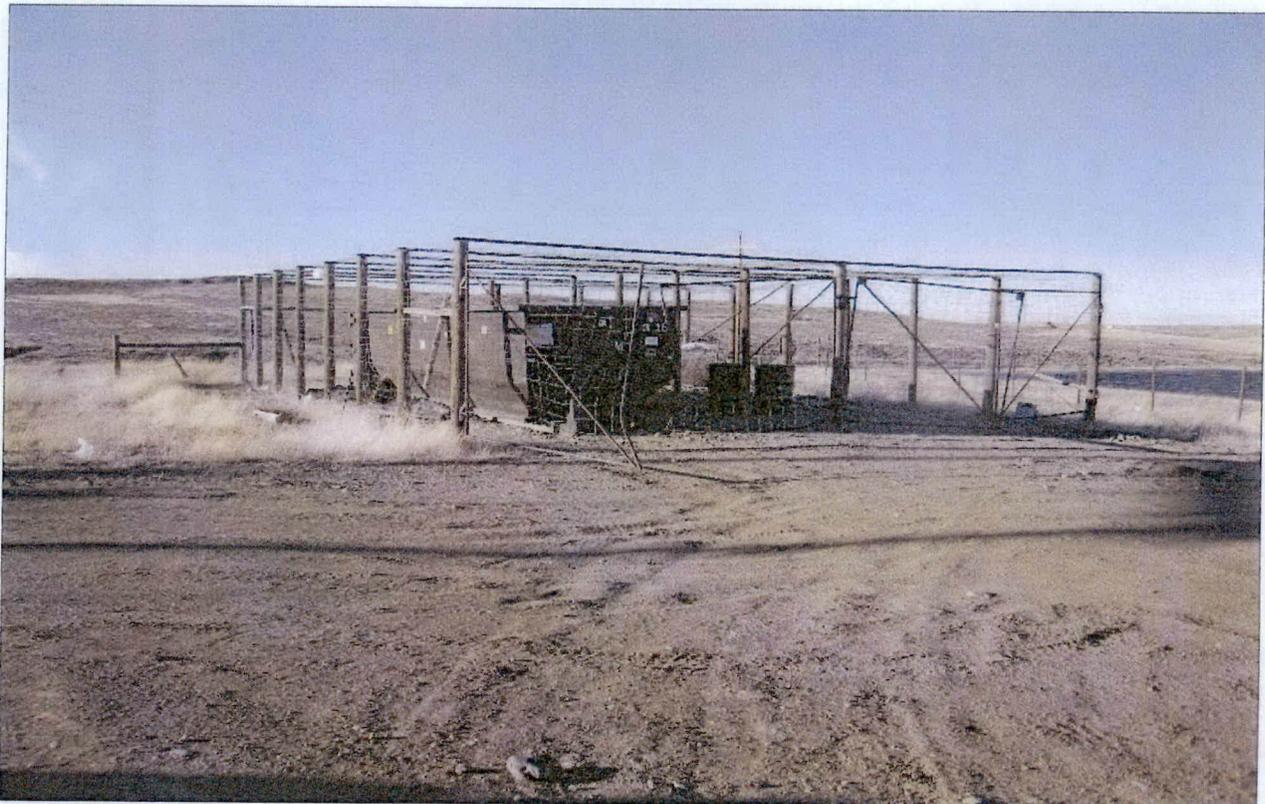
Photo #10: View of Christensen Ranch Facility solid waste disposal (common trash).

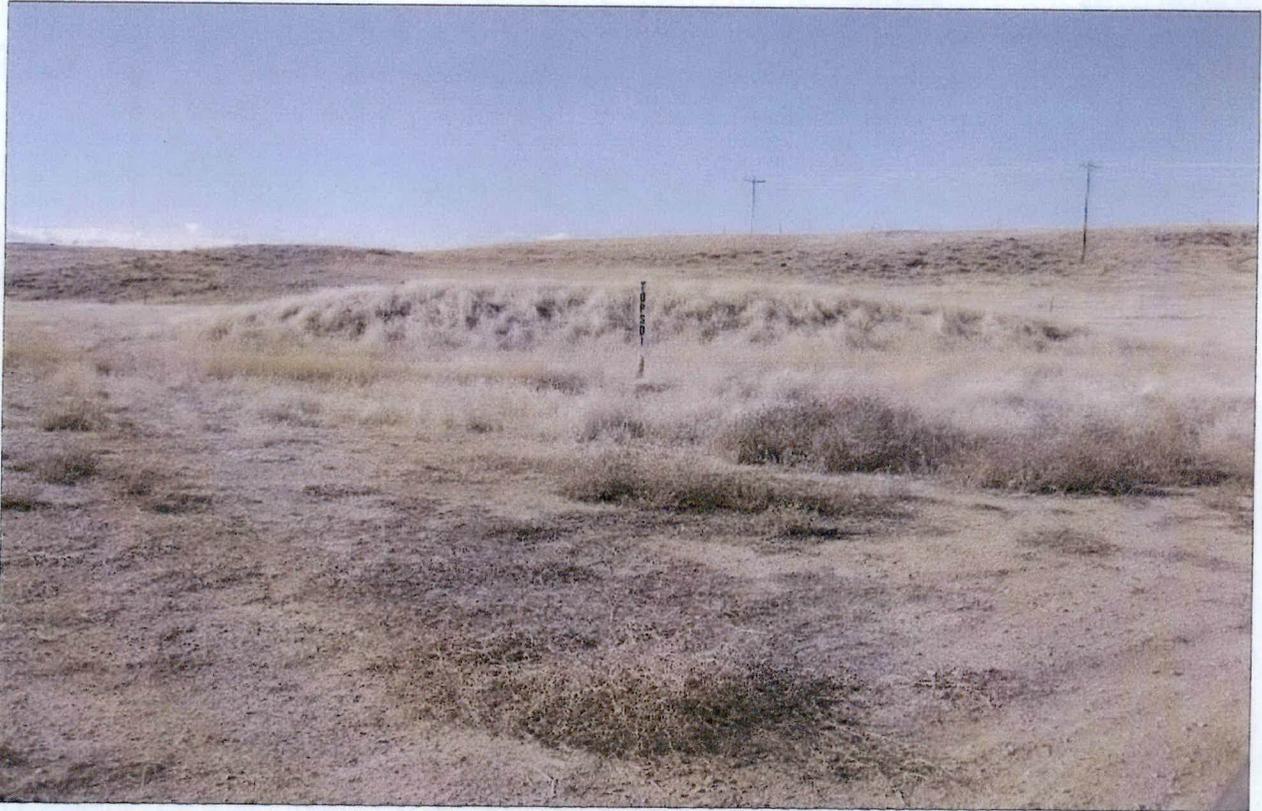
Photo #11: View of Christensen Ranch Topsoil Stockpile #28, typical of CR stockpiles viewed.

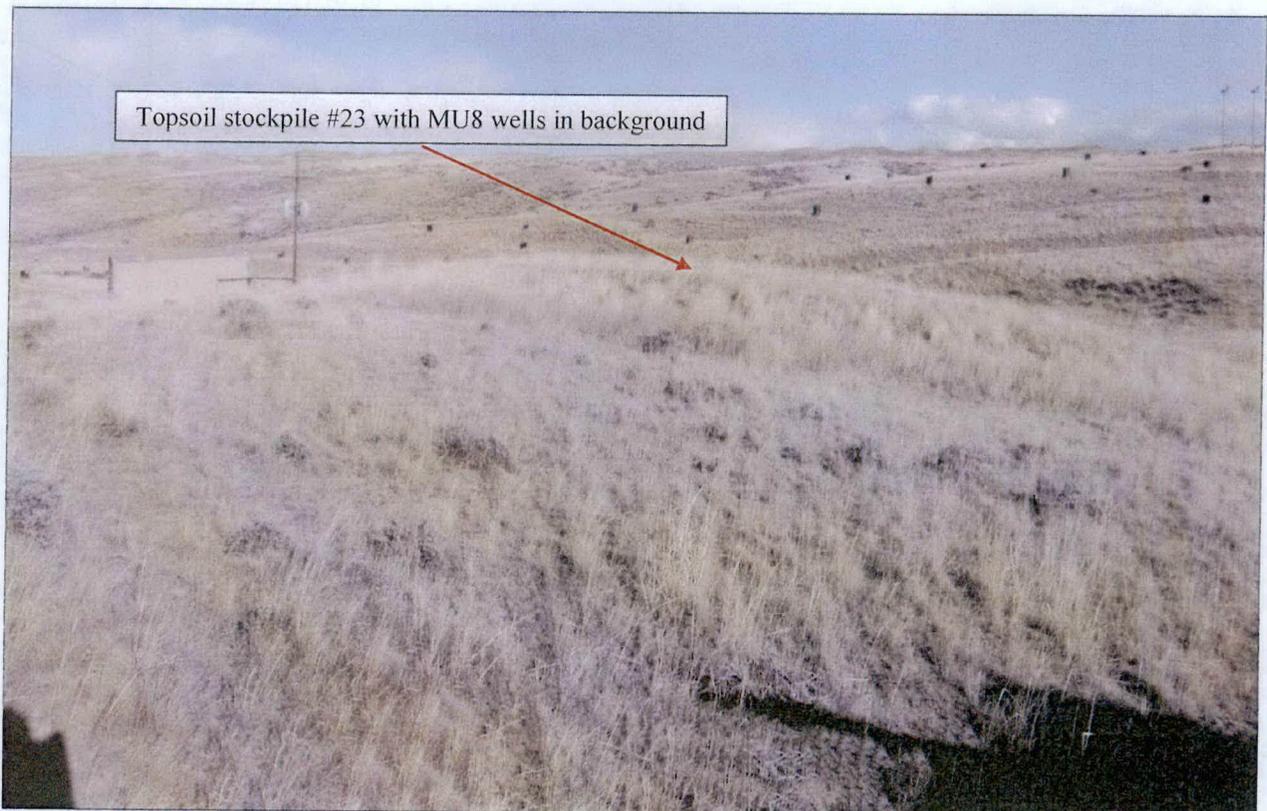
Photo #12: View of CR Topsoil Stockpile #23, no topsoil identification sign present.

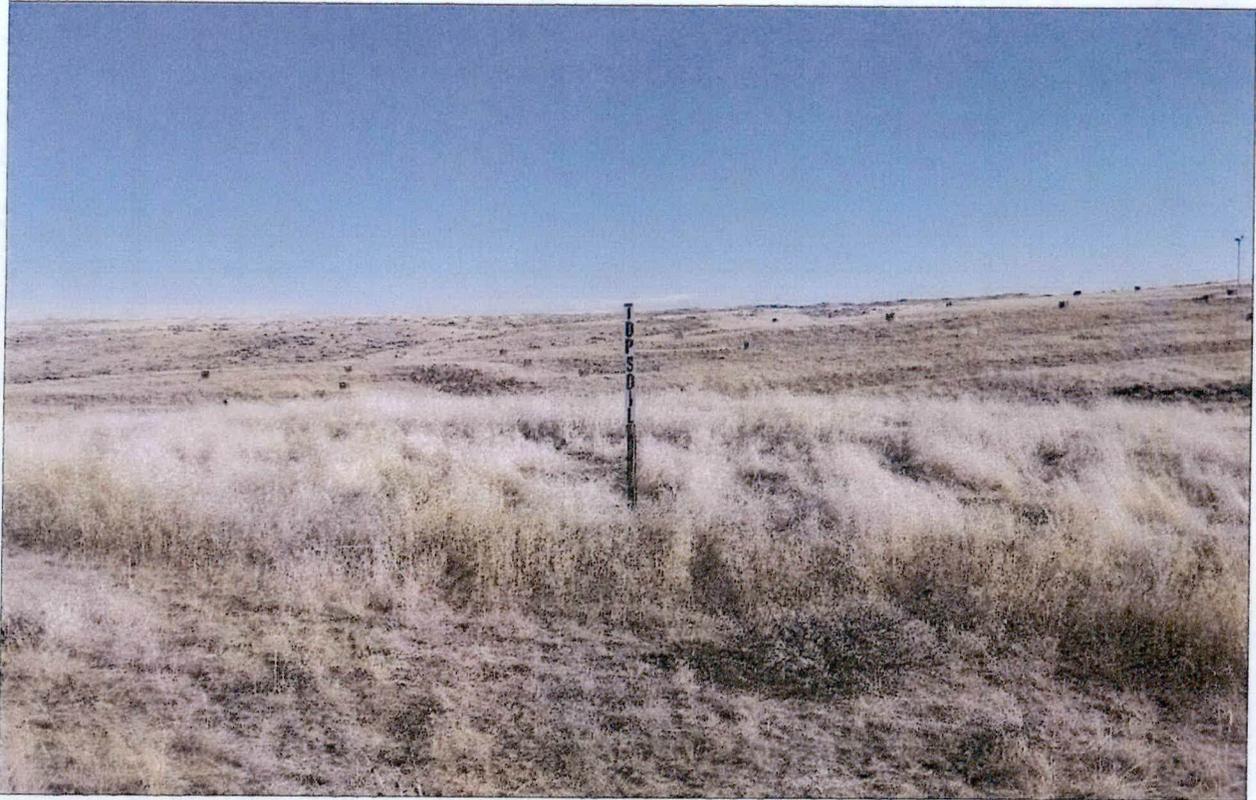
Photo #13: View of CR Topsoil Stockpile #23 with topsoil identification sign posted.

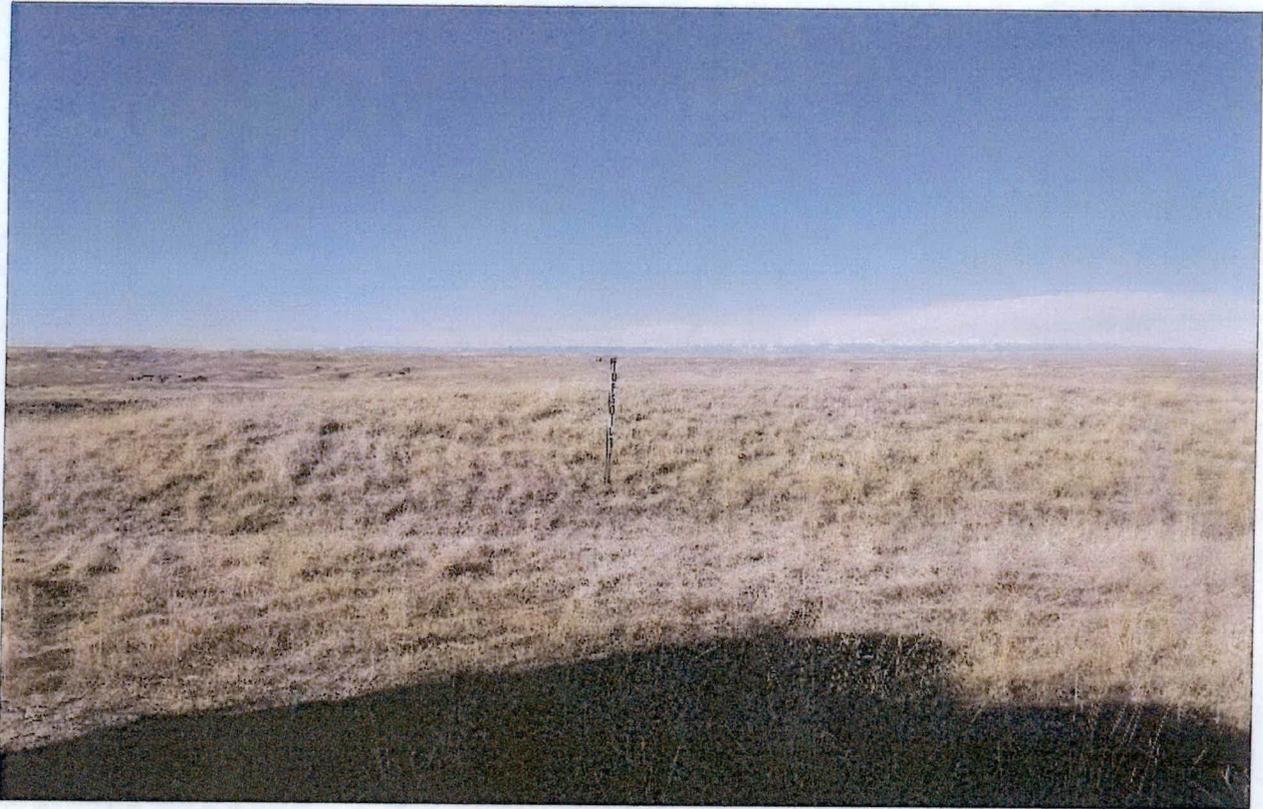
Photo #15: View of CR Topsoil Stockpile #30 with topsoil identification sign posted.

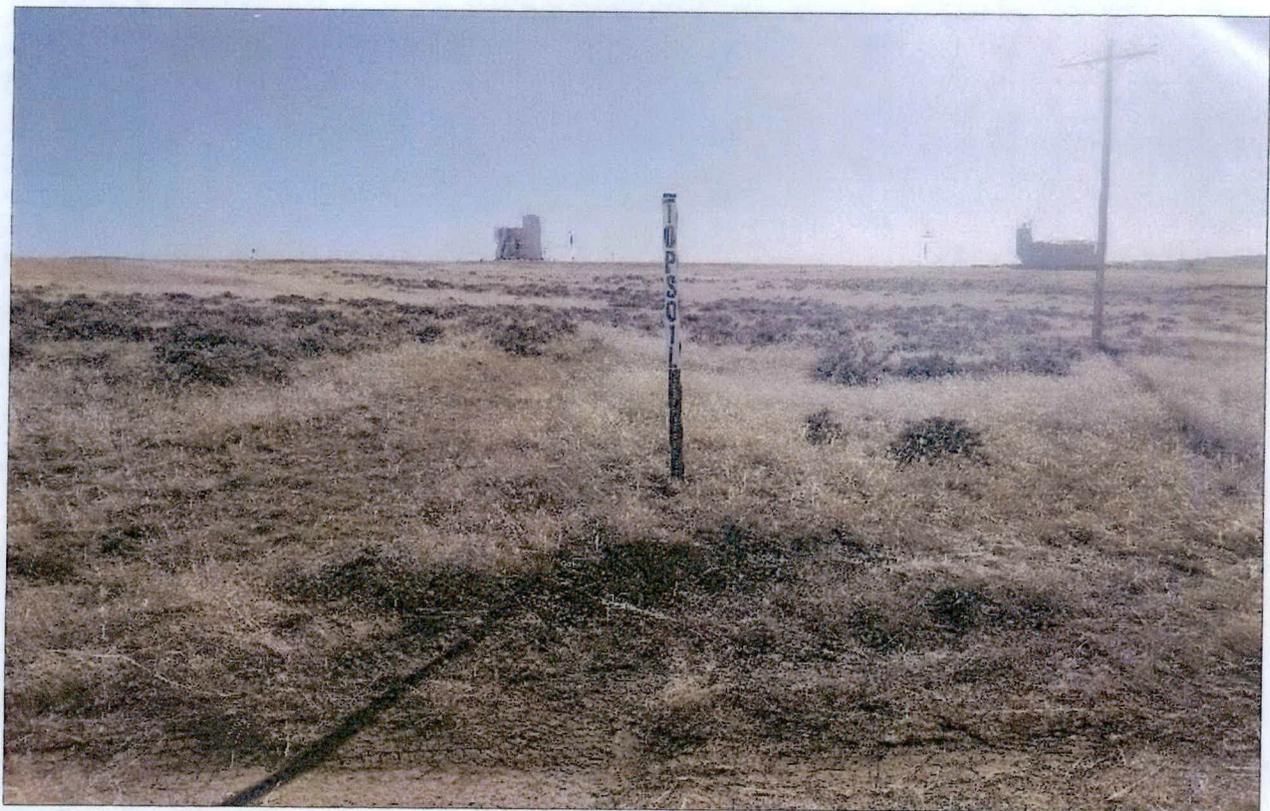
Photo #16: View of Christensen Ranch Topsoil Stockpile #35.

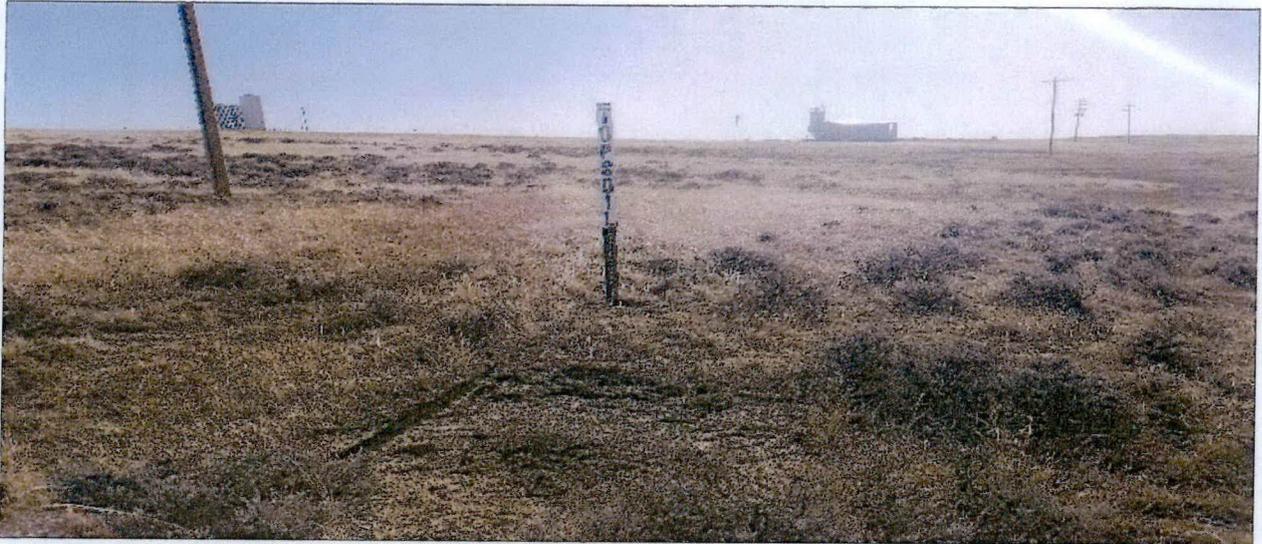
Photo #17: View of Christensen Ranch Topsoil Stockpile #36.

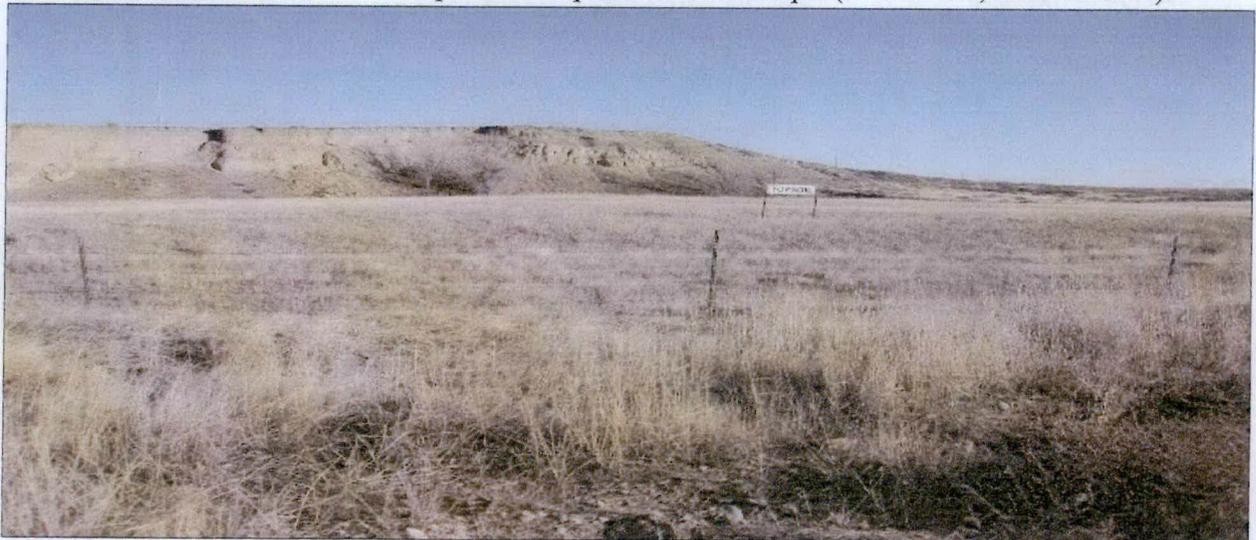
Inspection Topic	In Compliance
● Ponds	Yes
<p>The evaporation ponds (active and inactive) located at the Irigaray and Christensen sites were viewed in passing. The Irigaray facility has seven (7) ponds, three of which have had their liners removed and are no longer in use. The remaining four, IR-B, IR-D, IR-RA, and IR-RB were in use at the time of the inspection and no issues were identified with the Irigaray ponds. The Christensen facility has five (5) ponds, all of which were in use at the time of the inspection (Photo #6). No issues with the Christensen facility ponds were identified during the inspection.</p>	
● Signs	Yes
<p>The permit signs for the Irigaray site and the Christensen Ranch site were found to be up to date and posted with the appropriate information (Photos #1 and #5).</p>	
● Topsoil Stockpiles	Yes
<p>Based on the Annual Report and the Annual Inspection, a total of 49 topsoil stockpiles (Photos #4 & #11) and two (2) subsoil stockpiles (Photo #21) are present at Willow Creek Mine. All of these stockpiles were viewed during the annual inspection and were found to be in stable condition with no erosional issues. Two (2) of the topsoil stockpiles, #23 & #30 were found to be missing topsoil identification signs. Following the inspection, Uranium One posted topsoil signs at stockpiles #23 and #30 and emailed photographs of the identification signs posted at stockpiles #23 and #30 to the inspector on November 30, 2017 (Photos #12, #13, #14, #15). Topsoil stockpiles #35 & #36, not listed in the Annual Report topsoil stockpile table but shown on the Annual Report map for the Christensen area, could not be located during the inspection. Although #35 & #36 could not be located, it was noted during the inspection that these stockpiles were quite small and relatively difficult to see from a distance. Following the inspection, Uranium One found and verified the mapped locations for stockpiles #35 & #36, and emailed photographs to the inspector on November 30, 2017 (Photos #16, #17).</p> <p>Of the Forty-nine topsoil stockpiles viewed during the inspection, three (3) of the topsoil stockpiles were not listed in the Annual Report stockpile table or on the Annual Report maps. The three unnamed topsoil stockpiles were found located next to the maintenance area burn pit (43.802264, -106.031164), located next to the Mine Unit 3 access road (43.807297, -106.034825), and located next to the access road between Mine Unit 4 and Mine Unit 5 (43.785218, -106.028453). These stockpiles were found to be stable and posted with a topsoil identification sign (Photos #18, #19, #20). As requested in LQD's annual report review memorandum, these stockpiles will need to be added to the applicable annual report table and map.</p>

Photo #19: unnamed CR topsoil stockpile next to MU3 access road (43.807297, -106.034825).

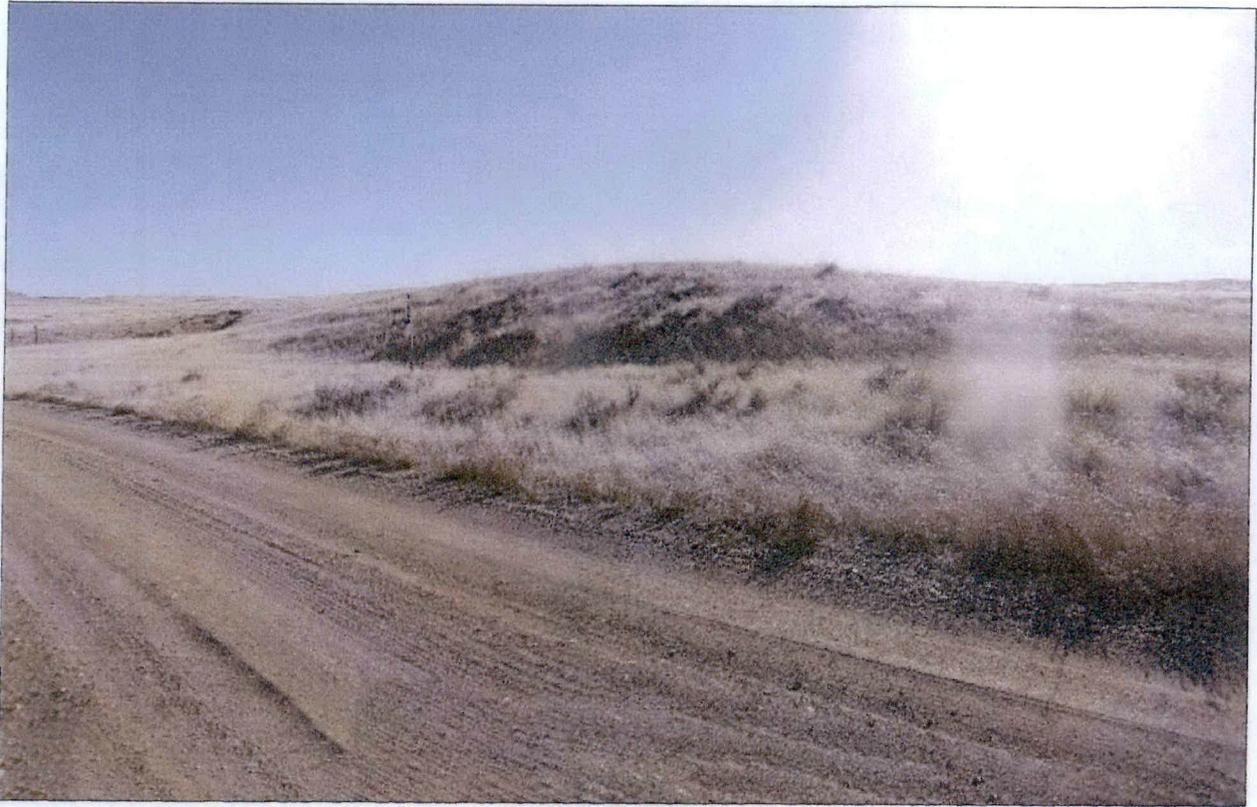
Photo #20: unnamed CR topsoil stockpile by MU4/MU5 access road (43.785218, -106.028453)

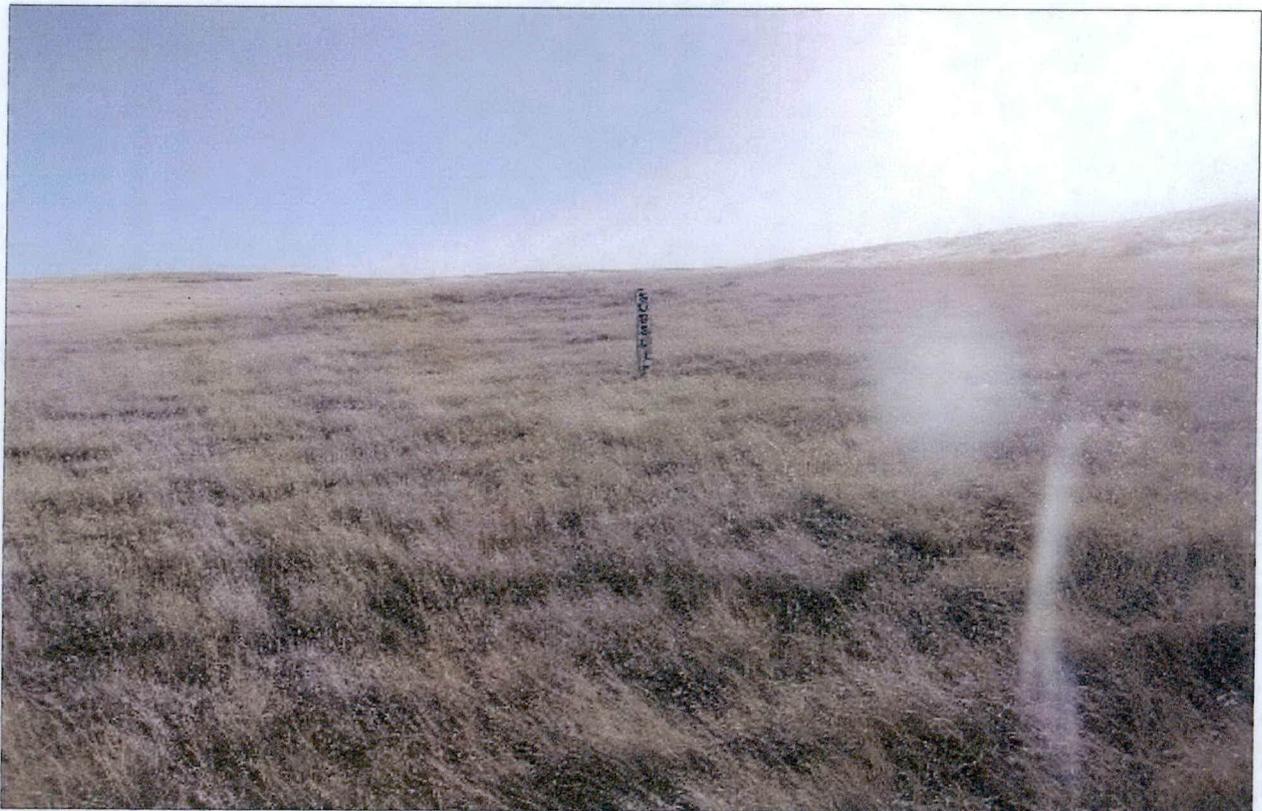
Photo #21: View of CR Subsoil Stockpile #8, typical of subsoil stockpiles viewed.

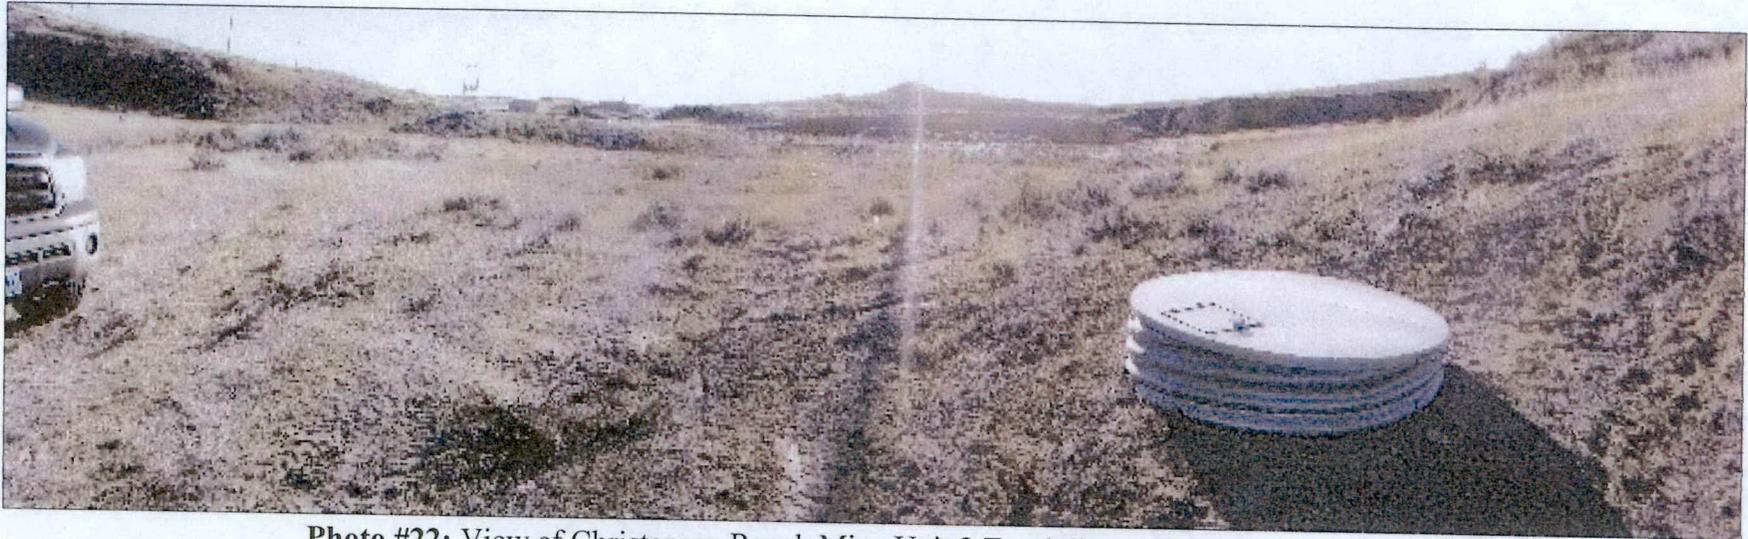
Inspection Topic	In Compliance
• Spills	Yes
<p>In August of 2017 Willow Creek Mine reported a spill from the Mine Unit 2 trunk line where a 10" x 6" poly transition which ties-in Module 2-2 to the Mine Unit 2 trunk line had failed. Groundwater is pumped from this wellfield and conveyed through the trunk line in order to maintain an inward gradient in the wellfield. Assessment of spill impacts and repair of the trunk line had been completed prior to the inspection. The site of the spill and repair was viewed during the inspection and all repair work was observed to be complete (Photo #22). Mine Unit 2 has undergone groundwater restoration efforts and therefore is no longer being mined. Groundwater restoration has not yet been approved by LQD for Mine Unit 2.</p>

Photo #22: View of Christensen Ranch Mine Unit 2 Trunk line spill location and repair.

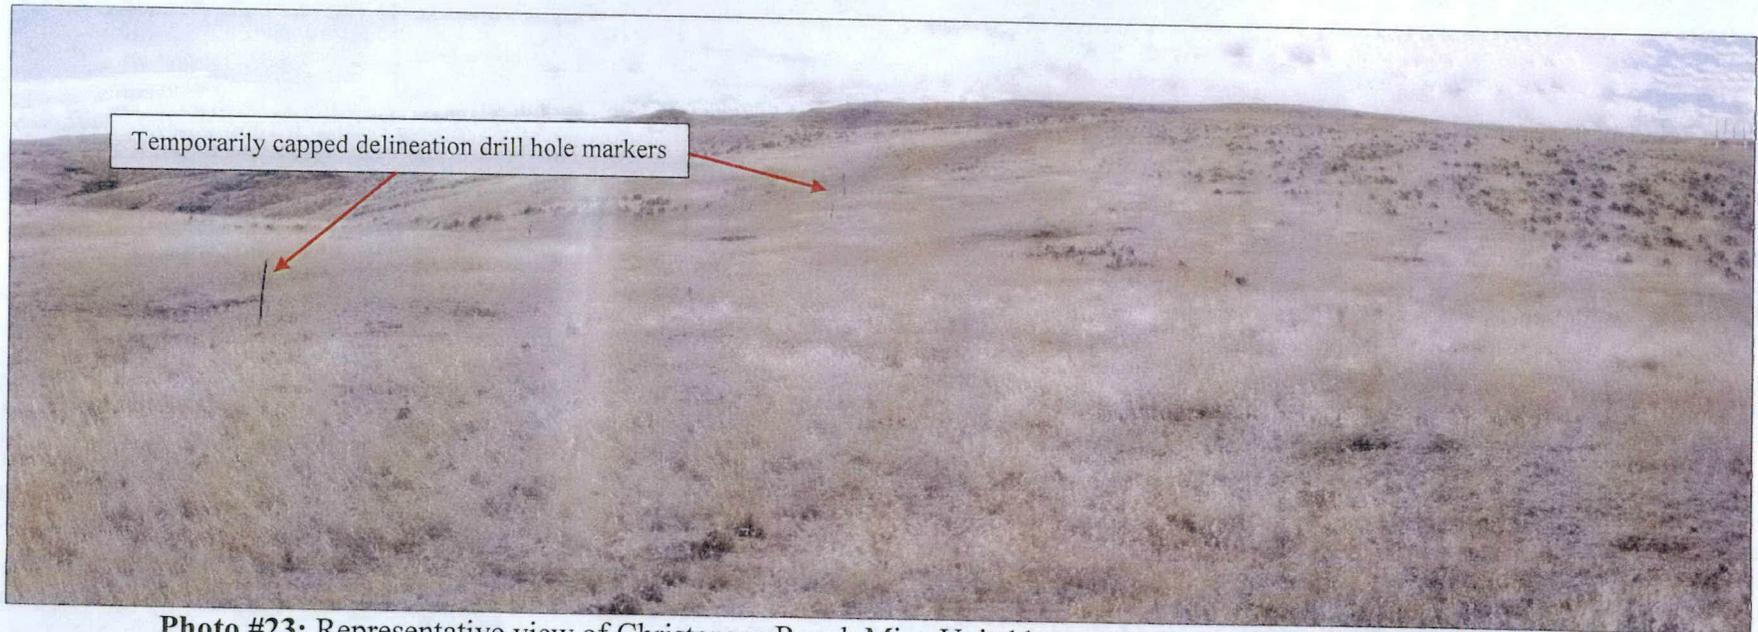
Inspection Topic	In Compliance
Drill Holes	N/A
• Delineation Drilling	Yes
<p>Temporarily capped pilot holes in undeveloped portions of Mine Unit 10 and temporarily capped delineation drilling holes in undeveloped Mine Units 11 & 12 were viewed during the inspection (Photo #23). No issues were identified at the surface with these temporarily capped holes. The reclamation status for the temporarily capped pilot holes in Mine Unit 10 is discussed in Section IV of the Annual Report. However, the reclamation status of temporarily capped delineation holes located in Mine Units 11 & 12 needs to be clarified as was discussed during the inspection. This issue is being addressed under Comment #3 of LQD's Review Memorandum for the 2016-2017 Annual Report (dated 12/15/17), and therefore this issue is not listed under the <i>Actions Required</i> section of this inspection report.</p>	
General	N/A

No violations were issued as a result of this inspection. No new maintenance items were generated as a result of this inspection. As discussed during the inspection, the reclamation status of temporarily capped delineation holes located in Mine Units 11 & 12 needs to be clarified. However, this issue is being addressed under Comment #3 of LQD's Review Memorandum for the 2016-2017 Annual Report (dated 12/15/17), and therefore is not listed under the *Actions Required* section of this inspection report. At the time of this inspection, the approved reclamation bond had been posted by Uranium One in the amount of \$21,707,323 as set forth in the LQD Director's Bond Letter dated April 3, 2017.

Photo #23: Representative view of Christensen Ranch Mine Unit 11 temporarily capped delineation drill holes.
