SUBJECT: TRANSMITTAL OF FINAL TURKEY POINT NUCLEAR GENERATING
UNIT NO. 3 ACCIDENT SEQUENCE PRECURSOR REPORT
(LICENSEE EVENT REPORT 250-2017-001)

**Final Accident Sequence Precursor Analysis - Turkey Point
Nuclear Generating Station (Unit 3), Loss of 3A 4kV Vital Bus
Results in Reactor Trip, Safety System Actuations, and Loss of
Safety Injection Function (LER 250-2017-001) - Precursor**

Accident Sequence Precursor Program – Office of Nuclear Regulatory Research			
Turkey Point Nuclear Generating Station, Unit 3		Loss of 3A 4kV Vital Bus Results in Reactor Trip, Safety System Actuations, and Loss of Safety Injection Function	
Event Date: 3/18/2017	LER: 250-2017-001 IRs: 05000250/2017008 and 05000250/2017002	CCDP = 3×10^{-6}	
Plant Type: Westinghouse 3-Loop Pressurized-Water Reactor (PWR) with Dry, Ambient Pressure Containment			
Plant Operating Mode (Reactor Power Level): Mode 1 (100% Reactor Power)			
Analyst: Chris Hunter	Reviewer: Ian Gifford	Contributors: N/A	Approval Date: 02/12/2018

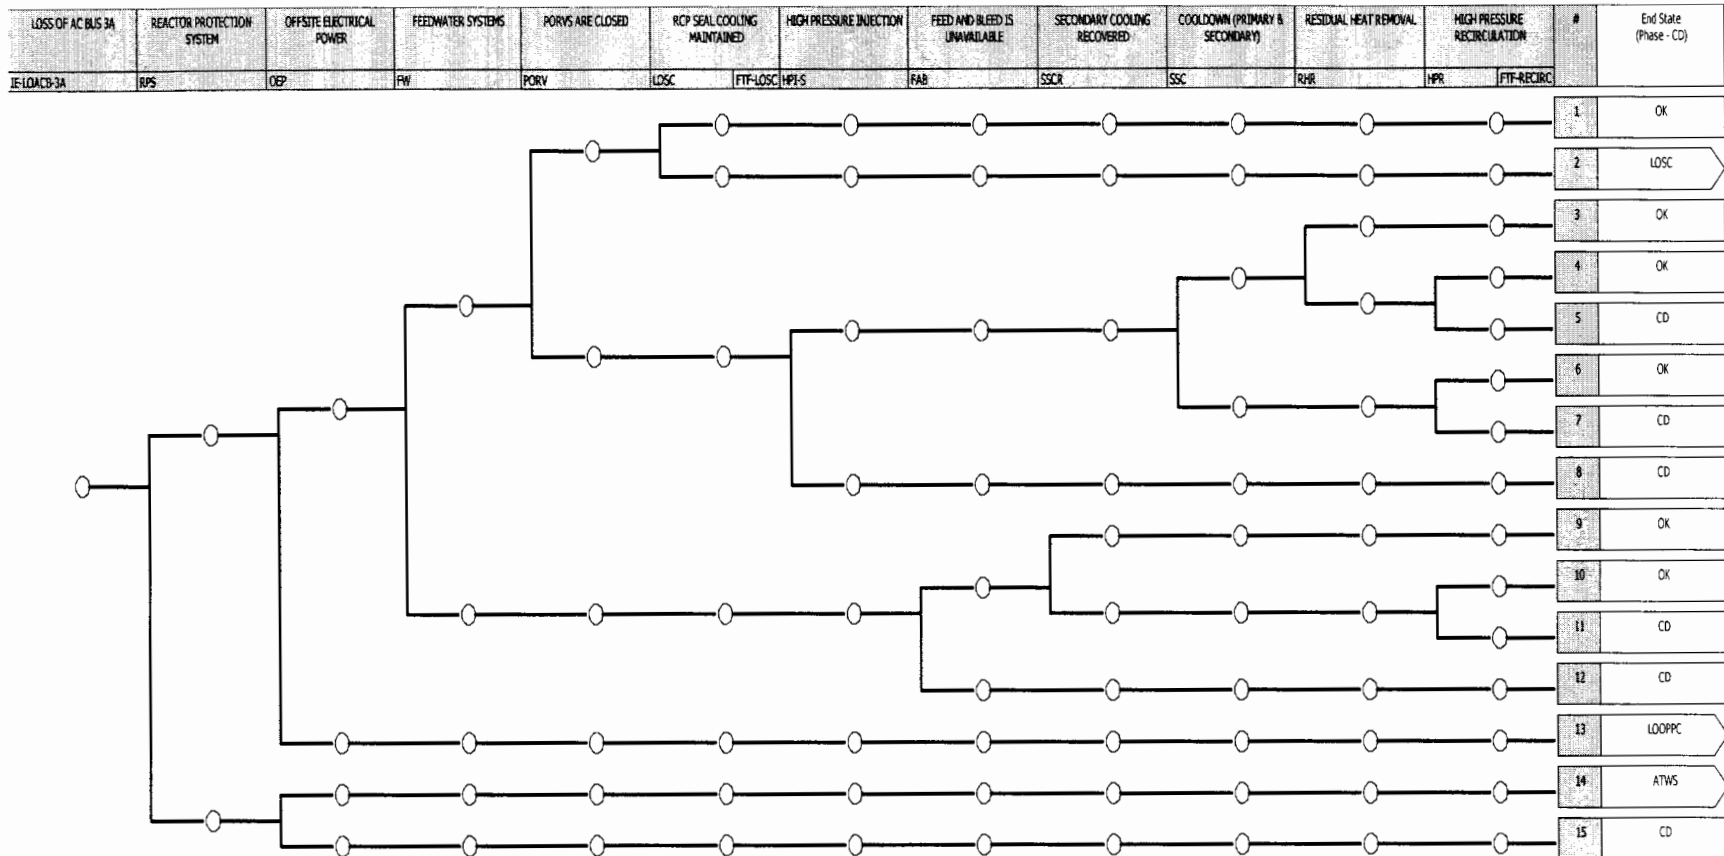
Figure A-1. Turkey Point Loss of 4.16kV Safety-Related Bus 3A Event Tree

Dominant Sequence. The dominant accident sequence is LAC3A sequence 13-16-22 (CCDP = 2.30×10^{-6}), which contributes approximately 71 percent of the total internal events CCDP. The dominant sequences that contribute at least 1.0 percent to the total internal events CCDP are provided in the following table. The dominant sequence is shown graphically in Figures A-1 through A-4 in Appendix A.

Sequence	CCDP	Percentage	Description
LAC3A 13-16-22	2.30E-6	71.4%	Loss of safety-related bus 3A initiating event; successful reactor trip; subsequent loss of bus 3B results in a loss of all safety-related AC power; AFW succeeds; a PORV fails to reclose resulting in a LOCA; all HHSI pumps are unavailable due to no electrical power (Unit 3) or maintenance (Unit 4), which results in core damage
LAC3A 13-16-20	2.68E-7	8.3%	Loss of safety-related bus 3A initiating event; successful reactor trip; subsequent loss of bus 3B results in a loss of all safety-related AC power; AFW succeeds; RCP seal injection/cooling is lost and a subsequent RCP seal LOCA occurs; all HHSI pumps are unavailable due to no electrical power (Unit 3) or maintenance (Unit 4), which results in core damage
LAC3A 02-9-05	1.21E-7	3.8%	Loss of safety-related bus 3A initiating event; successful reactor trip; AFW succeeds; RCP seal injection/cooling is lost and a subsequent RCP seal LOCA occurs due operators failing to trip the RCPs; high-pressure injection succeeds; accumulators successfully inject in the reactor coolant system; secondary-side cooldown fails, and high-pressure recirculation fails resulting in core damage

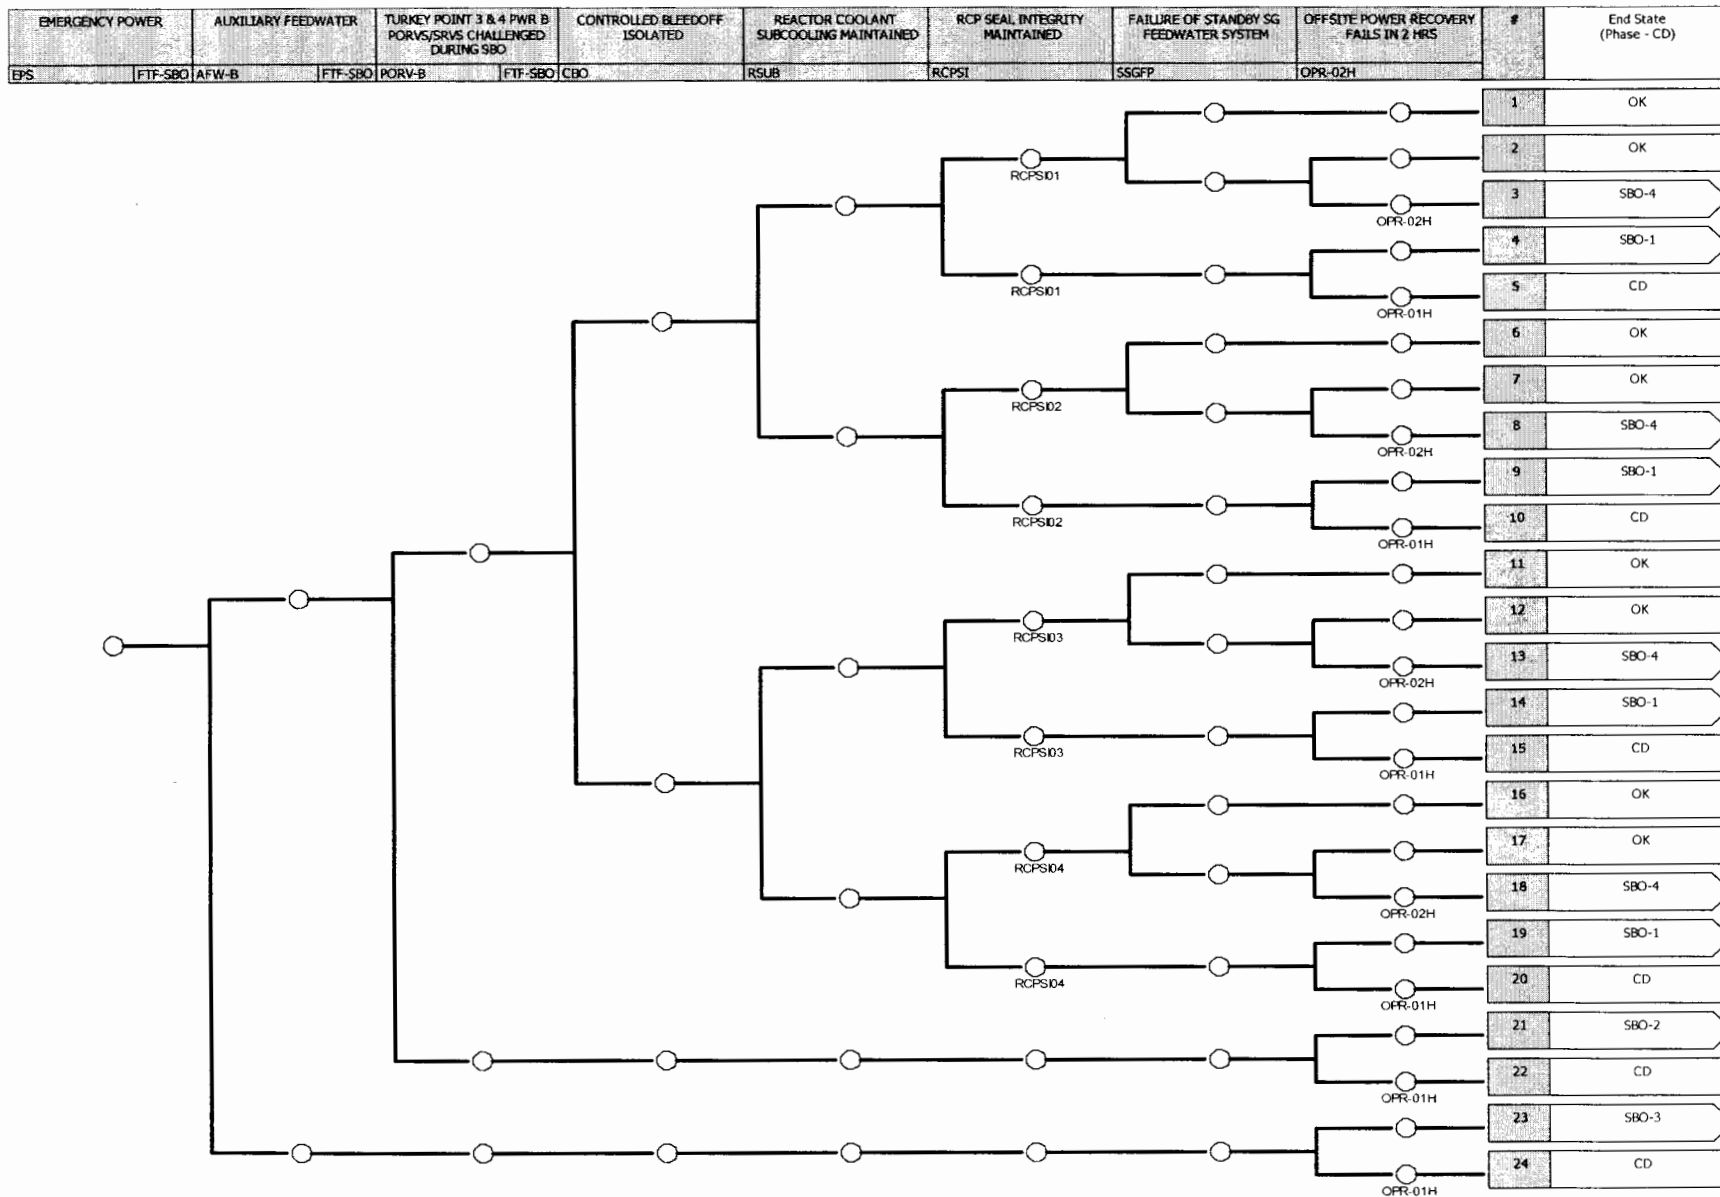
Figure A-3. Modified Turkey Point SBO Event Tree

- In ASP analyses, recovery credit for EDG failures is limited to cases where event information supports credit for EDG recovery. Therefore, the DGR-02H (*diesel generator recovery in 2 hours*) top event (including applicable event tree branching) was eliminated from the station blackout (SBO) event tree. The modified SBO event tree is shown in [Figure A-3](#).

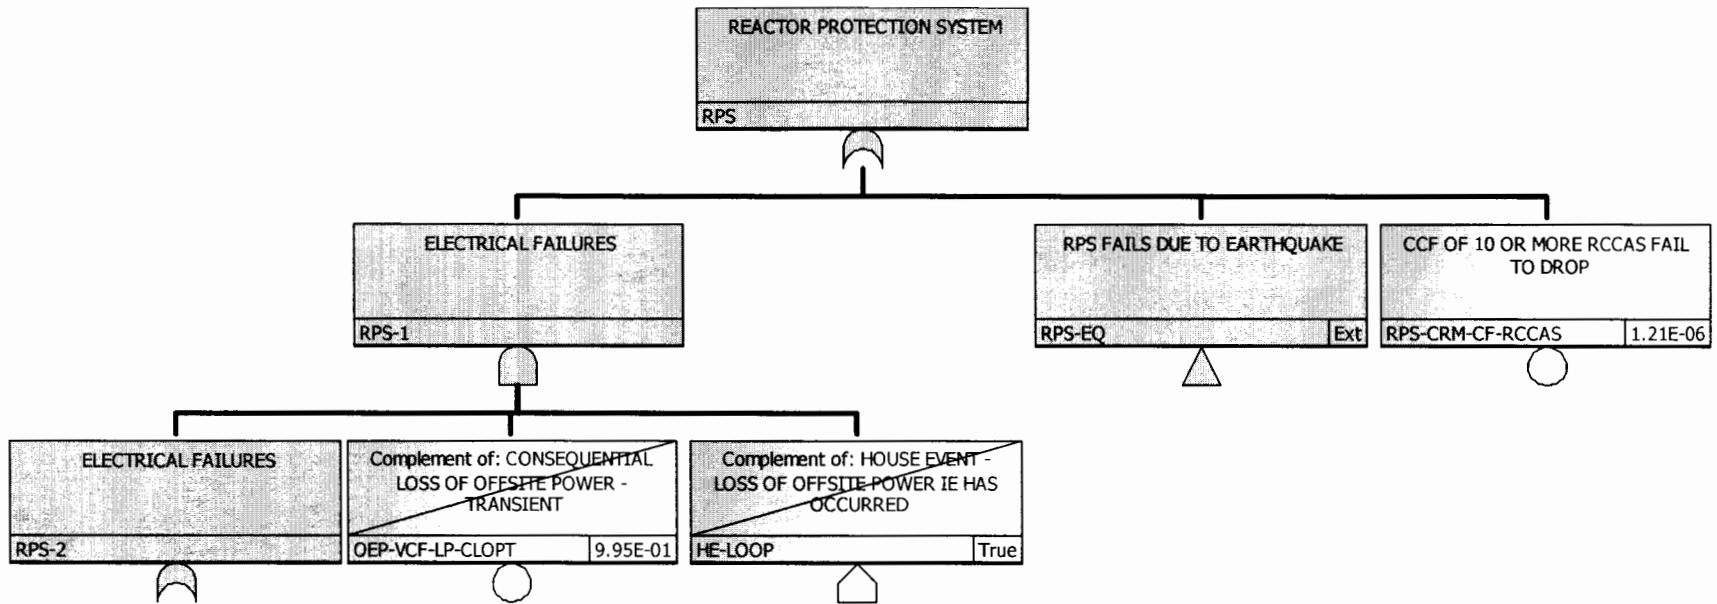
Figure B-1. Modified Turkey Point RPS Fault Tree

- To prevent risk contributions from certain anticipated transient without scram (ATWS) cut sets that do not apply to this assessment, the complement basic event OEP-VCF-LP-CLOPT (*consequential loss of offsite power—transient*) was inserted under gate RPS-1 (*electrical failures*) in the RPS (*reactor protection system fault tree*). An ATWS is only possible during a consequential loss of offsite power (LOOP) if the rods fail to insert into the reactor (i.e., they are mechanically stuck). The modified RPS fault tree is shown in [Figure B-1](#).

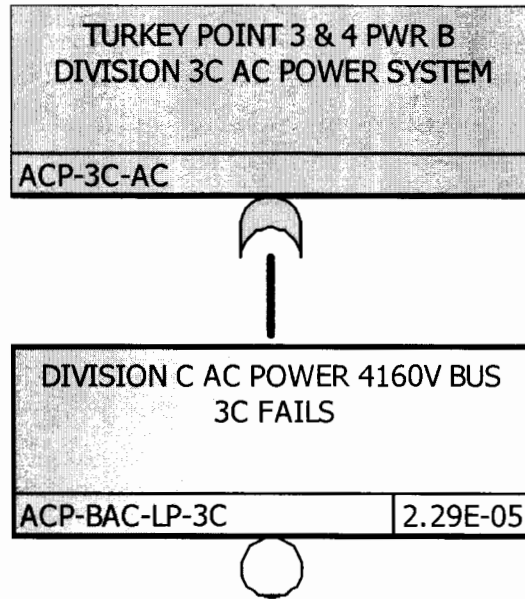
Figure B-2. Modified Turkey Point ACP-3C-AC Fault Tree

- During the event, nonsafety-related AC bus 3C remained energized and, therefore, the motor-driven standby SG feedwater pump was available to provide inventory makeup to the SGs. This pump would also be available for the dominant (postulated) scenarios in this analysis (i.e., loss of all safety-related 4.16 kV power). To ensure that credit for this pump is provided in this analysis, basic events HE-LOOP (*house event—loss of offsite power initiating event has occurred*) and HE-LOSP-3C (*loss of division 3C offsite power flag*) were deleted from the ACP-3C-AC (*Turkey Point 3 and 4 PWR B division 3C AC power system*) fault tree. The modified ACP-3C-AC fault tree is shown in [Figure B-2](#).
