ONS-2018-016

February 12, 2018

Duke Energy Carolina, LLC (Duke Energy)  
Oconee Nuclear Station, Units 1, 2 and 3  
Docket Numbers 50-269, 50-270, 50-287  
Renewed License Numbers DPR-38, DPR-47, and DPR-55

**Subject:** Duke Energy Responses to Request for Additional Information (RAI); Request for Alternative to Codes and Standards Requirements Pursuant to 10 CFR 50.55a(z) to Satisfy 10 CFR 50.55a(h)(2) Associated with Bronze Tape Wrapped Emergency Power Cables in Use at the Oconee Nuclear Station

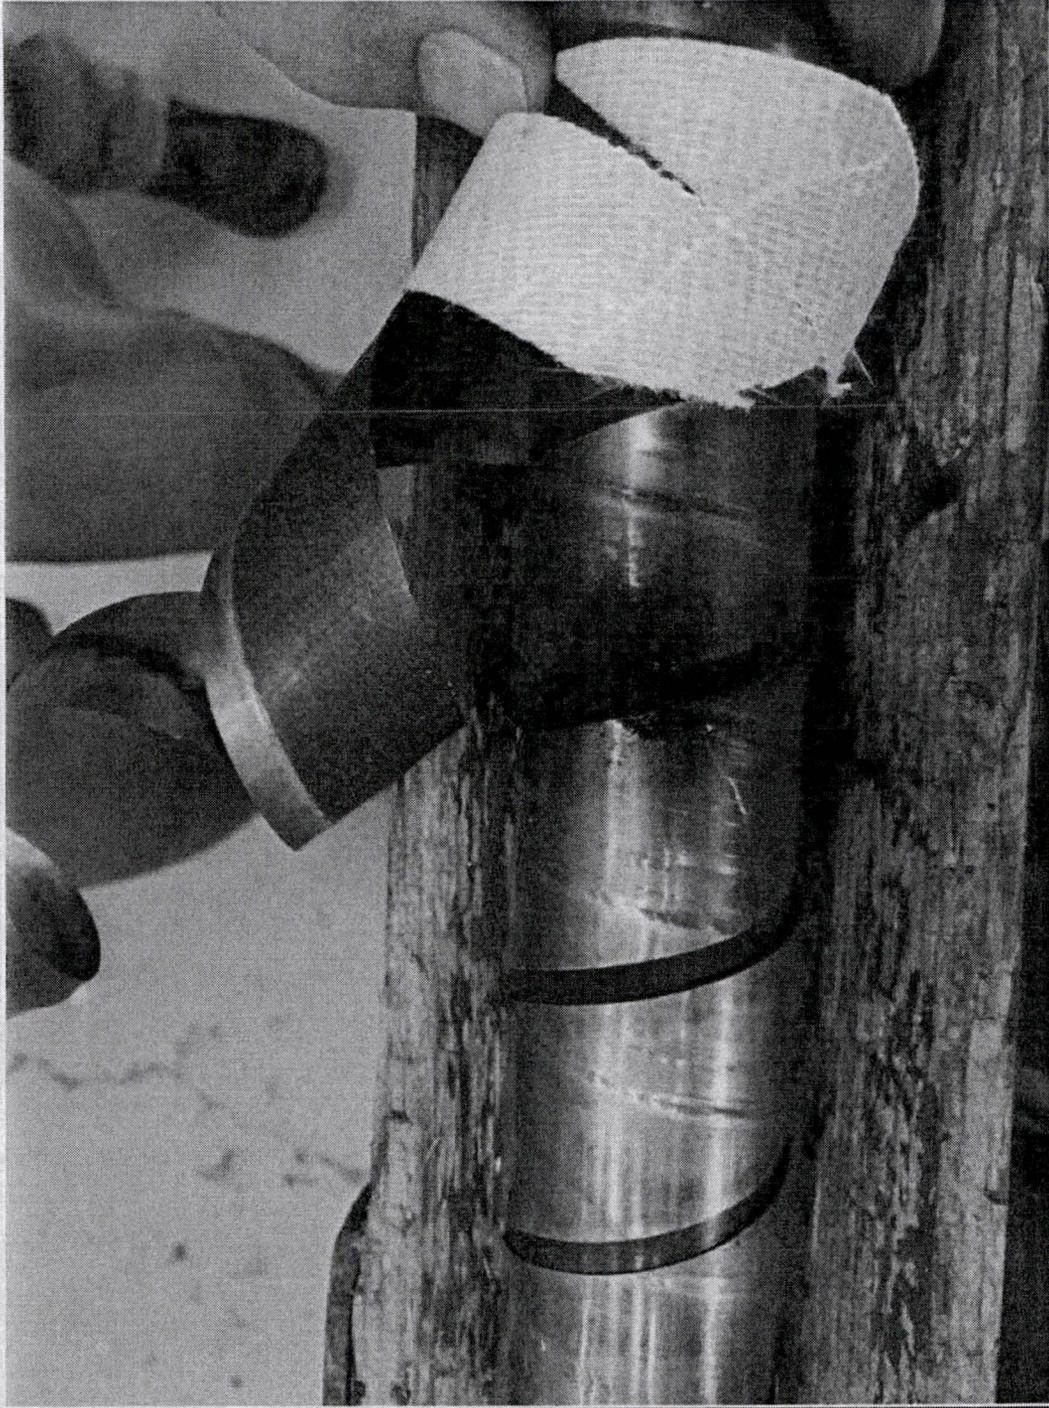
High Voltage Impulse Fault

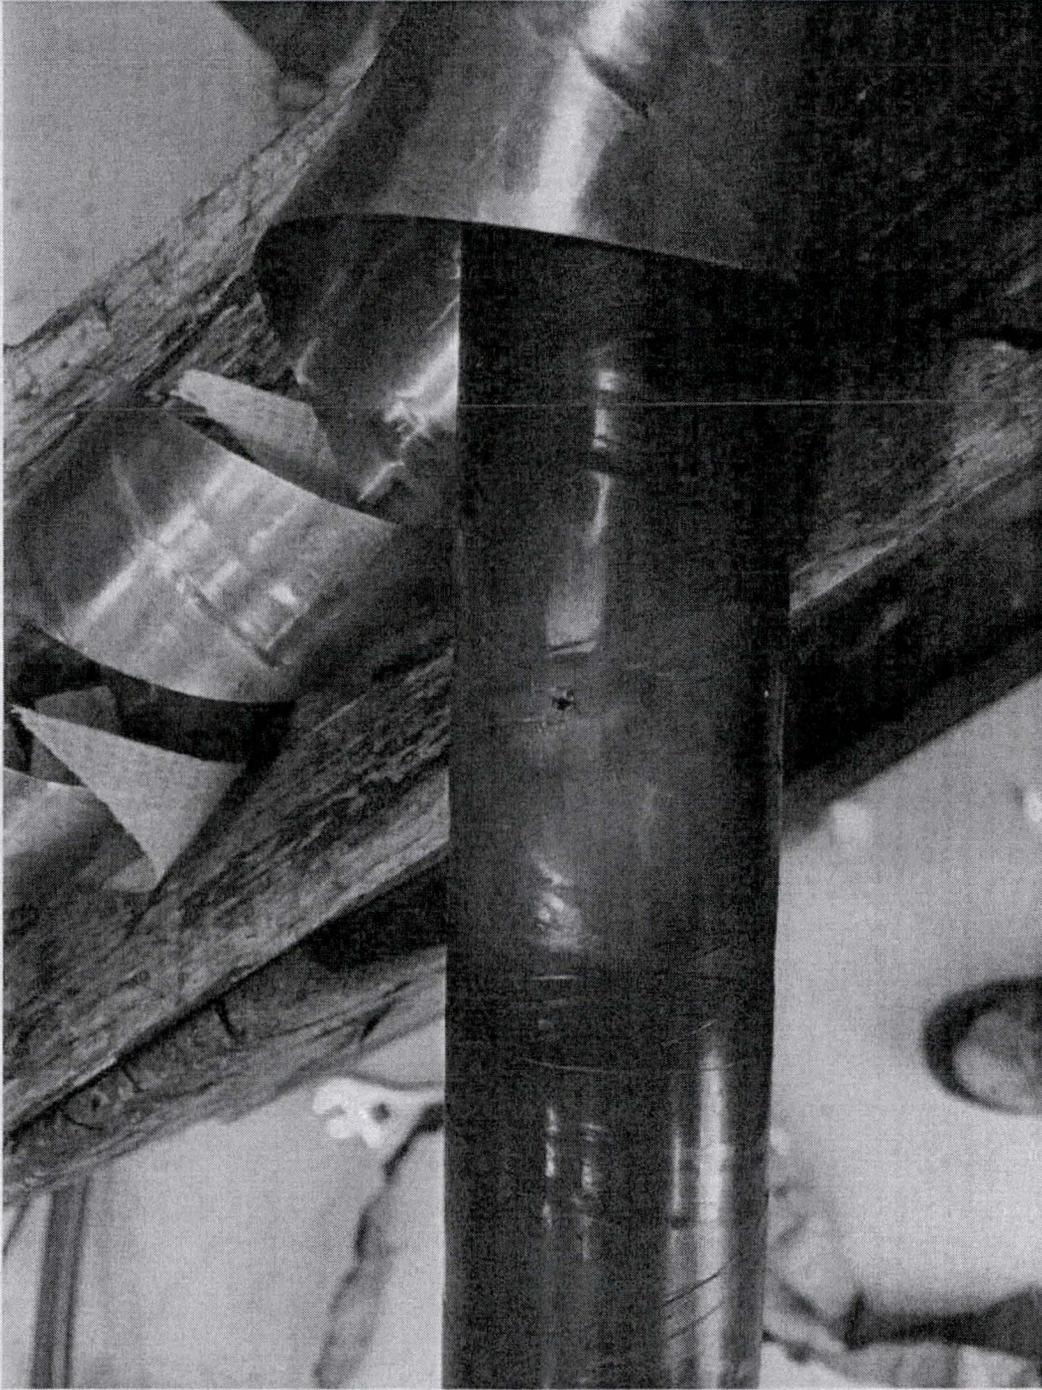
High Voltage Impulse Fault  
Insulation Semiconductor Layer Exposed

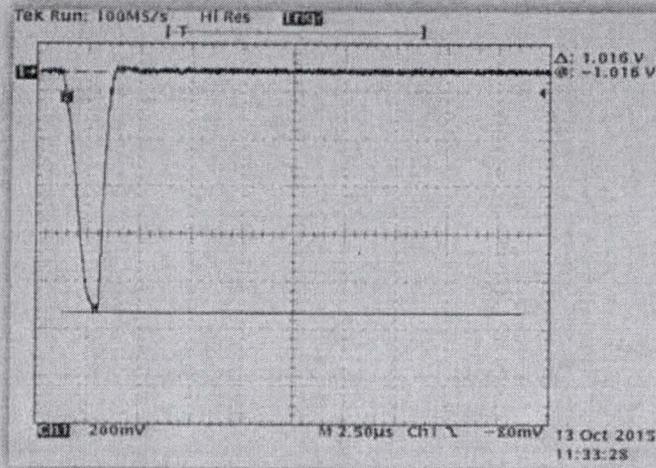
Test #2 Impulse failure at -420kV

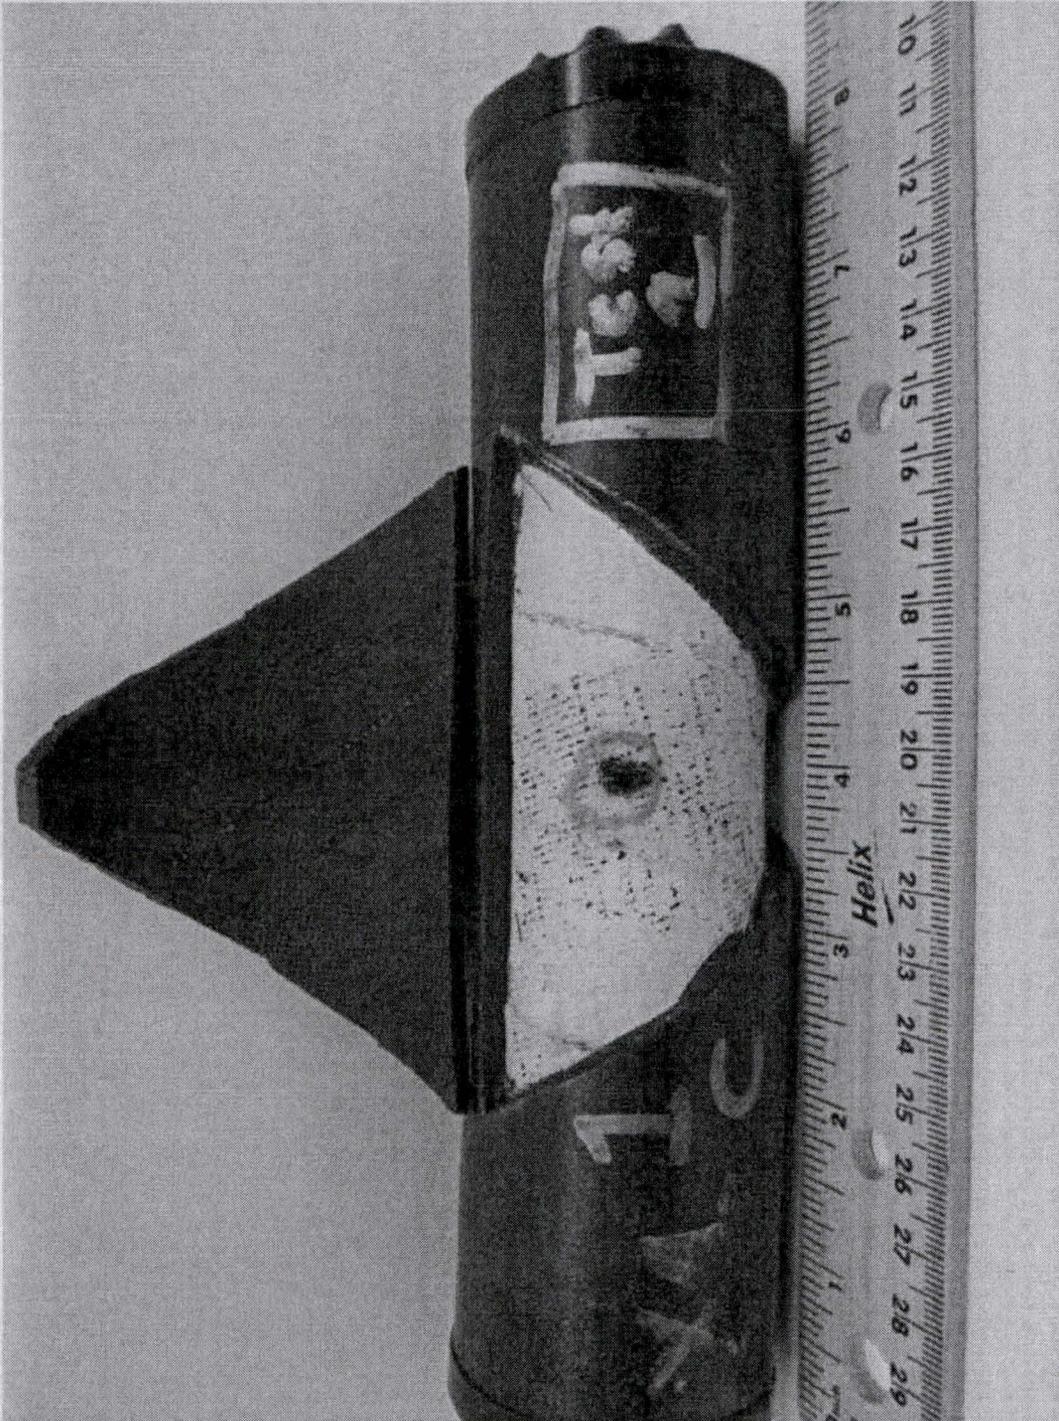
Test 1 C-Phase Cable  
CT4 Configuration With Resistance Grounded Power Source

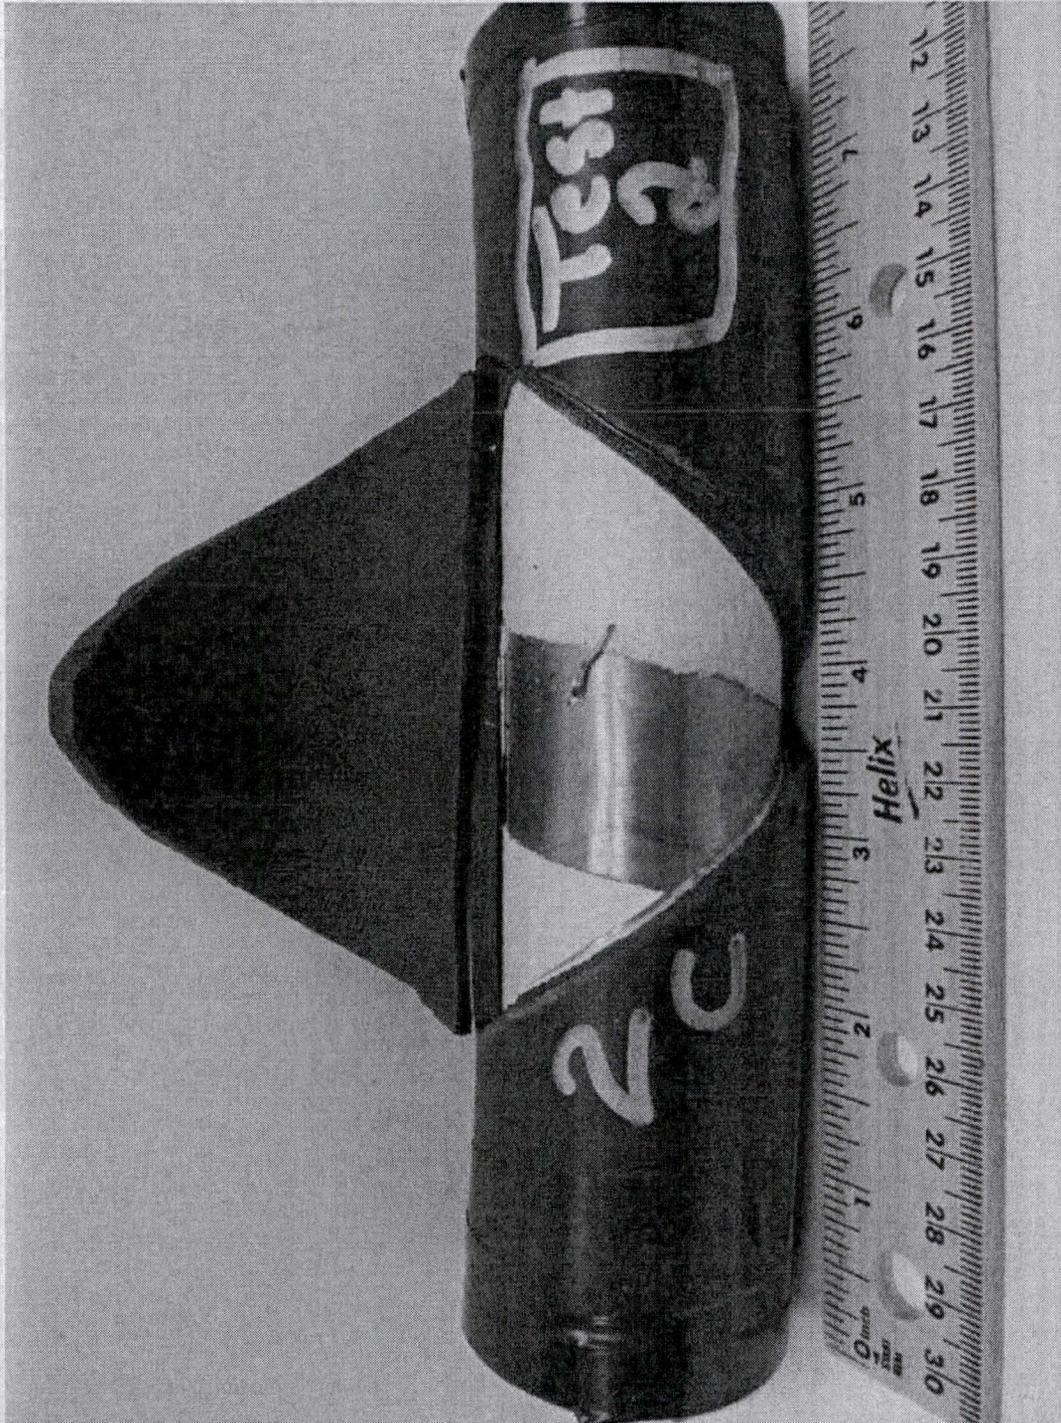
Test 2 C-Phase Cable  
CT4 Configuration With Resistance Grounded Power Source

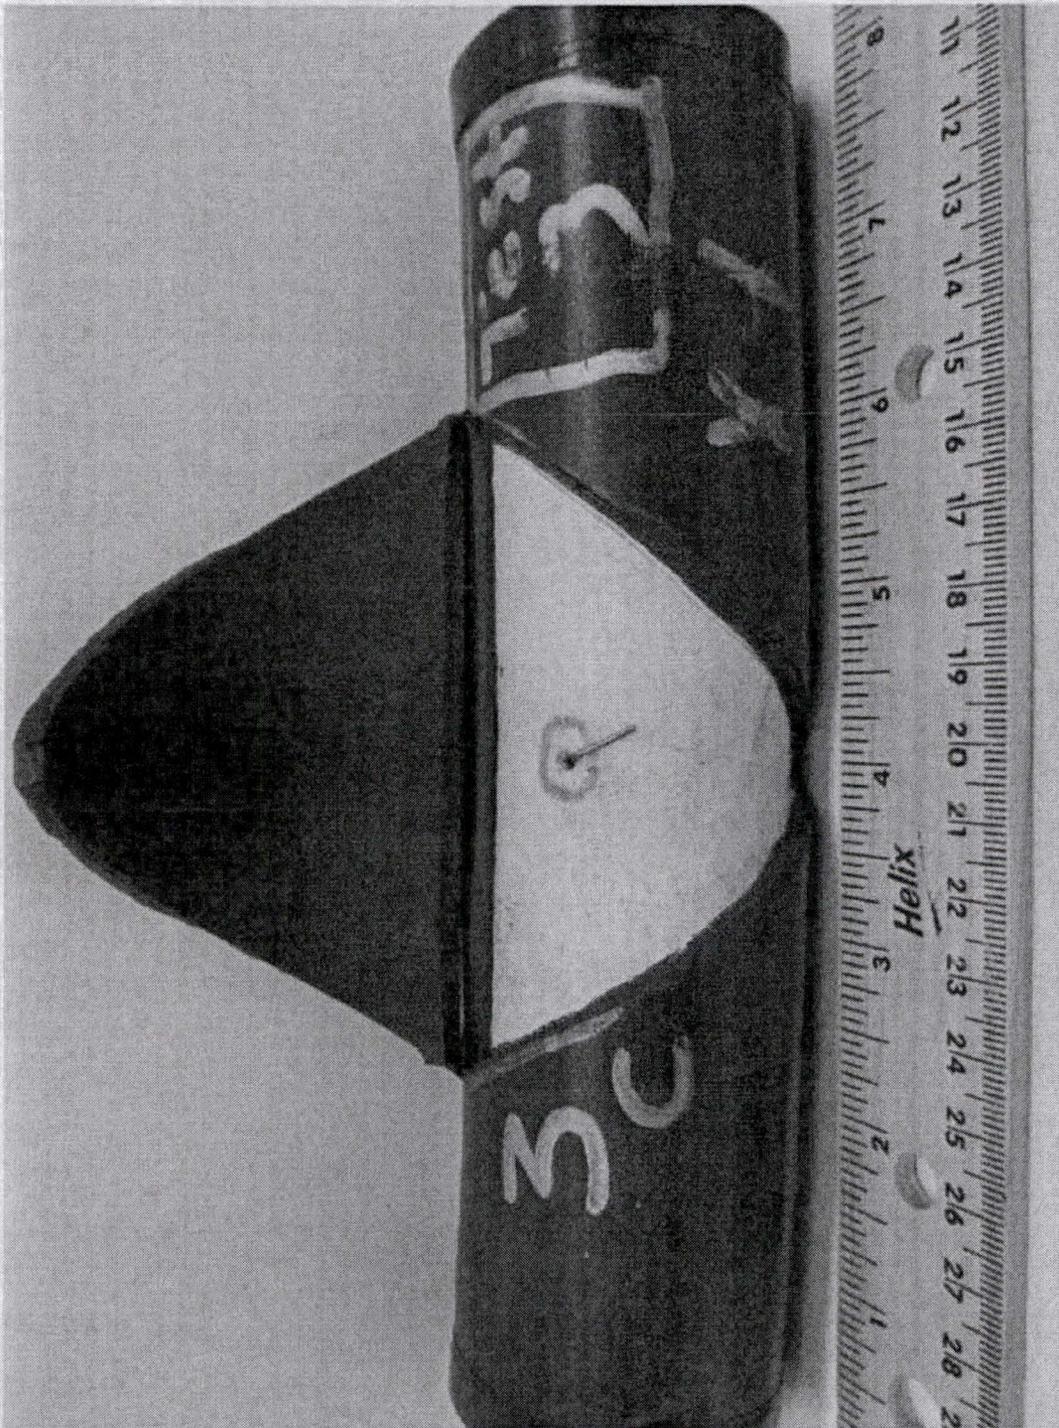
Test 3 C-Phase Cable  
CT4 Configuration With Resistance Grounded Power Source

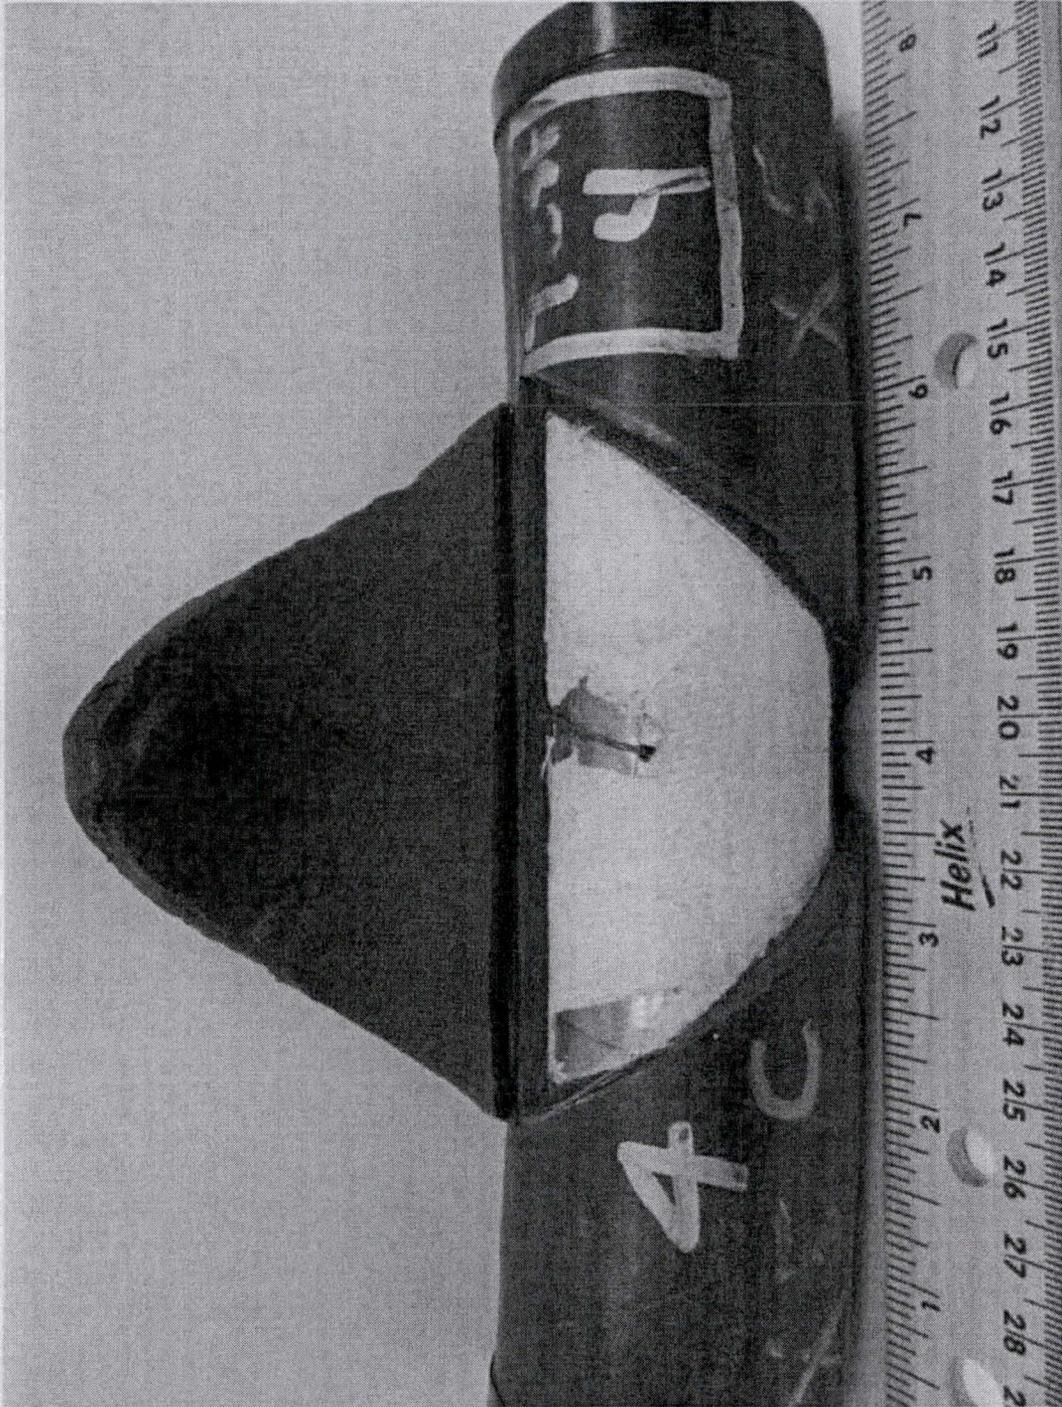
Test 4 CT4-Phase Cable  
CT4 Configuration With Resistance Grounded Power Source

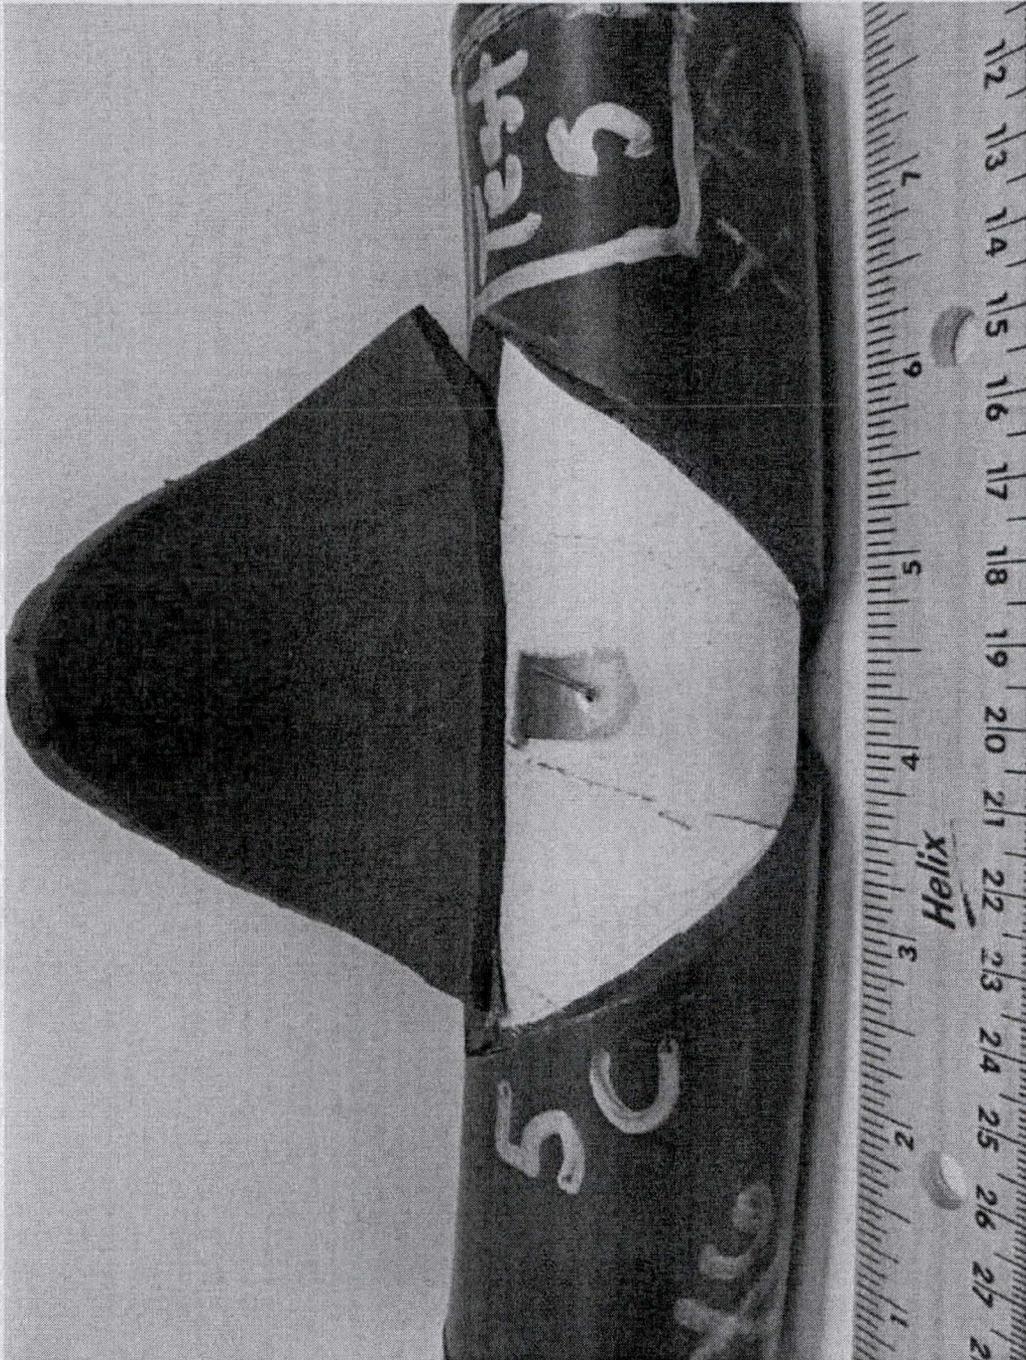
Test 5 C-Phase Cable  
CT4 Configuration With Resistance Grounded Power Source

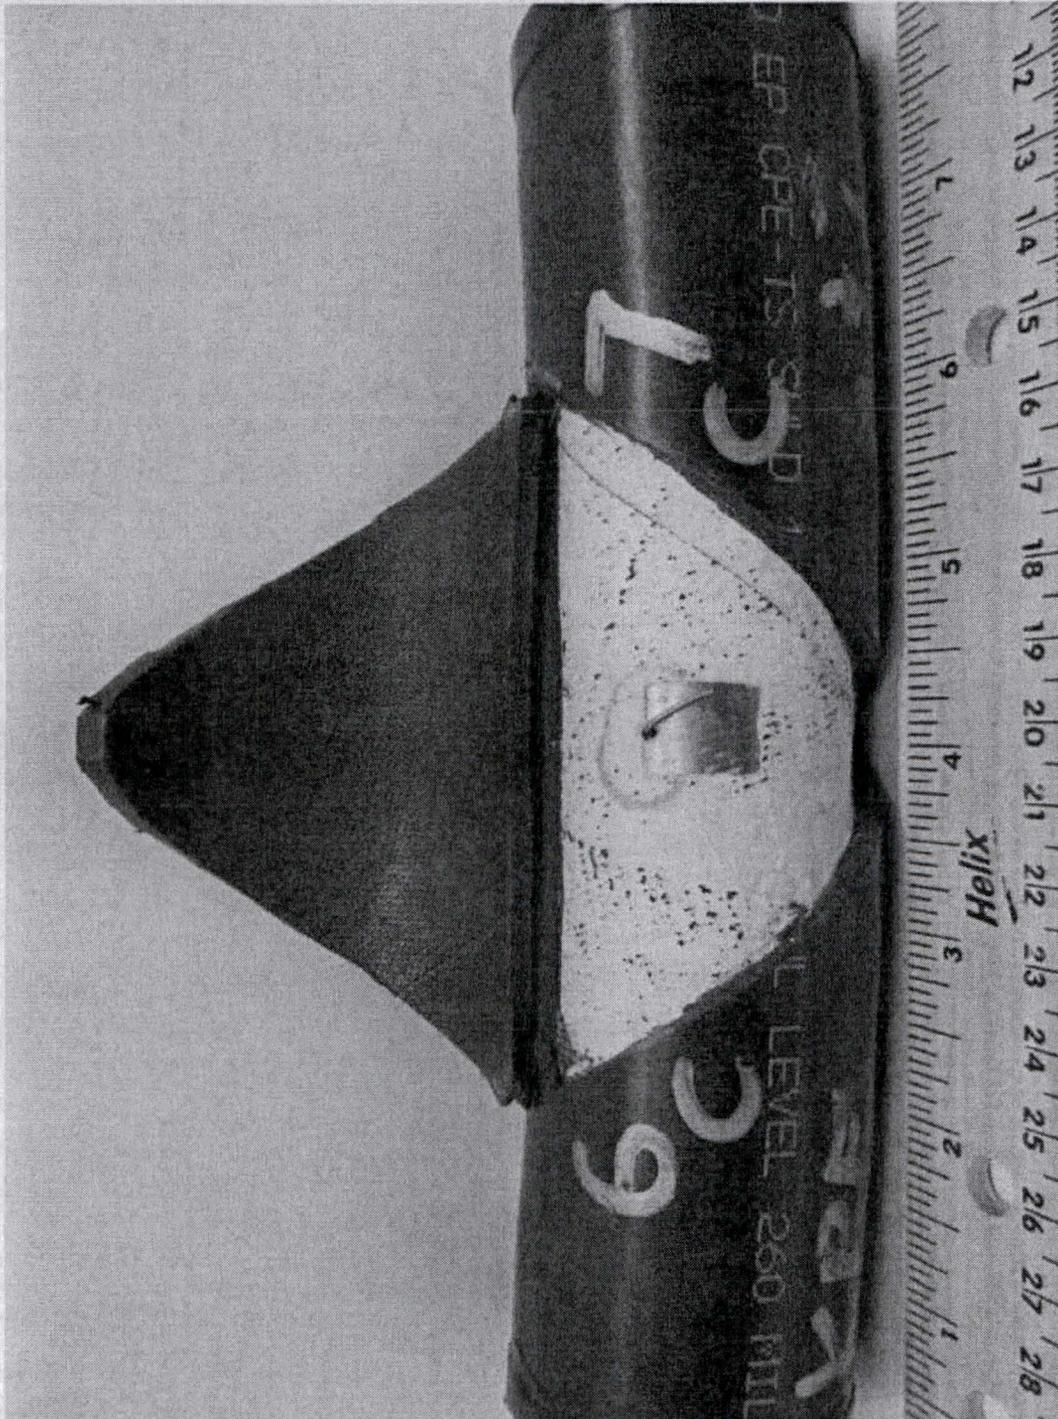
Tests 6 and 7 C-Phase Cable  
KPF Configuration With Resistance Grounded Power Source

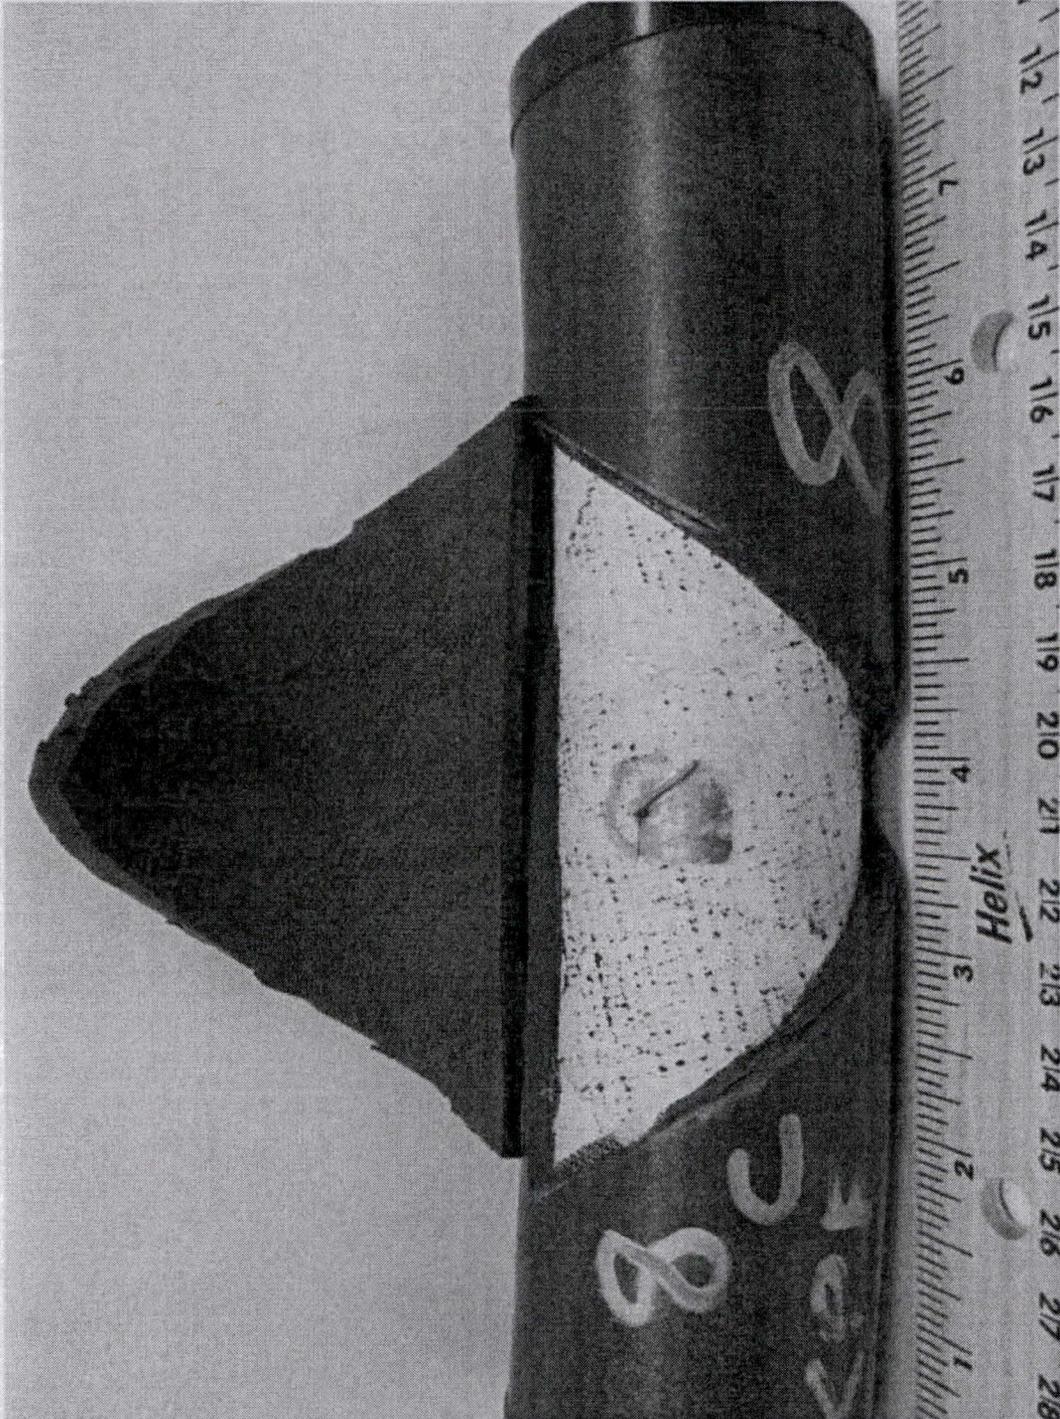
Test 8 C-Phase Cable  
KPF Configuration With Resistance Grounded Power Source

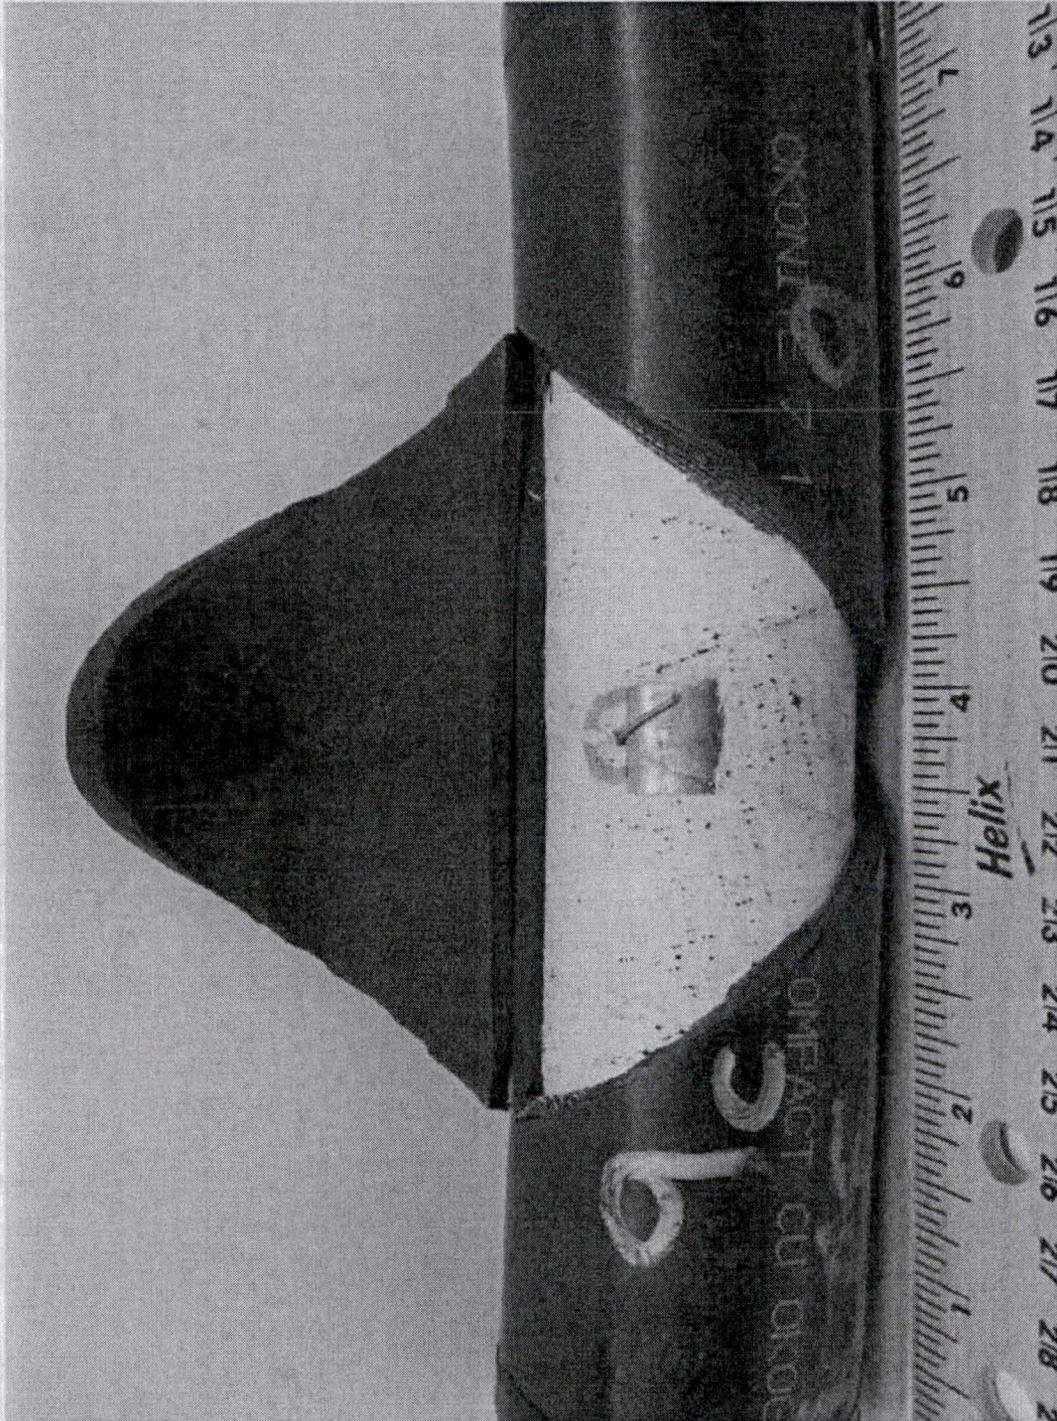
Test 9 C-Phase Cable  
KPF Configuration With Resistance Grounded Power Source

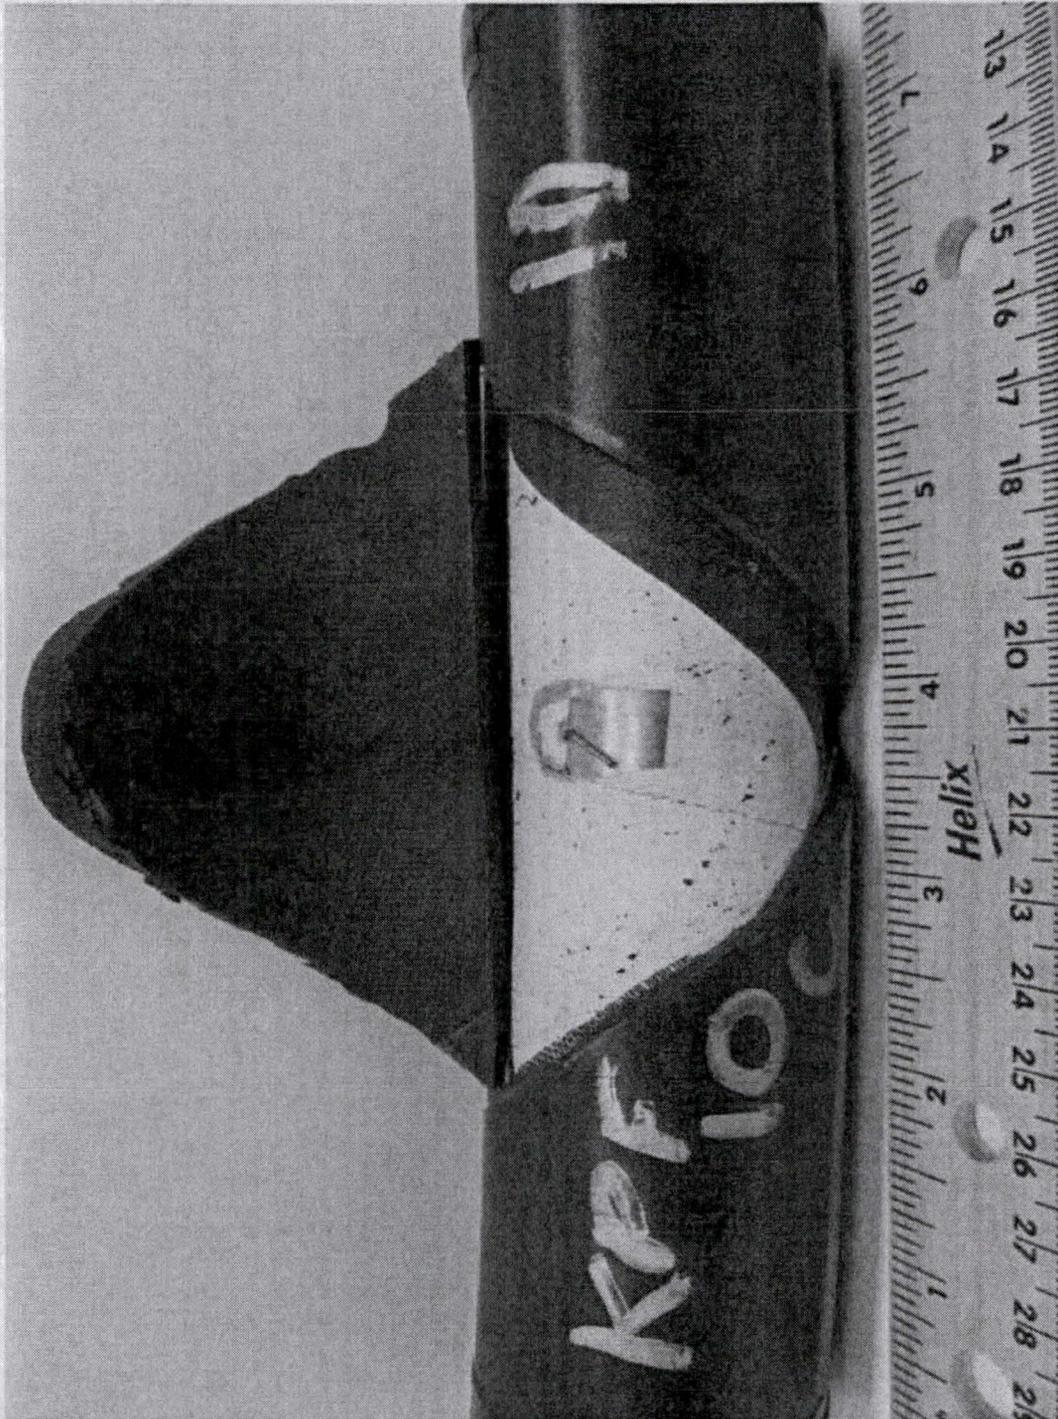
Test 10 C-Phase Cable  
KPF Configuration With Resistance Grounded Power Source

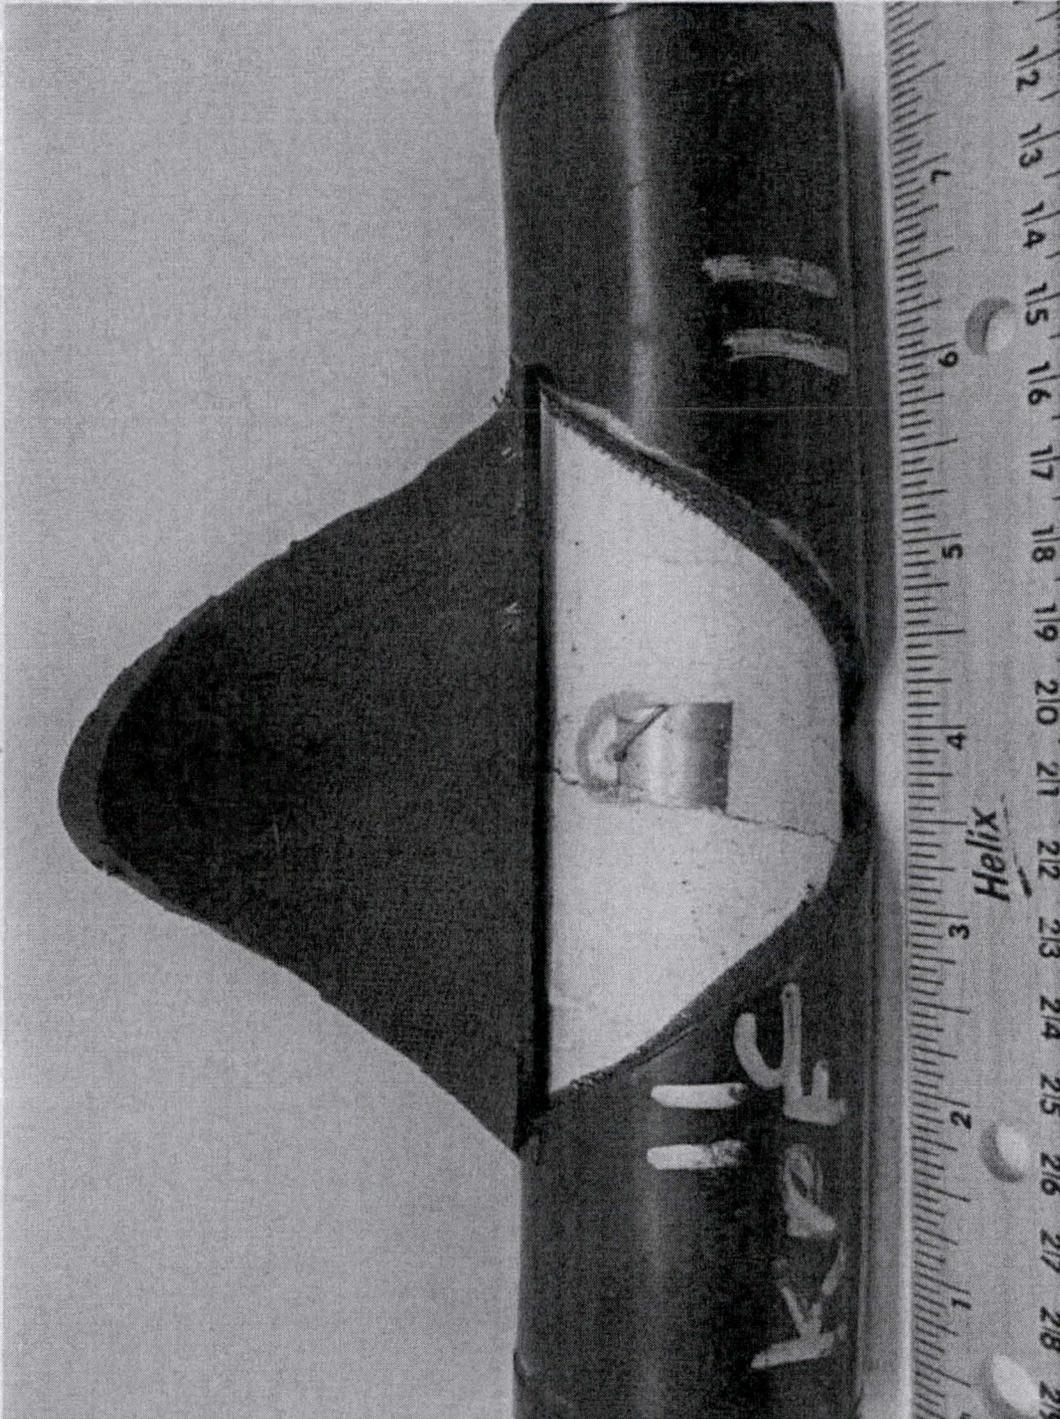
Test 11 C-Phase Cable  
KPF Configuration With Resistance Grounded Power Source

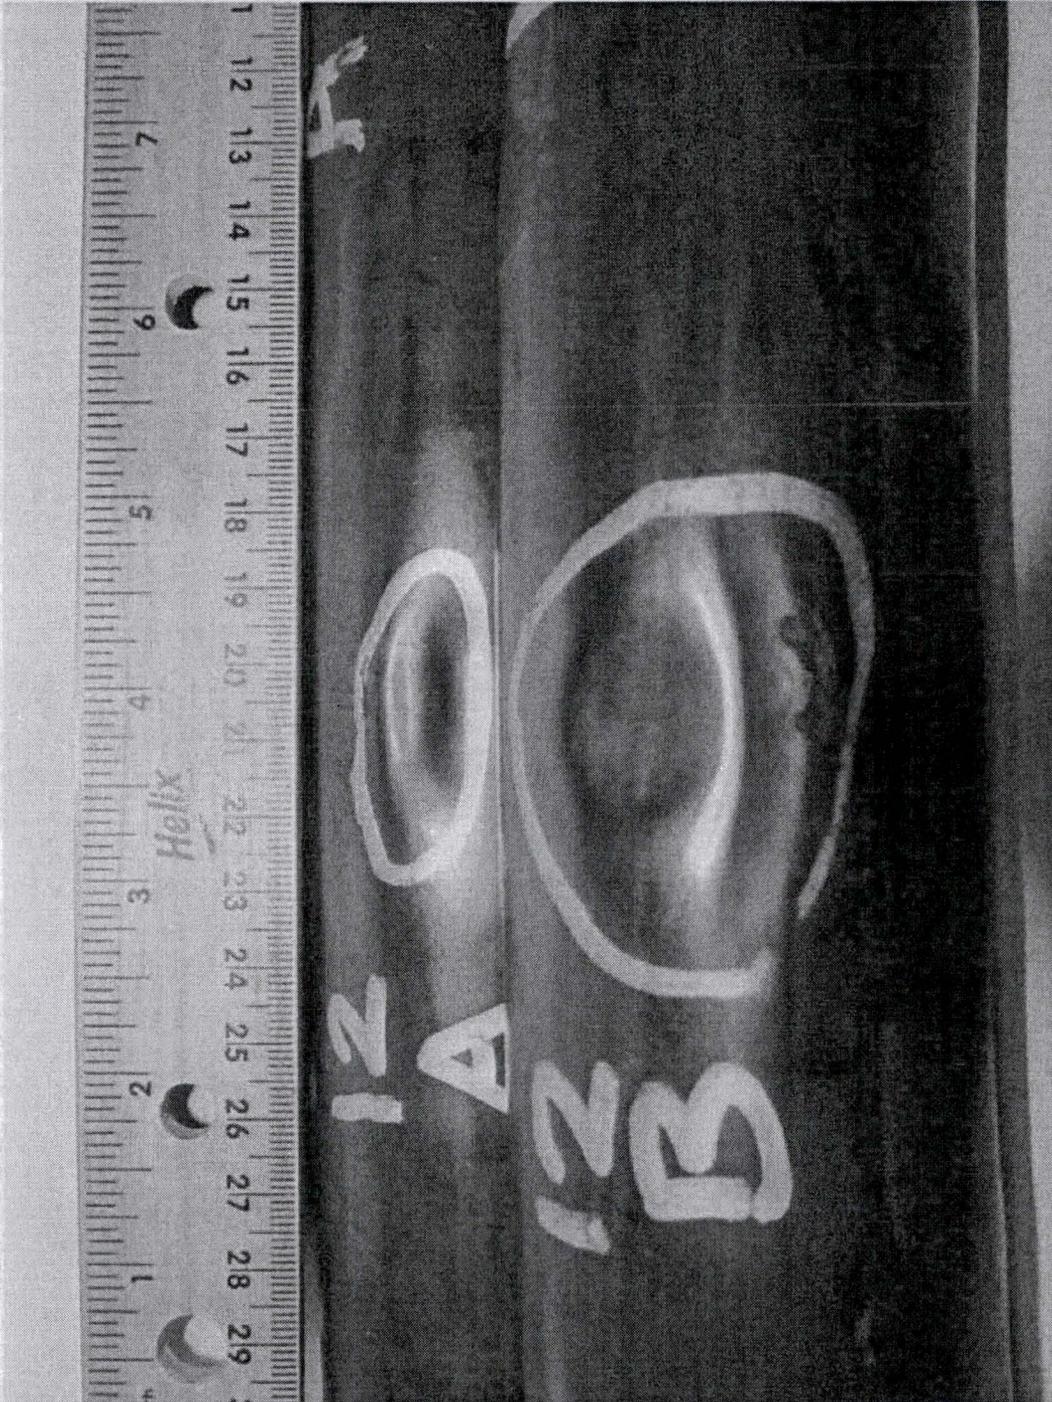
Test 12 A-Phase and B-Phase Cables  
Fant Configuration With Solidly Grounded Power Source

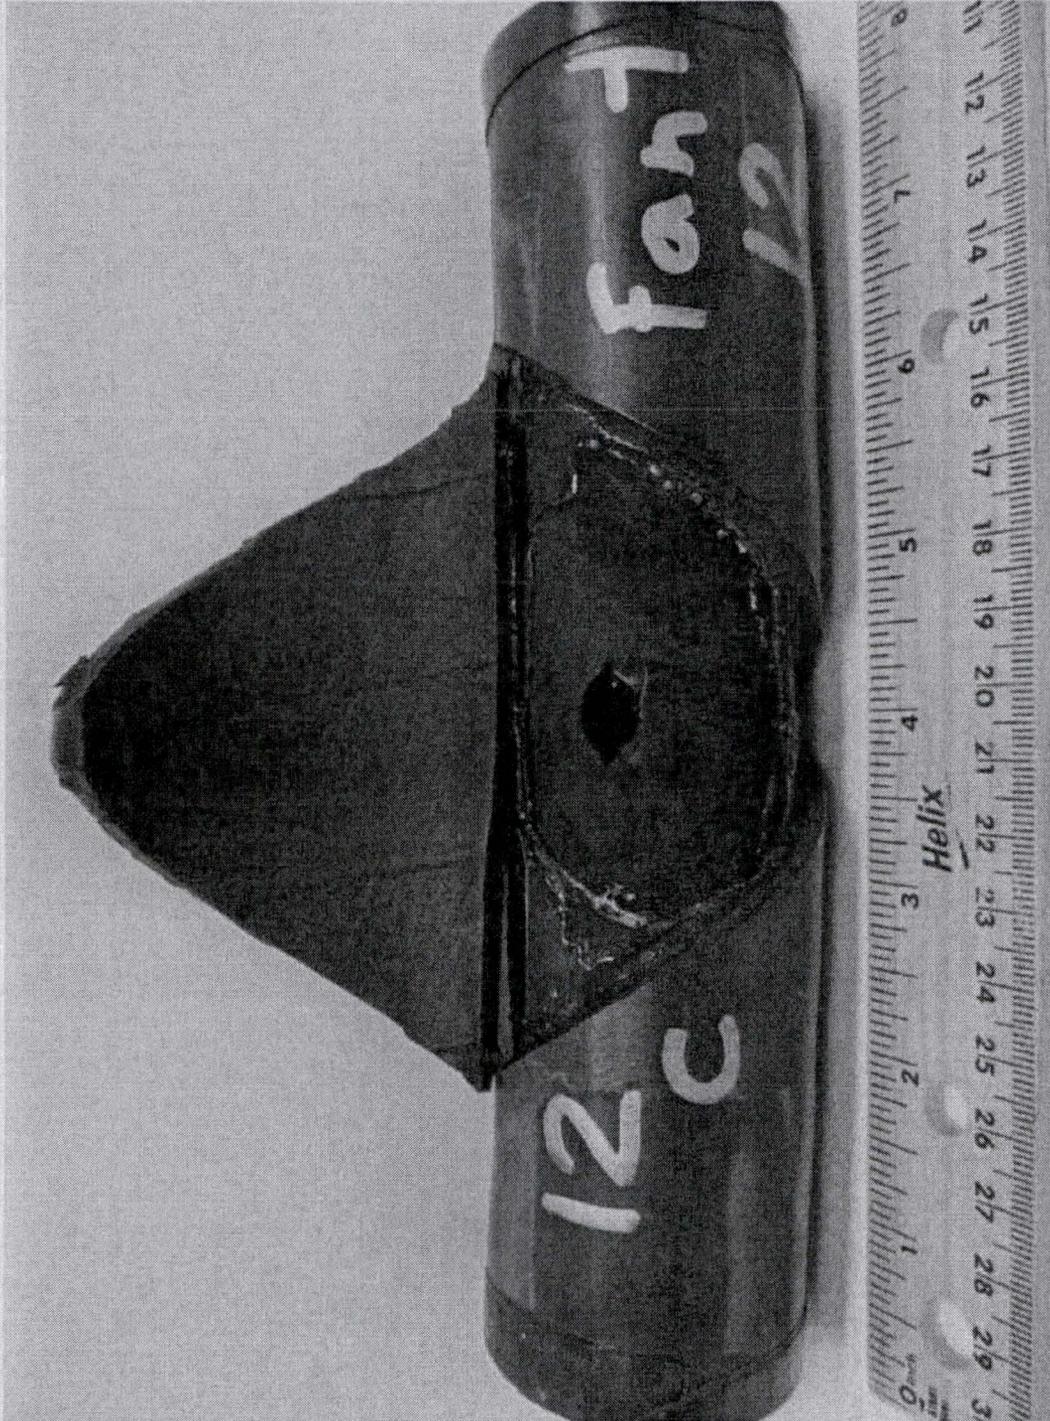
Test 12 C-Phase Cable  
Fant Configuration With Solidly Grounded Power Source

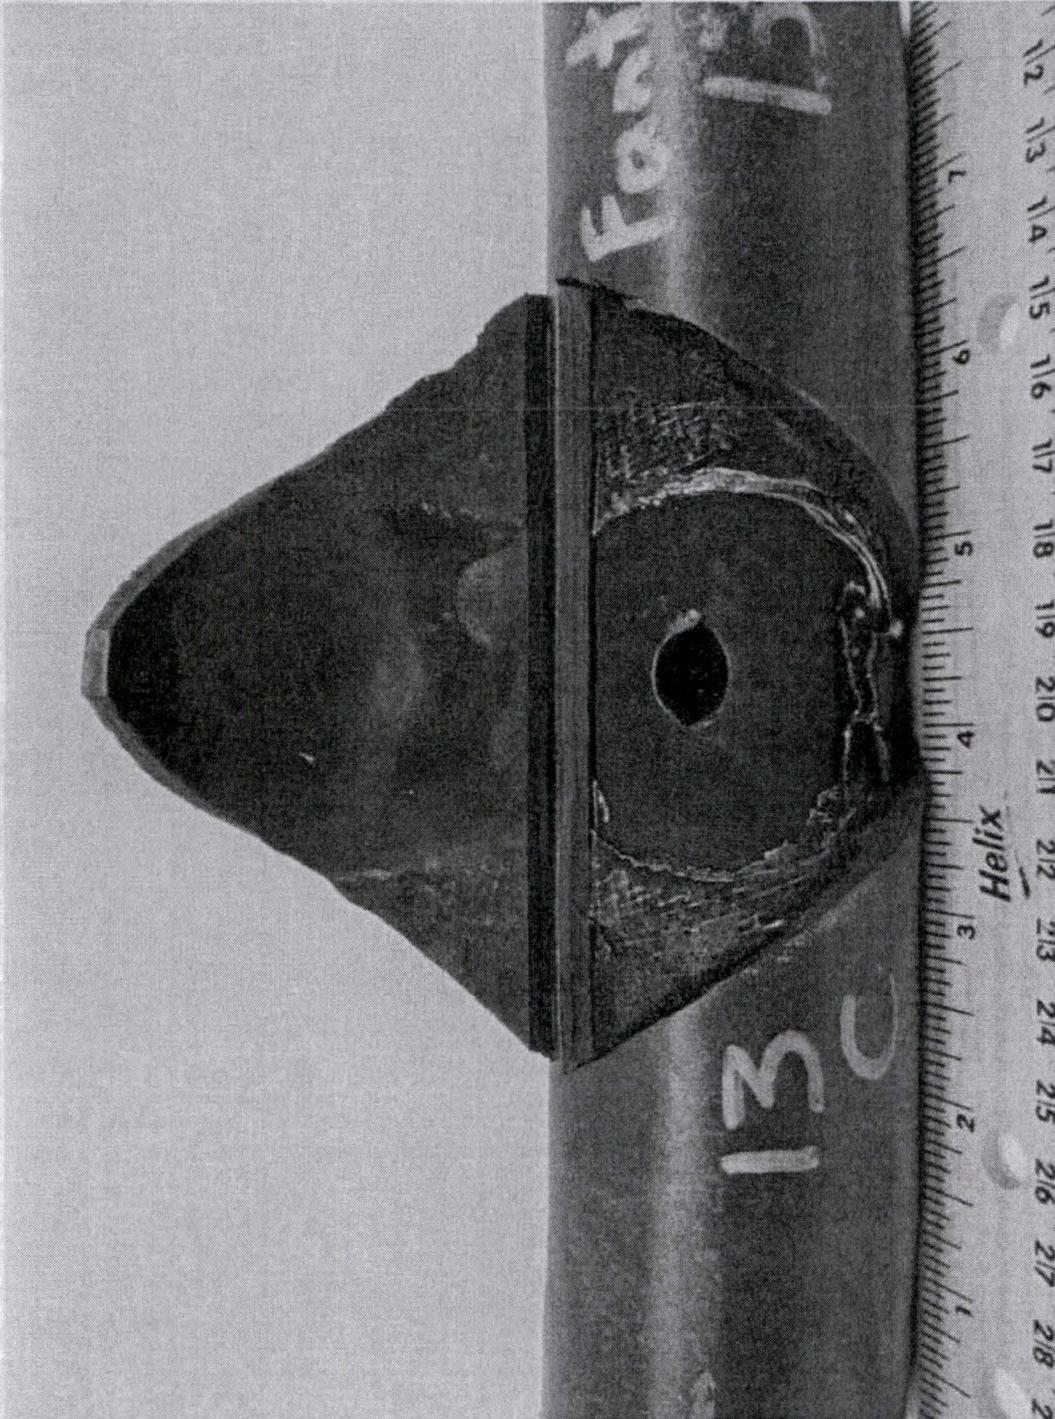
Test 13 C-Phase Cable  
Fant Configuration With Solidly Grounded Power Source
