ONS-2018-016

February 12, 2018

Duke Energy Carolina, LLC (Duke Energy)  
Oconee Nuclear Station, Units 1, 2 and 3  
Docket Numbers 50-269, 50-270, 50-287  
Renewed License Numbers DPR-38, DPR-47, and DPR-55

**Subject:** Duke Energy Responses to Request for Additional Information (RAI); Request for Alternative to Codes and Standards Requirements Pursuant to 10 CFR 50.55a(z) to Satisfy 10 CFR 50.55a(h)(2) Associated with Bronze Tape Wrapped Emergency Power Cables in Use at the Oconee Nuclear Station

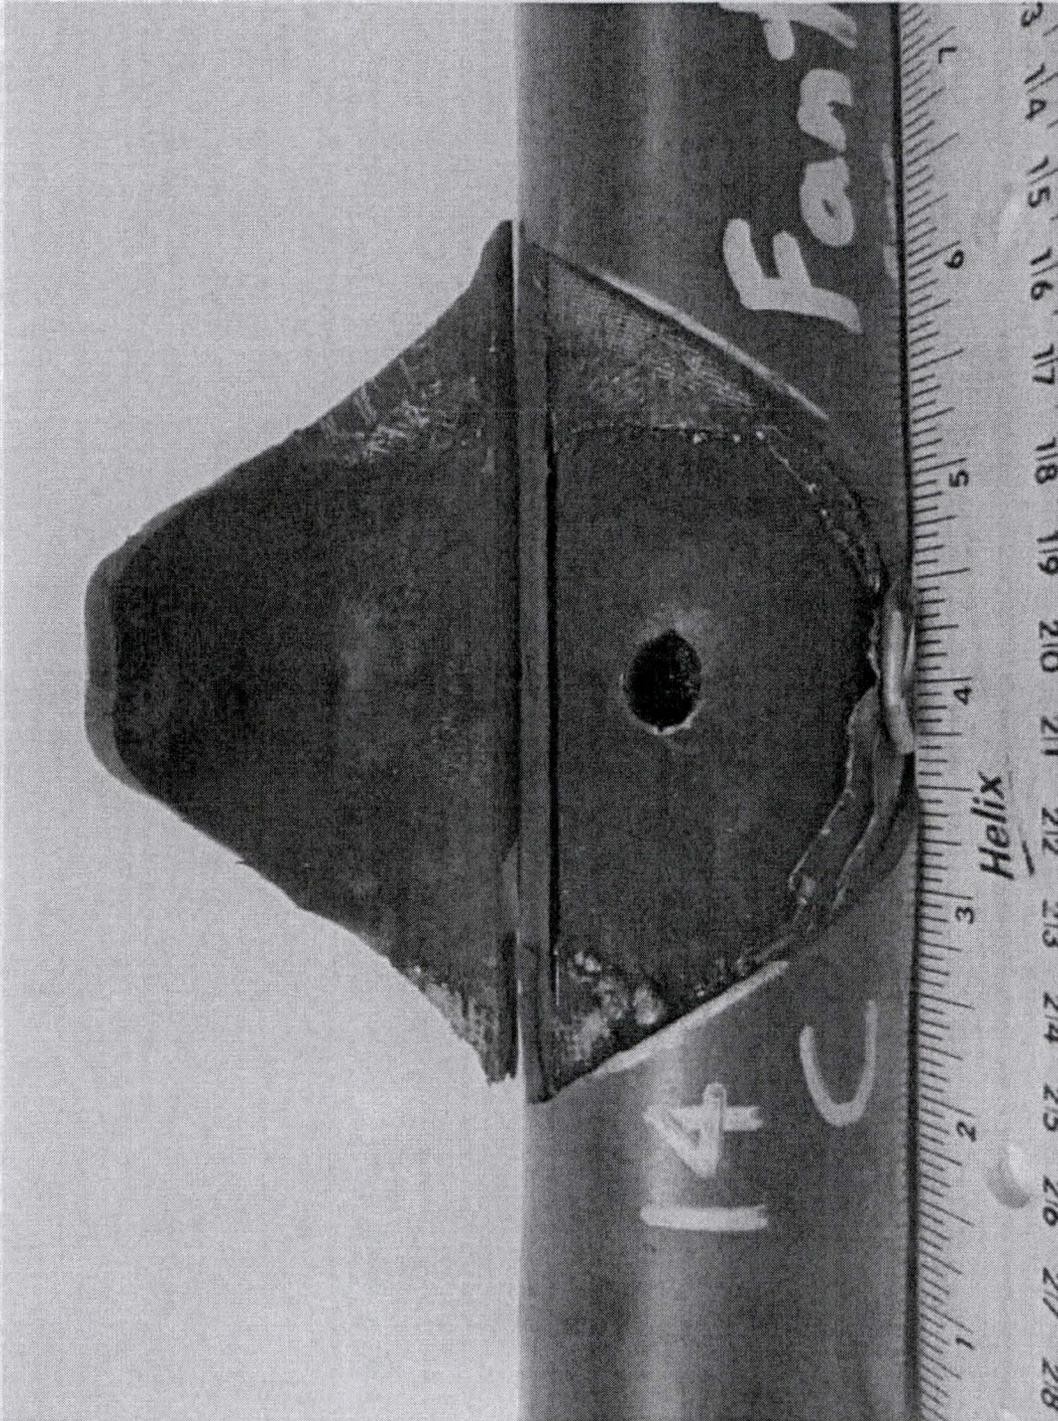
Test 14 C-Phase Cable  
Fant Configuration With Solidly Grounded Power Source

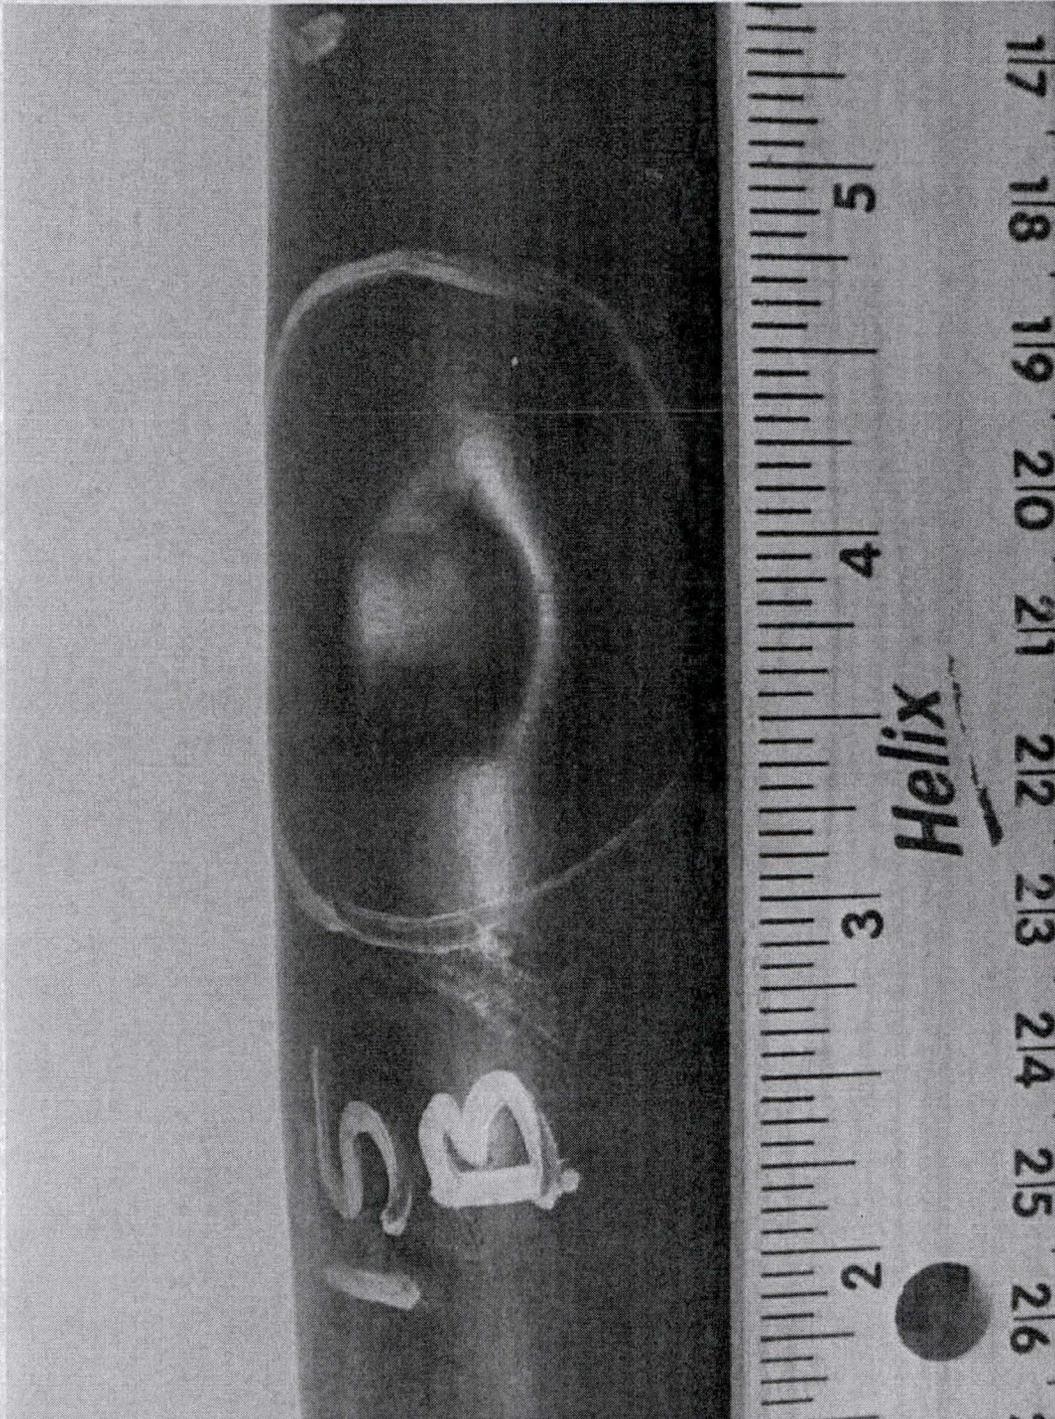
Test 15 B-Phase Cable  
Fant Configuration With Solidly Grounded Power Source

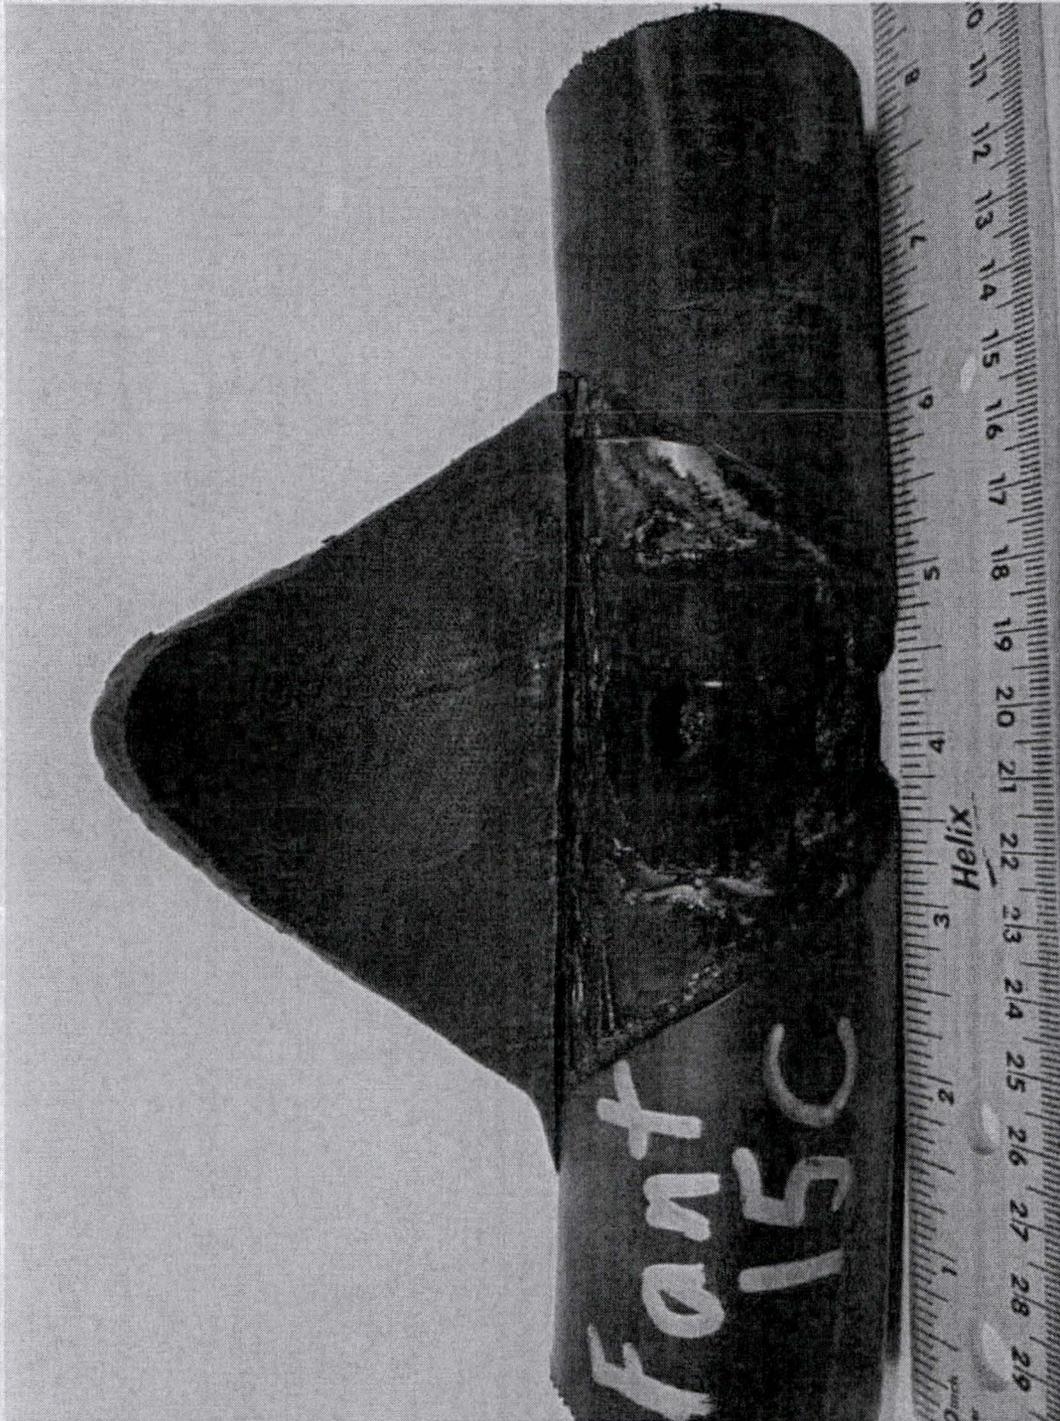
Test 15 C-Phase Cable  
Fant Configuration With Solidly Grounded Power Source

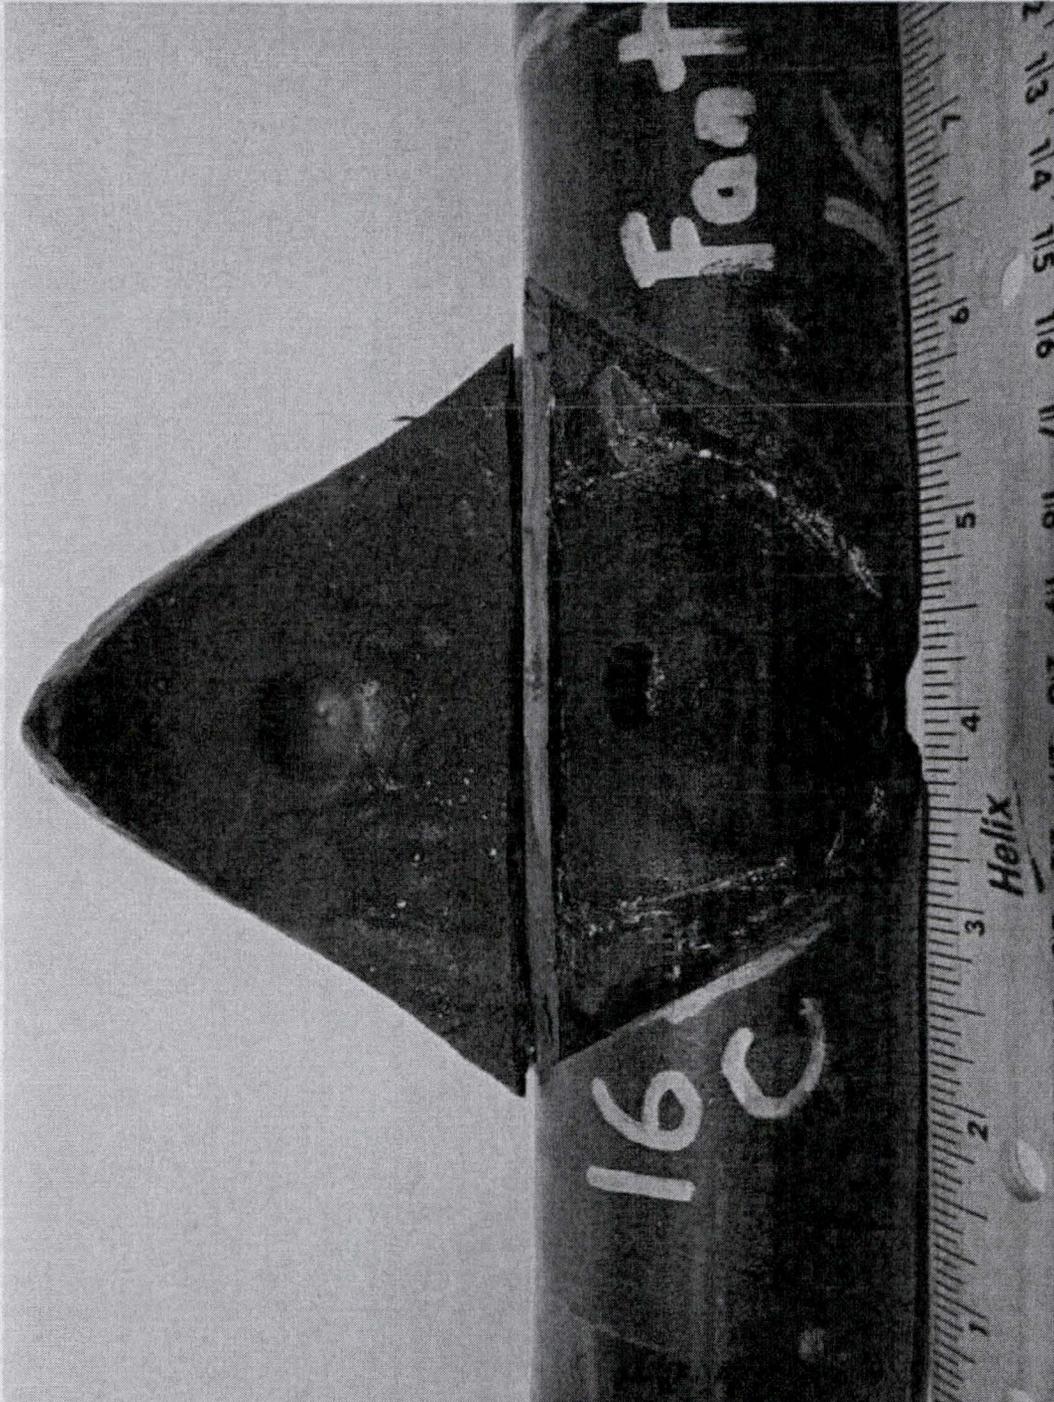
Test 16 C-Phase Cable  
Fant Configuration With Solidly Grounded Power Source

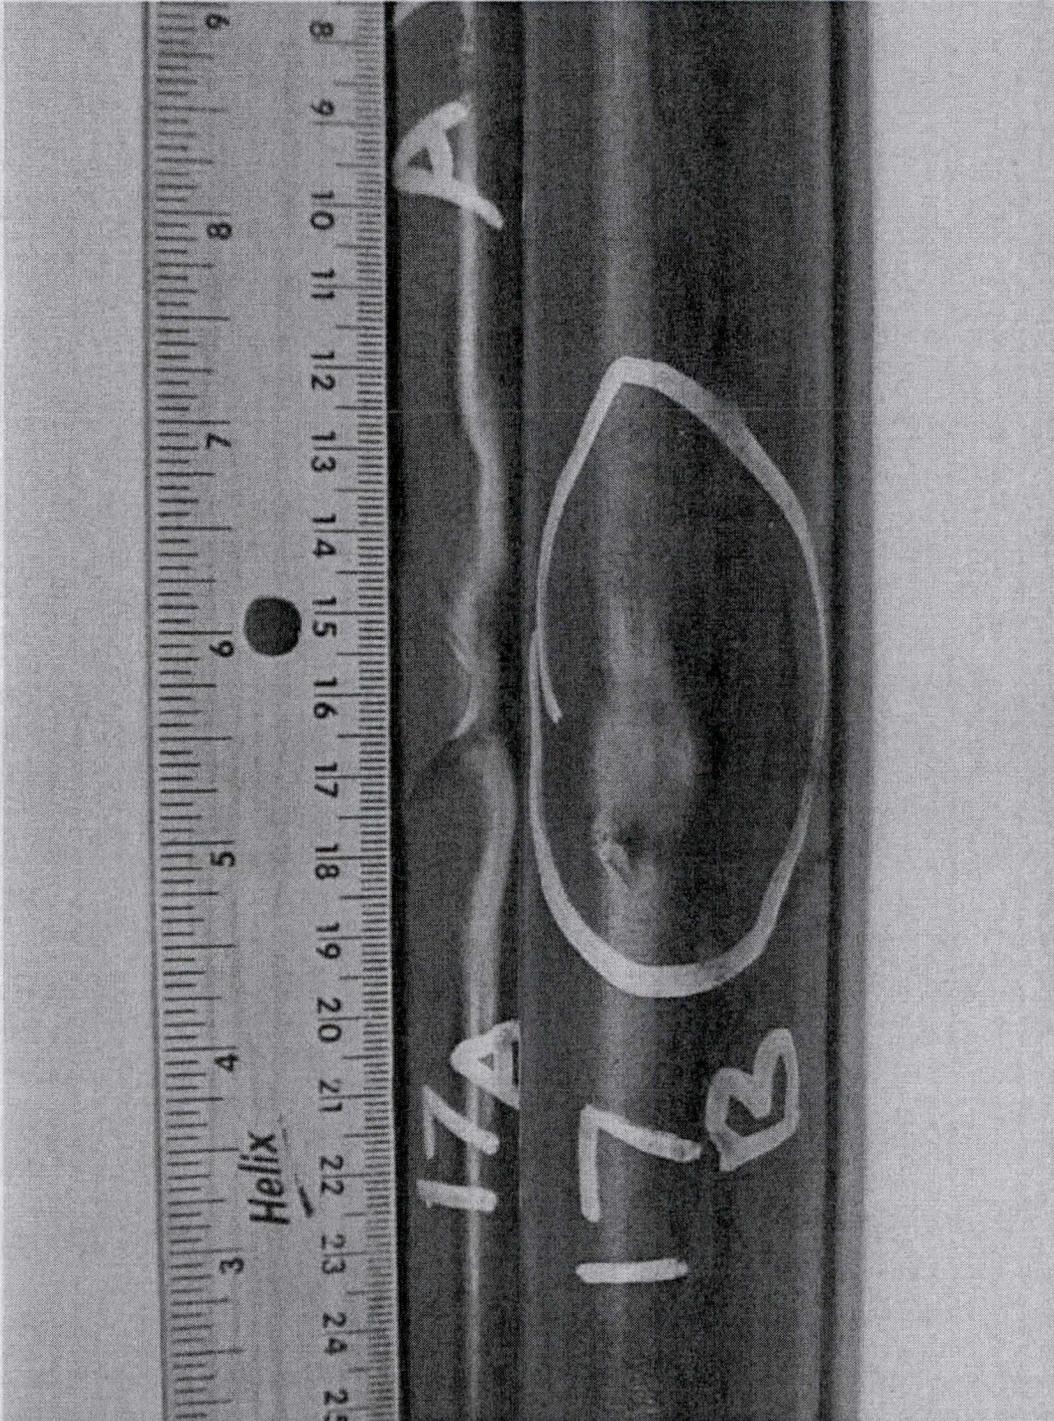
Test 17 A-Phase and B-Phase Cables  
CX Configuration With Solidly Grounded Power Source

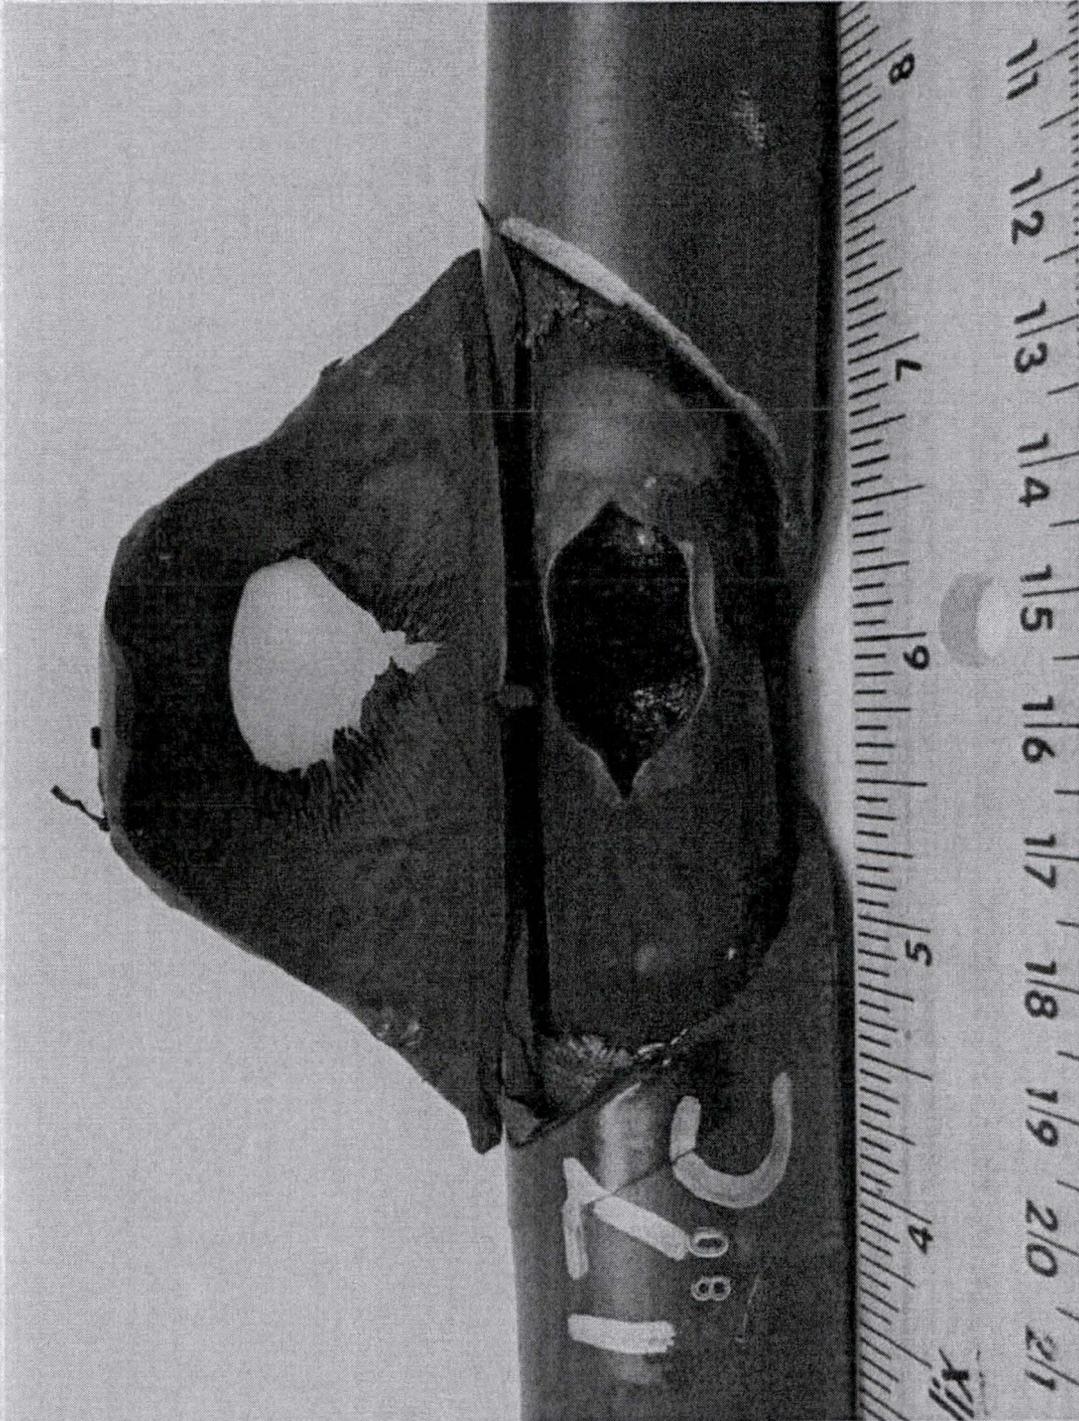
Test 17 C-Phase Cable  
CX Configuration With Solidly Grounded Power Source

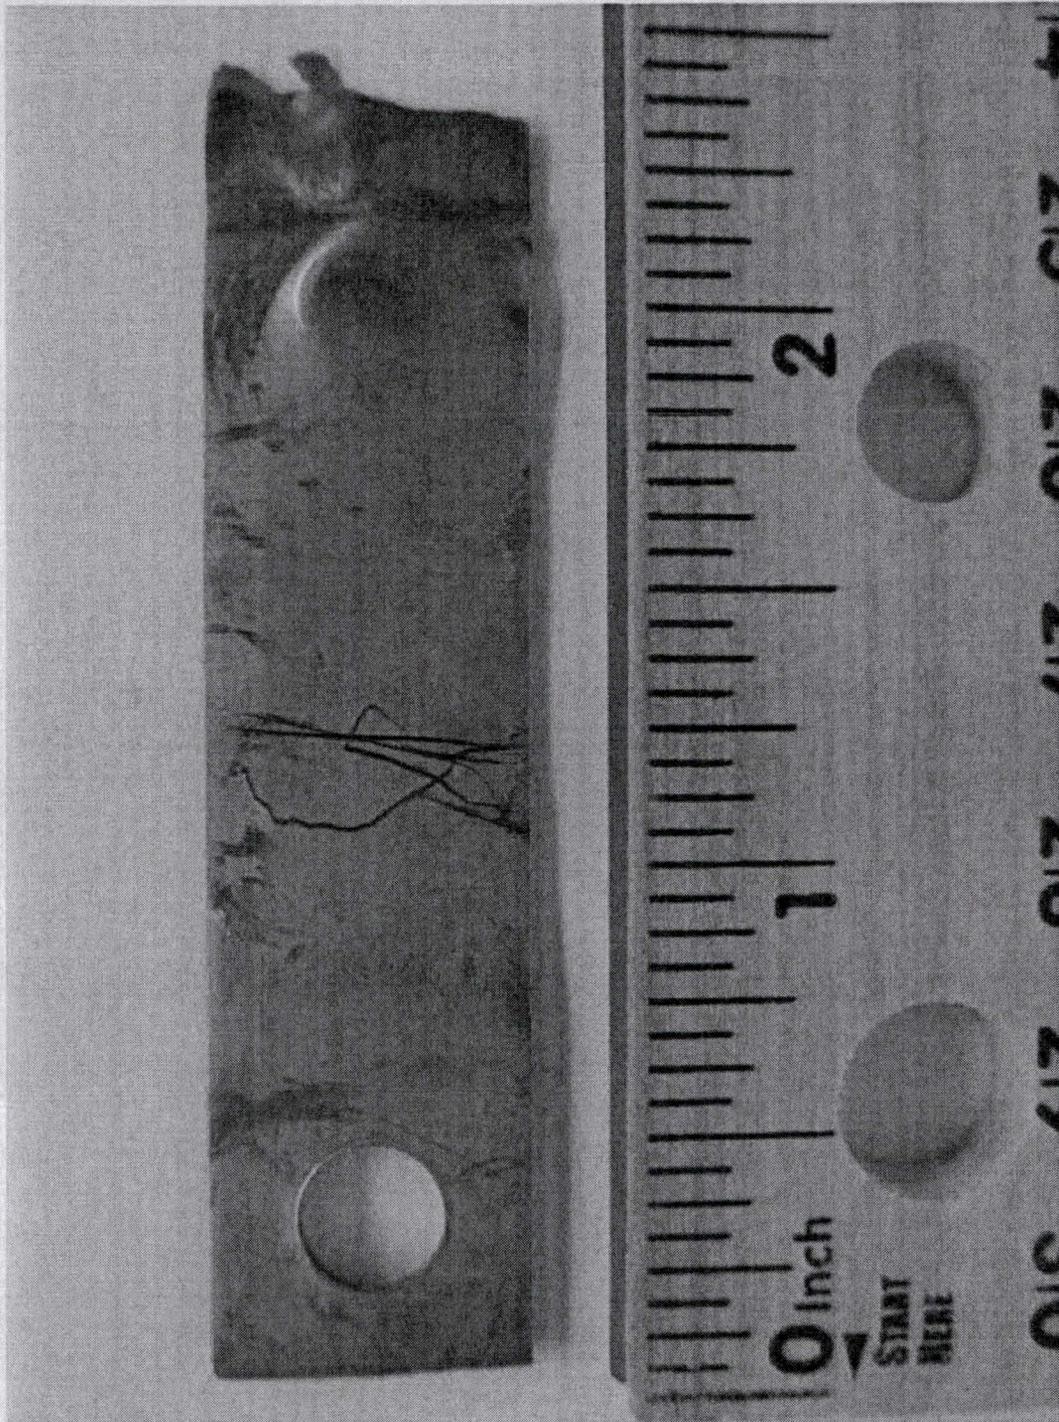
Test 17 C-Phase Load-Side Termination Ground Strap  
CX Configuration With Solidly Grounded Power Source

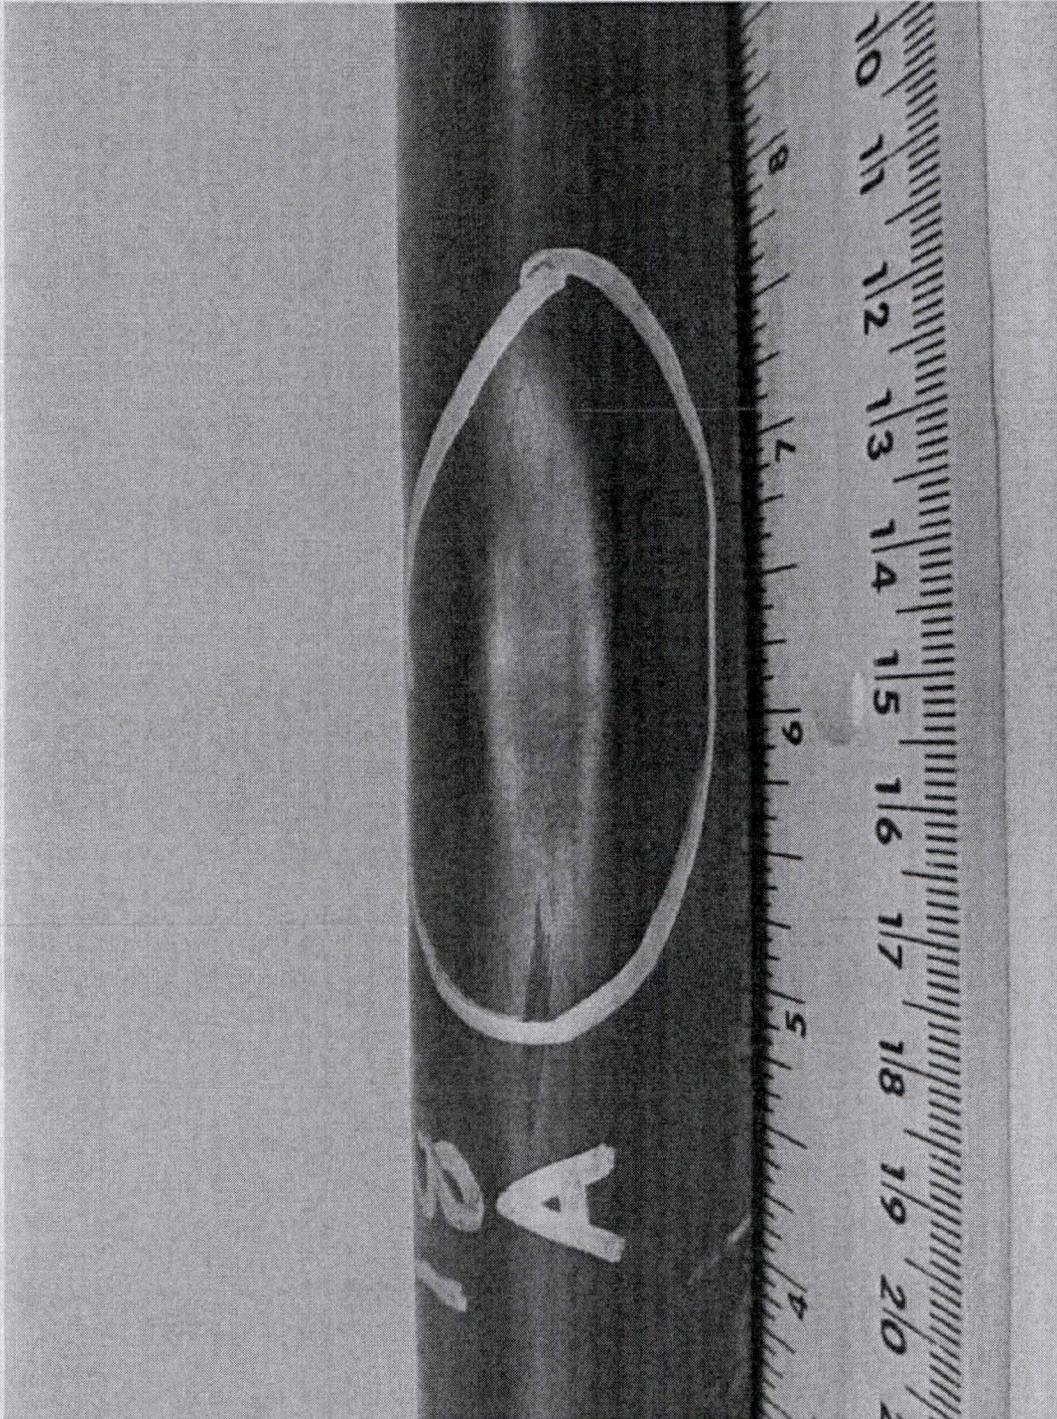
Test 18 A-Phase Cable  
CX Configuration With Solidly Grounded Power Source

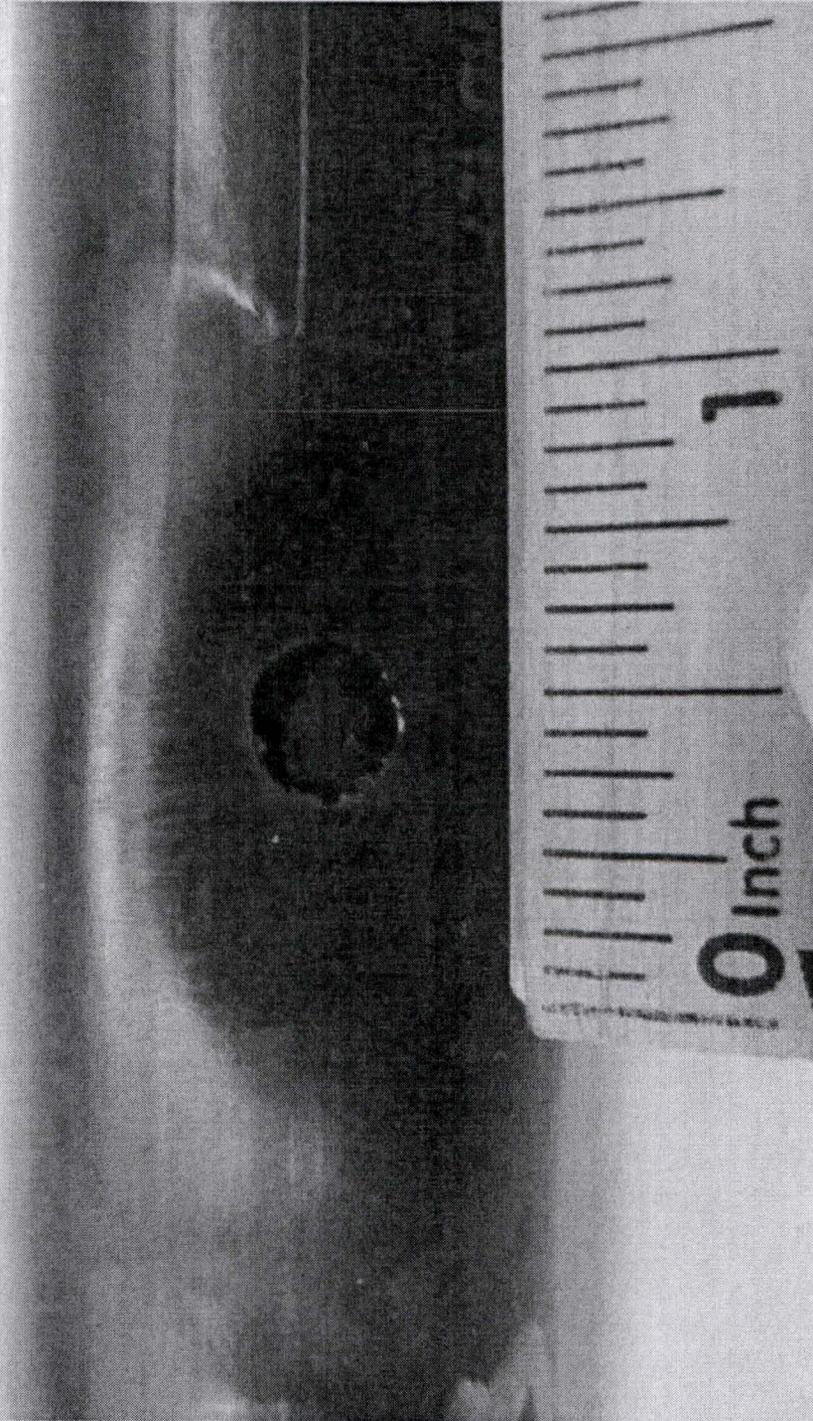
Test 18 B-Phase Cable  
CX Configuration With Solidly Grounded Power Source

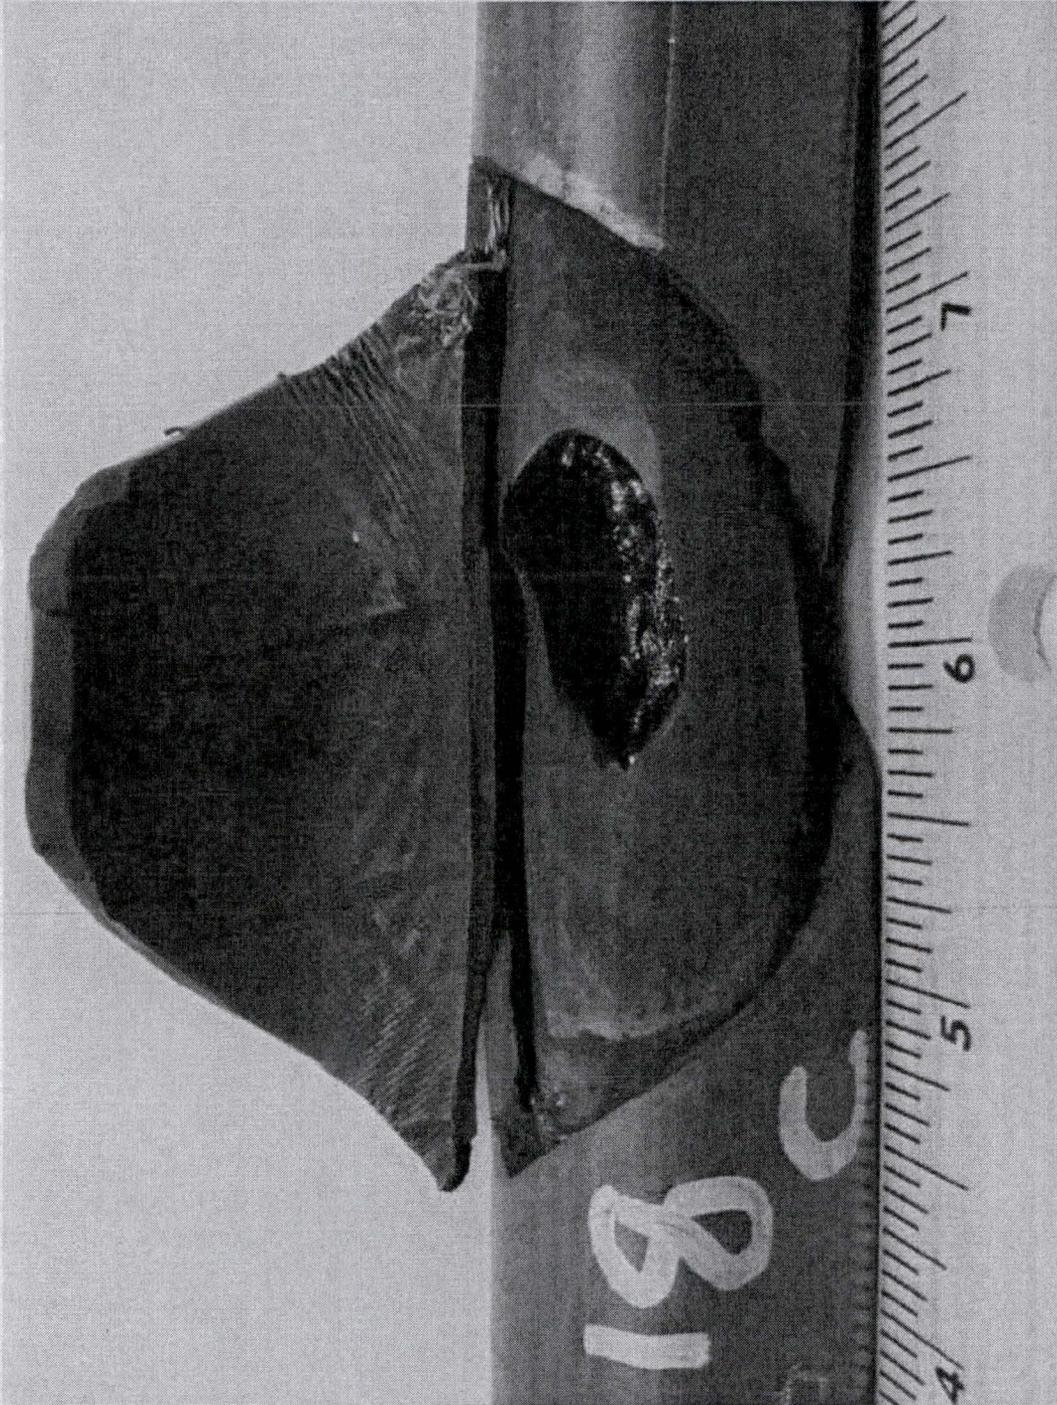
Test 18 C-Phase Cable  
CX Configuration With Solidly Grounded Power Source

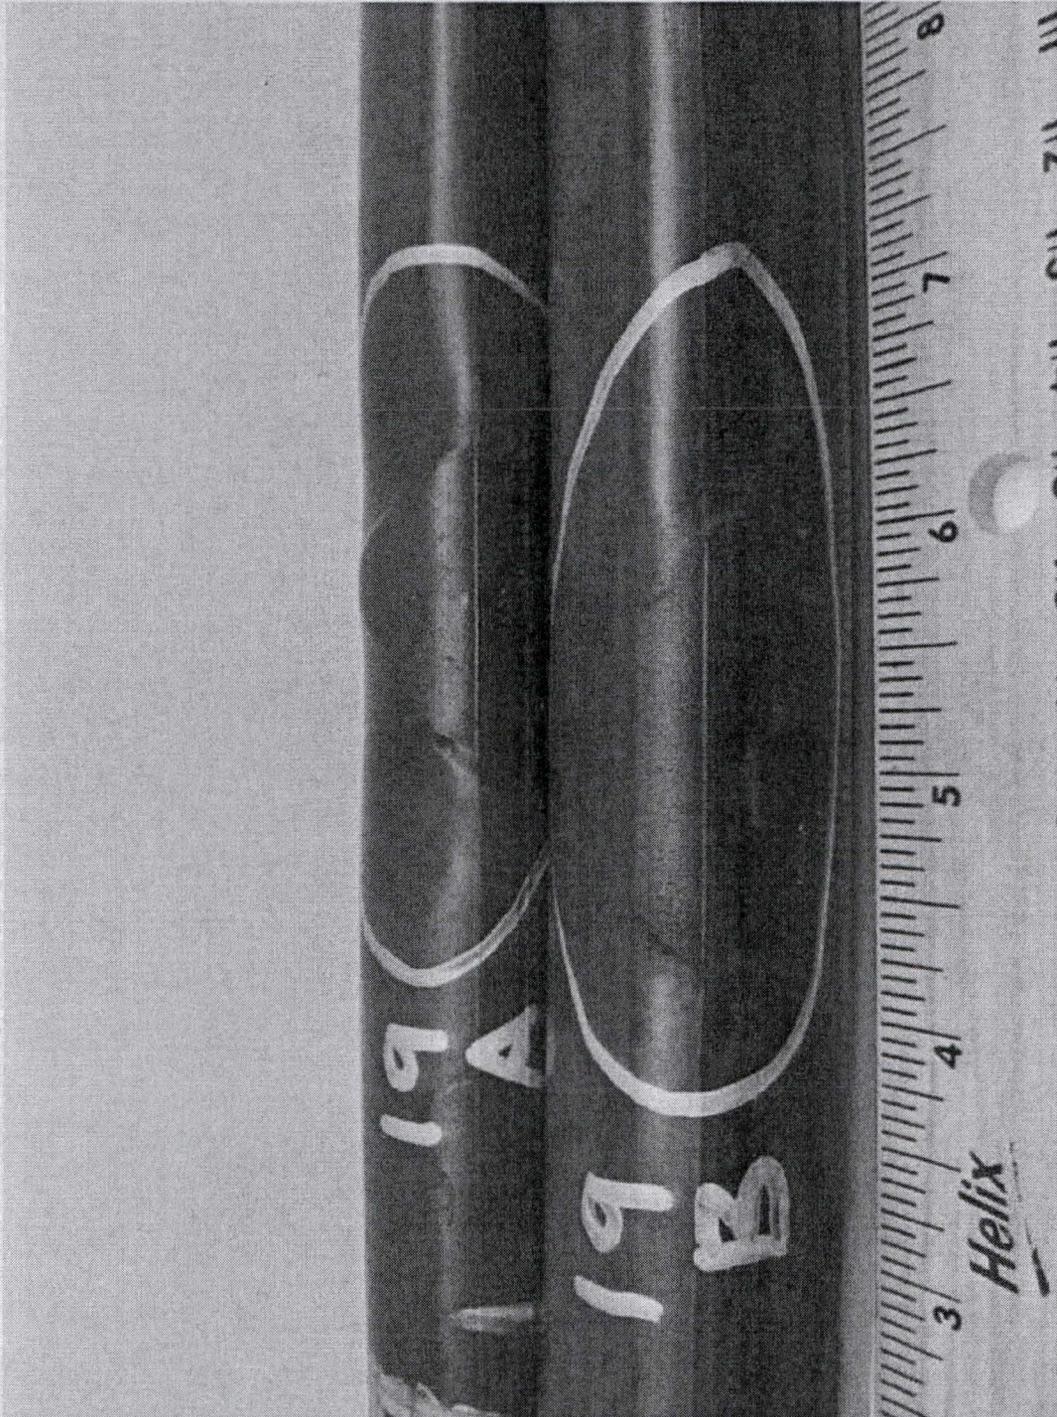
Test 19 A-Phase and B-Phase Cables  
CX Configuration With Solidly Grounded Power Source

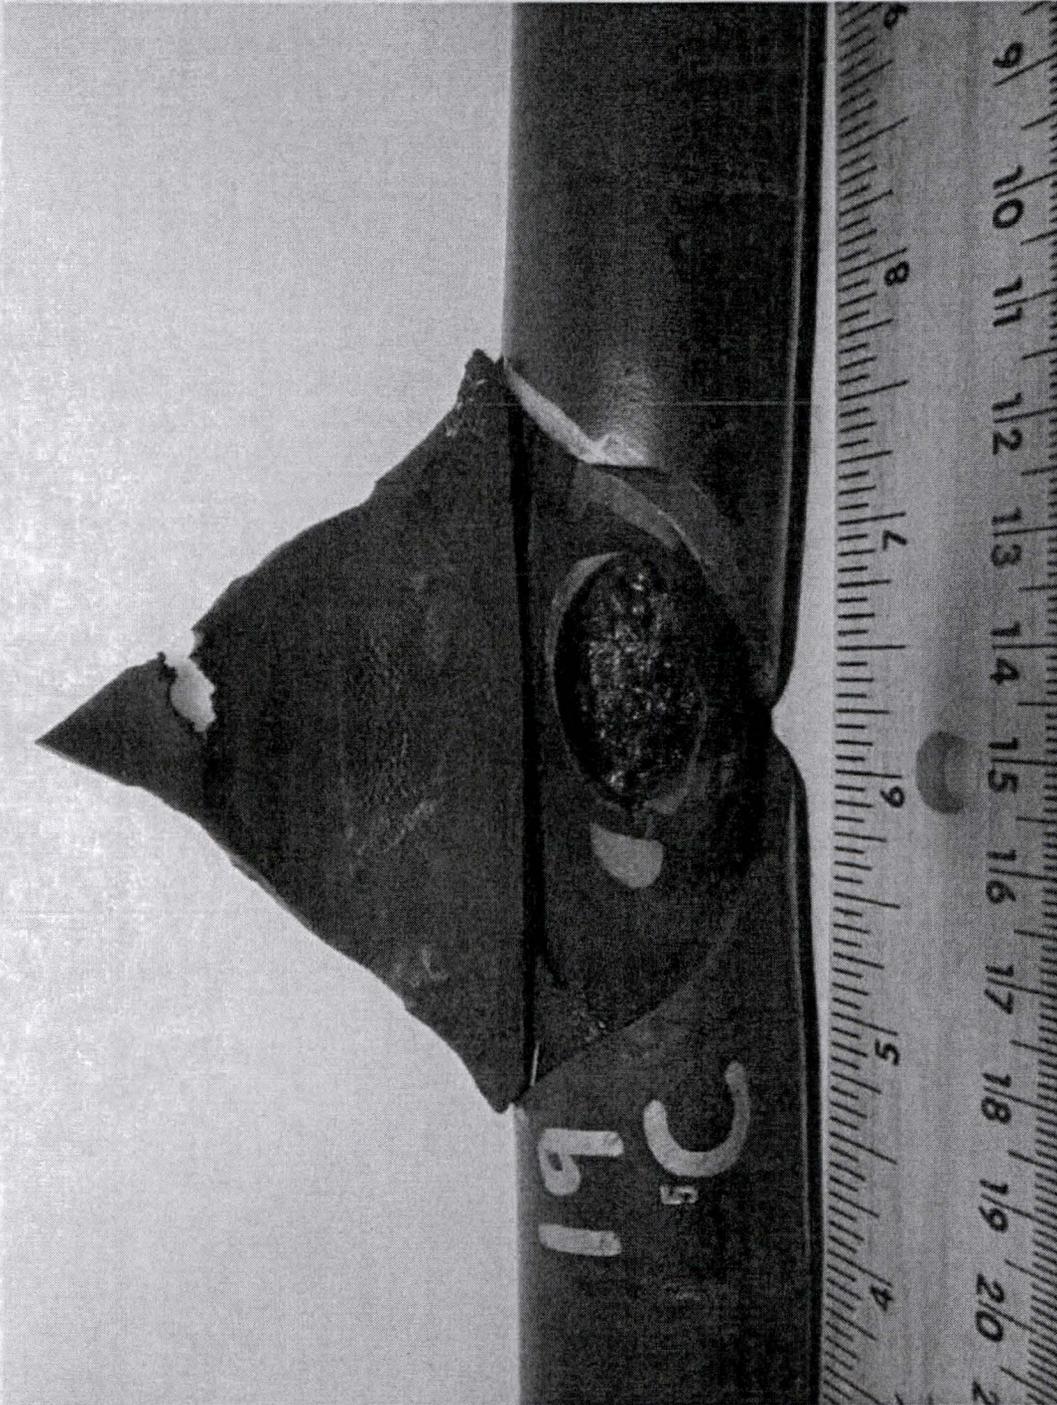
Test 19 C-Phase Cable  
CX Configuration With Solidly Grounded Power Source

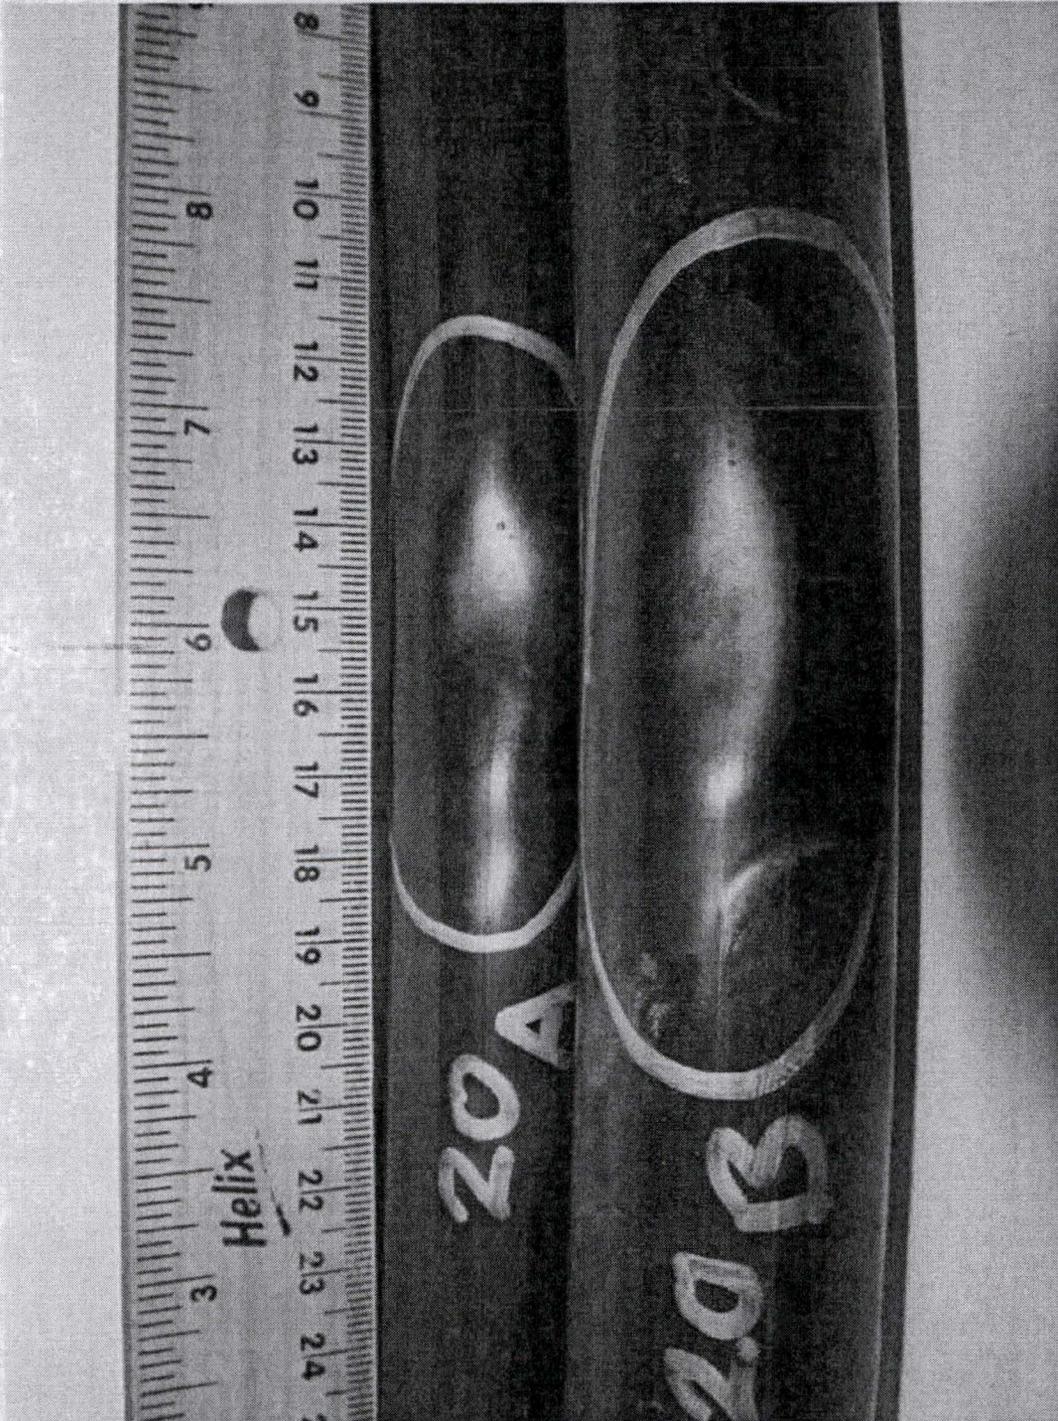
Test 20 A-Phase and B-Phase Cables  
CX Configuration With Solidly Grounded Power Source

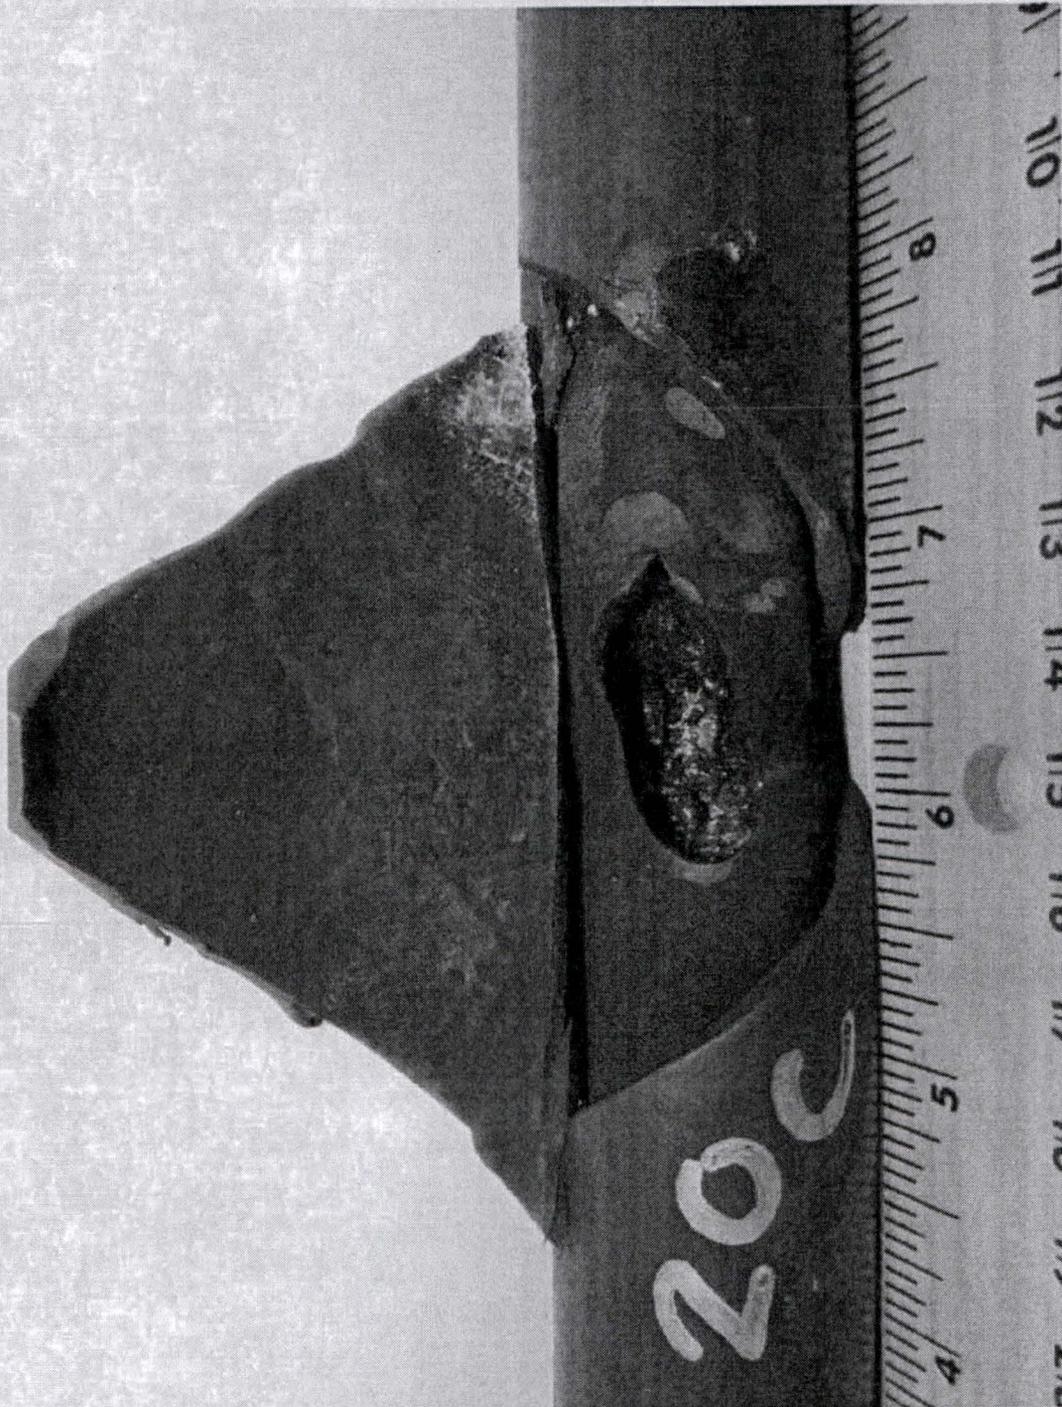
Test 20 C-Phase Cable  
CX Configuration With Solidly Grounded Power Source

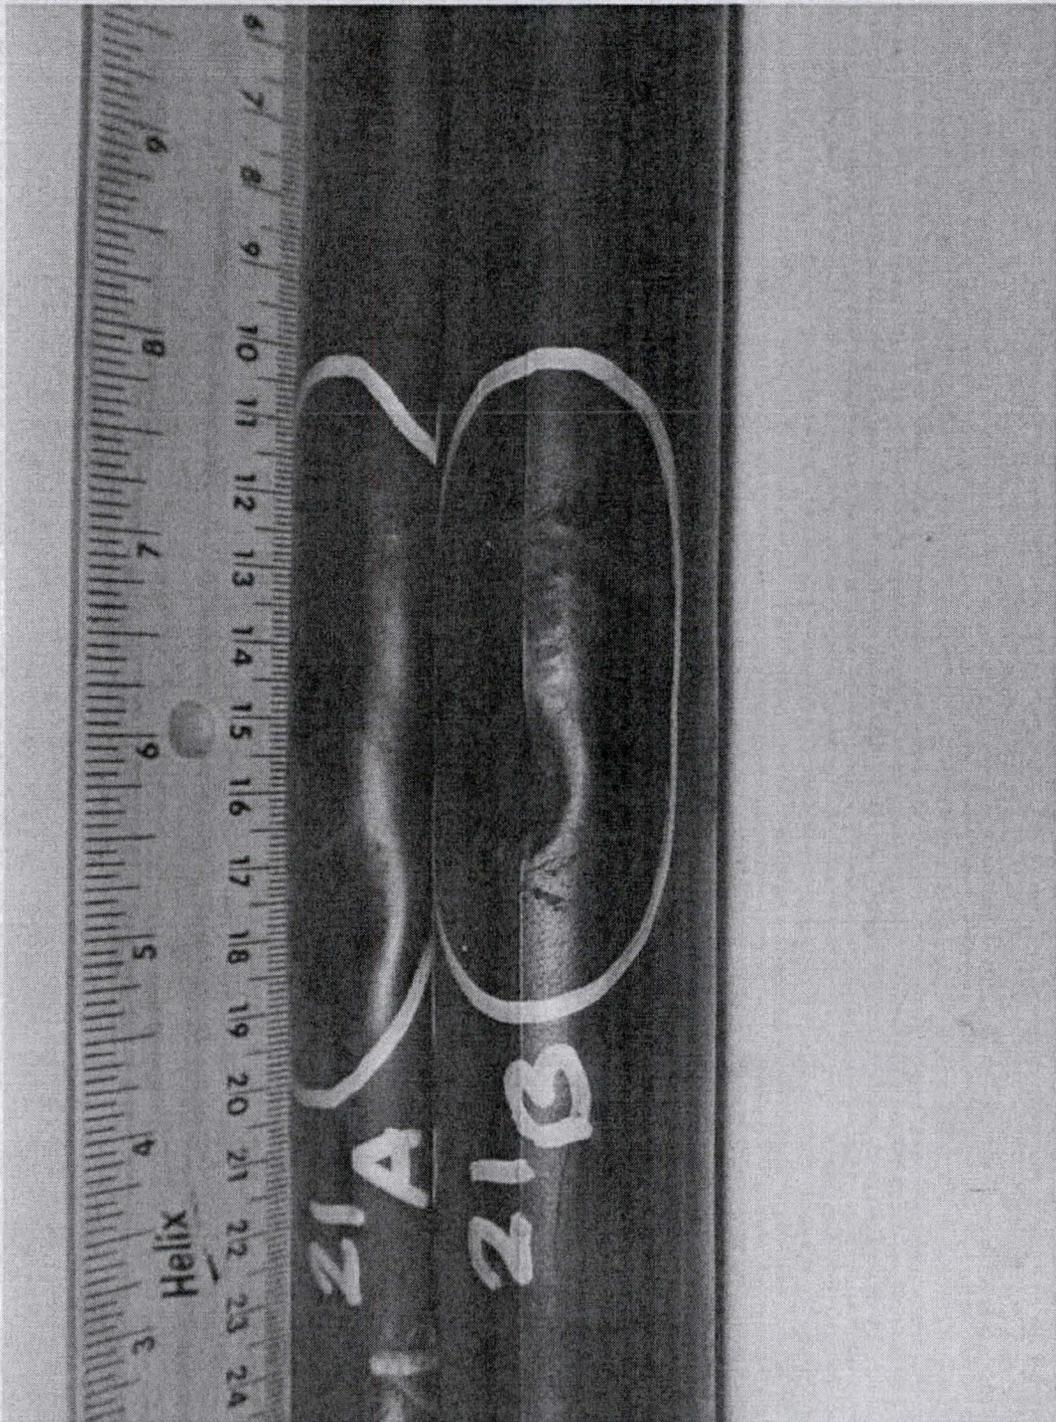
Test 21 A-Phase and B-Phase Cables  
CX Configuration With Solidly Grounded Power Source
