ONS-2018-016

February 12, 2018

Duke Energy Carolina, LLC (Duke Energy)  
Oconee Nuclear Station, Units 1, 2 and 3  
Docket Numbers 50-269, 50-270, 50-287  
Renewed License Numbers DPR-38, DPR-47, and DPR-55

**Subject:** Duke Energy Responses to Request for Additional Information (RAI); Request for Alternative to Codes and Standards Requirements Pursuant to 10 CFR 50.55a(z) to Satisfy 10 CFR 50.55a(h)(2) Associated with Bronze Tape Wrapped Emergency Power Cables in Use at the Oconee Nuclear Station

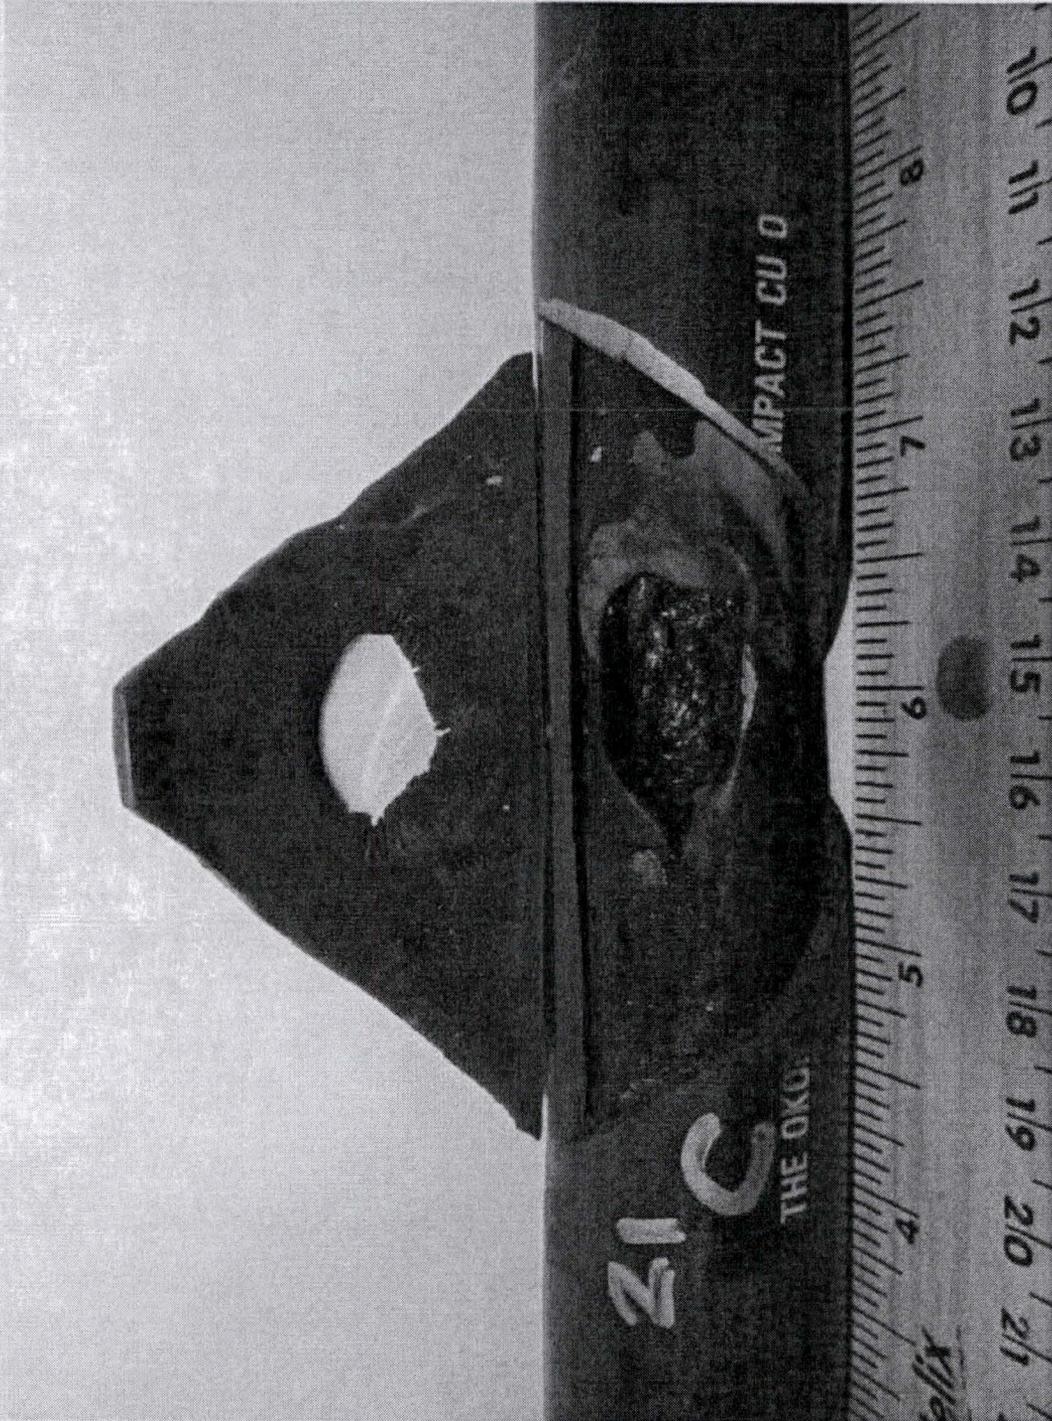
Test 21 C-Phase Cable  
CX Configuration With Solidly Grounded Power Source
