UNITED STATES  
NUCLEAR REGULATORY COMMISSION  
OFFICE OF INSPECTION AND ENFORCEMENT  
WASHINGTON, D.C. 20555

IE Information Notice No. 81-04: CRACKING IN MAIN STEAM LINES

PLANT: SURRY 1  
NSSS: (W)  
A/E: SFW

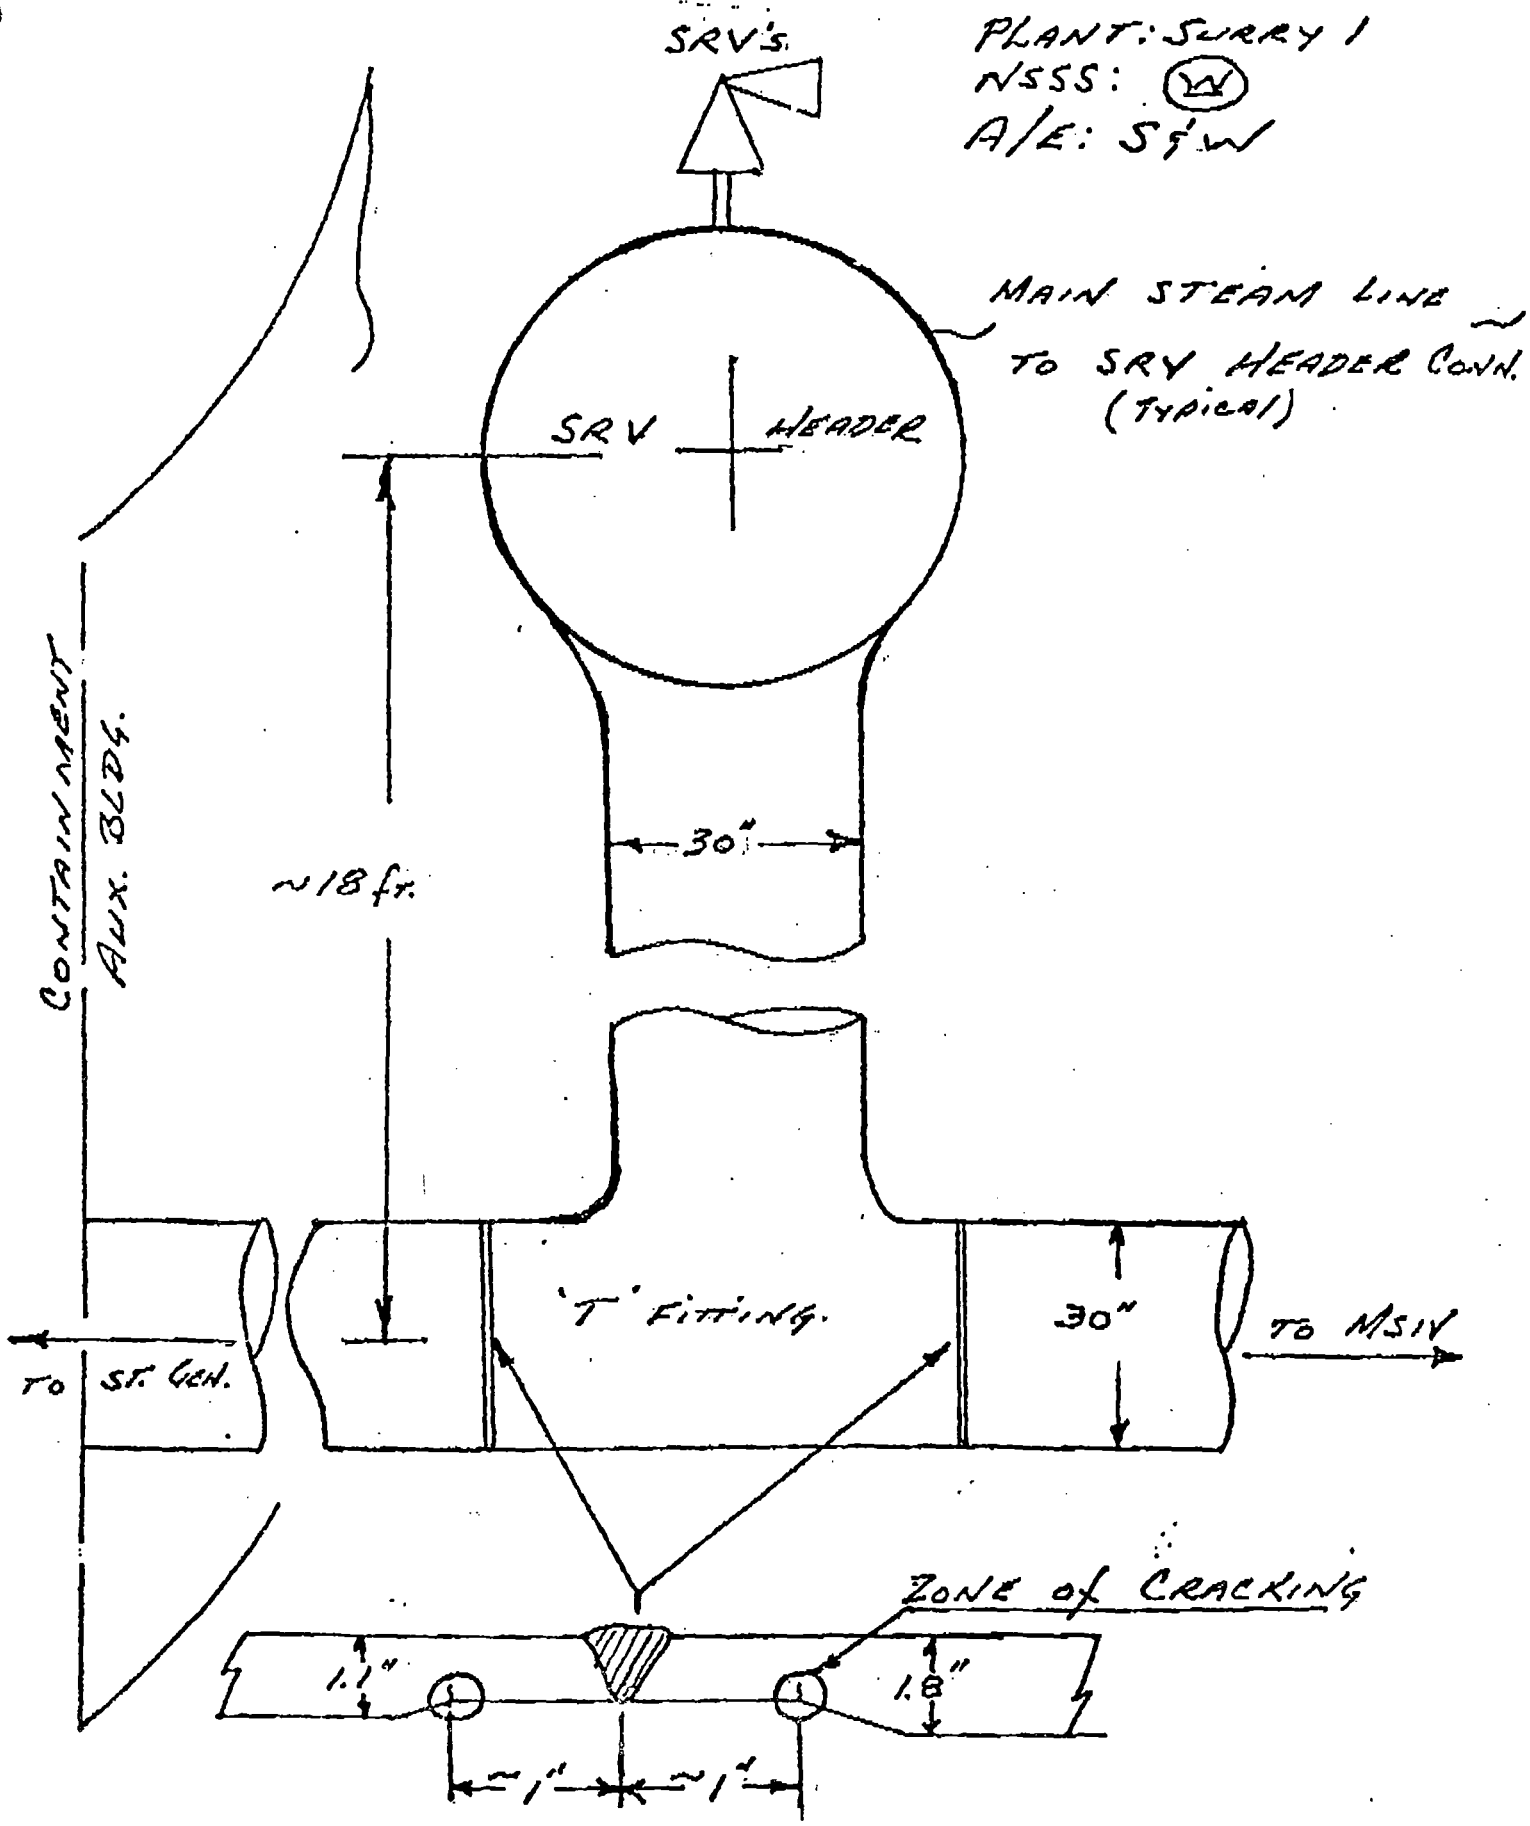
The Virginia Electric Power Company promptly notified the NRC on February 23, 1981 that a radiography examination, during the ongoing steam generator replacement outage at Surry Unit 1, had revealed a lengthy crack indication in the I.D. counterbore area of a weldment on the in-line "T" fitting which connects the vertical run of 30-inch piping to the safety relief valve header and 30-inch main steam line of Steam Generator "A". This piping connection is located outside the containment penetration immediately upstream of the main steam isolation valve as shown in the attached sketch.

A visual and dye penetrant examination on the pipe I.D. surface of the weldment nearest the containment penetration established that the cracking extended about 120° around the fitting counterbore between the 4 o'clock to 8 o'clock position. Cracking was also observed in the weld counterbore at the opposite end of the T-fitting during visual examination of the piping interior. Radiographic examination of "B" and "C" main steam line T-fitting welds disclosed crack indications at similar locations.

Metallurgical specimens of the cracking were trepanned from the T-fitting of the "A" main steam line for analysis. Controlled excavation and depth measurements of the crack at its mid-length indicated a crack depth of about 0.090" in this location. The cause of cracking has not yet been established.

ZONE of CRACKING

This information is provided as an early notification of a significant safety matter that is still under review by the NRC staff. It is expected that recipients will review the information for possible applicability to their plants. For those plants having similar main steam line configurations which are currently in a refueling or extended repair outage, it is recommended that a ultrasonic and/or radiographic examination of the three welds and counterbore areas of the T-fittings be performed before resumption of operations, unless some current basis for assurance of piping integrity is available.
