NUCLEAR POWER SYSTEMS  
COMBUSTION ENGINEERING, INC.  
COMPONENTS ENGINEERING  
Chattanooga, Tennessee

DALISADES AUXILIARY FEEDWATER  
NOZZLE GRINDOUTS

CONSUMERS POWER  
CUSTOMER

STEAM GENERATOR  
COMPONENT

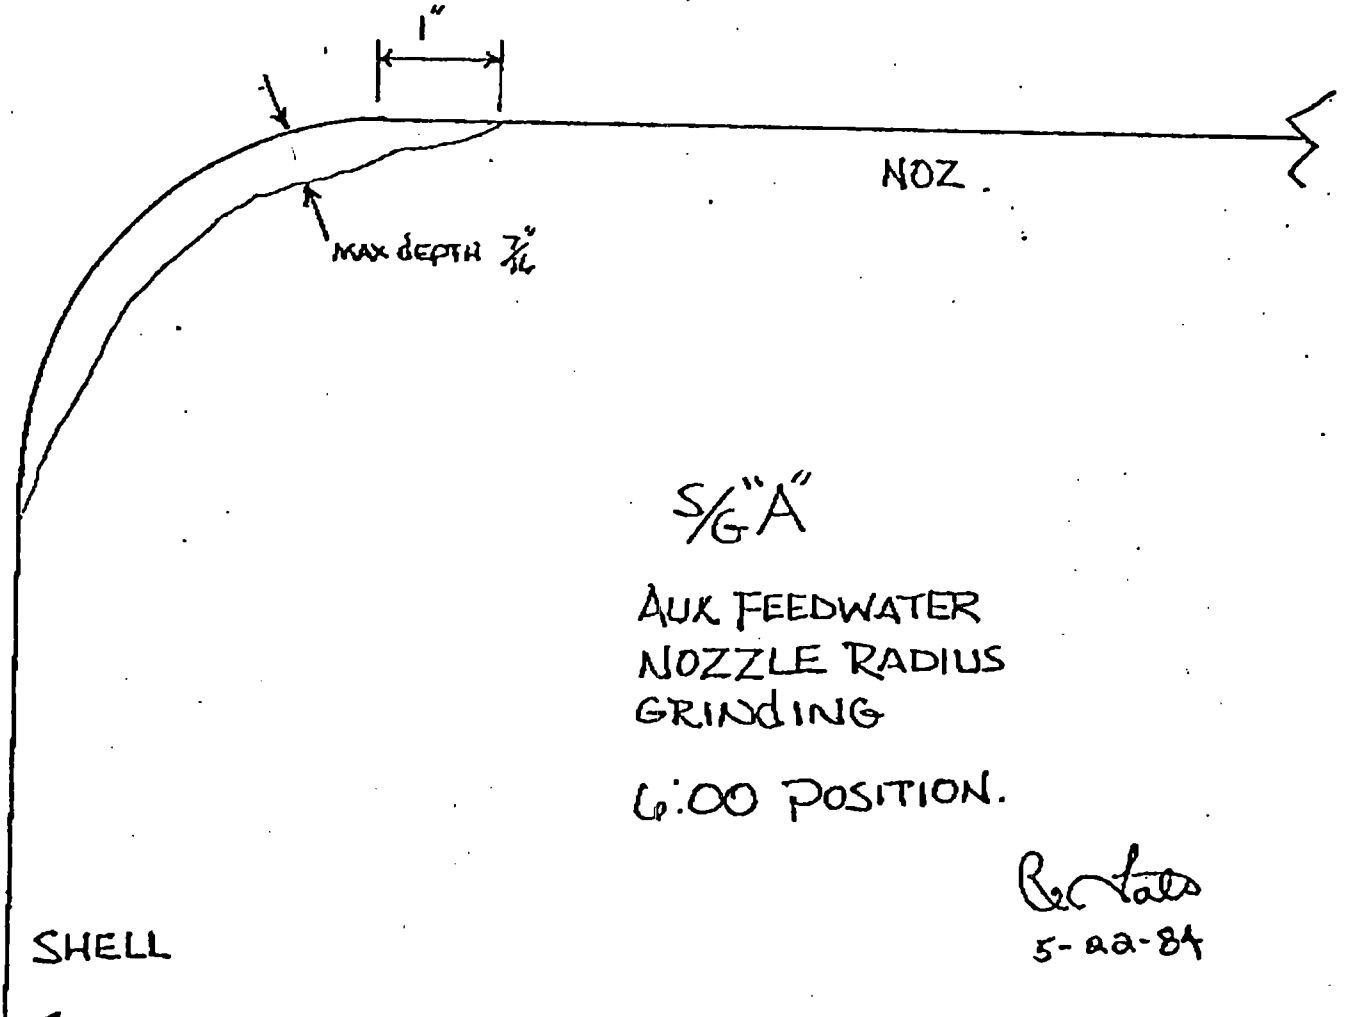
5/8" A  
AUX FEEDWATER  
NOZZLE RADIUS  
GRINDING  
6:00 POSITION.

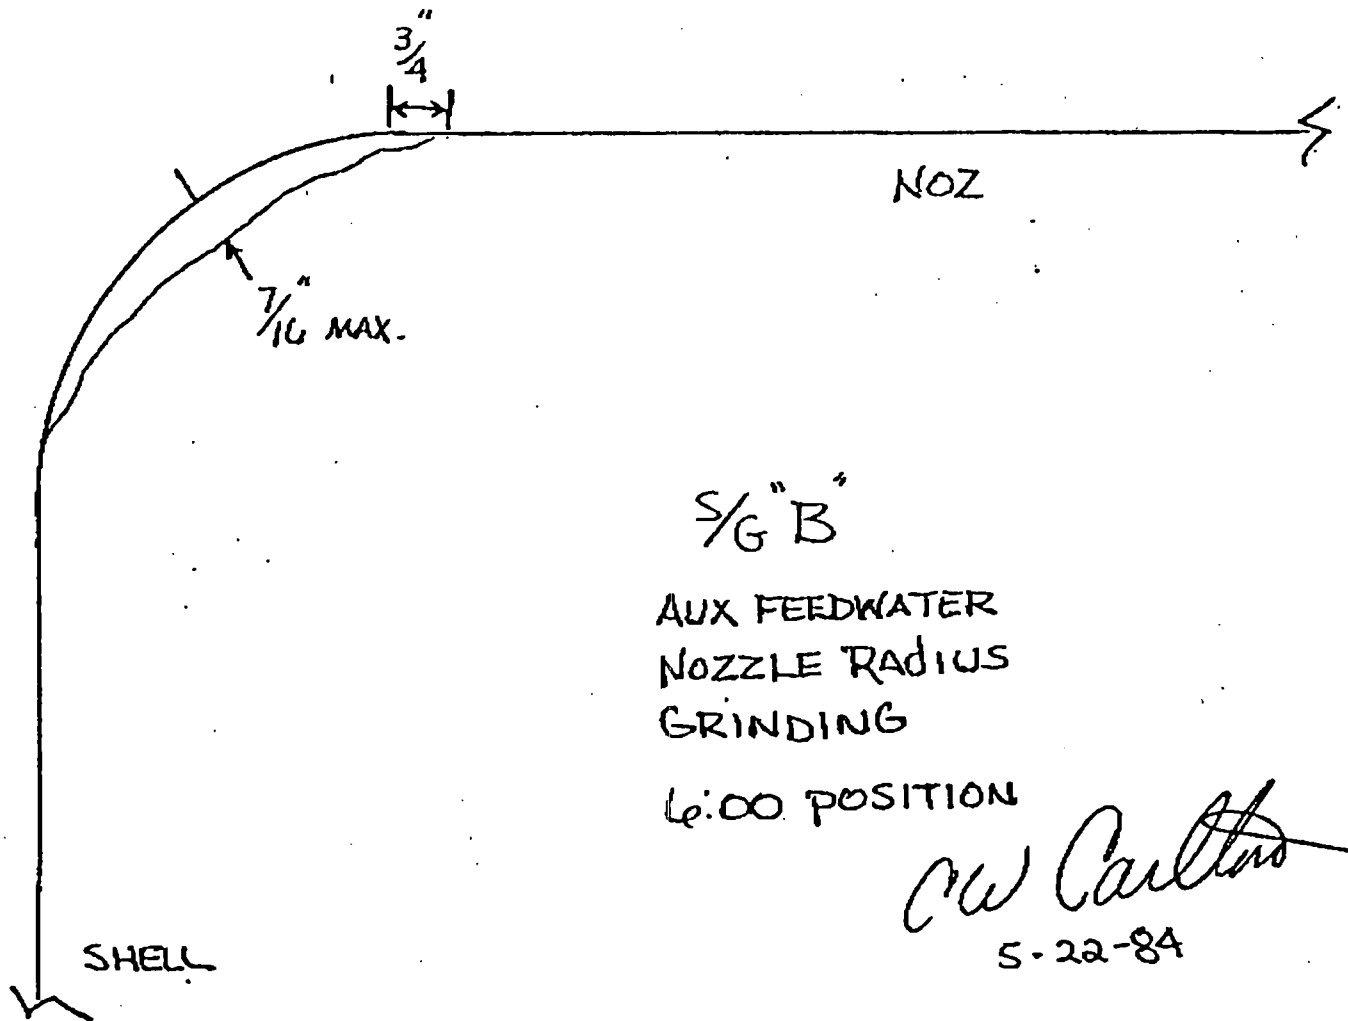
7/16" MAX.

AUX FEEDWATER  
NOZZLE RADIUS  
GRINDING

6:00 POSITION

GRINDING DEPTHS ARE MAX. DEPTH AT LOCATION INDICATED.  
NO LOCAL GRINDOUTS EXIST AS THE TOTAL RADIUS SURFACE  
WAS GROUND WITH TAPERED TRANSITION BETWEEN  
HIGH AND LOW AREAS.

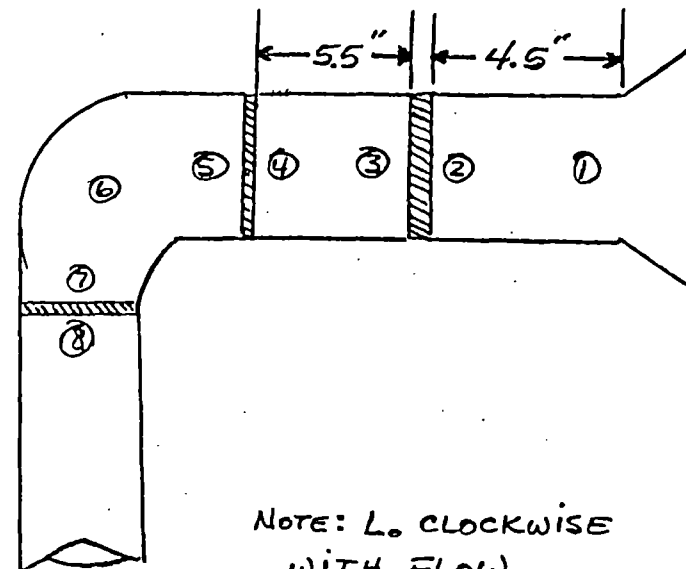
S/G 'B'

C DESCRIPTION OF OCCURRENCE OR CONDITION: Ultrasonic measurement of the wall thickness on the auxiliary feedwater piping immediately adjacent to steam generator B has shown the actual piping wall thickness in some areas to be less than the nominal wall thickness shown within piping tables for schedule 40 4" piping.

A DESCRIBE CAUSE OF DEVIATION: The cause of the observed wall thinning is believed to be inherent in the design and failed condition of the steam generator auxiliary feedwater sparger. Under such conditions, Combustion Engineering describes the possibility of steam bubble collapse within the failed sparger (see P-CE-7597, Combustion Engineering Auxiliary Feedwater Sparger Study, Paragraph 1, Page 4 of 7, Attachment 1). During steam bubble collapse large differential pressures are realized which accelerate the incoming cold auxiliary feedwater to velocities which result in erosion of the nozzle liner and pressure boundary piping.

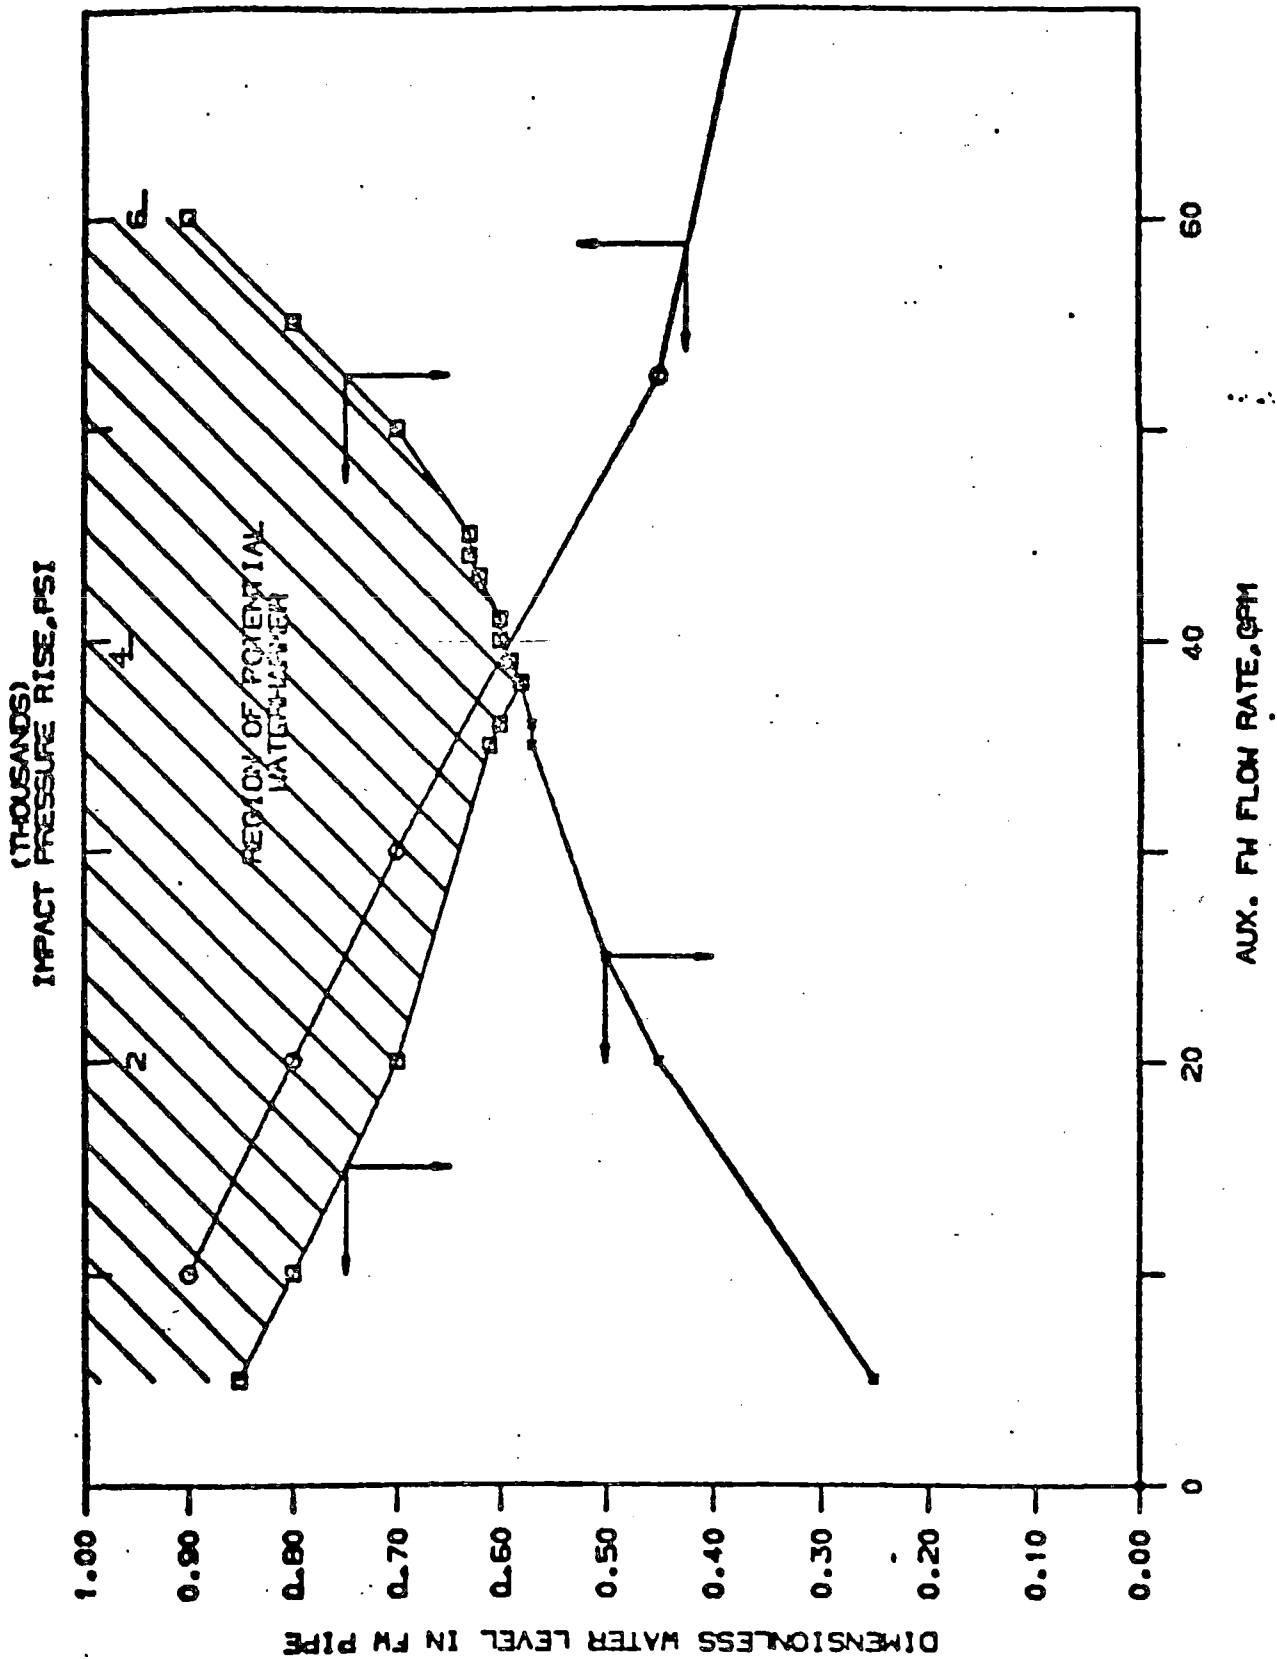
PALISADES REGION OF POTENTIAL  
 WATERHAMMER AND IMPACT PRESSURE RISE RELATION

As shown on the attached figure there is a theoretical possibility of water hammer over a range of flows of 5 gpm (when the auxiliary feedwater nozzle is being recovered) to 60 gpm. The recommended operational restriction is 70 gpm.

Based on reported operators' recollections, waterhammer (when it was observed) occurred at flow rates of 30 to 40 gpm and ceased when the flow rate was increased to 50 gpm. This is in excellent agreement with our calculations as shown on the attached figure. Based on the operators' observations the actual upper limit for observable water hammer to occur may be approximately 50 gpm.

If a flow rate less than 70 gpm occurs at a steam generator level below 60% (NR) the flow rate should be promptly increased to greater than 70 gpm, or terminated.
