CONSUMERS
POWER

DOCKET 50-255 - LICENSE DPR-20 - PALISADES PLANT -
IE INSPECTION REPORT 86032, ADDITIONAL INFORMATION

To RJFrigo, Palisades
From KAToner, Palisades *KAT*
Date March 19, 1987
Subject PALISADES PLANT - EEQ TRANSMITTER ERROR
ANALYSIS - IMPACT ON OPERATING PROCEDURES
CC RAFenech, Palisades
KEOsborne, Palisades

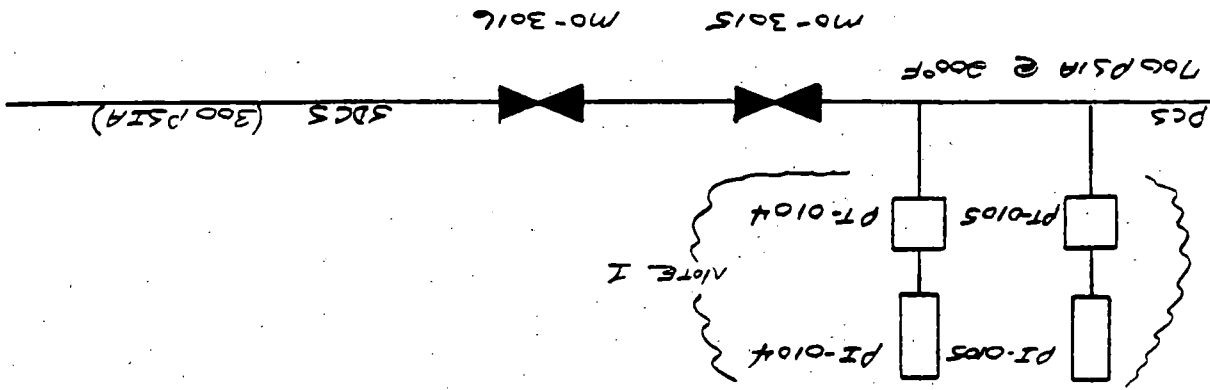
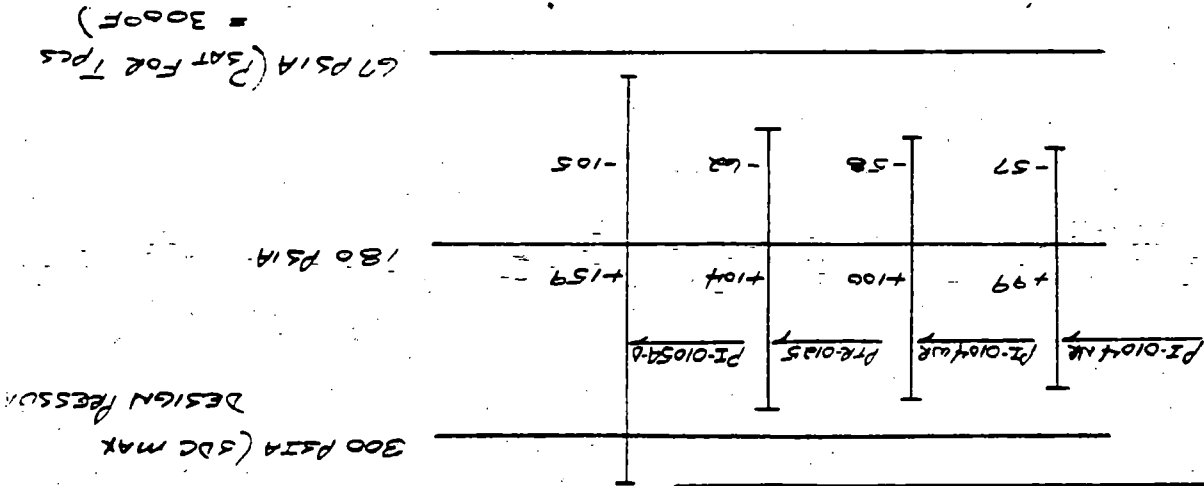
INDICATION ERRORS RELATED TO DETERMINING SHUTDOWN COOLING ENTRY CONDITIONS

The strict use of PI-0104 and PTR-0125 is preferred over averaging all indications in this case, since the shifts in output owing to transmitter error are less for these instruments than that expected for the 0105 loops previously identified. Incorporating Recommendation 2 will ensure that neither the maximum SDCS design pressure or the minimum PCS pressure to ensure subcooling will be exceeded if PI-0104 and PTR-0125 are used (see attached sketch).

The 0105 loop errors result in peak-to-peak output shift variations of a magnitude which exceeds the pressure band between the overpressurization and subcooling limits regardless of what pressure within the band would be specified as signifying when the operator should open the valves. As a result, using the 0105 loops for this function would require averaging all readings; a practice which would likely reduce the overall inaccuracy of the reading but would not necessarily ensure that the actual PCS pressure would be within the acceptable bounds (see attached sketch).

1. Either the strict use of PI-0104 (preferably narrow range, however either narrow or wide range is acceptable) and PTR-0125, or the average of all qualified PCS pressure indications (the aforementioned indicators as well as indicators PI-0105A through D) are to be used to determine when the Shutdown Cooling System (SDCS) isolation valves MO-3015 and MO-3016 are to be manually opened to commence SDC.
2. The indication at which the SDCS isolation valves are to be opened should be revised from 270 psia to 180 psia to ensure that the upper and lower pressure limits as described in Item 1 above are not exceeded.
