U. S. NUCLEAR REGULATORY COMMISSION

AUGMENTED INSPECTION TEAM

Report No. 50-255/87019(DRP)

Facility Name: Palisades

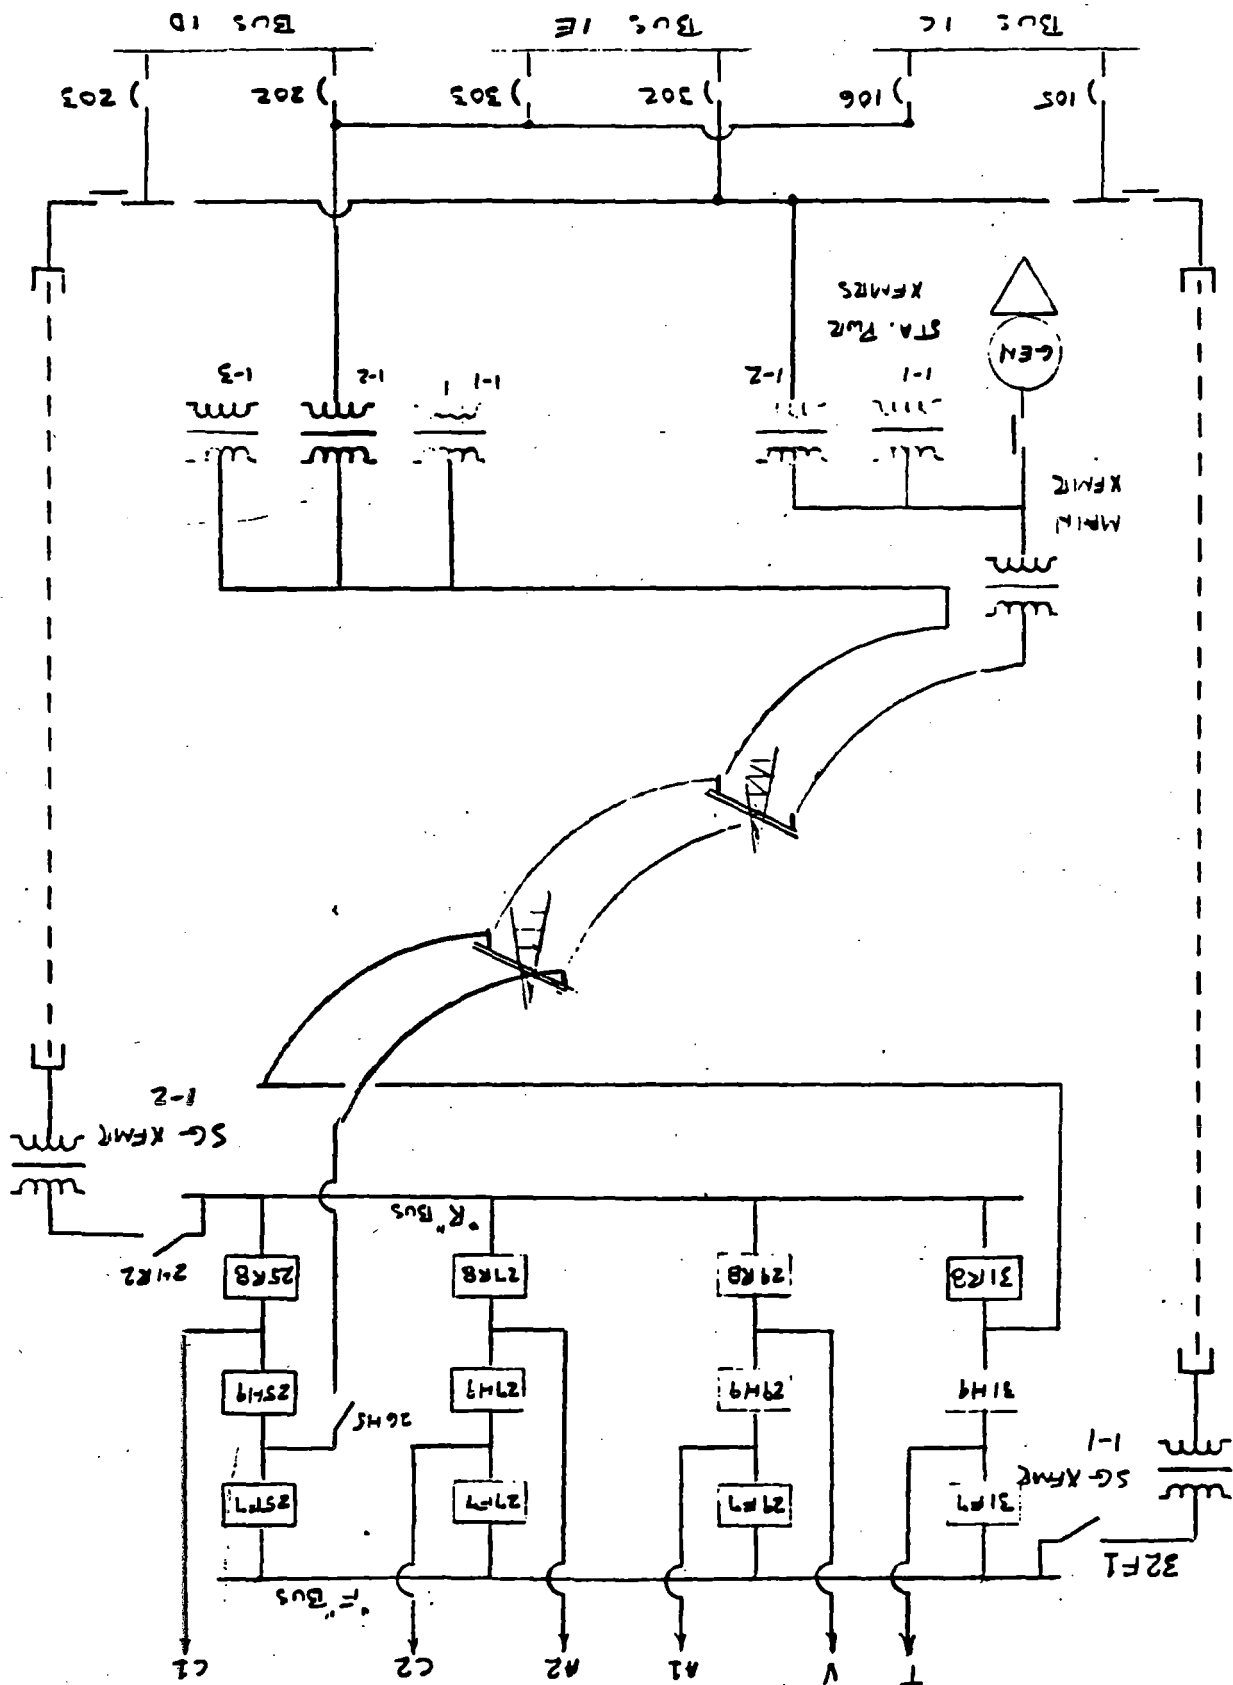
FIGURE 1

The Palisades offsite power system (Figure 1) consists of a switchyard, six transmission lines connecting the grid network to the switchyard, and an immediate and delayed access circuit connecting the switchyard to the onsite Class 1E distribution system. The immediate access circuit consists of a 345KV transmission line, 345KV to 24KV Startup Transformer 1-2 which failed July 14, 1987, and a 2400 volt bus duct. The delayed access circuit consists of 345KV transmission line, 345KV to 24KV main transformer, 24KV bus duct, 24KV to 2.4KV station power transformer (No. 1-2), and 2.4KV bus duct.
