DOCKET 50-255 - LICENSE DPR-20 - PALISADES PLANT - REPLY TO OPEN ITEM  
CONTAINED IN ROUTINE UNANNOUNCED RESIDENT INSPECTION REPORT 50-255/92016 (DRP)

REPLY TO OPEN ITEM 255/92016-01 (DRP)

Open Item 255/92016-01; Palisades Reactor Head/ Pressurizer Vent System

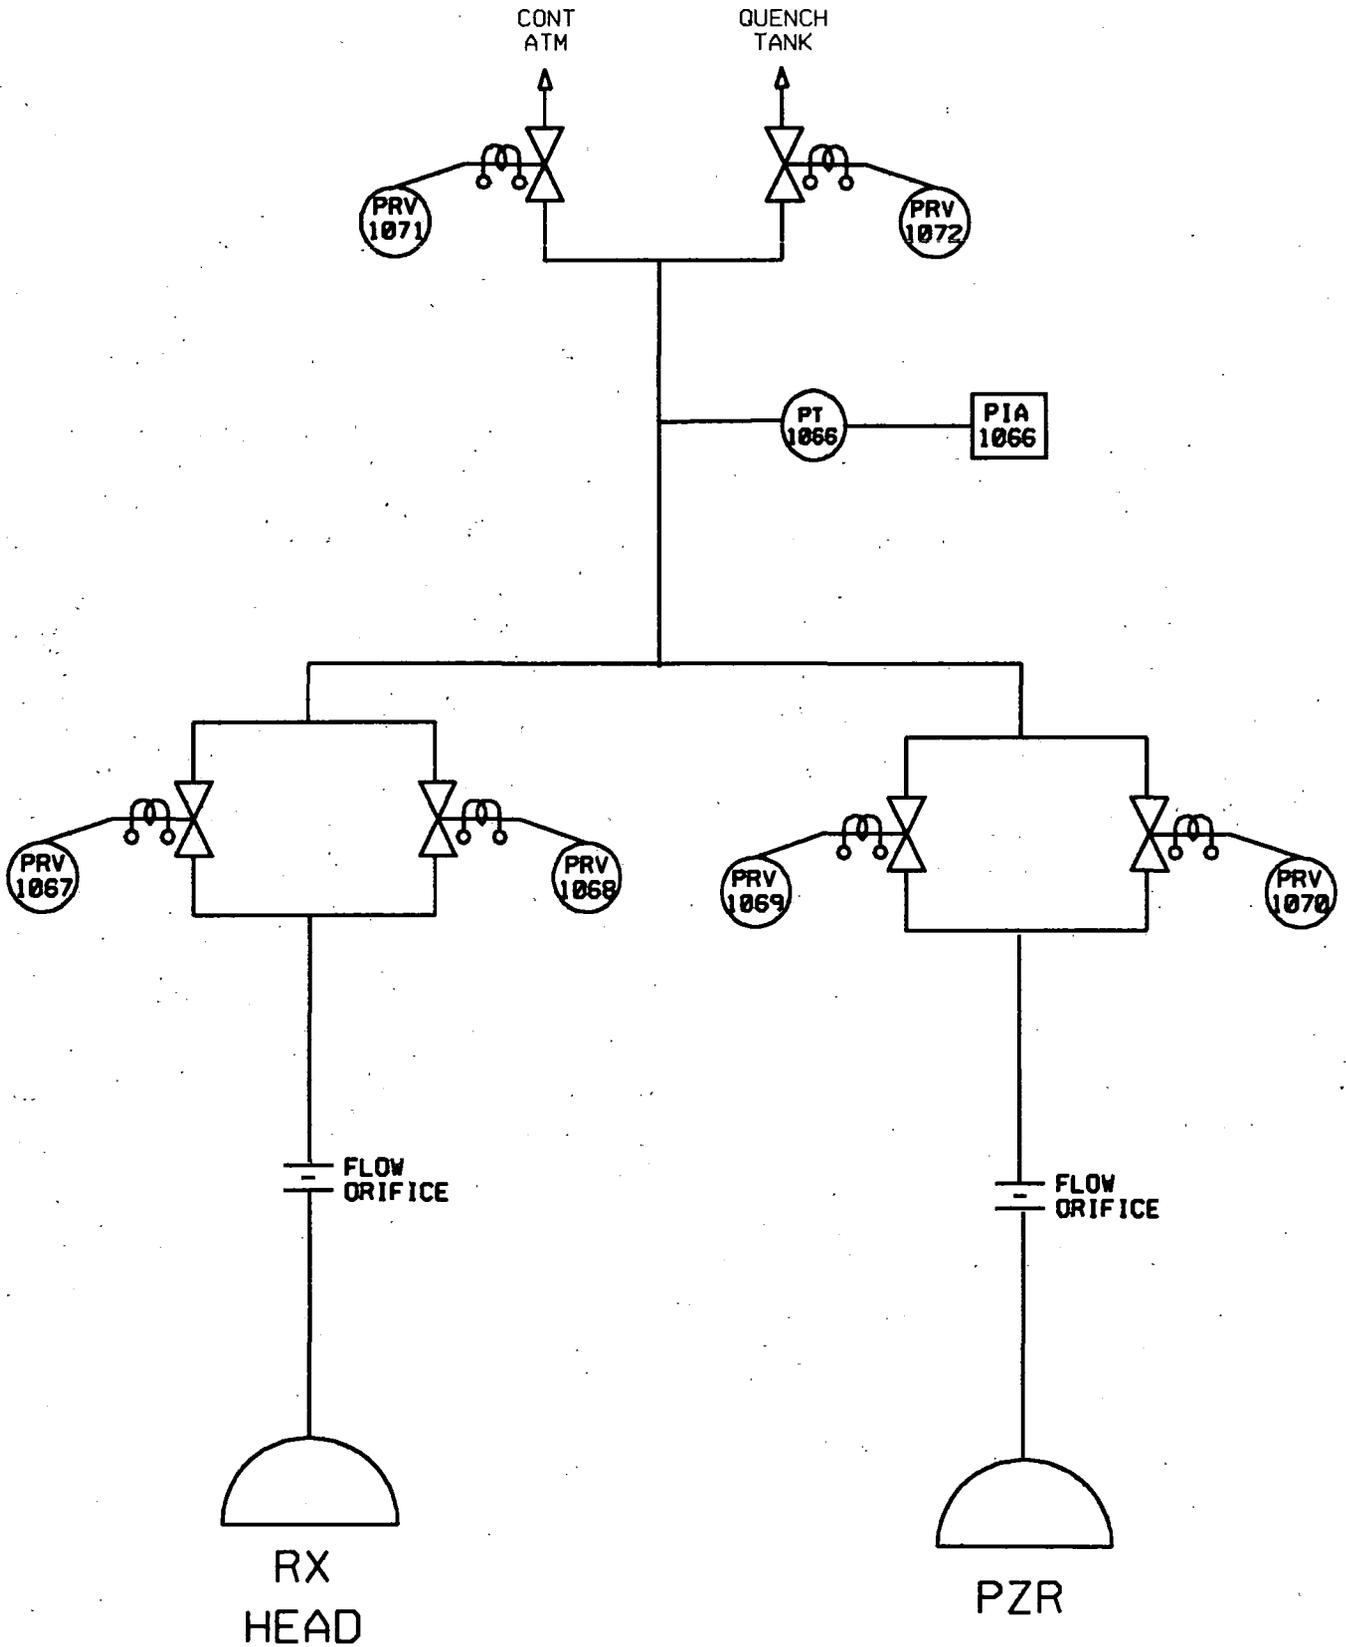
FIGURE 1

The vent system is connected to both the reactor vessel head and pressurizer. The line relieves to either the pressurizer quench tank or directly to the containment atmosphere. The system configuration provides for dual isolation from either the head or the pressurizer to the containment atmosphere. PIA-1066 is installed on the common piping between the first and second isolation valves. The increase in pressure at PIA-1066 indicated that the second set of isolation valves were holding pressure. This was confirmed by the stable pressurizer quench tank readings and by stable containment atmospheric temperature and humidity readings.

The isolation valves are Target Rock, one inch, pilot operated solenoid valves. The design basis of the system includes flow limiting orifices, located upstream of the reactor head and pressurizer vent isolation valves, which will limit leakage from either vent source to less than the make-up capacity of a single charging pump. The normal discharge for the vent system is to the quench tank, however redundant discharge capability is available to the containment atmosphere. It should also be noted that the piping configuration is such that opening the downstream valves will not drain the piping. The attached Figure 1 shows the vent system.

- 1) The apparent leakage of the isolation valves upstream from PIA-1066 is not a significant safety issue since the design basis relies on the flow limiting orifices.
- 2) Since the line is water solid upon start-up, containment temperature has a significant affect on the vent system pressure.
- 3) The downstream isolation valves are not leaking.
- 4) Any leakage from the upstream isolation valves due to valve degradation is very small.

# RX HEAD/PZR VENT SYSTEM

Based on these conclusions, the system engineering department will continue monitoring the condition of the isolation valves and will schedule appropriate corrective action if and when the upstream valve leakage becomes significant or the downstream valves show evidence of leakage. It should be noted that testing can only be performed during heat-up and cool-down. In addition, system engineering is evaluating the design basis of the alarm function as well as methods for further testing of the upstream isolation valves to determine which of the four (4) valves are actually leaking.

Since the design basis of the vent system rests on the existence of the flow limiting orifice, the downstream isolation valves are not leaking and upstream valve leakage is minor, the small amount of leakage in the upstream valves and the resultant increase in pressure between the isolation valves is not considered to adversely affect either safe shutdown capability or the safe operation of the plant. Therefore, at this time, no additional corrective action is planned.
