LICENSEE: Consumers Power Company
FACILITY: Palisades Nuclear Generating Plant
SUBJECT: RECENT PLANT PERFORMANCE MEETING SUMMARY

A meeting was held at NRC Headquarters on November 30, 1992 to discuss recent plant performance at the Palisades Plant. Enclosure 1 provides a list of attendees; Enclosure 2, the handouts from the meeting.

Subject: Palisades Plant
Performance Monitoring Report
Third Quarter 1992 -Revised

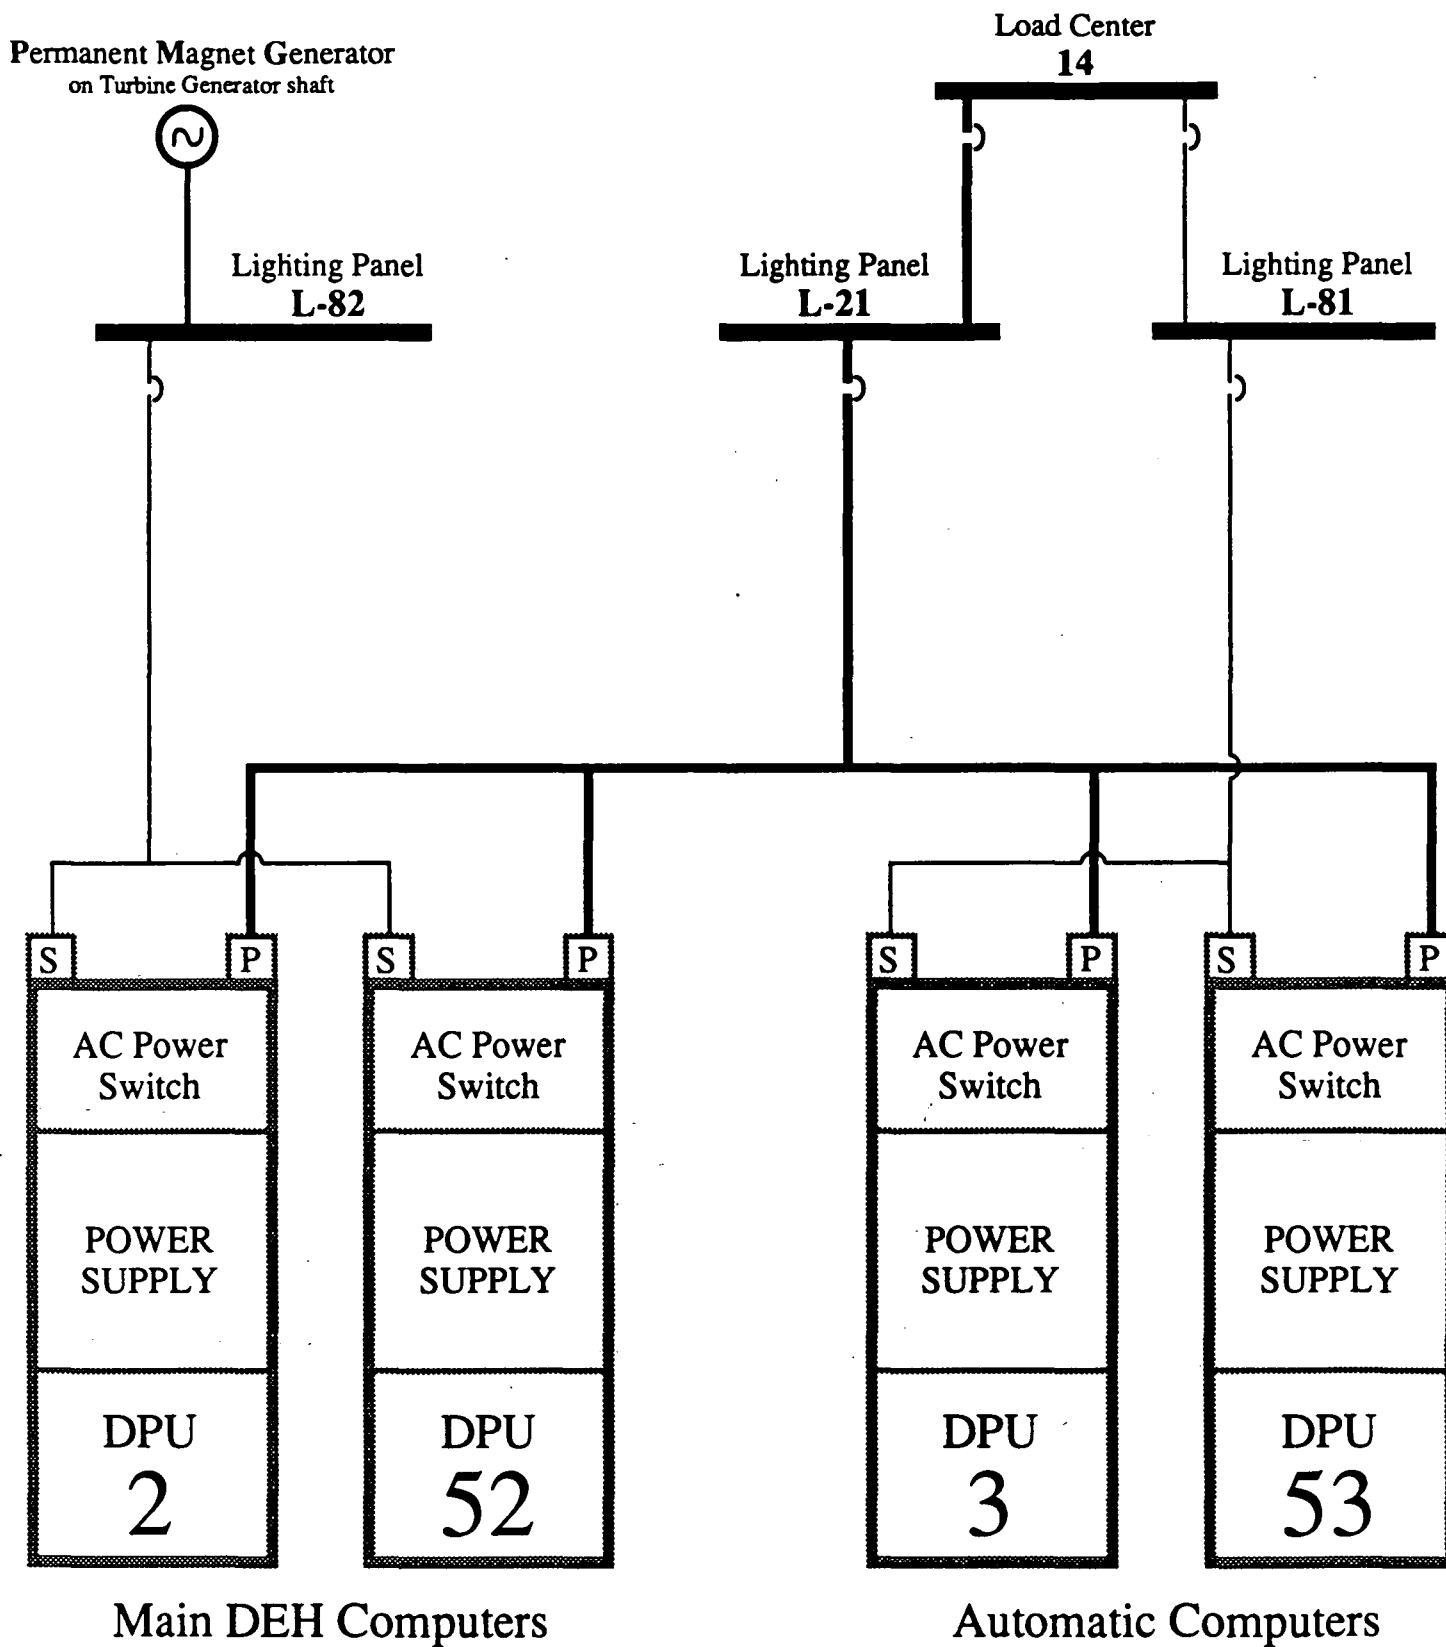
Simplified DEH computer layout and power supplies

- **PLANT OPERATING NORMALLY AT 100%**
- **TURBINE TRIP**
- **REACTOR TRIP CAUSED BY TURBINE TRIP**
- **CAUSE: LOOSE CONNECTORS IN DEH COMPUTERS, POWER SUPPLY VOLTAGE TRANSIENT**
- **PLANT RESPONSE VERY GOOD**

SHOWS PRIOR TO ADDITION OF UPS FOLLOWING JULY 24, '92 REACTOR TRIP

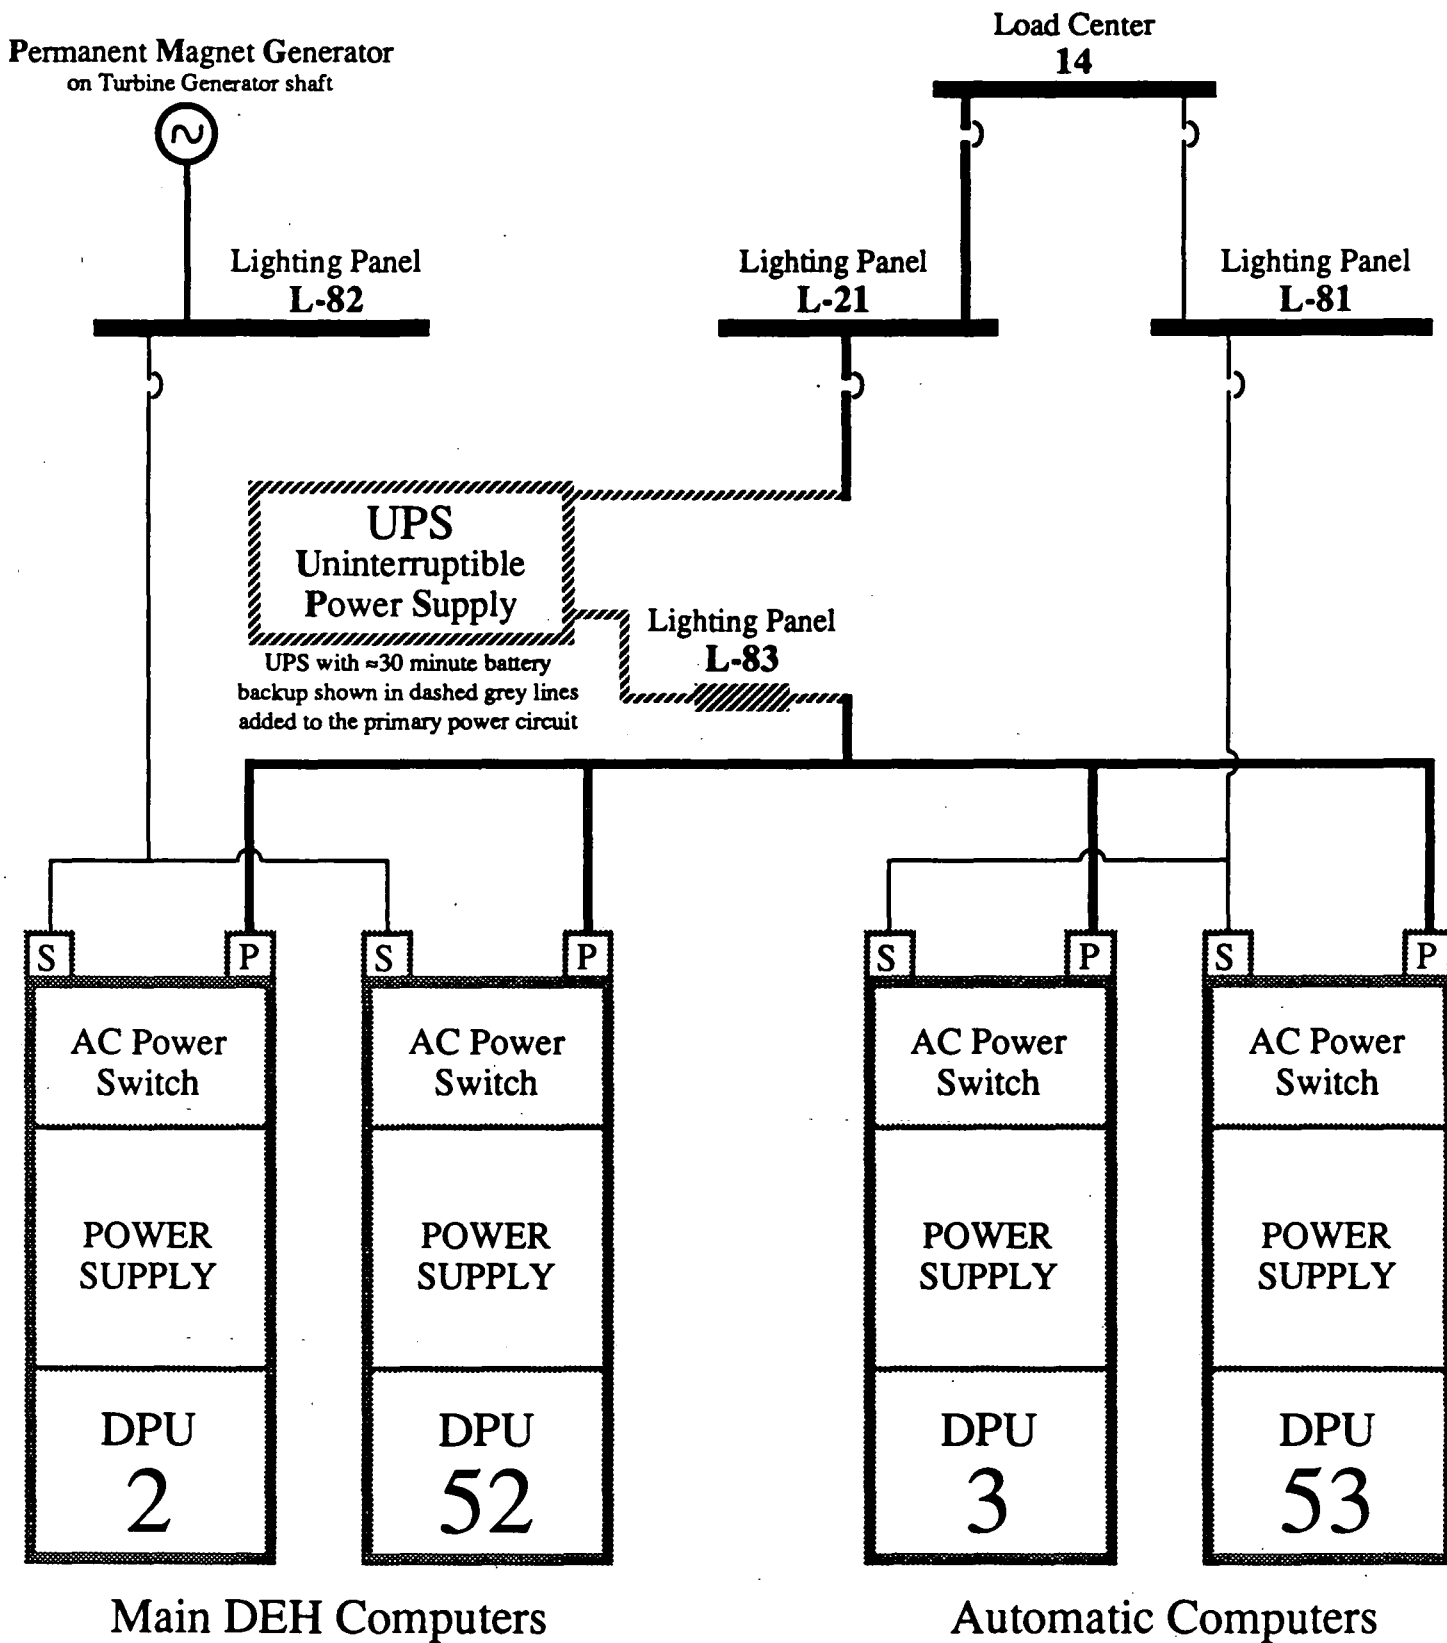
Simplified DEH computer layout and power supplies

- **PLANT OPERATING NORMALLY
AT 100%**
- **TURBINE TRIP**
- **REACTOR TRIP CAUSED BY
TURBINE TRIP**
- **CAUSE: VOLTAGE TRANSIENT
DURING SURVEILLANCE TEST
CAUSED DEH COMPUTERS TO
DROP OFF**
- **DEH COMPUTERS FUNCTIONING
PROPERLY DURING SAME TEST
ON 10/26/92**
- **PLANT RESPONSE EXCELLENT**

SHOWS ADDITION OF UPS FOLLOWING JULY 24, '92 REACTOR TRIP

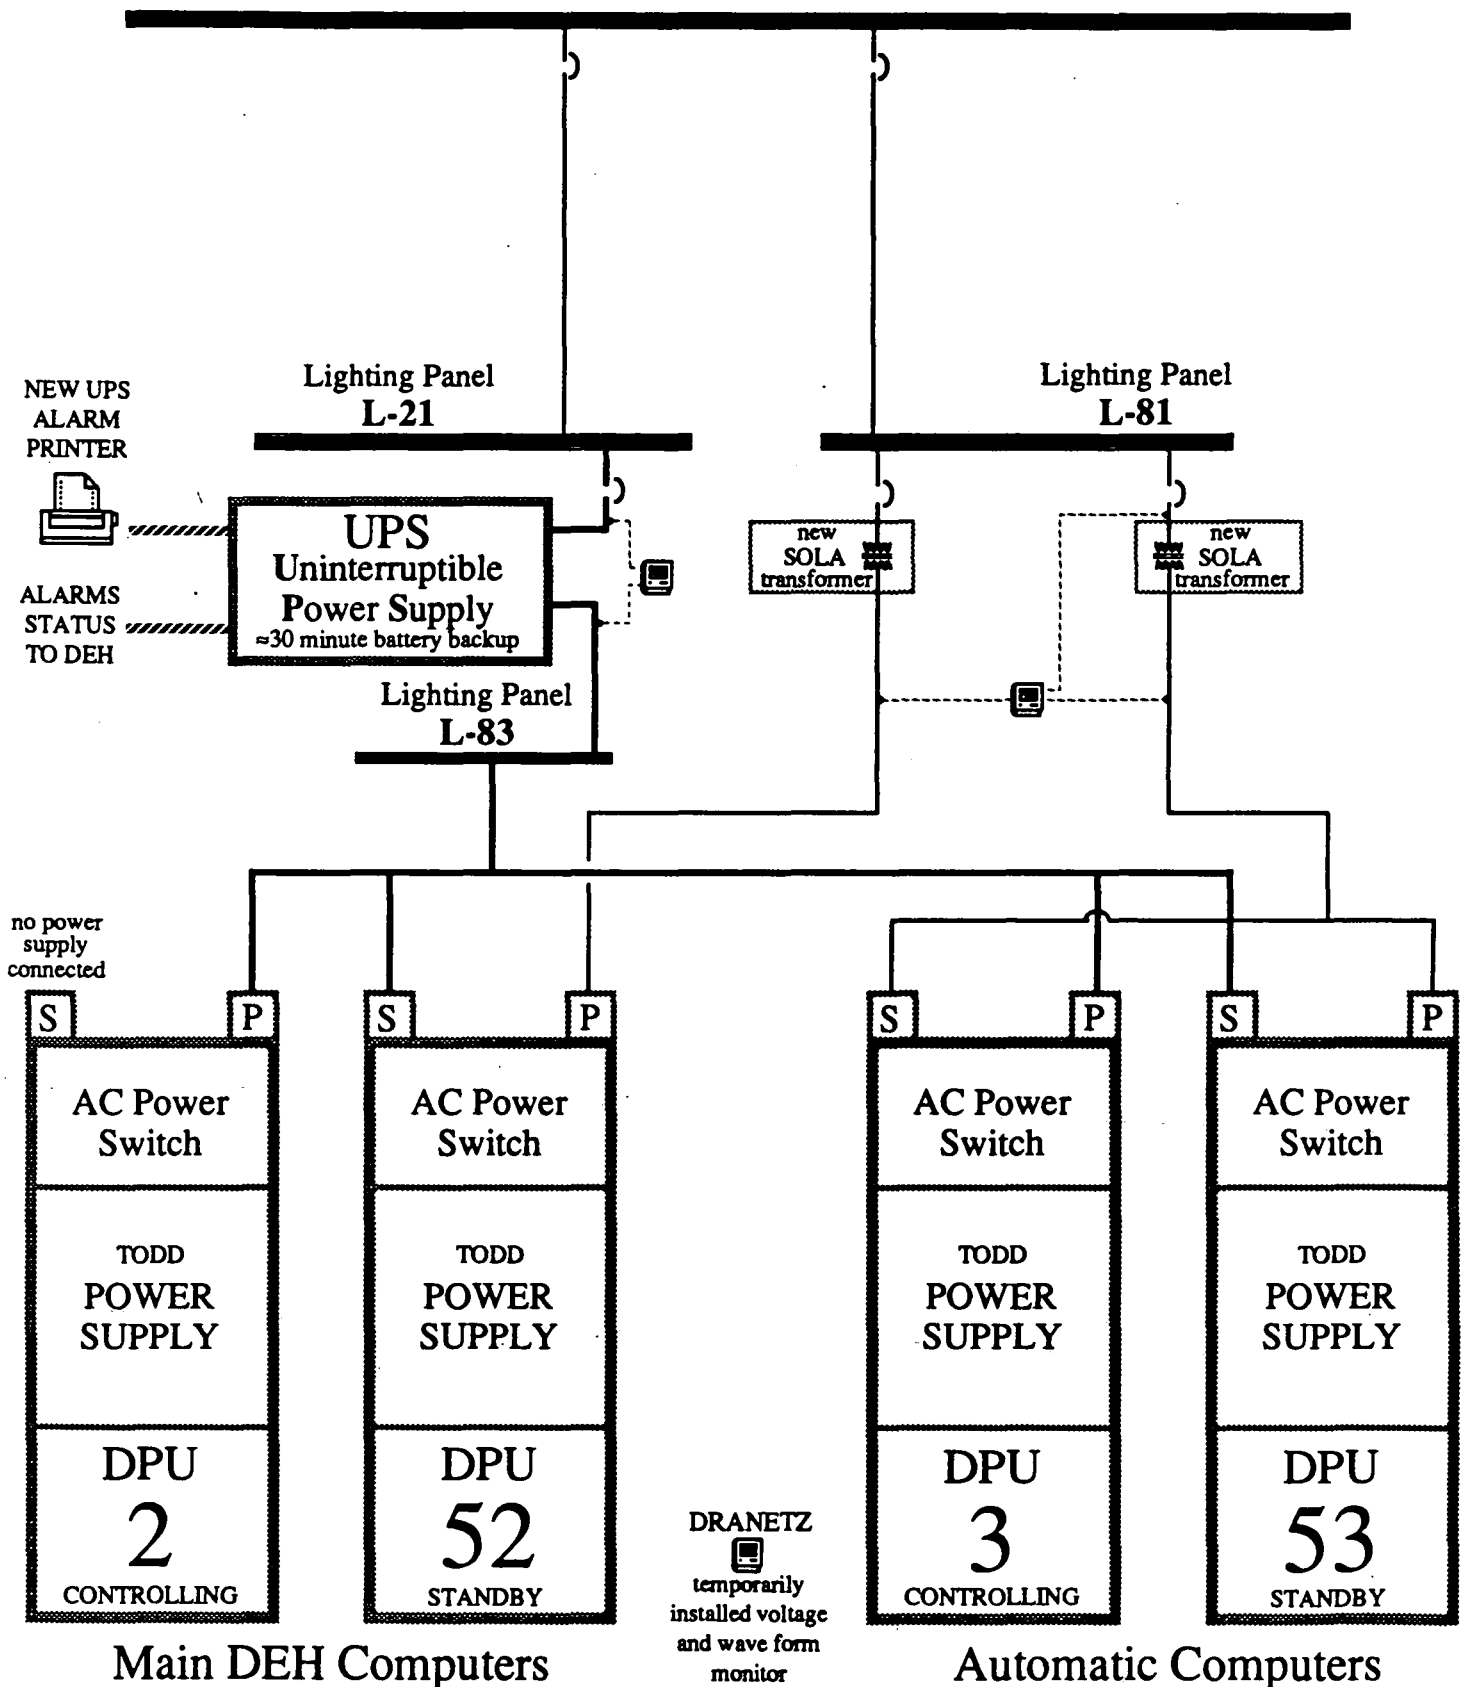
- **PLANT OPERATING NORMALLY AT 100%**
- **TURBINE TRIP**
- **REACTOR TRIP CAUSED BY TURBINE TRIP**
- **CAUSE: FAILURE OF UNINTERRUPTIBLE
POWER SUPPLY TO DEH COMPUTERS**
- **DEH FUNCTIONING PROPERLY DURING
TRANSMISSION SYSTEM TRANSIENTS ON
11/16/92**
- **PLANT RESPONSE VERY GOOD**

Shows rewiring of DPU power supplies, SOLA, and addition of new UPS alarm printer and status information to DEH.
