Palisades Nuclear Plant: 27780 Blue Star Memorial Highway, Covert, MI 49043

DOCKET 50-255 - LICENSE DPR-20 - PALISADES PLANT - LICENSEE EVENT REPORT
93-011 - PRESSURIZER TEMPERATURE ELEMENT CRACK RESULTS IN PCS LEAKAGE

TITLE (4) **PRESSURIZER TEMPERATURE ELEMENT CRACK RESULTS IN PCS LEAKAGE**

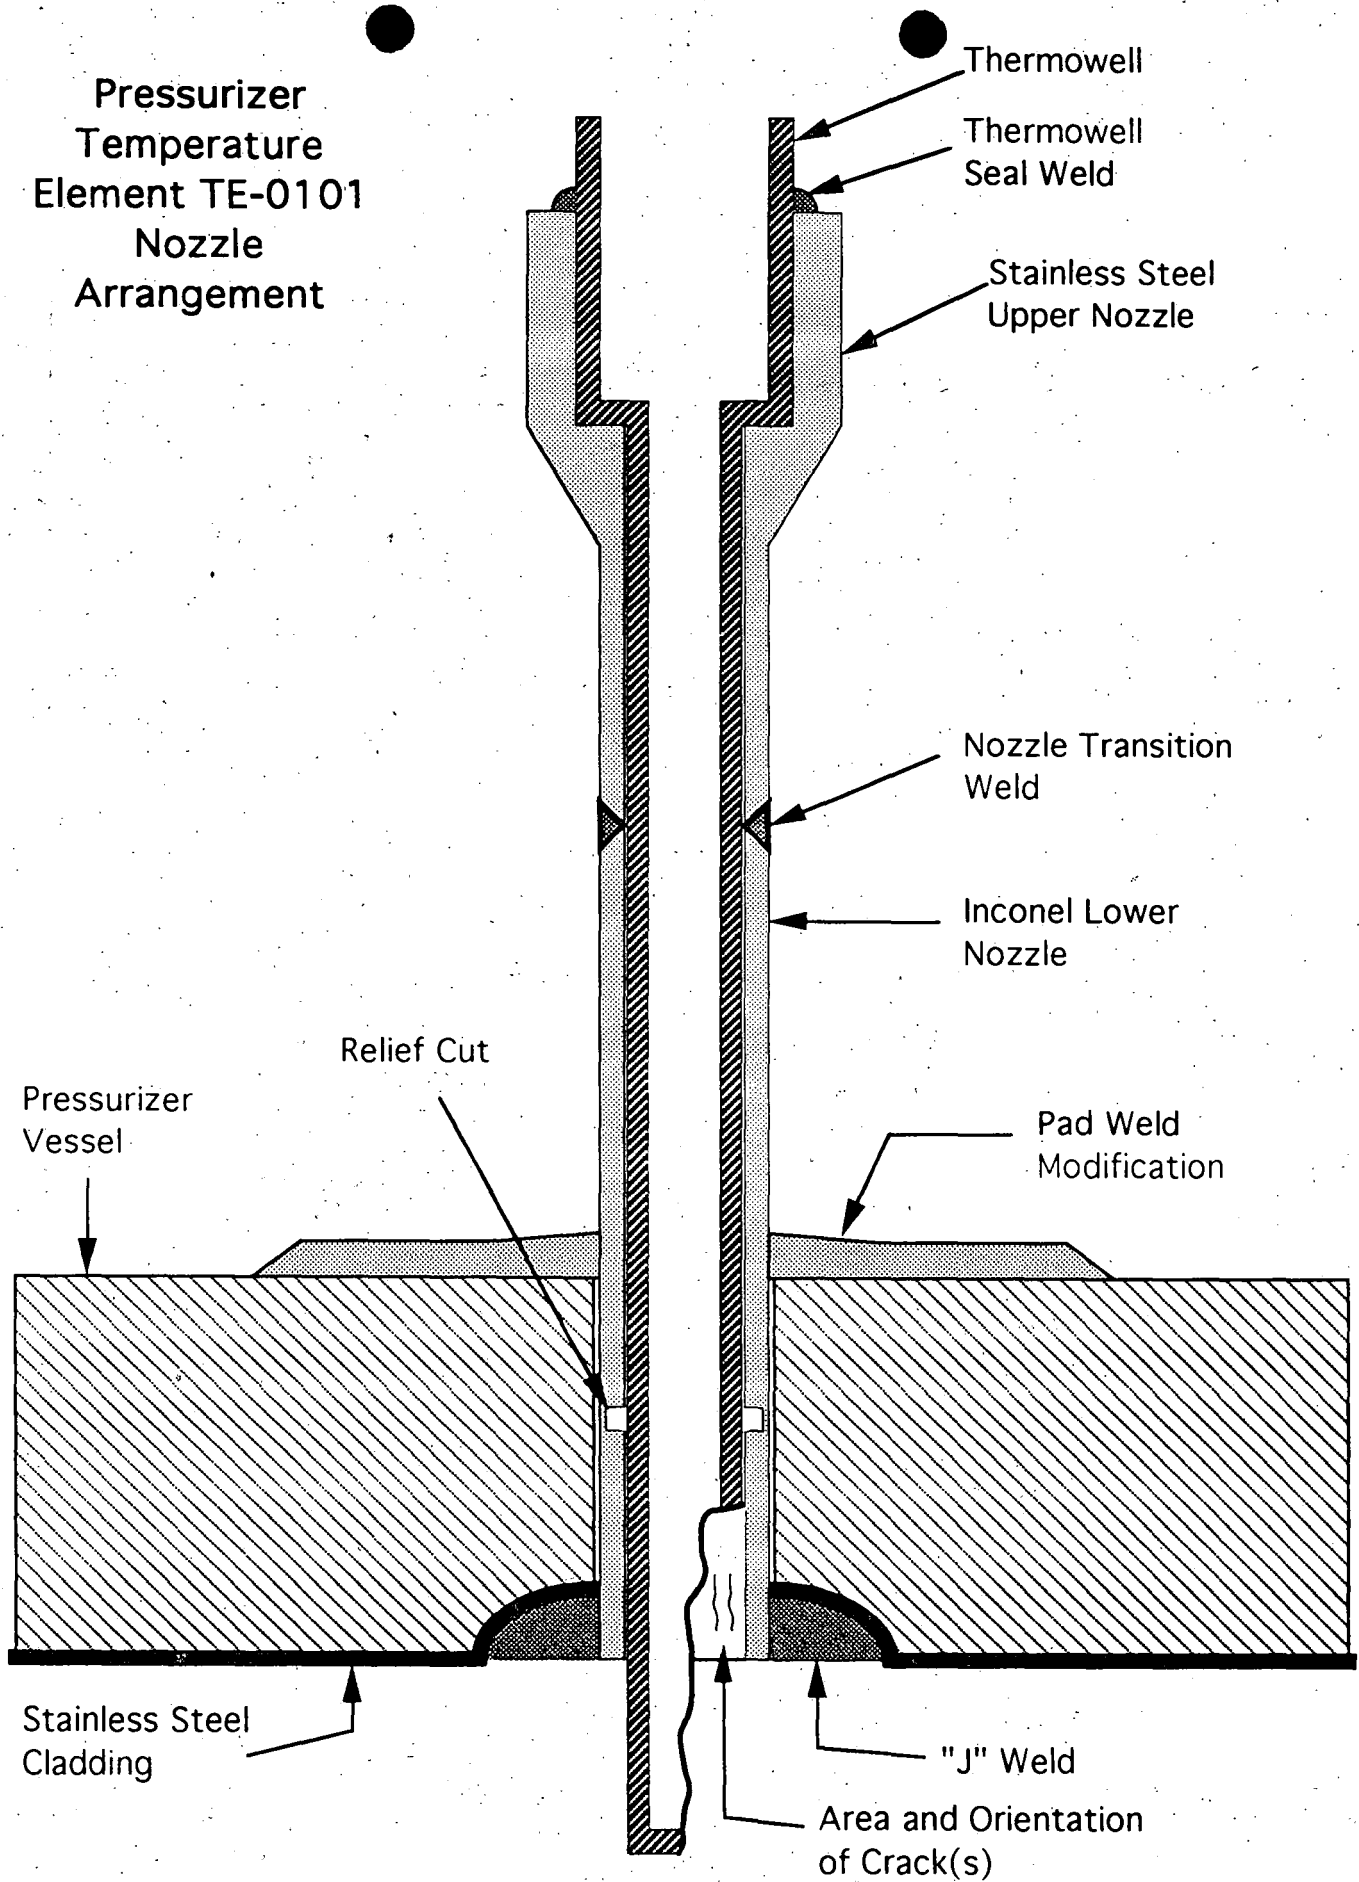
Figure 1

The cause of the nozzle cracking has been attributed to primary water stress corrosion cracking of the pressurizer temperature penetration Inconel 600 nozzle material. The cracking is similar in orientation and extent to the axial cracks that have been observed in pressurizer heater sleeves and instrument nozzles in several other nuclear power plants in this country and abroad. Similar cracking has occurred in heater sleeves and instrument nozzles in the Calvert Cliffs-2 pressurizer, as well as pressurizer instrument nozzles at San Onofre-3, St. Lucie-2, Arkansas Nuclear One-1 and several Electricite de France plants. All of these previous events have been associated with partial penetration welds (J-weld) similar to those used to attach the Palisades Inconel pressurizer temperature nozzles to the pressurizer shell.

Eddy current examination of temperature instrumentation nozzle TE-0101 indicated four axial cracks beginning near the structural "J weld" to the pressurizer and each extending a length of approximately one-half inch towards the outside of the pressurizer (see Figure 1). The four axial cracks were located about equidistant around the circumference of the nozzle. Similar cracks are suspected in instrument nozzle TE-0102, although these cracks were not confirmed by eddy current examination due to the difficulties and significant dose associated with performing an examination of this nozzle.

Pressurizer
Temperature
Element TE-0101
Nozzle
Arrangement

- Both upper and lower pressurizer temperature nozzles (TE-0101 and TE-0102) were repaired by installation of a weld pad on the outside of the pressurizer shell (see figures 1 and 2 for TE-0101 and TE-0102 respectively). The following NDE examinations were performed in conjunction with these repairs.

Prior to the repair, the external area of the pressurizer surrounding the temperature nozzle was MT (magnetic particle test) and UT (Ultrasonic Test) tested. Following the repair, the repair area was PT (Dye penetrant test) tested while the area of the pressurizer surrounding the repair was MT and UT tested. Since the temperature nozzle well was removed from TE-0101, the nozzle was eddy current tested before and after the repair process. Also, after the repair was complete and the well re-installed in the TE-0101 nozzle, the thermowell to nozzle seal weld was PT tested. All test results were acceptable.

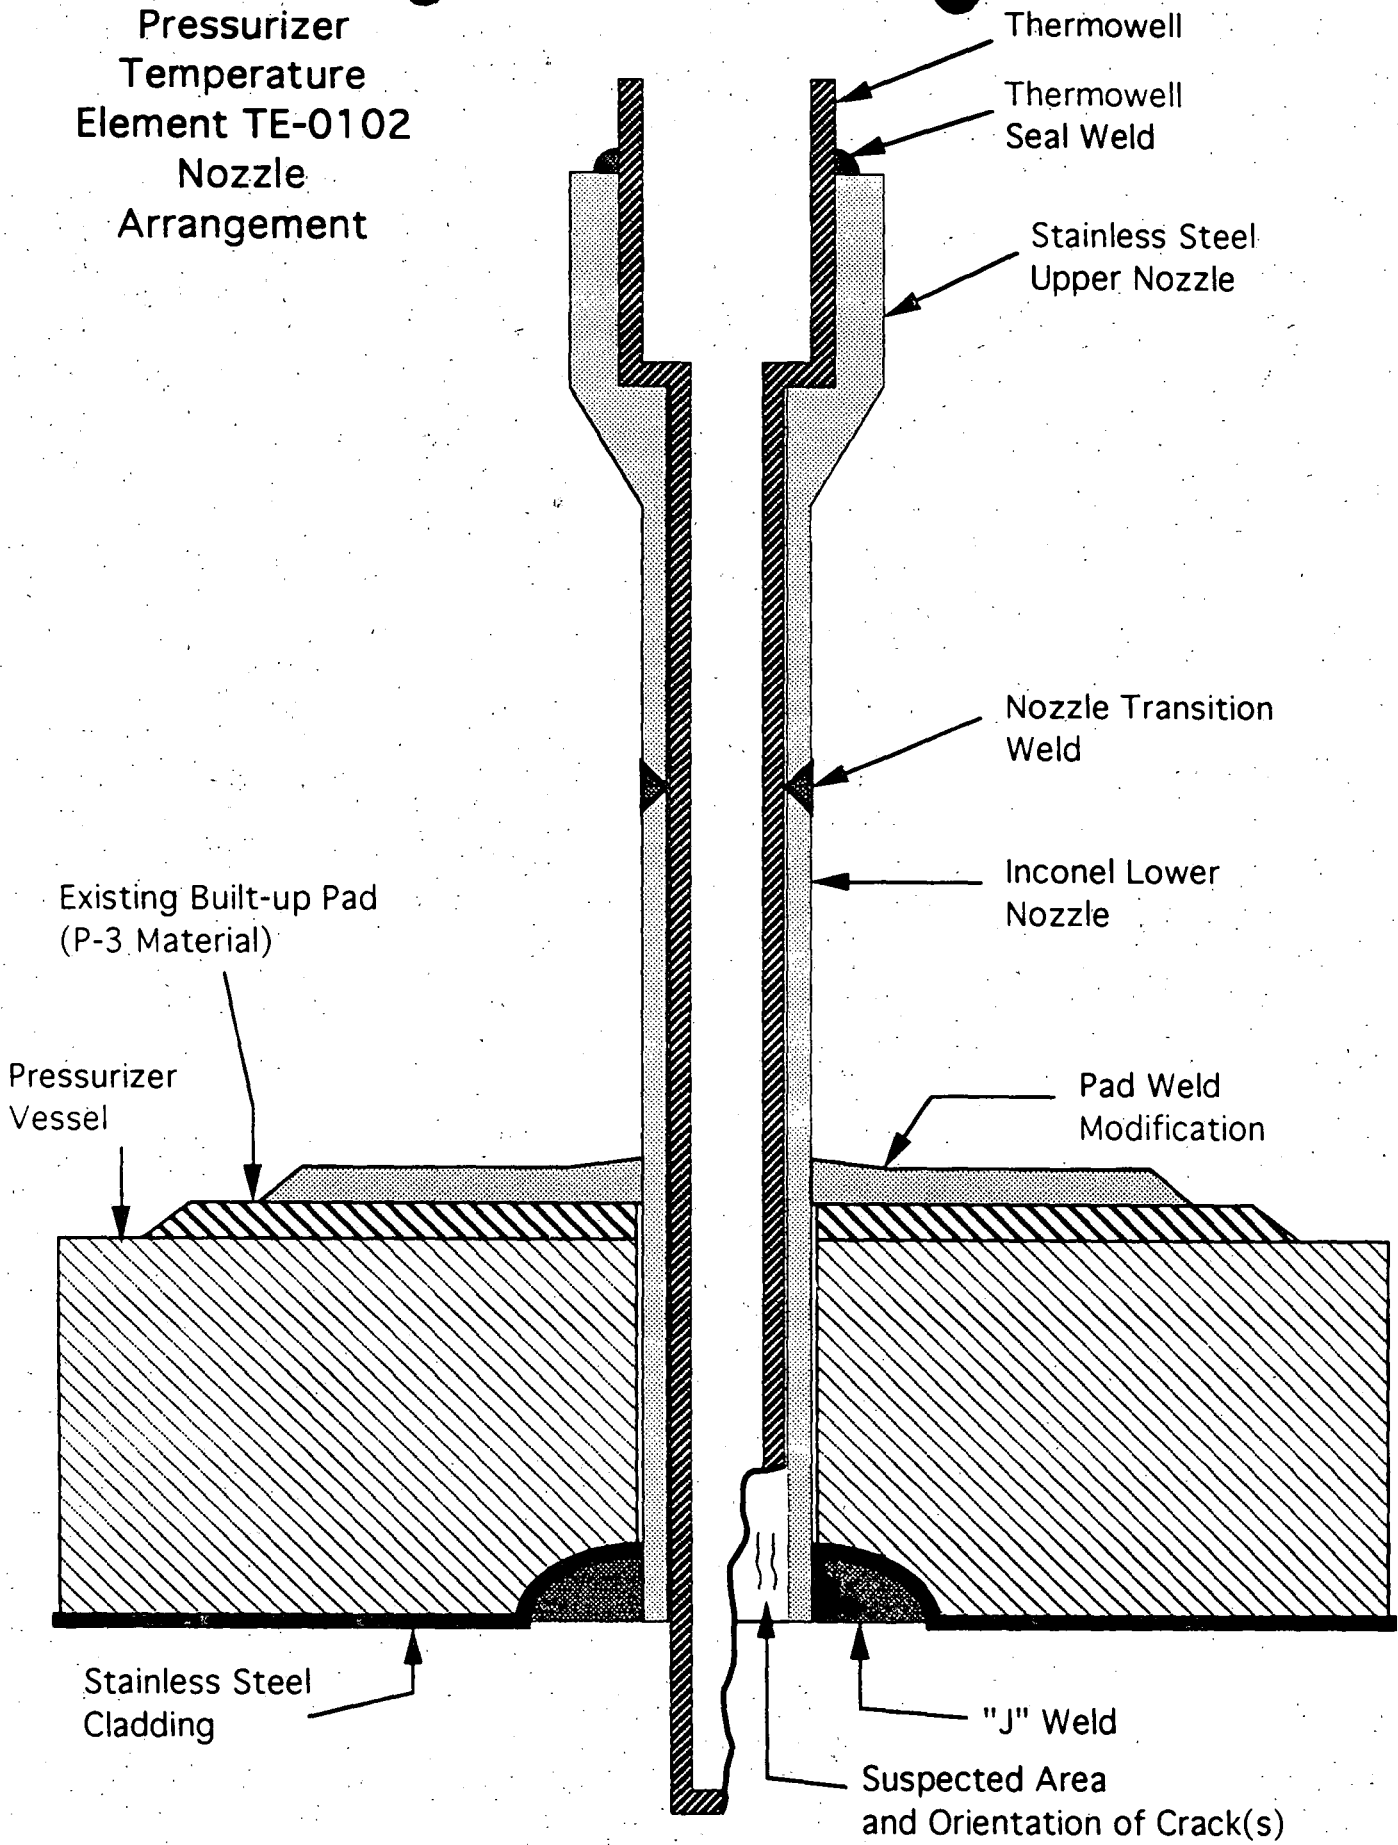
Figure 2

Pressurizer
Temperature
Element TE-0102
Nozzle
Arrangement
