LICENSEE EVENT REPORT (LER)

FACILITY NAME (1) Palisades Plant	DOCKET NUMBER (2) 0 5 0 0 0 2 5 5	PAGE (3) 1 OF 0 5
---	--	----------------------------

TITLE (4) **DEGRADATION OF BORAFLEX NEUTRON ABSORBER IN SURVEILLANCE COUPONS - SUPPLEMENTAL REPORT**

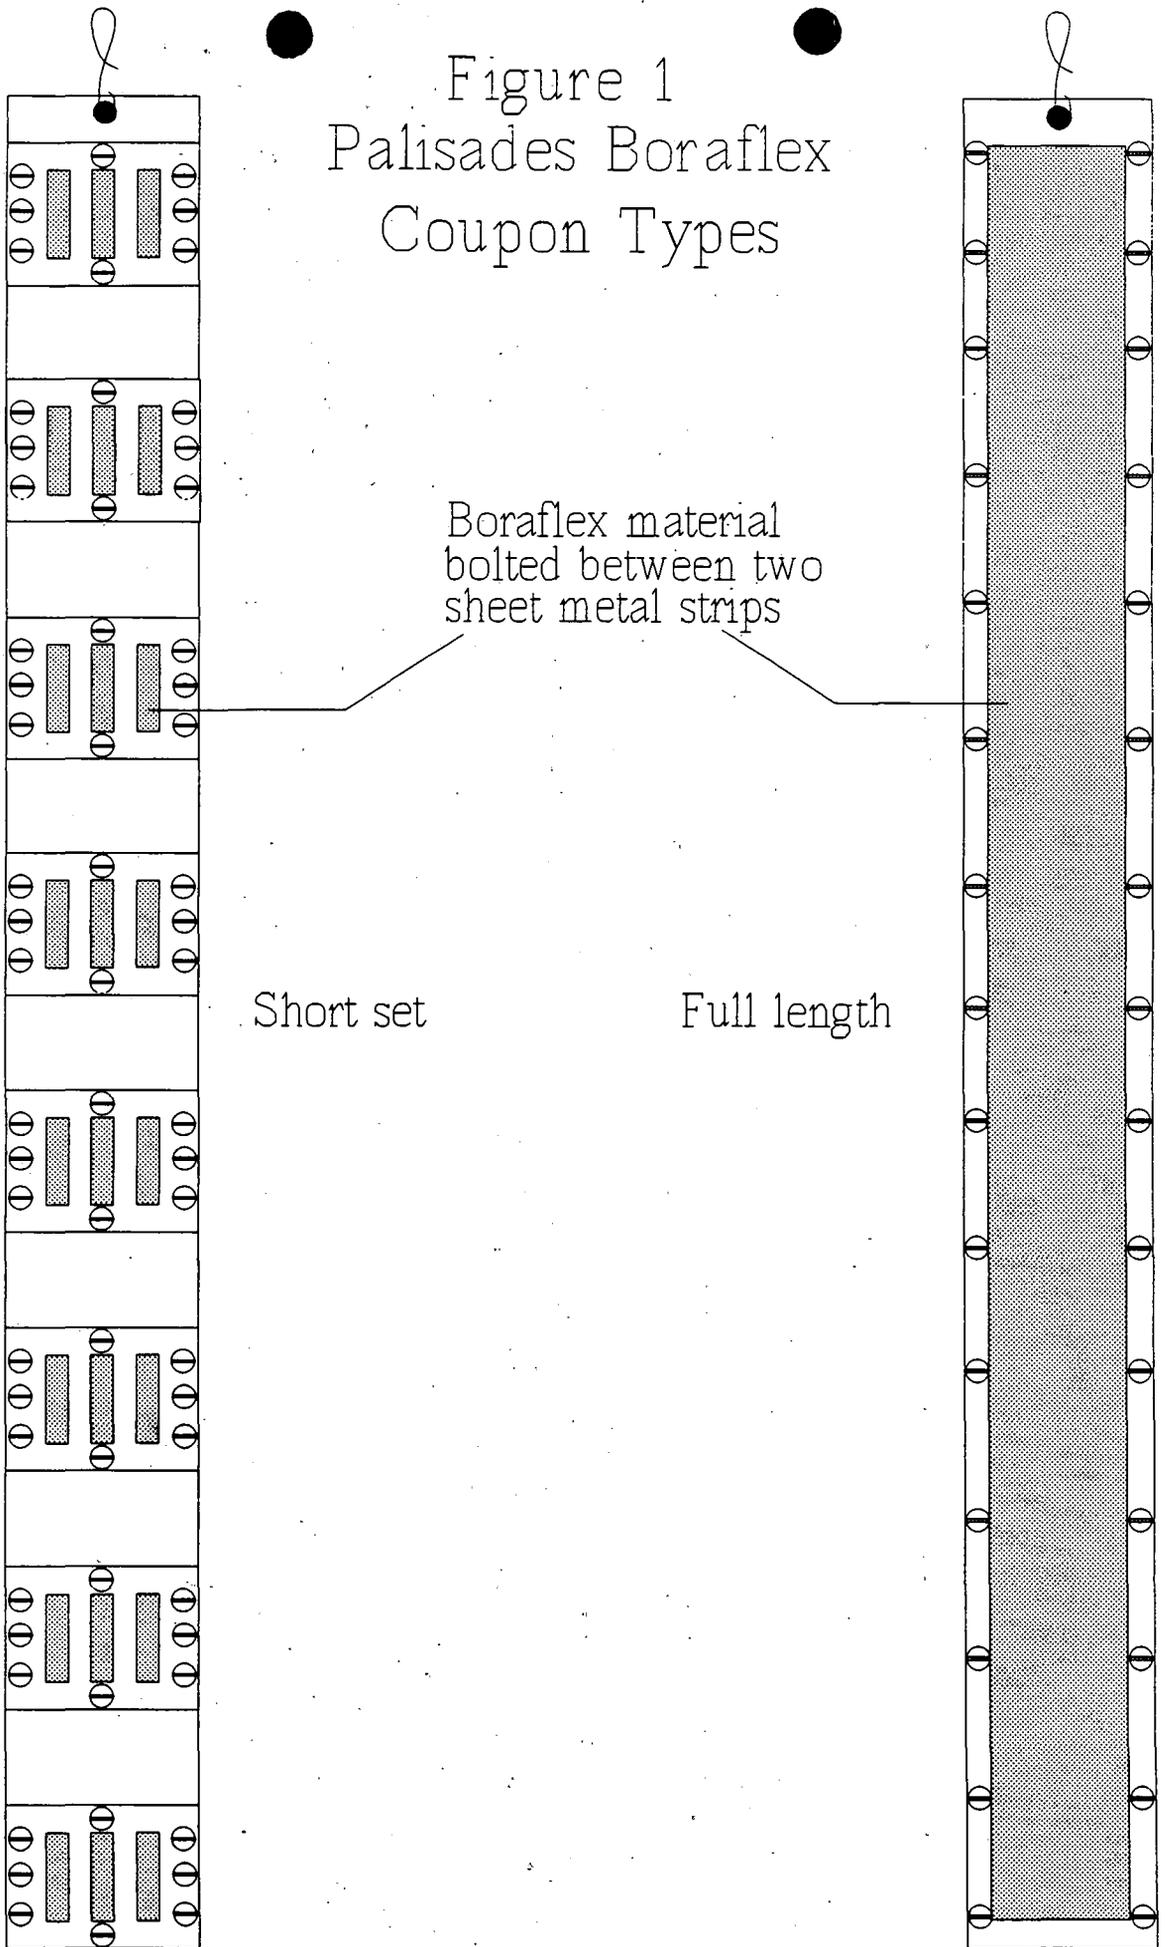
Figure 1
Palisades Boraflex
Coupon Types

There are two types of coupons at Palisades (refer to Figure 1): Full length coupons and short set coupons. Some full length coupons have the Boraflex bonded to one side of their sheet metal wrapper; in others, the Boraflex is not bonded. Four of the five coupons removed for testing were full length coupons and the other was a short set coupon. Three of the full length coupons had Boraflex bonded to the sheet metal. Material lost from the full length coupons varied from 38 percent to an estimated 90 percent. All of the Boraflex material in the short set coupon was retained. The Boraflex material in the full set coupons was from a different batch of material than that used in the short set coupons.

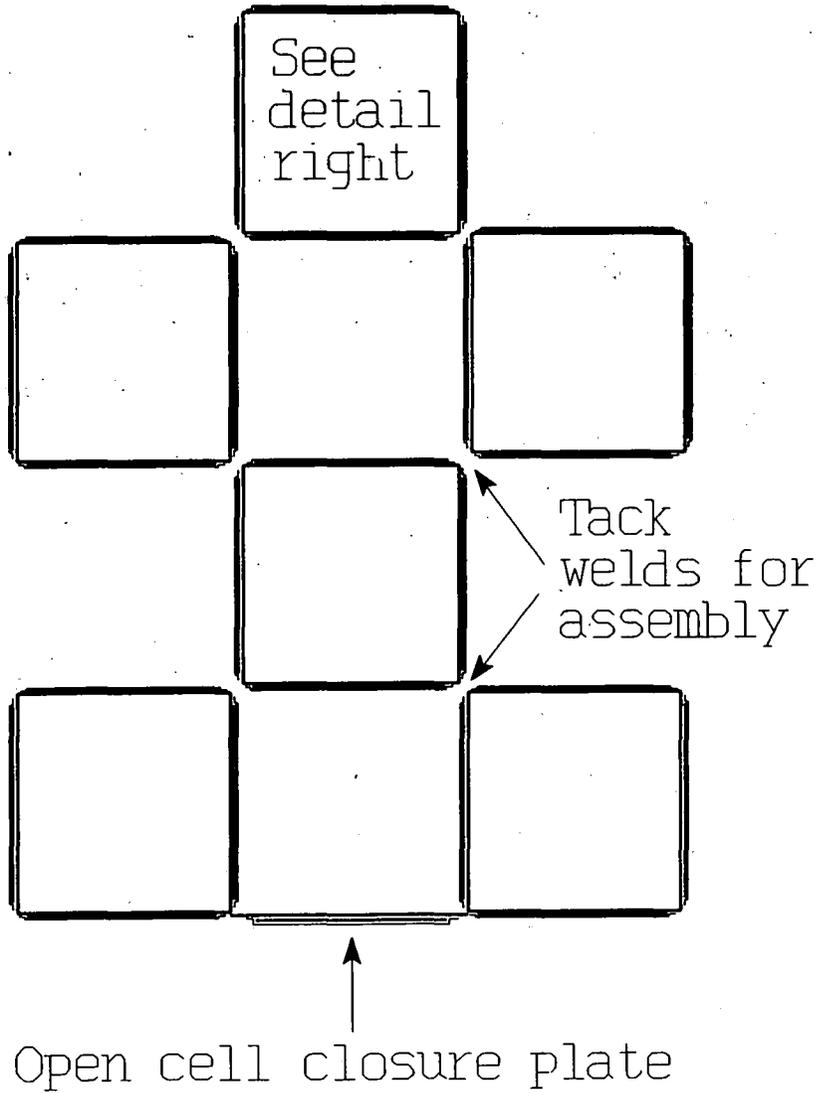
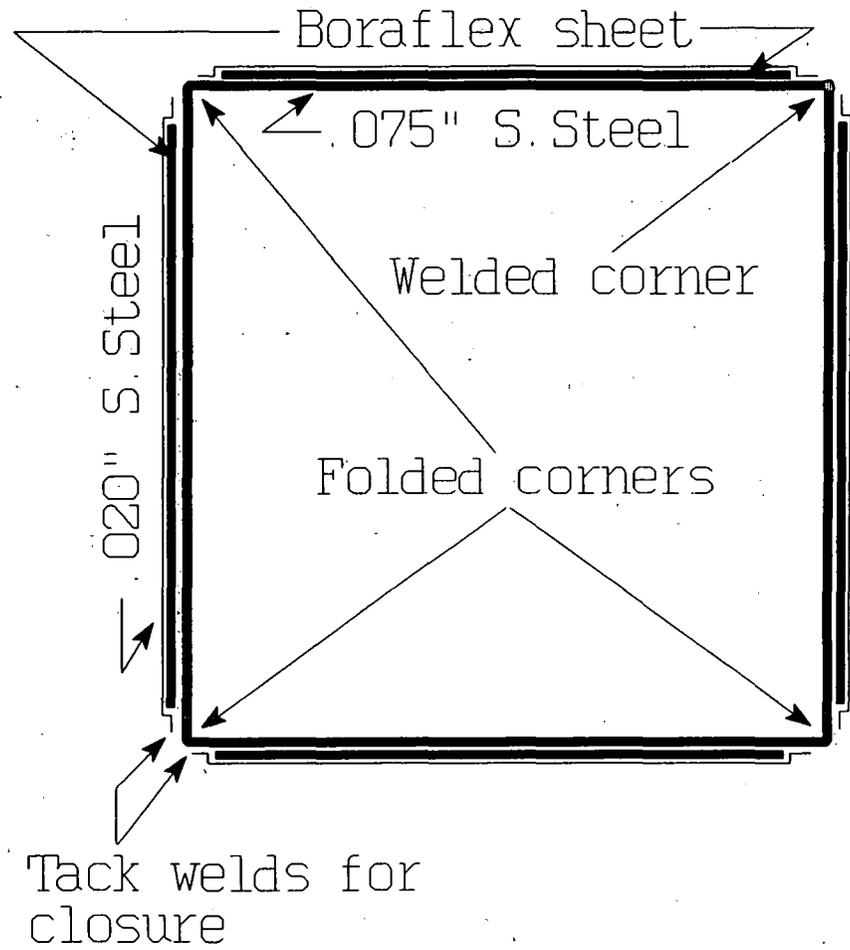
Figure 3 Rack construction

Mechanical construction differences do exist between the SFP racks and the surveillance coupons. The racks were constructed by folding a 75 mil thick, 36" wide and approximately 146" long sheet of stainless steel into a 9" square box. The resulting seam was then welded. To each side of this box, a sheet of Boraflex™ was laid. Over this sheet, a 20 mil thick, 8" wide and approximately 146" long sheet of stainless steel, stamped to form a 42 mil recess approximately the width and length of the Boraflex™ sheet, was laid and then tack welded in place along the sides. Spots of RTV were used to hold the Boraflex™ in place during this process. This was repeated for each of the four sides of the box. Series of these boxes were then arranged in a checkerboard fashion and welded again at the corners to form a rack. Open cells at the periphery were closed by a single sheet of 75 mil stainless steel with a Boraflex™ sheet enclosed in a similar manner (Refer to Figure 3).

Full length coupon construction is similar, however, two sheets of 20 mil stainless steel were utilized for closure. As well, the seams were closed via bolting. At the time of coupon construction, it was believed that this would approximate the rack conditions while allowing for inspection of the Boraflex™ without the use of destructive opening methods. The short sets were likewise fabricated except that only one full length sheet of stainless steel was utilized. The groupings of three coupon strips were enclosed by a second 20 mil thick stainless steel sheet approximately 8" square. Each of these squares was bolted down using 8 fasteners. This is significant in that it appears, from visual inspections, as though a water-tight seal was formed around the short set coupon.

During removal of the full length coupons, a cloudy material was seen flowing from the sides and bottom of the coupon. This suggests that water was able to pass through the seams of the coupons. The composition of irradiated Boraflex™ does reduce to mainly silica and boron carbide with time, silica being the primary binding agent as most of the polymer deteriorates. This water exchange through the coupon interior could easily carry away varying amounts of silica, depending on the rate of water exchange. Once the binding agents have been reduced, rapid degradation of the structure of the Boraflex™ logically follows. This is a possibility agreed upon by experts in the industry.

Due to the construction differences, the full length coupons are far more flimsy than the SFP racks. A rigid base is simply not afforded. This likely resulted in more "open" seams on the full length coupons, allowing for a higher than normal water exchange rate. This cannot be conclusively shown, however, until a determination of the actual rack Boraflex™ condition is made. For this, blackness testing is required.

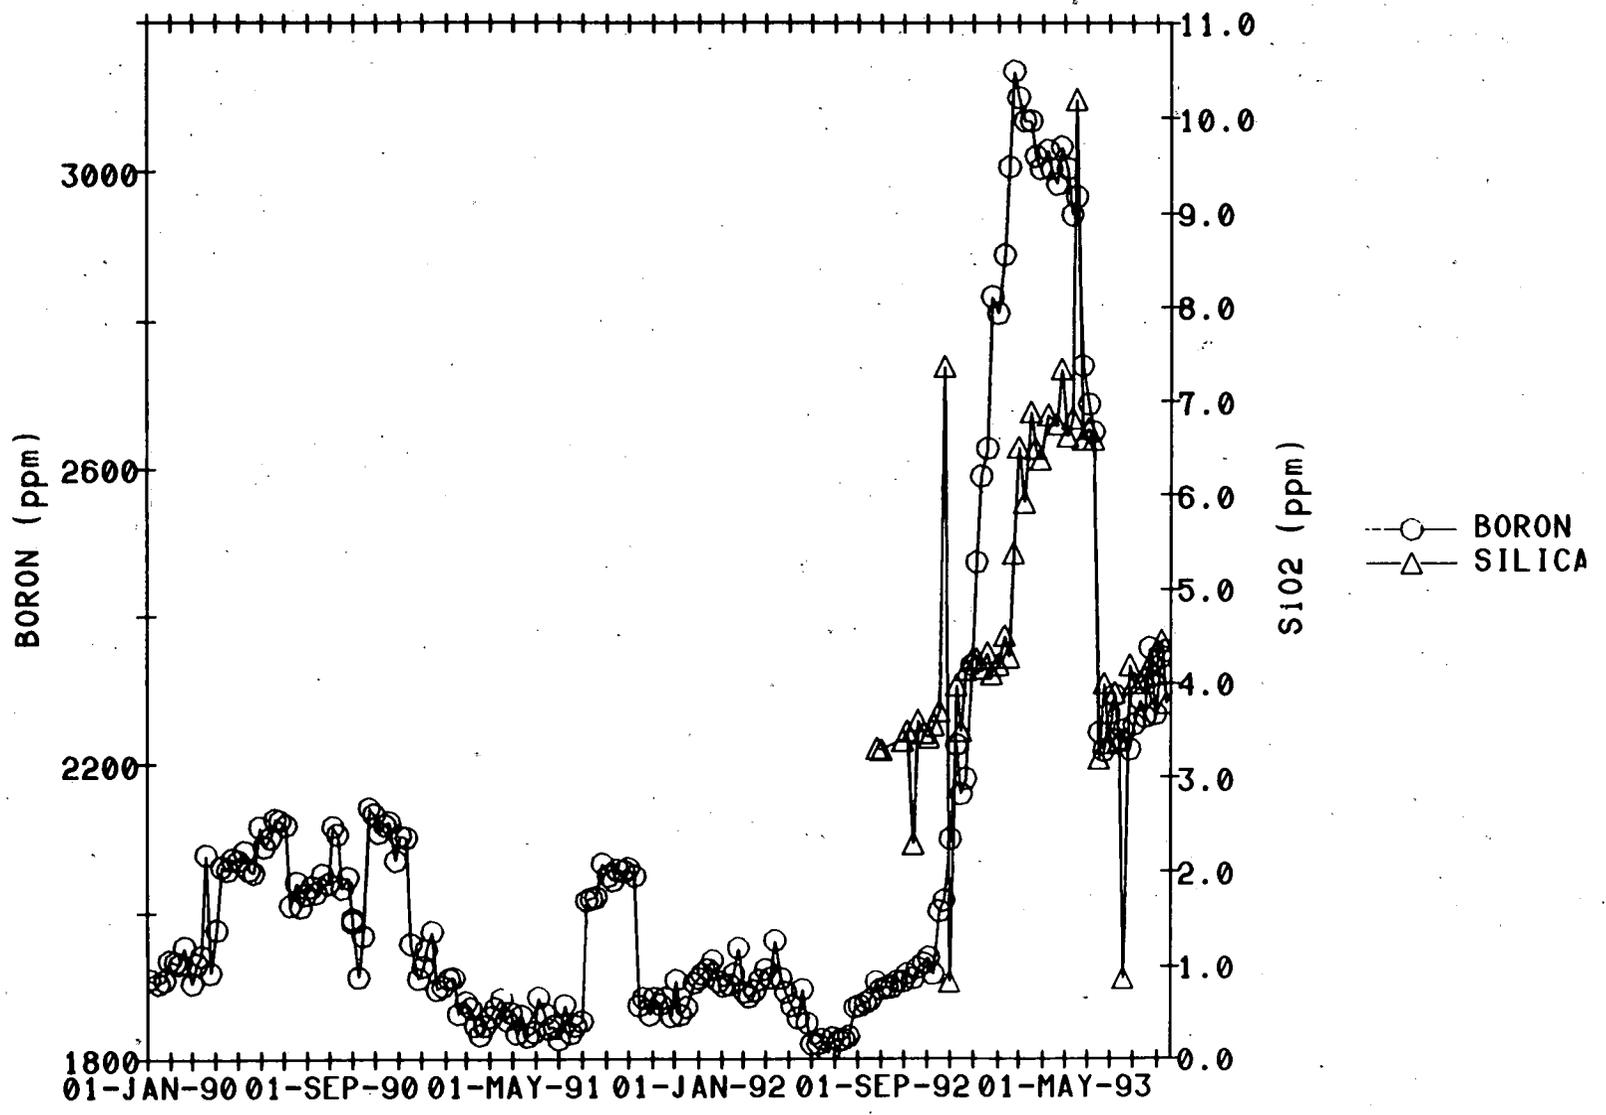
SFP BORON AND SILICA

These factors were discussed with Boraflex™ experts within the industry. The SFP pH typically ranges from approximately 4.8 to 5.2. Occasional spikes to near 7.0 have occurred. Due to MSB loading activities, SFP boron levels have been relatively high, in the range of 2900 ppm, at times. Lastly, one inadvertent hydrazine addition to the SFP did occur, albeit some time ago. None of these factors were considered to have a significant, adverse impact on the condition of Boraflex™.
