EXAMINATION OF SECTIONS OF THE PRESSURIZER PORV
LINE SAFE-END FAILURE FROM THE
PALISADES NUCLEAR GENERATING STATION

TR-MCC-306

OCTOBER 1993

METALLURGICAL EXAMINATION REPORT - NON-PROPRIETARY
EXAMINATION OF SECTIONS OF THE PRESSURIZER PORV
LINE SAFE-END FAILURE
FROM THE PALISADES NUCLEAR GENERATING STATION
(TAC No. 87760)

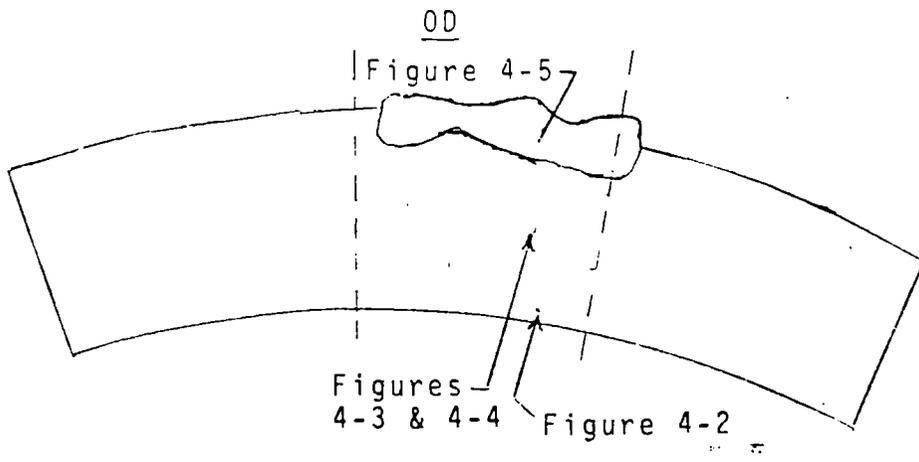
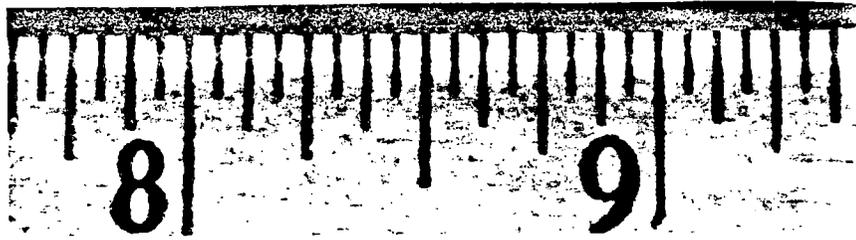
A portion of the Inconel 600 half of the safe-end fracture, shown in Figure 4-1 was sent to ABB/CE for characterization. The fracture surface had been replicated and some of the replicating material remained on the surface. The sample was cleaned in an ultrasonic bath of acetone to remove the replicating material so that it wouldn't charge up in the SEM. By cutting axially in 2 locations the sample was divided into essentially 3 equal size pieces. A sketch is provided in Figure 4-1 detailing the sectioning scheme. A photo-montage was recorded for each third of the fracture surface. Single SEM views along with EDS results were obtained on several locations on the center piece of the fracture. The locations of the micrographs and EDS spectra are shown on the sketch in Figure 4-1 and the results for the identified locations are shown in Figures 4-2 through 4-5 respectively.

Figure 4-1. Inconel 600 Half of Safe-End Fracture.

The as-received fracture surface exhibited a light brown color and was very obviously an intergranular crack as evidenced by the large grains (rated as ASTM 00). By the nature of the submitted sample ABB/CE can not make any statements as to the origin of the crack (ID vs OD). Based on the crack length at the ID and OD Palisades has concluded that the failure was PWSCC.

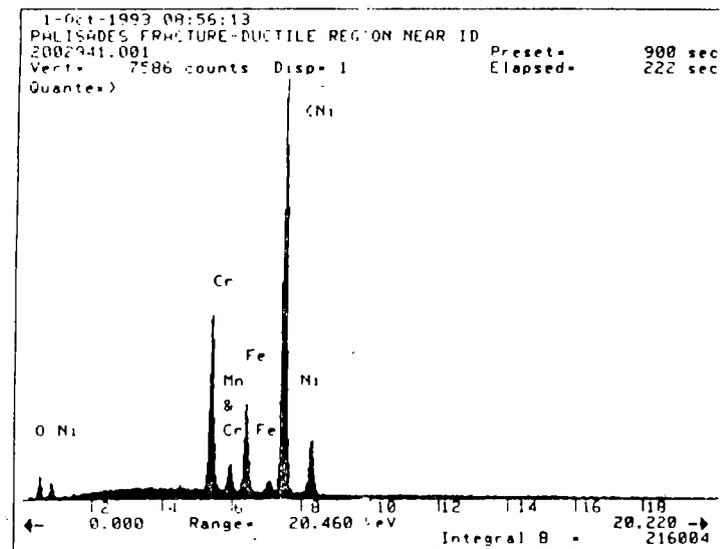
Figure 4-2 shows a region on the fracture surface near the inner wall of the pipe. At lower magnification (about 10X) this region was unusual in that it had the appearance of a ductile fracture, but upon closer examination it does not have ductile dimpling typical of ductile tearing. The appearance of the grains are unusual and do not clearly resemble any one known fracture of Alloy 600. Their appearance suggests intergranular fracture followed by abrasion of some sort which rounded off the sharp edges of the "rock candy" shaped fracture grains. EDS analysis of this region shows a typical Alloy 600 spectra.

Figure 4-2. Fracture Surface Near ID and EDS Spectra.

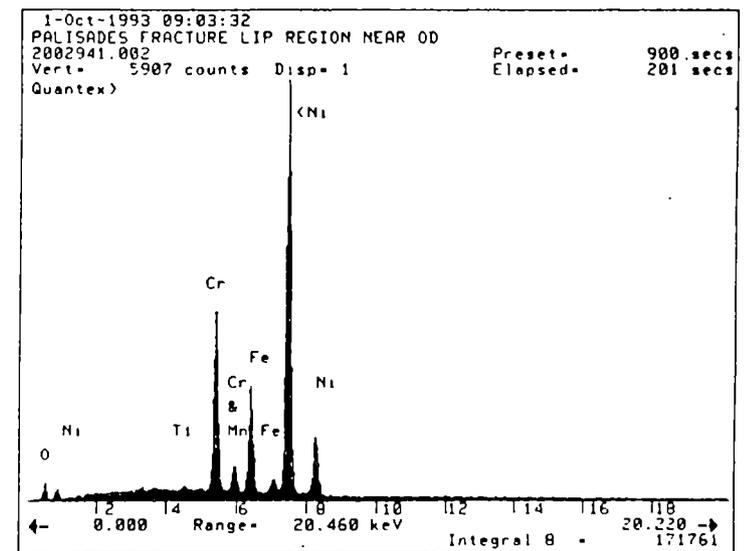
Figure 4-5 shows a region near the OD which was out of the fracture plane and did not appear as an intergranular fracture. This region may represent a portion of the crack that extended into the weld, although the EDS spectra shown in Figure 4-5 closely resembles that of Alloy 600.

Figure 4-5. Fracture Lip Region Near OD.

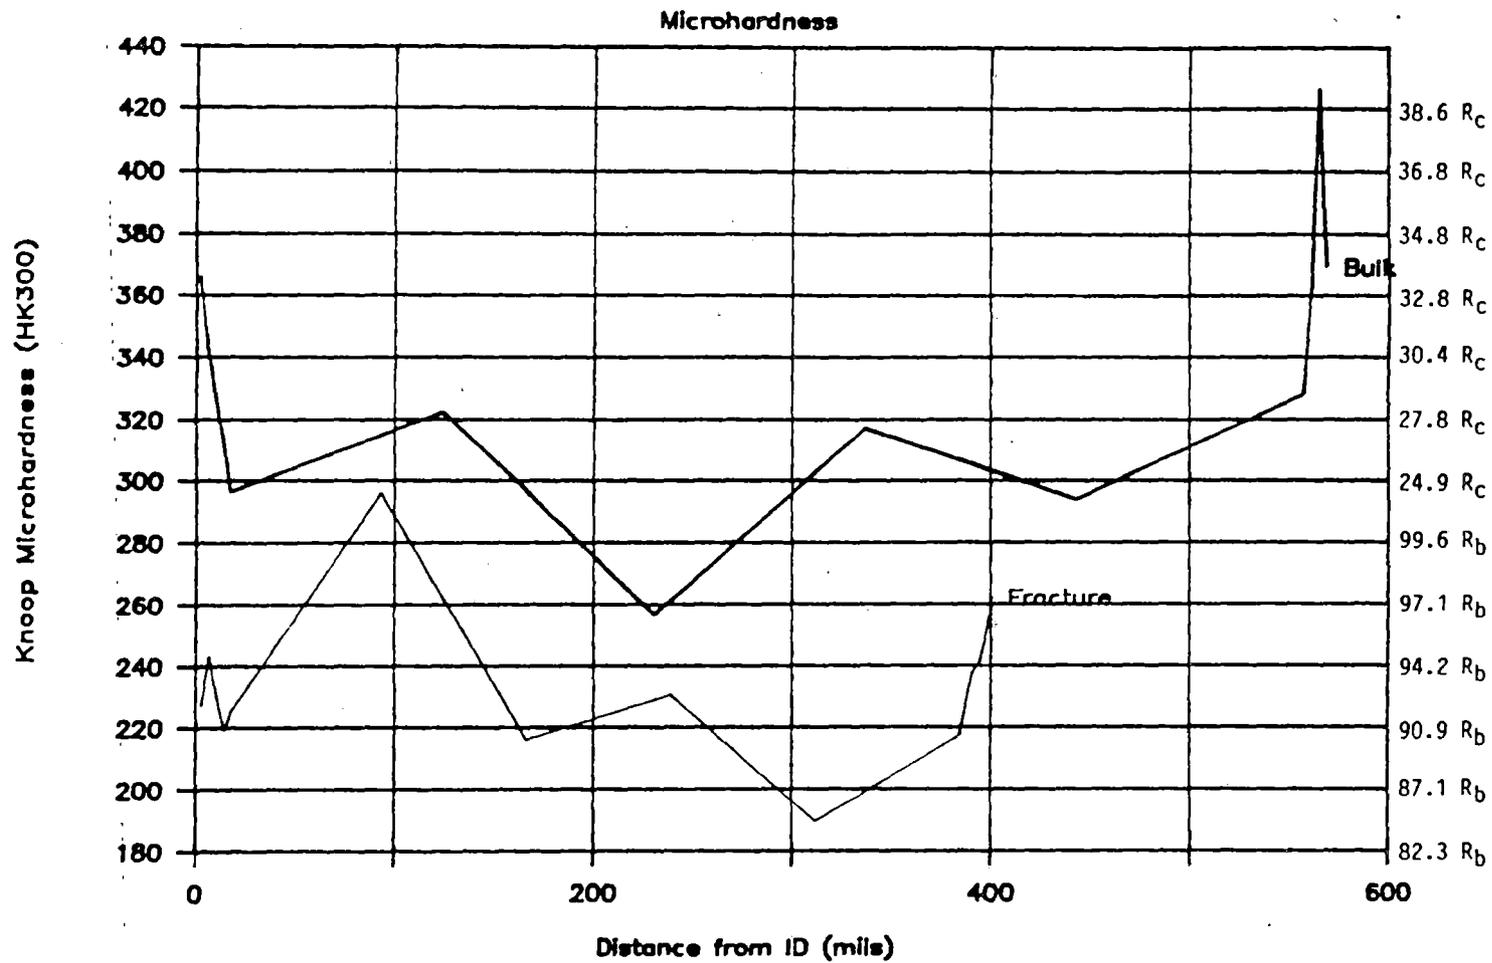
A longitudinal section near the midline of the center section of the fracture sample was prepared and Knoop microhardness transverses were taken in the HAZ and base metal regions across the thickness of the sample from ID to OD. Indentations were made on a Shimadzu Type M78328 microhardness tester, using a Knoop indenter, under a 300 grain load for 15 seconds. Indentations were measured at a magnification of 400X in microns, and converted to HK_{300} in accordance with ASTM E384. The results of these traverses are shown in Figure 4-6. The base metal traverse was made about 1/2 inch from the fracture. Readings in the HAZ were taken as close to the fracture as deemed feasible, ie., about 5 to 10 mils away. There is a great deal of variability in the microhardness across the nozzle wall, however the general trends show that the microhardness near the HAZ was less than that of the bulk alloy. The microhardness values are very high, especially near the periphery of the bulk metal. Pressurizer instrumentation nozzles made of SB-166 forged bar stock from Calvert Cliffs 2 had a bulk metal microhardness of about 175 HK_{300} and about 210 HK_{300} near its cracks. A rough correlation of material strength and hardness would suggest that the bulk metal has an ultimate strength of 135 KSI (at 300 HK_{300}) and 105 KSI (at 230 HK_{300}) near the HAZ. The yield strength of the material is not related to the microhardness, since the diamond indenter penetrates and plasticly deforms the metal. The ultimate strength of the material as listed in the original material certification report was 114 KSI.

Figure 4-6. Plot of Microhardness Results from HAZ and Base Metal.

The microhardness surveys were useful in documenting the softening that occurred in the HAZ. This is important because the crack initiated and propagated in the HAZ and not the harder base metal characterized by the 77.5 KSI yield strength on the CMTR. The resulting circumferential crack associated with the butt weld is dramatically different than in previously examined partial penetration welds of nozzles that exhibit axial cracking in the base metal and typically not in close proximity to the weld. The high values of hardness in the base metal surfaces, particularly the OD, could be

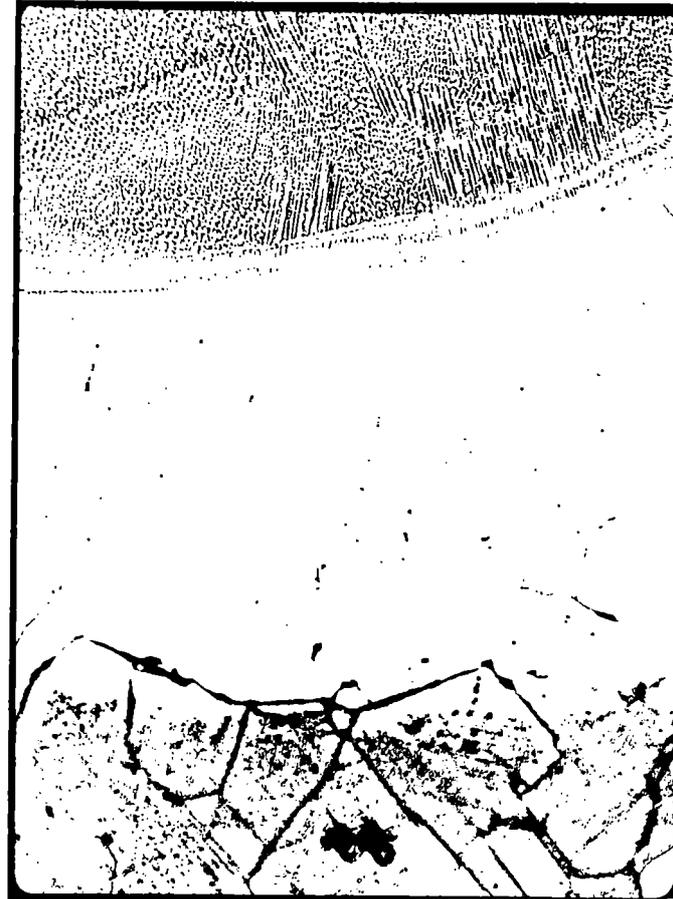
These photomicrographs show good correspondence between carbides and grain boundaries. The grains are very large, mostly ASTM size 00. The orthophosphoric acid etch photomicrograph shown in Figure 4-12 clearly shows the HAZ, a region having absolutely no intragranular indications. The HAZ is about 30 mils wide. The orthophosphoric acid etch revealed indications that appeared to line up in three directions. These are not carbides but rather are etch pits due to stress relaxation. The structure is similar to that of a failed SONGS-3 pressurizer nozzle, having large grains and numerous intergranular carbides.

Figure 4-12. Dual Etch Metallography on HAZ near OD.

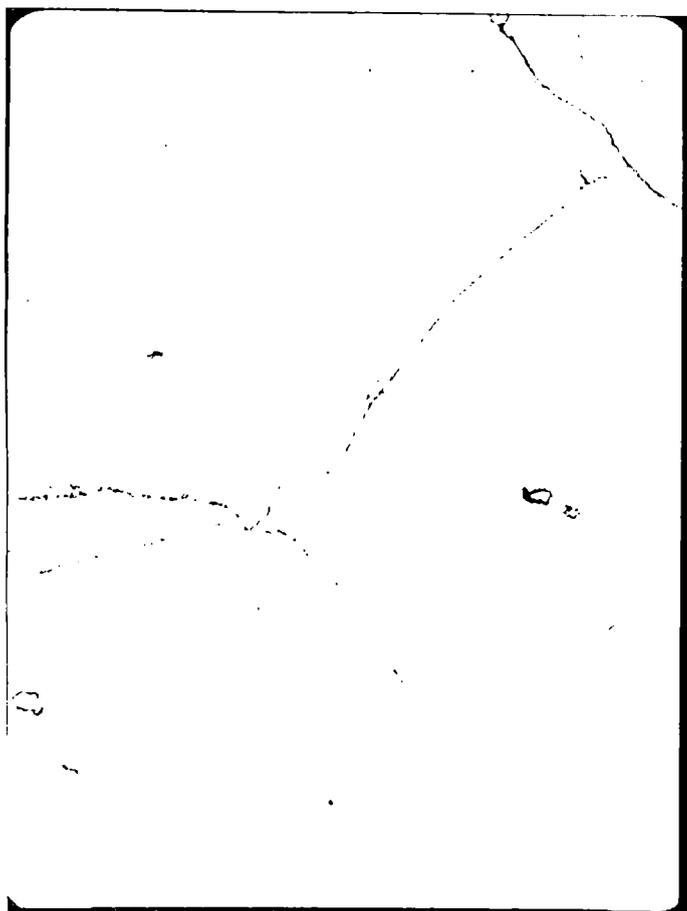
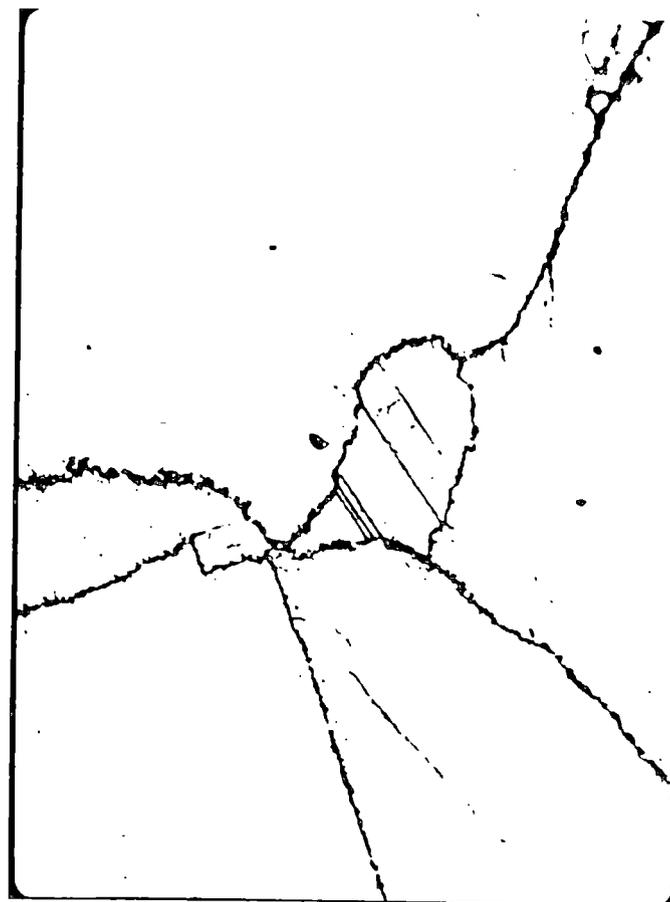
An attempt was made to resolve the grain boundary particles employing higher magnification and the H_3PO_4 etch. The results are shown in Figures 4-13 and 4-14 for the base metal and HAZ respectively. In both cases the carbides are extremely fine.

Figure 4-13. High Magnification Micrograph of Base Metal Boundary Carbides H_3PO_4 Etch.

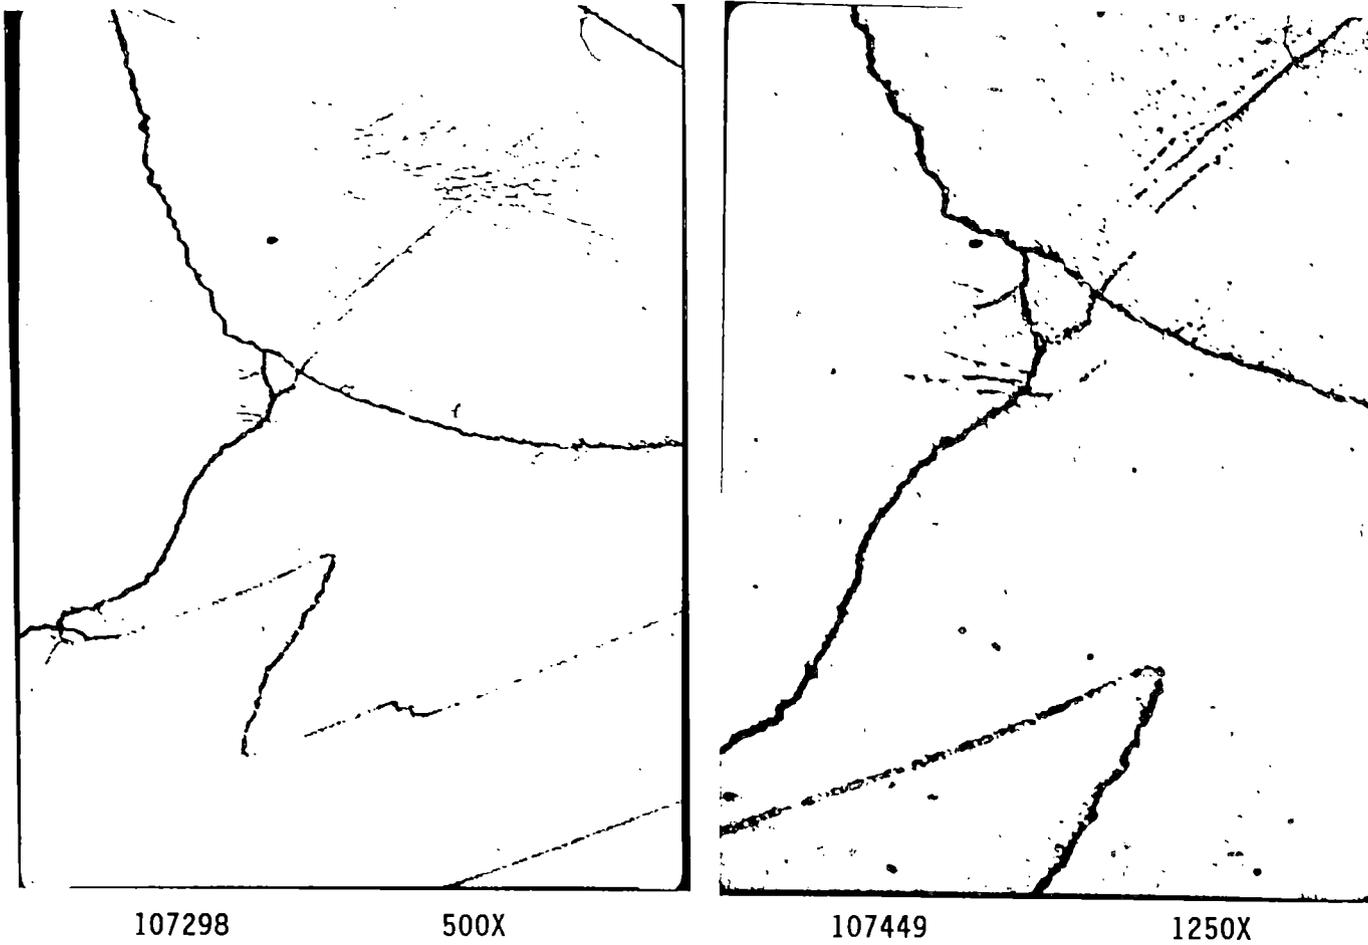
Figure 4-14. High Magnification Micrograph of HAZ Boundary Carbides H_3PO_4 Etch.

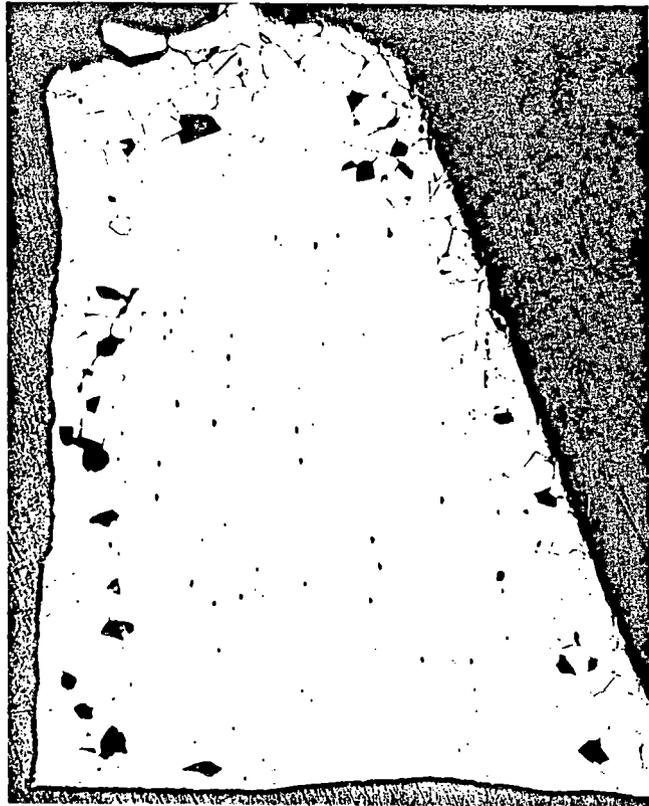
A section from the center third of the overall fracture sample was modified Huey tested, mounted, polished and etched in Glycerigia to assess the degree of attack. The micrograph in Figure 4-15 shows the attack to be fairly equal on the ID and OD surfaces but slightly deeper at the fracture surface. The Modified Huey test is a 25% boiling HNO_3 acid exposure for a period of 48 hours.

Figure 4-15. Polished and Etched Section of Modified Huey Test Sample.

Based on the attack shown in Figure 4-15 it appears that some degree of sensitization is present in the safe-end.

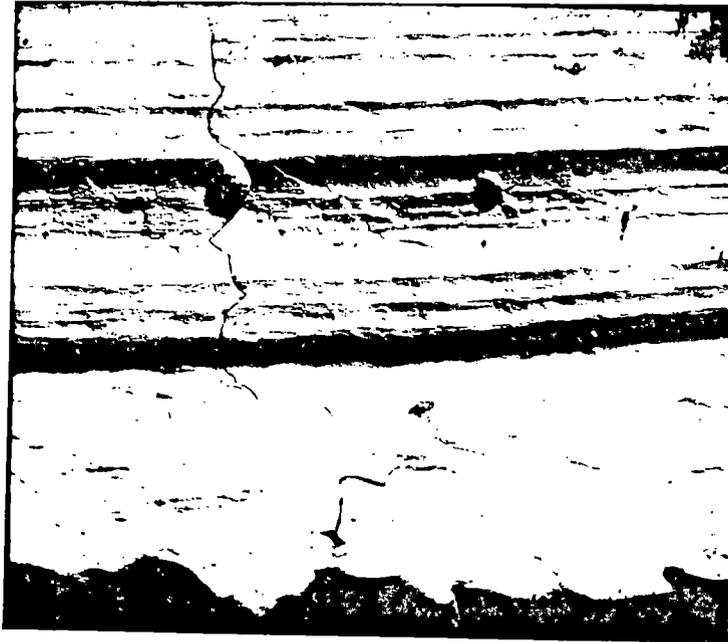
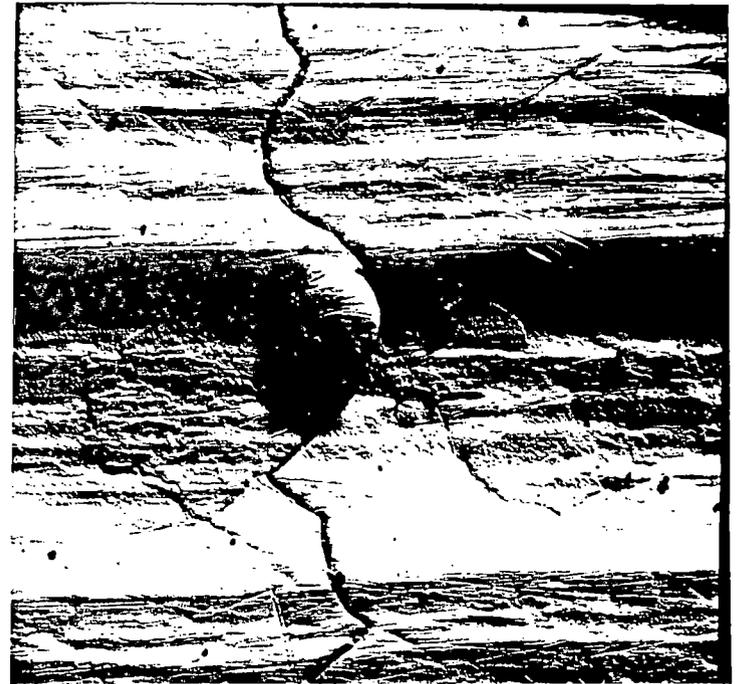
An axial intergranular crack was observed on the ID surface during the SEM

examination of the fracture surface. This crack was observed running from the fracture surface into the Inconel base metal and is shown in Figure 4-16. These SEM micrographs also show a closeup of a narrow circumferential groove on the inner surface. This groove also has a spherical droplet of weld metal on it. EDS analysis of this material showed that it had the same composition as the original I-82 weld material. The axial crack seems to be unrelated to the groove or the droplet. This crack was examined in metallographic mounts and was found to be 0.065" long (radial view) and 0.085" into the wall dimension (axial view as shown in Figure 4-17).

Figure 4-16. ID Surface Axial Crack.

As pointed out in Section 4.5 a secondary crack, axial in nature, was observed to be present on the ID surface. Metallographic measurements indicated 20% penetration into the wall dimension of the safe-end.

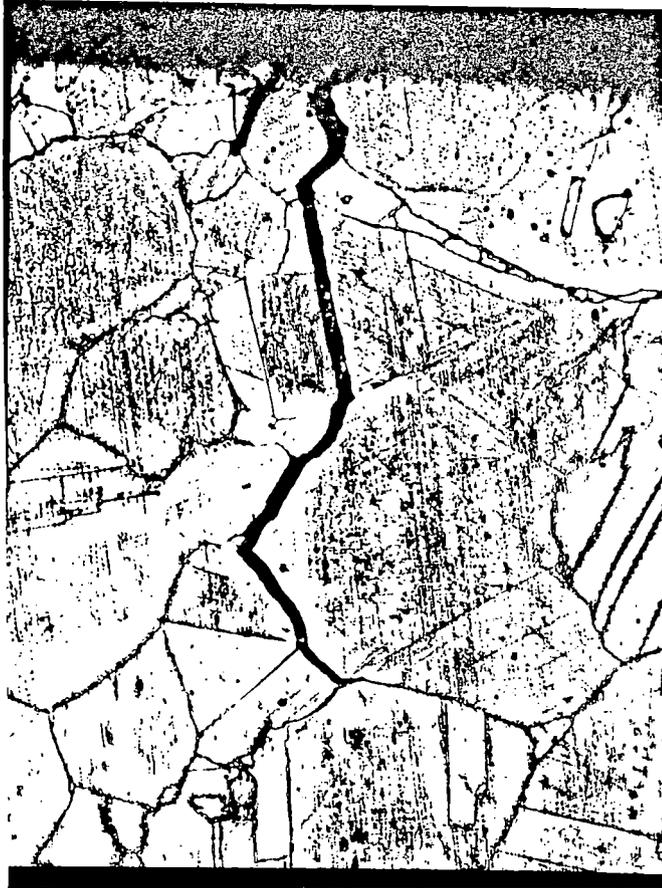
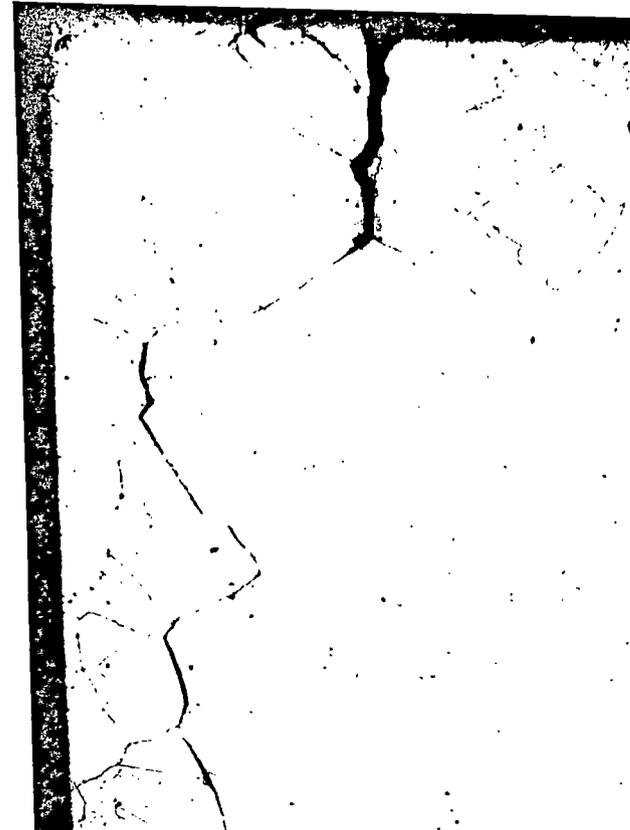
Figure 4-17. View of ID Surface Axial Crack.

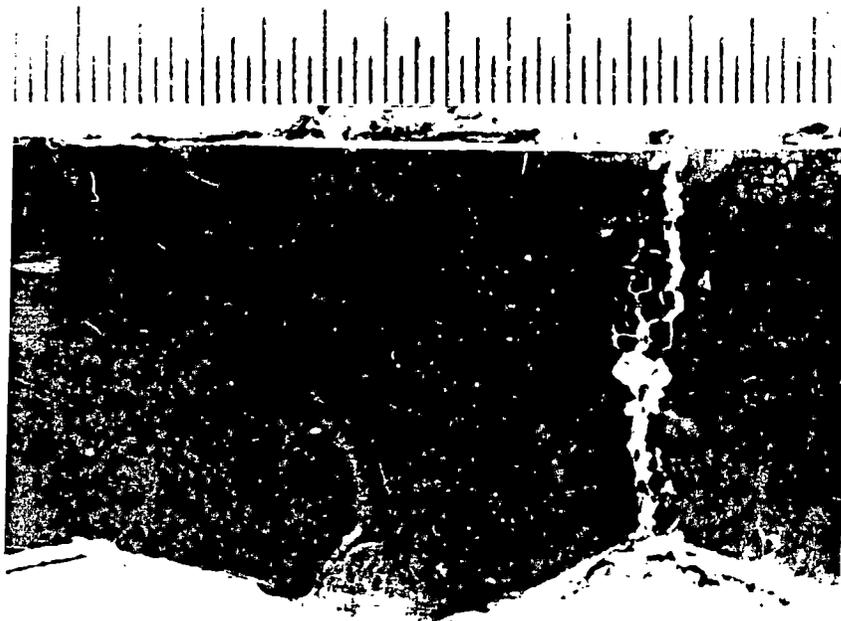
A metallographic mount identified as #3 was sent to ABB/CE for examination. The section includes what appears to be an ID repair weld. A low magnification SEM view of the repair weld is shown in Figure 5-1. EDS spectra were recorded in areas as noted on the micrograph in Figure 5-1. These spectra are shown in Figures 5-2 through 5-6 respectively. Table 5-1 summarizes the major elements in each of these EDS spectra. Table 5-1 shows that the repair weld has a composition between that of the original weld and the stainless steel. This difference in composition explains why this weld region etched differently than the other material.

Figure 5-1. Micrographs of Mount #3 Showing Repair Weld Region.
