LICENSEE EVENT REPORT (LER)

FACILITY NAME (1) Palisades Plant	DOCKET NUMBER (2) 0 5 0 0 0 2 5 5	PAGE (3) 1 OF 0 5
---------------------------------------------	----------------------------------------------------	----------------------------

TITLE (4) LICENSEE EVENT REPORT 95-004 - REDUNDANT DIESEL GENERATOR CIRCUITS NOT SEPARATED PER APPENDIX R

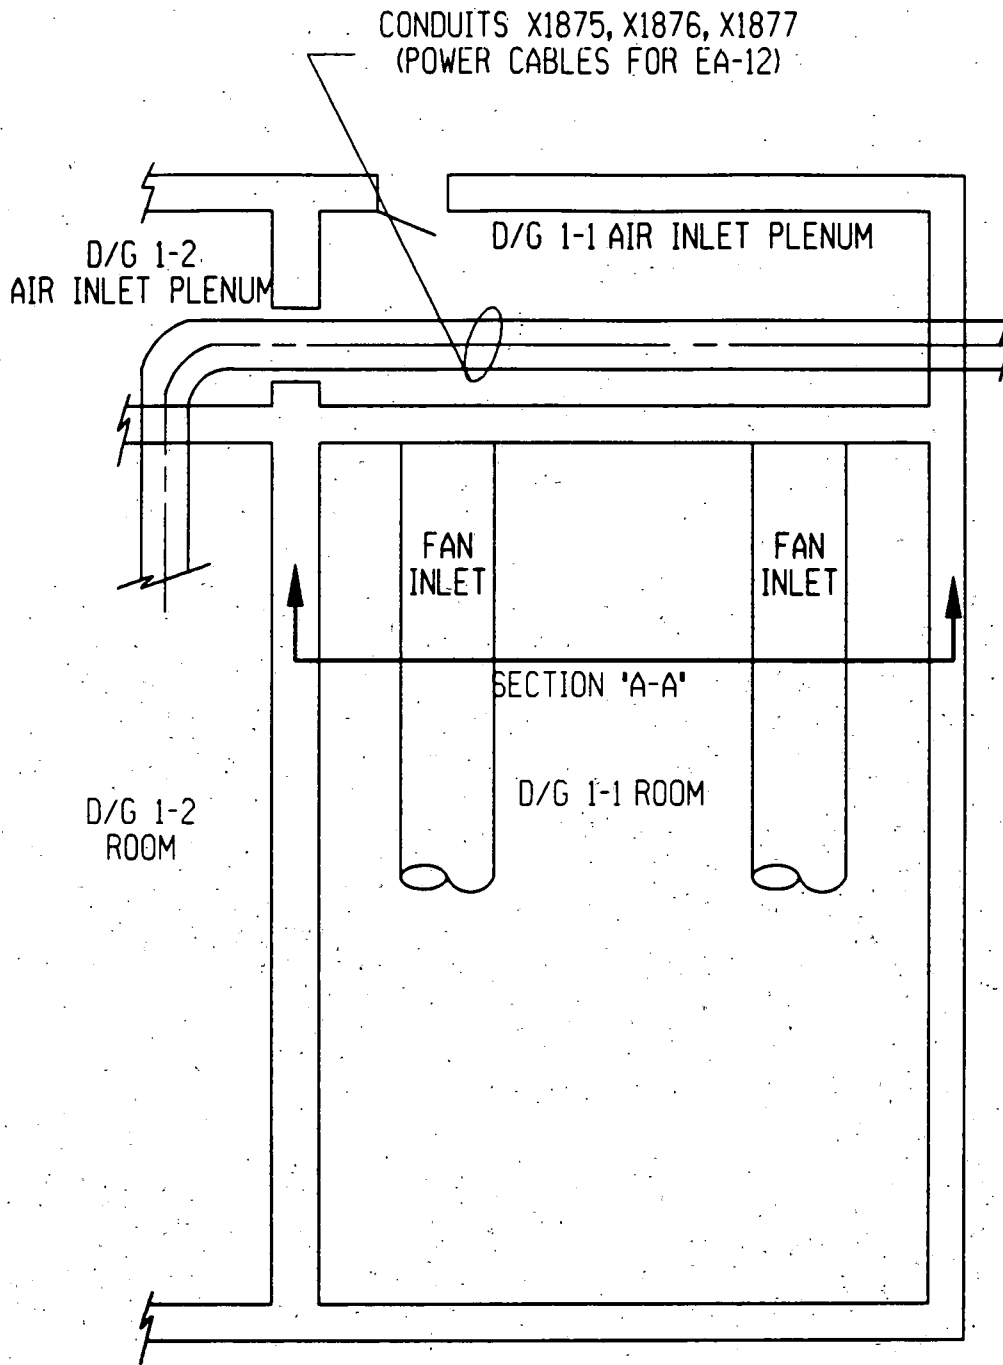
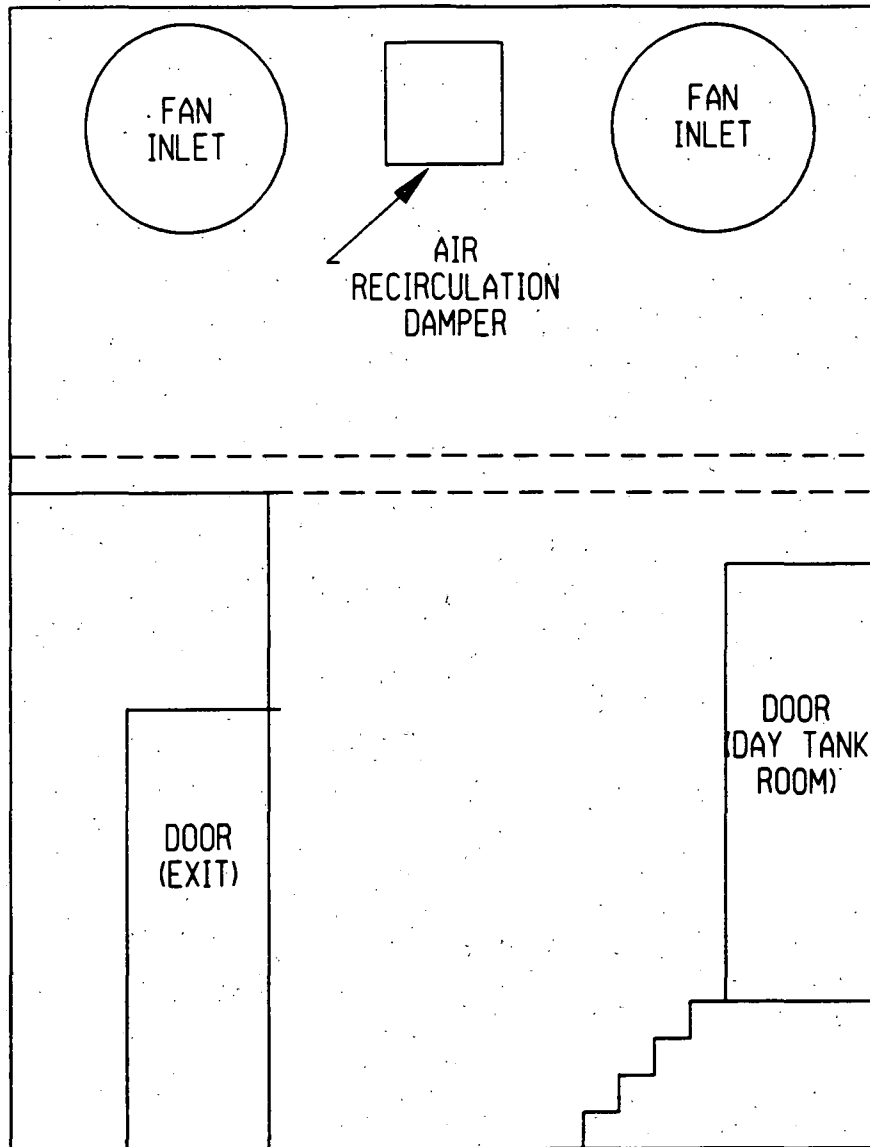
D/G 1-1 ROOM
SECTION 'A-A'

The hourly fire tour in the EDG 1-1 room was established as part of the initiation of the corrective action document. An overview drawing of the fire area in question is shown as Attachment B. For the period prior to July 14, 1995, the barrier as a whole cannot be considered operable for the following reasons:

Consequently, prior to July 14, 1995, when the hourly fire tour was established in the EDG 1-1 room, the plant operated with an inoperable fire barrier (non-rated fire wall) separating the EDG 1-1 room (Room 116) from the EDG 1-1 air plenum room (Room 148) where the redundant EDG 1-2 power and control circuits are located. This condition is outside the plant design basis required by 10 CFR 50, Appendix R, Section III.G.

Substantial protection is provided by the existing wall and ventilation penetrations between the 1-1 EDG room and air plenum even though they were not rated or inspected as a 3-hour fire barrier. The air plenum reinforced concrete wall is approximately 12 inches thick and a portion of the air plenum floor that provides separation from the EDG 1-1 room is approximately 9-1/2 inches thick. These portions of the barrier are acceptable as a 3-hour fire rated barrier as they exceed the 5-1/2 inch thickness required for 3-hour rating (per NFPA Fire Protection Handbook, 17th Edition, Figure 6-5G). The unrated ventilation air intake ductwork and recirculation damper in this wall are substantial steel enclosures that prevent direct impingement of smoke and hot gases on the circuits in the plenum. The two air intake ducts are opened at each end; one end in the EDG 1-1 room and the other end in the air plenum room. A plant walkdown determined that the horizontal distance between the openings at each end of the duct is equal to or greater than 20 feet thus providing a degree of separation between the two rooms. The air recirculation damper is currently failed closed such that it provides a passive fire stop configuration to limit the spread of smoke and hot gases. The EDG 1-1 room has a full area wet pipe sprinkler system which will greatly limit the intensity of a postulated fire. Water flow alarms which annunciate in the Control Room will provide notification of any fire thus initiating alarm response procedures which result in a fully trained fire brigade response. In addition, operations and security personnel inspect these areas on a frequent basis as a normal course of business. The fire loading in EDG 1-1 room, excluding the lube oil and fuel oil located in substantial metal enclosures, is light. The fire loading in the EDG 1-1 air plenum room is negligible as no exposed combustibles were identified in a plant walkdown. All of these factors help ensure that a realistic fire in the EDG 1-1 room would not likely propagate into the air plenum room and affect redundant safe shutdown circuits. We therefore conclude that the safety significance of this design deficiency is low.

A. Provide a resolution for the lack of proper Appendix R circuit separation between the EDG 1-2 power and control circuits routed in the air intake plenum to EDG 1-1 room.

A rigorous evaluation of the as-built configuration is underway. This evaluation will determine the adequacy of the existing fire barrier (EDG 1-1 air plenum) to protect the EDG 1-2 circuits. It will also identify other potential solutions to this non-compliant condition.

B. Maintain an hourly fire tour for diesel generator room 116 until a permanent resolution is provided for Appendix R circuit separation between the EDG 1-2 power and control circuits routed in the air intake plenum to EDG 1-1 room.
