**Coltec Industries**

File No. 98-001

Subject: FM-Alco 251 Engine, Wrist Pin Assembly, Catalog No.: 2420021-2

10 CFR PART 21 REPORT

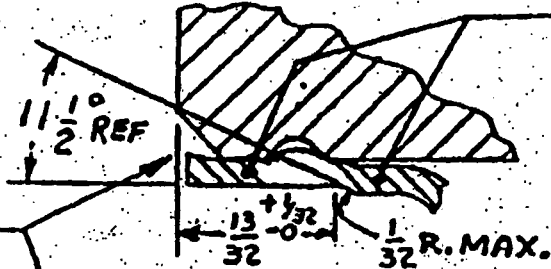
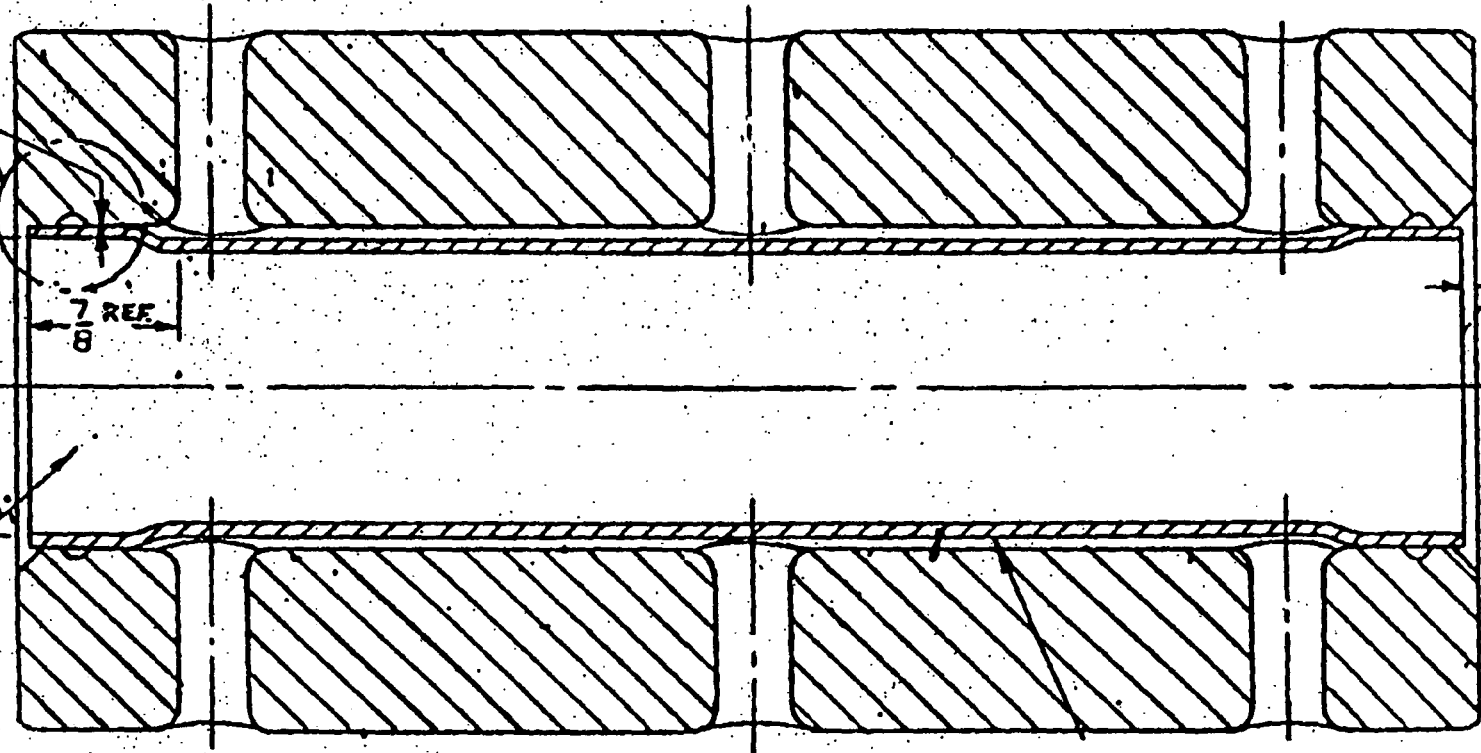
FIG. 1

On November 11, 1998, Coltec Industries, Fairbanks Engine Division (FMED), became aware of a potential safety hazard associated with the wrist pin assemblies for FM-Alco 251 engines. The wrist pin assembly consists of a wrist pin and a sleeve fitted in the bore of the wrist pin and held in place by rolling each end which causes a tight friction fit. The sleeves of the subject wrist pin assemblies were supplied with an incorrect material, which is not suitable for rolling - expansion. Therefore, the friction fit between the pin and the sleeve may not be sufficient, which could cause the sleeve to become loose and possibly contact the liner. A drawing of the wrist pin assembly is attached.

The only affected utility is Consumers Power - Palisades, which received a total of 36 wrist pin assemblies between 1995 and 1996. It should be noted that no failures have occurred to date and the problems with the wrist pin assemblies occurred in commercial applications after many thousands of hours of cyclic operation. FM-Alco 251 engines in nuclear applications are not typically subjected to this type of operation. However, it is recommended that the subject wrist pins be replaced with pin assemblies made with the correct sleeve material.
