Palisades Nuclear Plant: 27780 Blue Star Memorial Highway, Covert, MI 49043

**DOCKET 50-255 - LICENSE DPR-20 - PALISADES PLANT
RESPONSE TO NOTICE OF VIOLATION FOR TWO VIOLATIONS IN NRC
INTEGRATED INSPECTION REPORT NO. 50-255/96014(DRP)**

**RESPONSE TO TWO VIOLATIONS FROM NRC INSPECTION
REPORT NO. 50-255/96014 (DRP) DATED JANUARY 22, 1997**

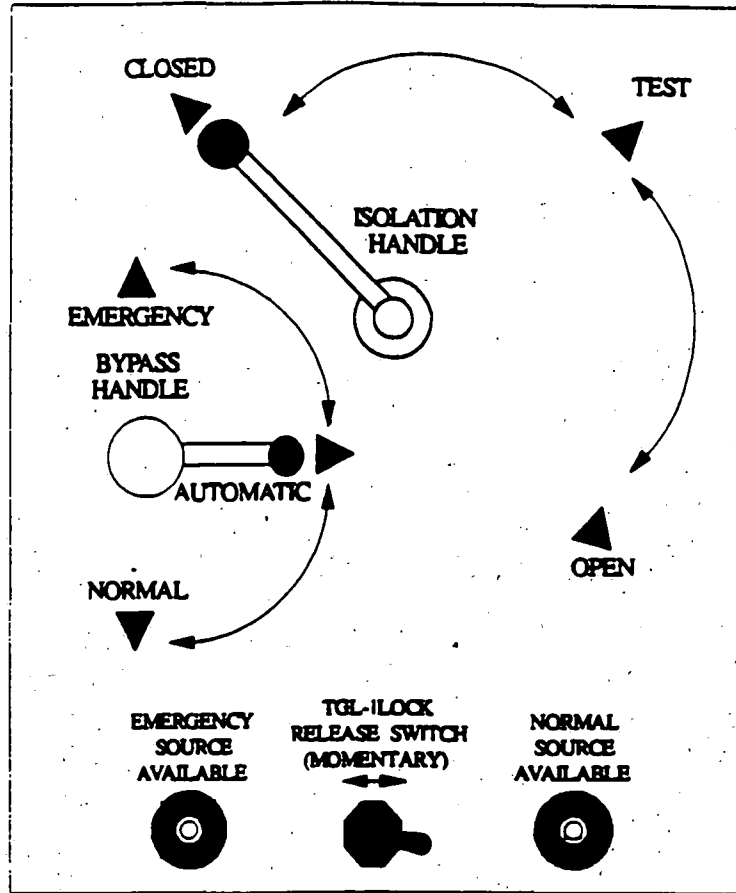
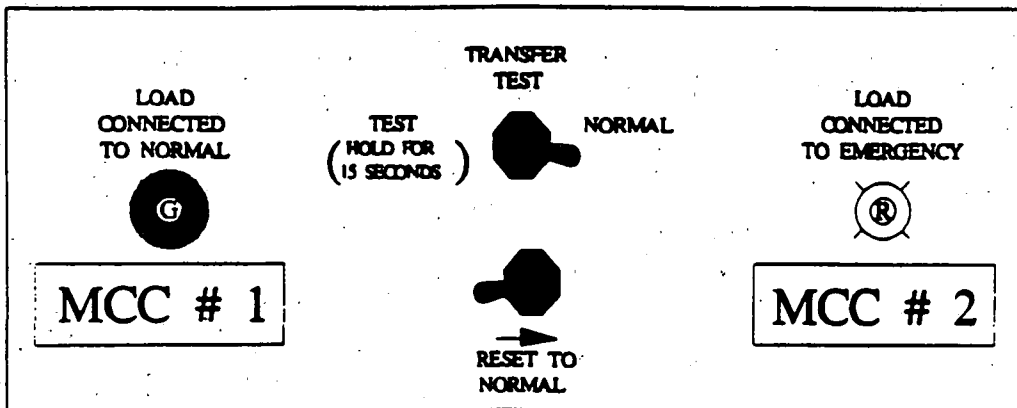
AUTOMATIC TRANSFER SWITCH

did not obtain a copy of the procedure to review, and failed to establish the full electrical maintenance work scope. Subsequently, Operations decided to implement a portion of SOP 30 that configured the Y50 switch from automatic to normal, but did not recognize the need to place the isolation handle to "open" (see attached sketch). This configuration fulfilled only one of two alignment steps specified in the PPAC.

The Shift Lead SRO and the AO went to perform the alignment of Y50. They observed the isolation handle, the source light indication and the switch's physical position, but they did not recognize their indications were different than expected. The AO placed the Y50 bypass handle from normal to automatic. Because the isolation handle had not been restored to the "close" position, Y50 failed to transfer and Y01 was de-energized.

Periodic activity, SPS050, will be revised to use the terminology of operating procedure, SOP 30, and to make the steps to align automatic transfer switch, Y50, an Operations responsibility with the appropriate sign offs.
