SUBJECT: TRANSMITTAL OF FINAL ACCIDENT SEQUENCE PRECURSOR ANALYSIS –
CLINTON POWER STATION, SHUTDOWN SERVICE WATER PUMP
(DIVISION 3) START FAILURE (LER-461-2017-008) - PRECURSOR

**Final Accident Sequence Precursor Analysis – Clinton Power
Station Shutdown Service Water Pump (Division 3)
Start Failure LER-461-2017-008 - Precursor**

Accident Sequence Precursor Program – Office of Nuclear Regulatory Research			
Clinton Power Station	Shutdown Service Water Pump (Division 3) Start Failure		
Event Date: 6/15/2017	LER(s): 461-2017-008 , 461-2017-005-01 461-2017-007-01	CCDP= 6×10^{-6}	
IR(s): 05000461/2017011			
Plant Type: General Electric Type 6 Boiling-Water Reactor (BWR) with Mark III Containment			
Plant Operating Mode (Reactor Power Level): Mode 1 (97% Reactor Power)			
Analyst: Dale Yeilding	Reviewer: Christopher Hunter	Contributors: Keith Tetter	Approval Date: 2/28/2018

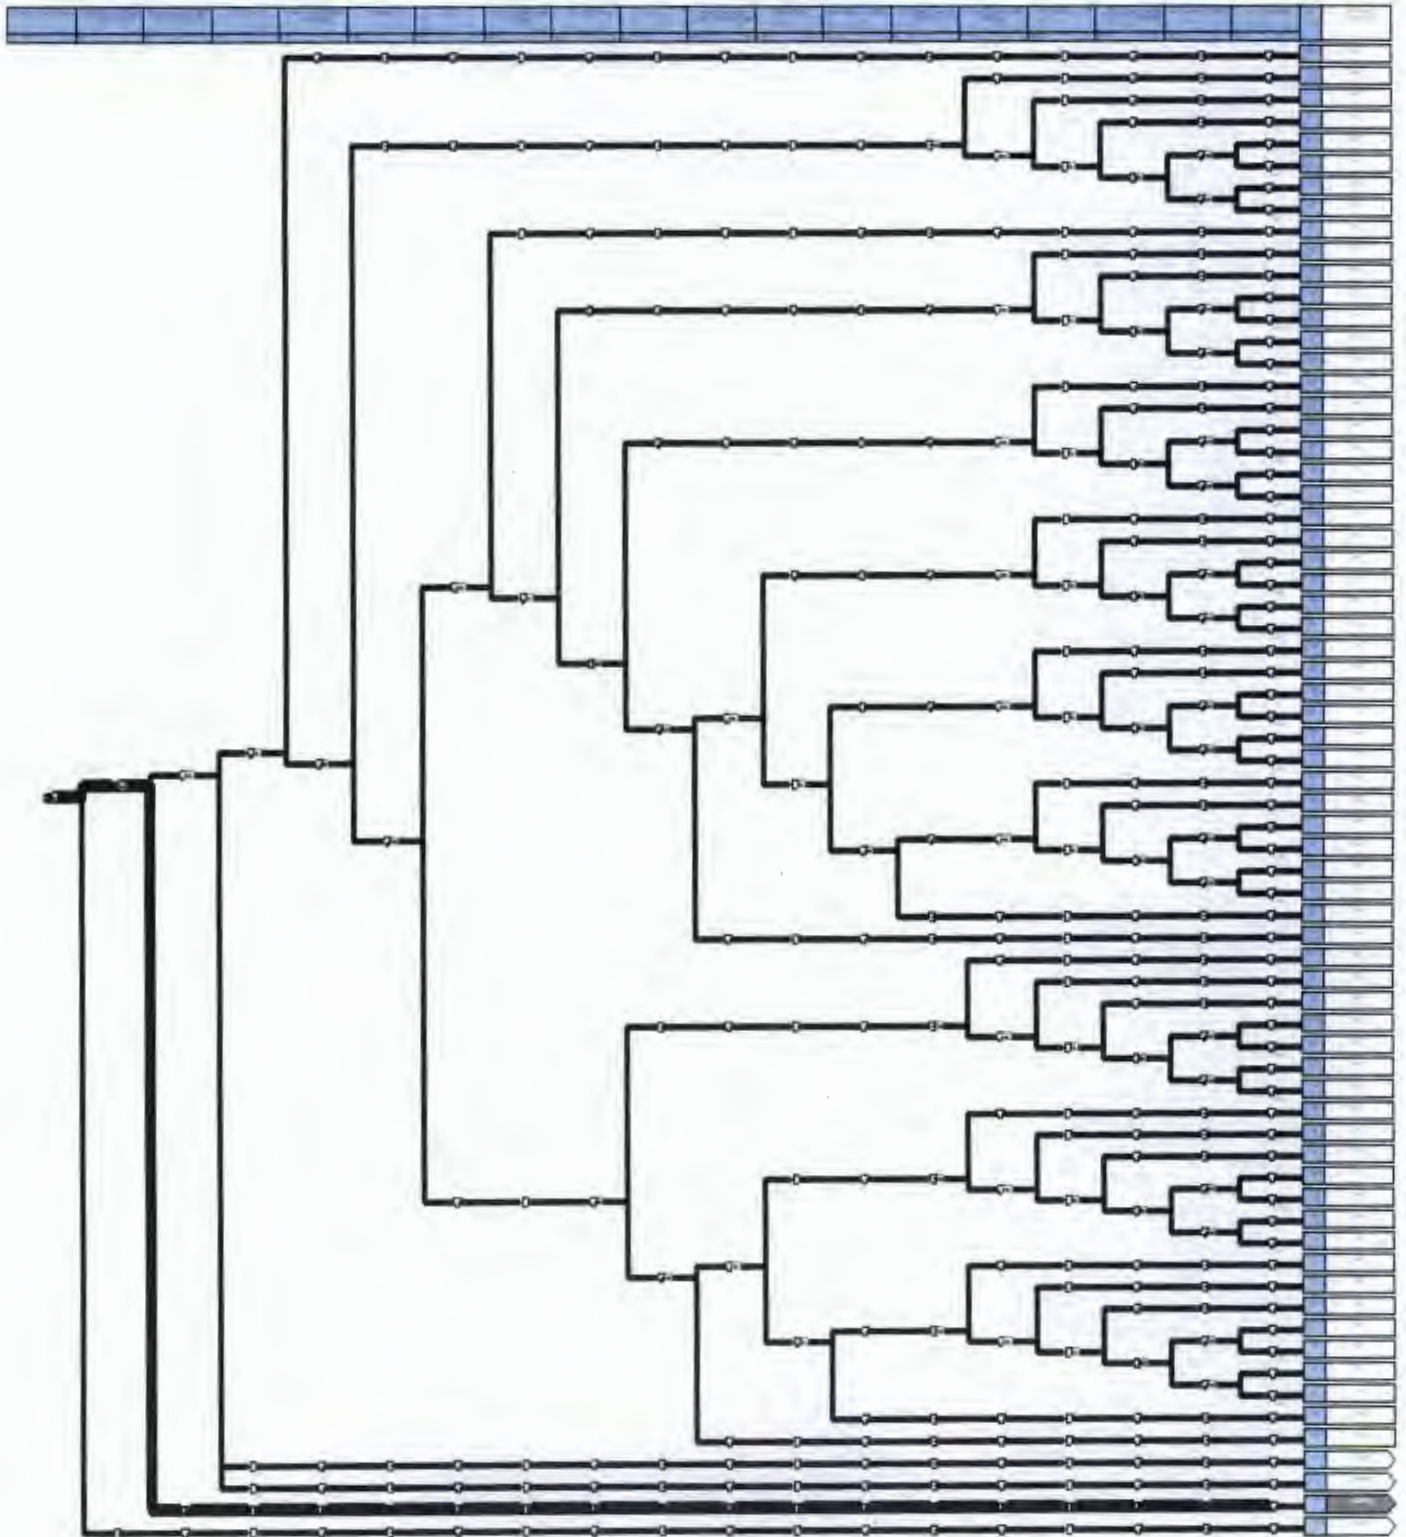
Figure A-1. Clinton Power Station General Transient Event Tree

Dominant Sequence. The dominant accident sequence is Transient Sequence 67-40-24 (CCDP = 8.75×10^{-7}) that contributes approximately 16 percent of the total CCDP. The dominant sequence is shown graphically in Figures A-1 through A-3 in [Appendix A](#). The sequences that contribute at least 1.0 percent to the total CCDP are provided in the following table.
