Final ASP Program Analysis - Precursor

Accident Sequence Precursor Program – Office of Nuclear Regulatory Research			
Cooper Nuclear Station	Concurrent Unavailabilities—Residual Heat Removal Loop A, Reactor Core Isolation Cooling, and Emergency Station Service Transformer		
Event Date: 2/5/2017	LERs: 298-2017-001-01 , 298-2016-007 , 298-2016-008 , IRs: 05000298/2017001 , 05000298/2017009 , 05000298/2017010 , 05000298/2017011 , 05000298/2017012	ΔCDP= 6×10 ⁻⁶	
Plant Type: General Electric Type 4 Boiling-Water Reactor (BWR) with a Wet Mark I Containment			
Plant Operating Mode (Reactor Power Level): Mode 1 (100% Reactor Power)			
Analyst: Keith Tetter	Reviewer: Chris Hunter	Contributors:	BC Approved Date: 03/09/2018

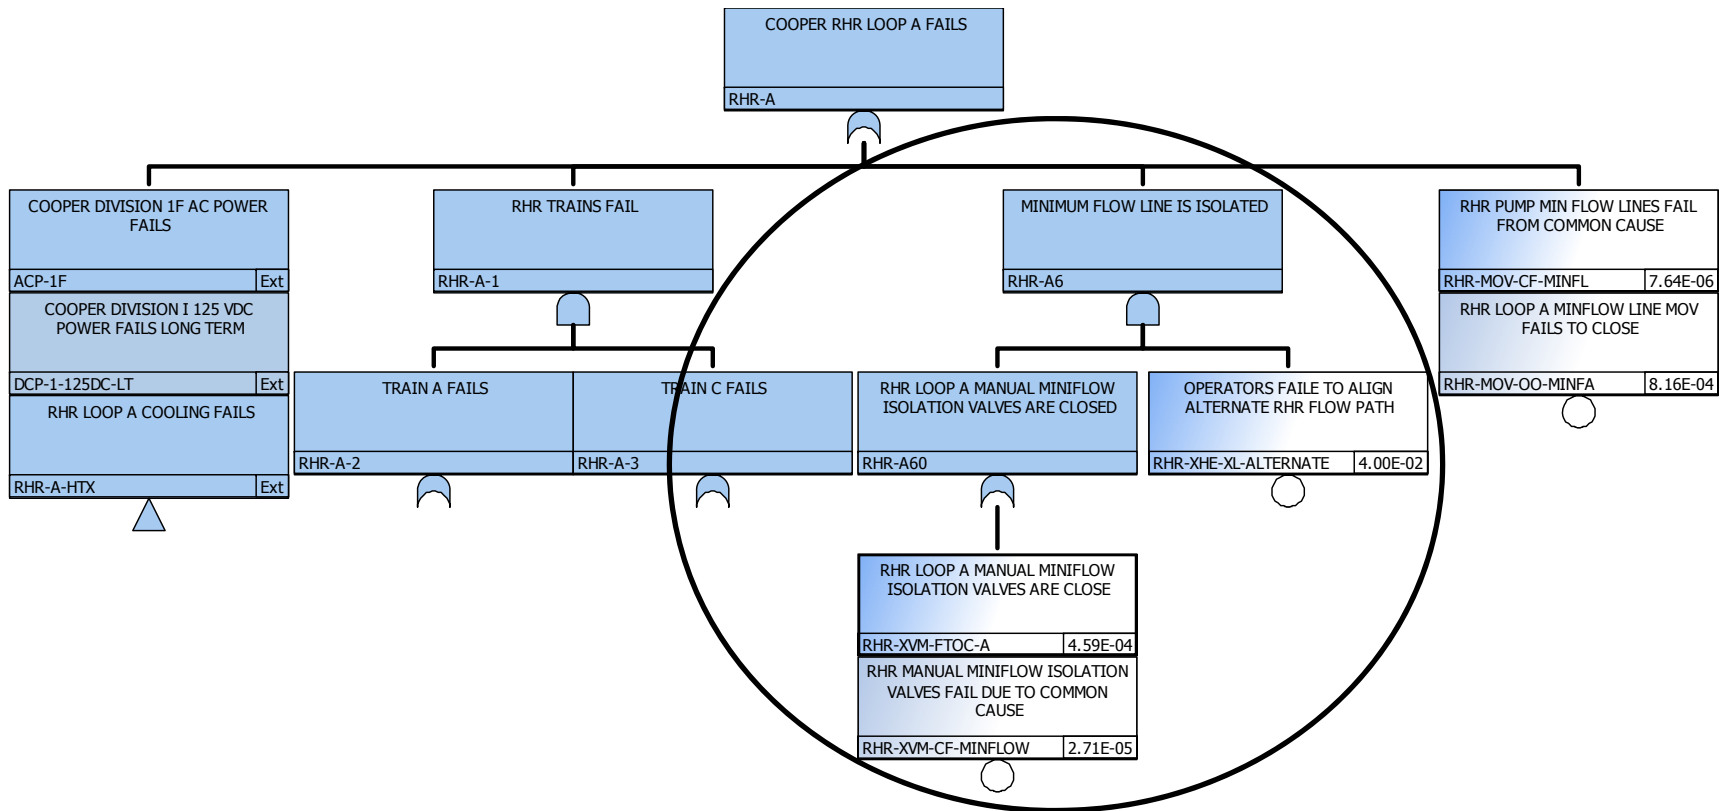
Figure B-1. Modified RHR-A Fault Tree

- Modifications were made to the applicable RHR fault trees. The RHR-A (*Cooper RHR loop A fails*) fault tree was modified to provide credit for operators aligning an alternate flow path (i.e., suppression pool cooling) and to account for potential common-cause failure (CCF) of the manual valves in the RHR minimum flow lines. A new 'AND' gate RHR-A6 (*minimum flow line is isolated*) was inserted under existing gate RHR-A (*Cooper RHR loop A fails*). Gate RHR-A60 (*RHR loop A miniflow isolation valves are closed*) was inserted under new 'AND' gate RHR-A6. Similar fault tree changes were made to the RHR-B (*Cooper RHR loop B fails*) fault tree. New basic events, RHR-XVM-FTOC-A (*RHR loop A miniflow isolation valves are closed*) and RHR-XVM-FTOC-B (*RHR loop B miniflow isolation valves are closed*), were inserted

under gates RHR-A60 and RHR-B60 (*RHR loop B miniflow isolation valves are closed*), respectively. The failure probabilities of these valves were set using template event ZT-AVM-FTOC (*manual valve fails to open*), which has a probability of 4.59×10^{-4} . A new basic event, RHR-XHE-XL-ALTERNATE (*operators fail to align alternate RHR flow path*), was inserted under gates RHR-A6 and RHR-B6. The failure probability of this basic event was set to 4.0×10^{-2} , per SPAR-H analysis described below, to provide for operator recovery credit to align an alternate RHR flow path. The RHR loop 'A' manual isolation valves for minimum flow that were incorrectly in the closed position were considered to be part of a common-cause component group (CCCG) with the similar valves in RHR loop 'B'.⁴ To create the CCF event, basic events RHR-XVM-FTOC-A and RHR-XVM-FTOC-B were used to create a new basic event, RHR-XVM-CF-MINFLW (*RHR manual miniflow isolation valves fail due to common-cause*), was inserted under gates RHR-A60 and RHR-B60 to account for potential CCF of the manual minimum flow isolation valves for loops 'A' and 'B'. The changes made in the RHR-A and RHR-B fault trees were made to the applicable SPC and low-pressure core injection (LPCI) fault trees. The revised RHR-A, RHR-B, SPC-A (*cooper RHR loop A fails*), SPC-B (*cooper RHR loop B fails*), LCI-A (*Cooper LPCI train A fails*), and LCI (*Cooper LPCI train B fails*) fault trees are provided in Figures B-1 through B-6 in [Appendix B](#).

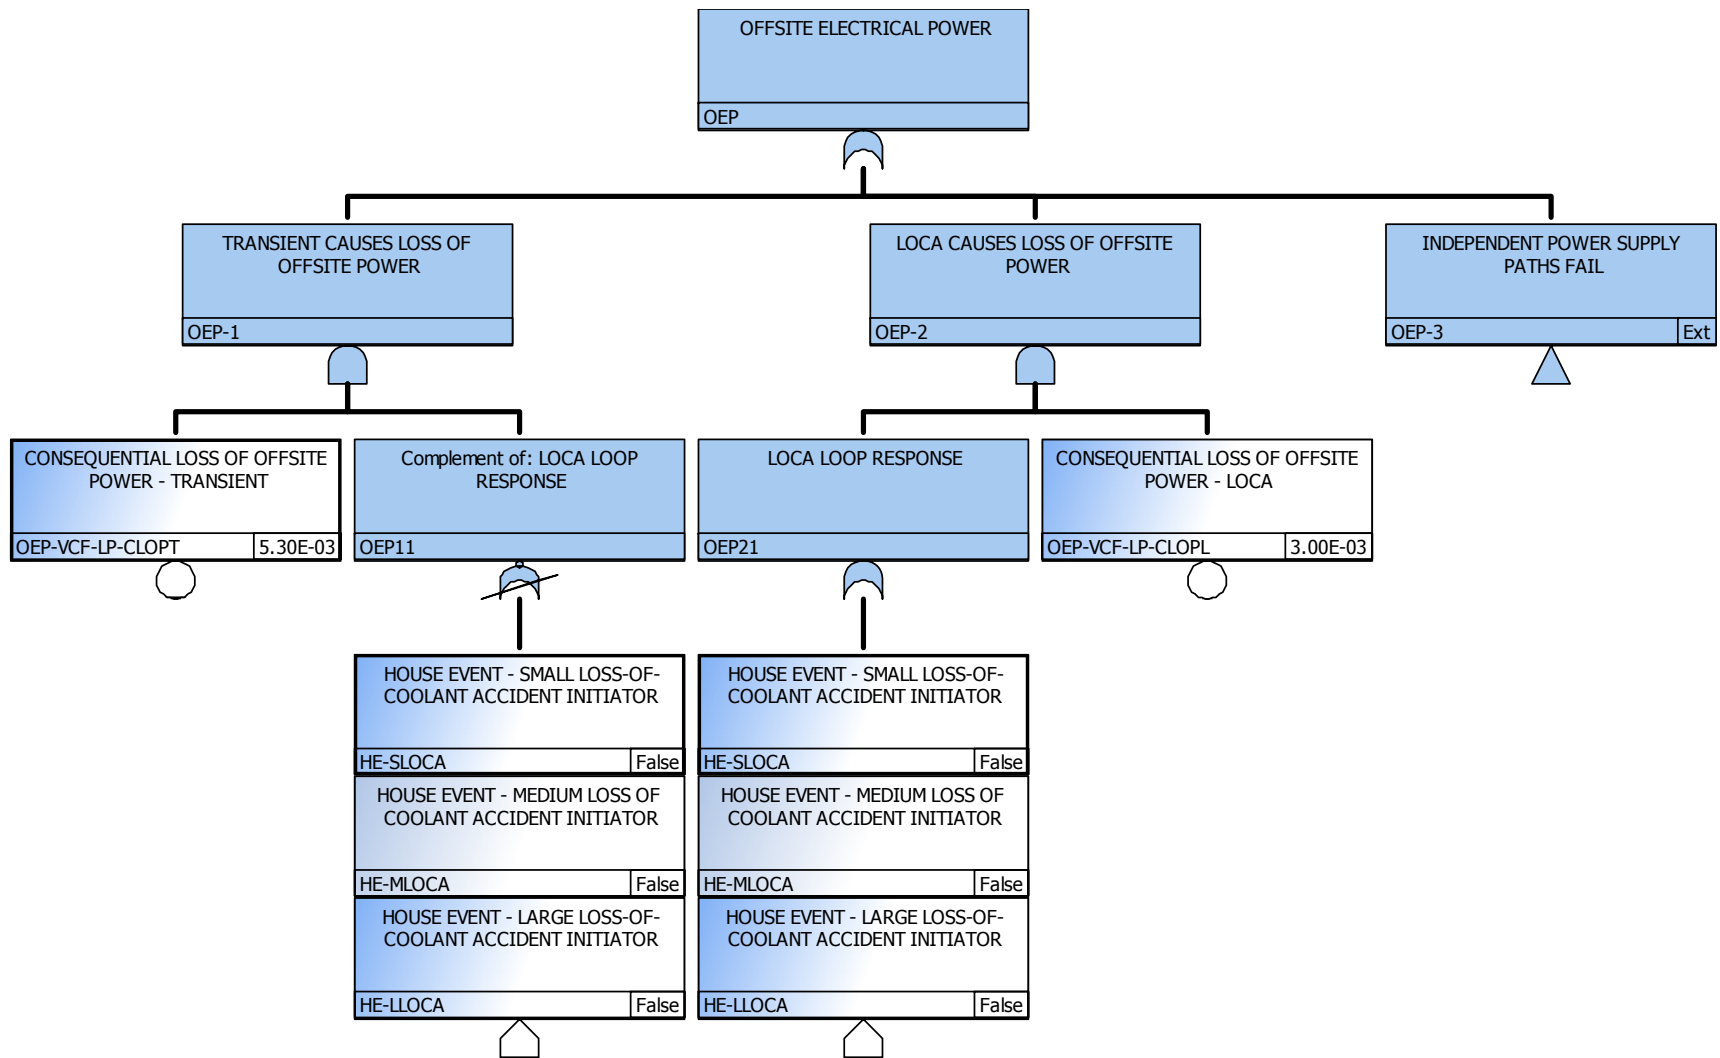
Figure B-7. Modified OEP Fault Tree

- Modifications were made to the ACP-1F-SWY (Cooper switchyard AC service to bus 1F), ACP-1G-SWY (Cooper switchyard AC service to bus 1G), OEP (offsite electrical power), OEP-3 (independent power supply paths fail), DGS (supplemental diesel generator faults), OPR (offsite power recovery), OPR-30M (offsite power recovery in 30 minutes), OPR-04H (offsite power recovery in 4 hours), OPR-08H (offsite power recovery in 8 hours), and OPR-12H (offsite power recovery in 12 hours) fault trees in a similar manner as in Attachment 2 in [IR 05000298/2017011](https://www.nrc.gov/reading-rm/doc-collections/investigation-reports/ir05000298/2017011). The revised ACP-1F-SWY,

ACP-1G-SWY, OEP, OEP-3, DGS and OPR fault trees are provided in Figures B-7 through B-12 in [Appendix B](#).

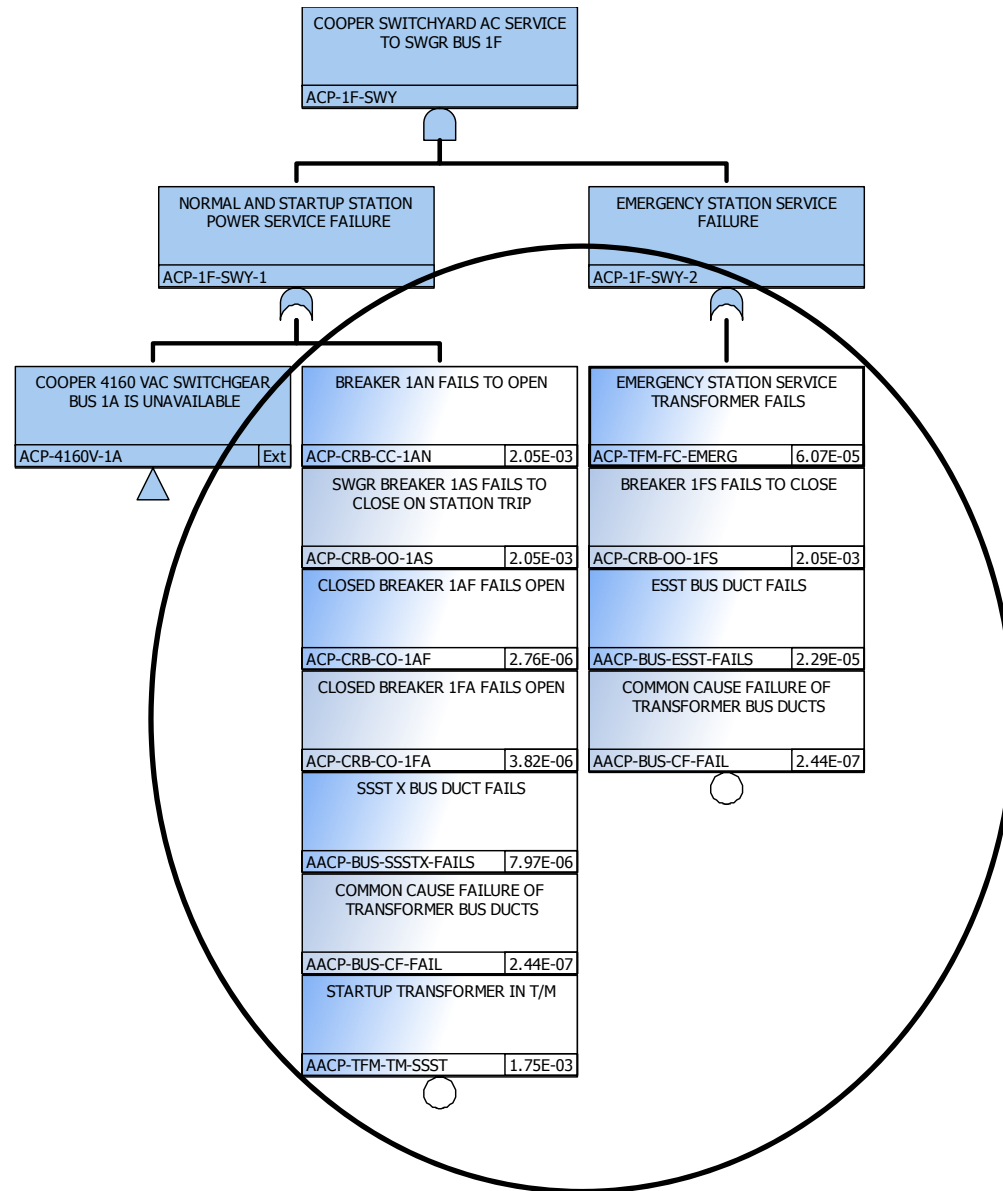
Figure B-8. Modified ACP-1F-SWY Fault Tree

- A new CCF basic event, AACP-BUS-CF-FAIL (*common-cause failure of transformer bus ducts*), representing the CCF of the ESST and SSST-X bus work was created. The common cause alpha factors, ZA-CCF-RATE-02A01 (*alpha factor 1 in group size 2 for component CCF with failure mode rate*) and ZA-CCF-RATE-02A02 (*alpha factor 2 in group size 2 for component CCF with failure mode rate*), were applied. These generic alpha factors for a CCG size of two are used because bus-work failure data is not explicitly collected and estimated for the SPAR models. This CCF basic event was inserted under existing 'OR' gates ACP-1F-SWY-1,

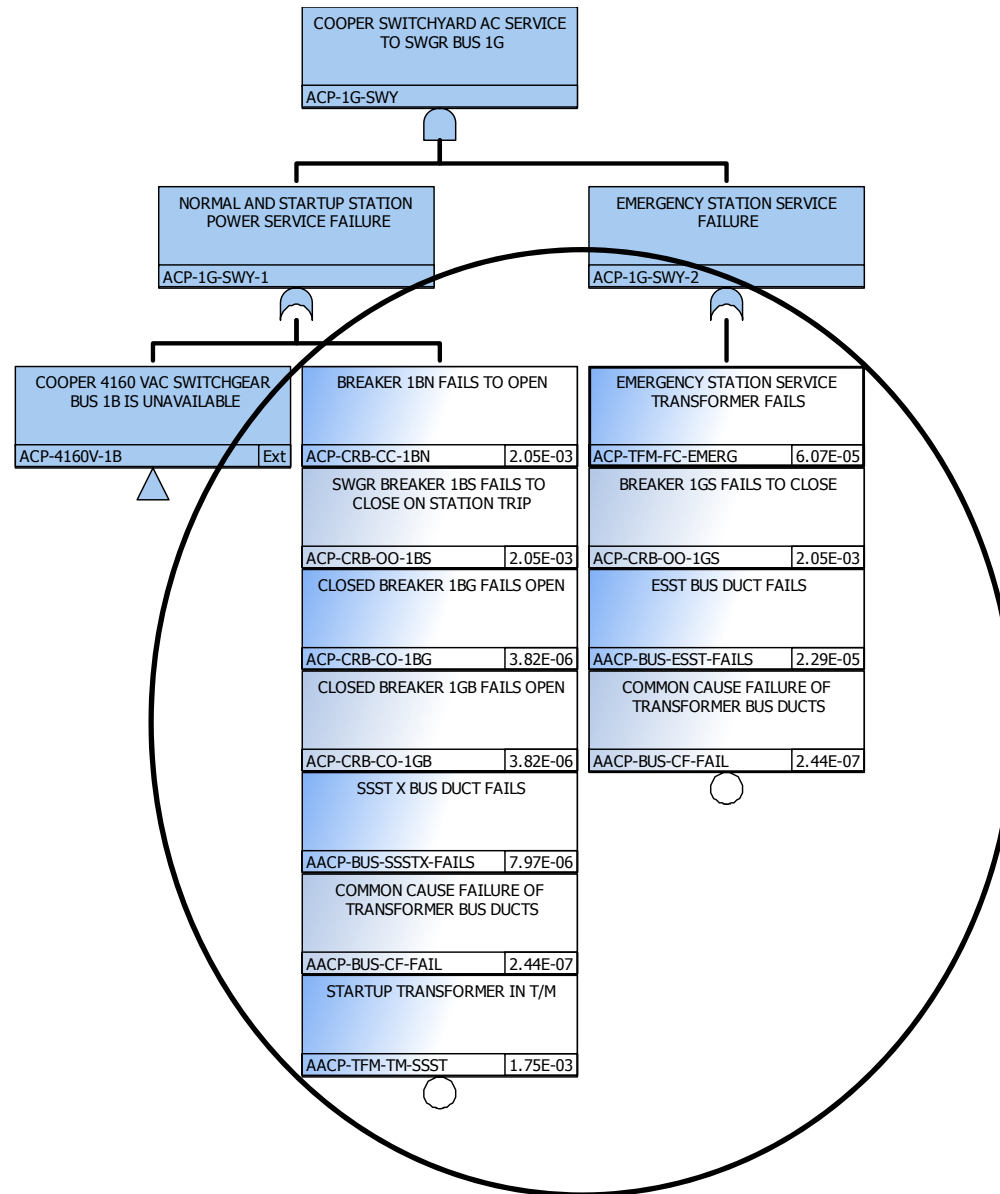
Figure B-9. Modified ACP-1G-SWY Fault Tree

-
- ACP-1G-SWY-1, OEP22110, OEP222110, OEP22111, and OEP222111 within the OEP-3 fault tree.
- The OEP-3 transfer tree was inserted under the existing top gate for the OPR-30M, OPR-04H, OPR-08H, and OPR-12H fault trees.
 - In ASP analyses, recovery credit for EDG failures is limited to cases where event information supports credit for EDG recovery. Therefore, the DGR (diesel generator recovery) top event (including applicable event tree branching) was eliminated from the station blackout (SBO) event tree. The revised SBO event tree is shown in [Figure A-3](#).
 - The basic event SPC-XHE-XL-NOREC (*late recovery of suppression pool cooling fails*) was set to TRUE. The base model probability of 0.5 is only used for benchmarking purposes.

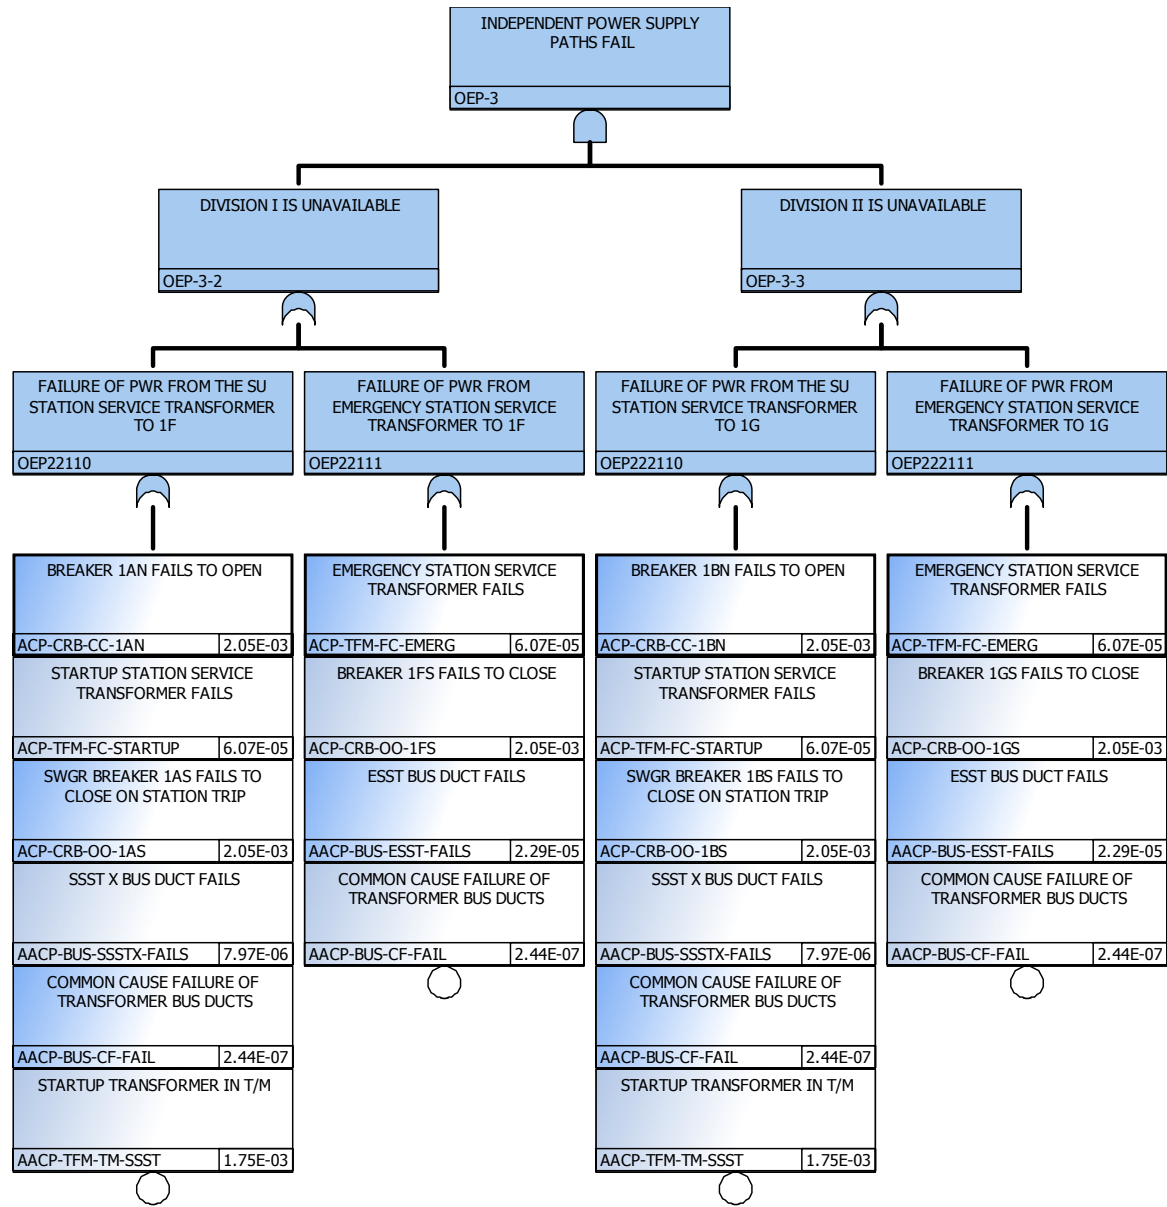
Figure B-10. Modified OEP-3 Fault Tree

- The OEP-3 fault tree was converted to transfer gate within the OEP fault tree.
- The nonsegregated bus work between the motor-operated disconnect associated with the ESST and electrical safety buses 1F and 1G is not included in the base SPAR model and is needed for this analysis. Therefore, new basic event AACP-BUS-ESST-FAILS (*ESST bus duct fails*) was created in the SPAR model using template ZT-BAC-LP (*AC bus fails to operate*). This basic event was added to the ACP-1F-SWY and ACP-1G-SWY fault trees under existing 'OR' gates ACP-1F-SWY-2 (*emergency station service failure*) and ACP-1G-SWY-2 (*emergency station service failure*). This basic event was also added to the OEP fault tree under existing 'OR' gates OEP22111 (*failure of power from ESST to 1F*) and OEP222111 (*failure of power from ESST to 1G*). Similarly, a new basic event, AACP-BUS-SSSTX-FAILS (*SSST-X bus duct fails*), representing the bus work from the X-winding of the SSST feeding the plant (which did not fail the SDG but was unavailable due to the failure of the ESST bus duct) was created using template ZT-BAC-LP and inserted under fault trees ACP-1F-SWY and ACP-1G-SWY as well under existing 'OR' gates OEP22110 (*failure of power from the startup station service transformer to 1F*) and OEP222110 (*failure of power from the startup station service transformer to 1G*) within the OEP-3 fault tree. In addition, basic event AACP-BUS-ESST-FAILS was inserted under the top gate of the DGS fault tree given the supplemental diesel generator would be unavailable given a bus duct failure.
