EVALUATION OF POTENTIAL MALFUNCTIONS
DUE TO HIGH ENERGY LINE BREAKS

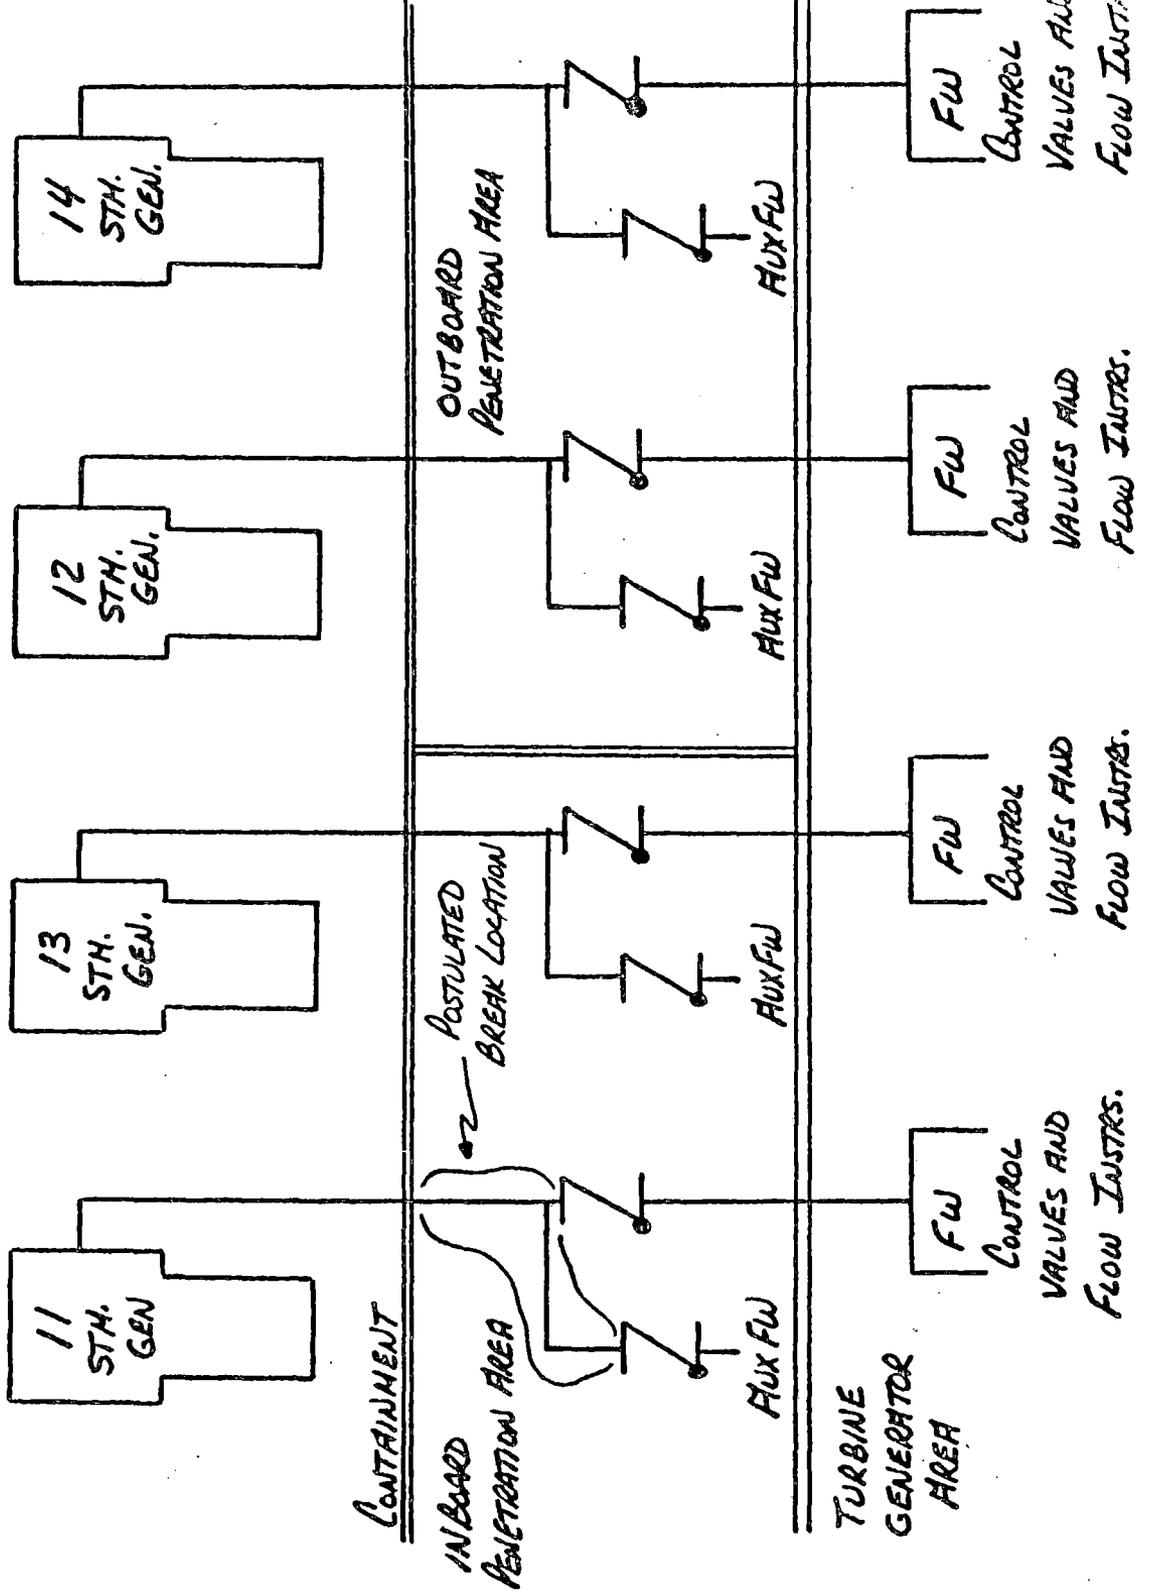
SIMPLIFIED MAIN FEEDWATER
DIAGRAM

The Salem plant is provided with two penetration areas outside the containment where this postulated feedwater line rupture could occur (refer to attached figures). Each penetration area is utilized for routing of steam and feedwater piping for two steam generators. The penetration areas are physically separated so that a break in one will not affect the other. Therefore this particular break can only affect the steam generator power operated relief valve control systems within the particular penetration area where the break is postulated.

attached figures). A rupture in No. 11 Steam Generator feedwater line will result in the loss of one steam feed for the turbine driven pump. The power operated relief valve for No. 13 Steam Generator (13MS10) employs a pneumatic control system which uses steam pressure as a control parameter. A control signal from No. 13 Steam Generator pressure transmitter (not safety-related) operates the valve through an electric/pneumatic converter. The pressure instrument, electric/pneumatic converter and power operated relief valve are located in the penetration area which is subject to the adverse environment resulting from the feedwater line break. This is control grade equipment and as such was not qualified for post accident operation and therefore could be subject to misoperation. The potential malfunction could be the opening of valve 13MS10 and depressurization of No. 13 Steam Generator with the eventual loss of the remaining turbine driven auxiliary feedwater pump steam supply.

This particular sequence of events as postulated by Westinghouse is not a safety consideration in that the loss of all auxiliary feedwater following a feedline rupture was factored into the Salem Safety Analysis. Operator action will assure auxiliary feedwater flow to the unaffected steam generators and can be accomplished within the allotted time frame. The Salem design basis considered operator action in recovery from feedwater/steam line break events. The indications and controls required for these operator actions are unaffected by the postulated break.

The Salem operating procedures and operator training program are being revised to address the concerns described herein.

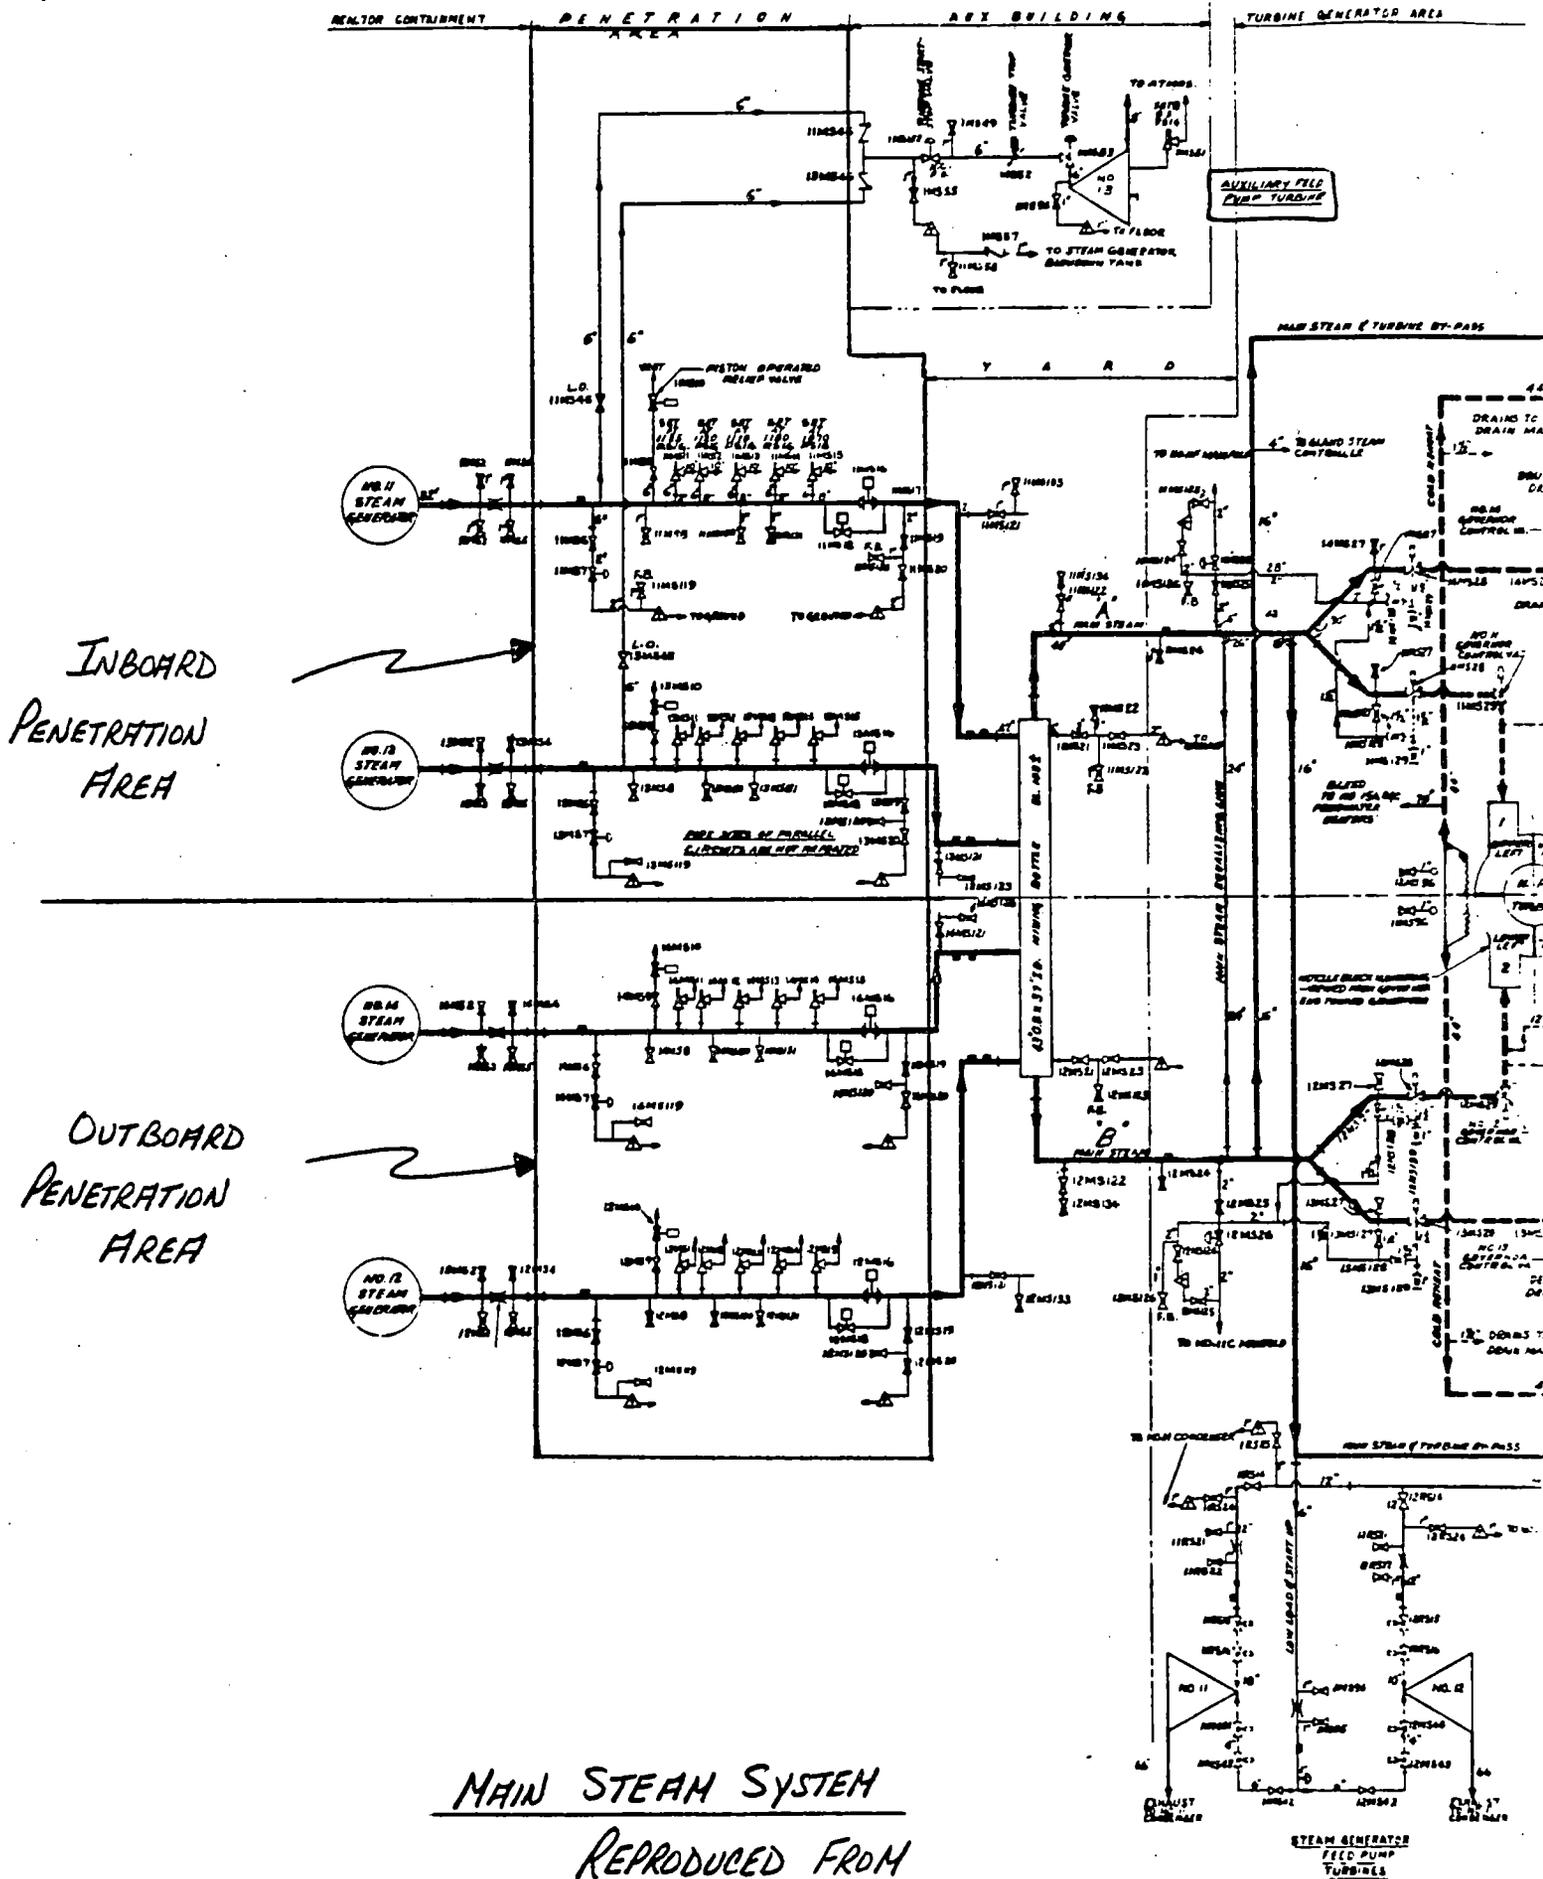
MAIN STEAM SYSTEM

The turbine driven auxiliary feedwater pump is supplied steam from No. 11 and 13 steamlines which are located within the same penetration area (refer to

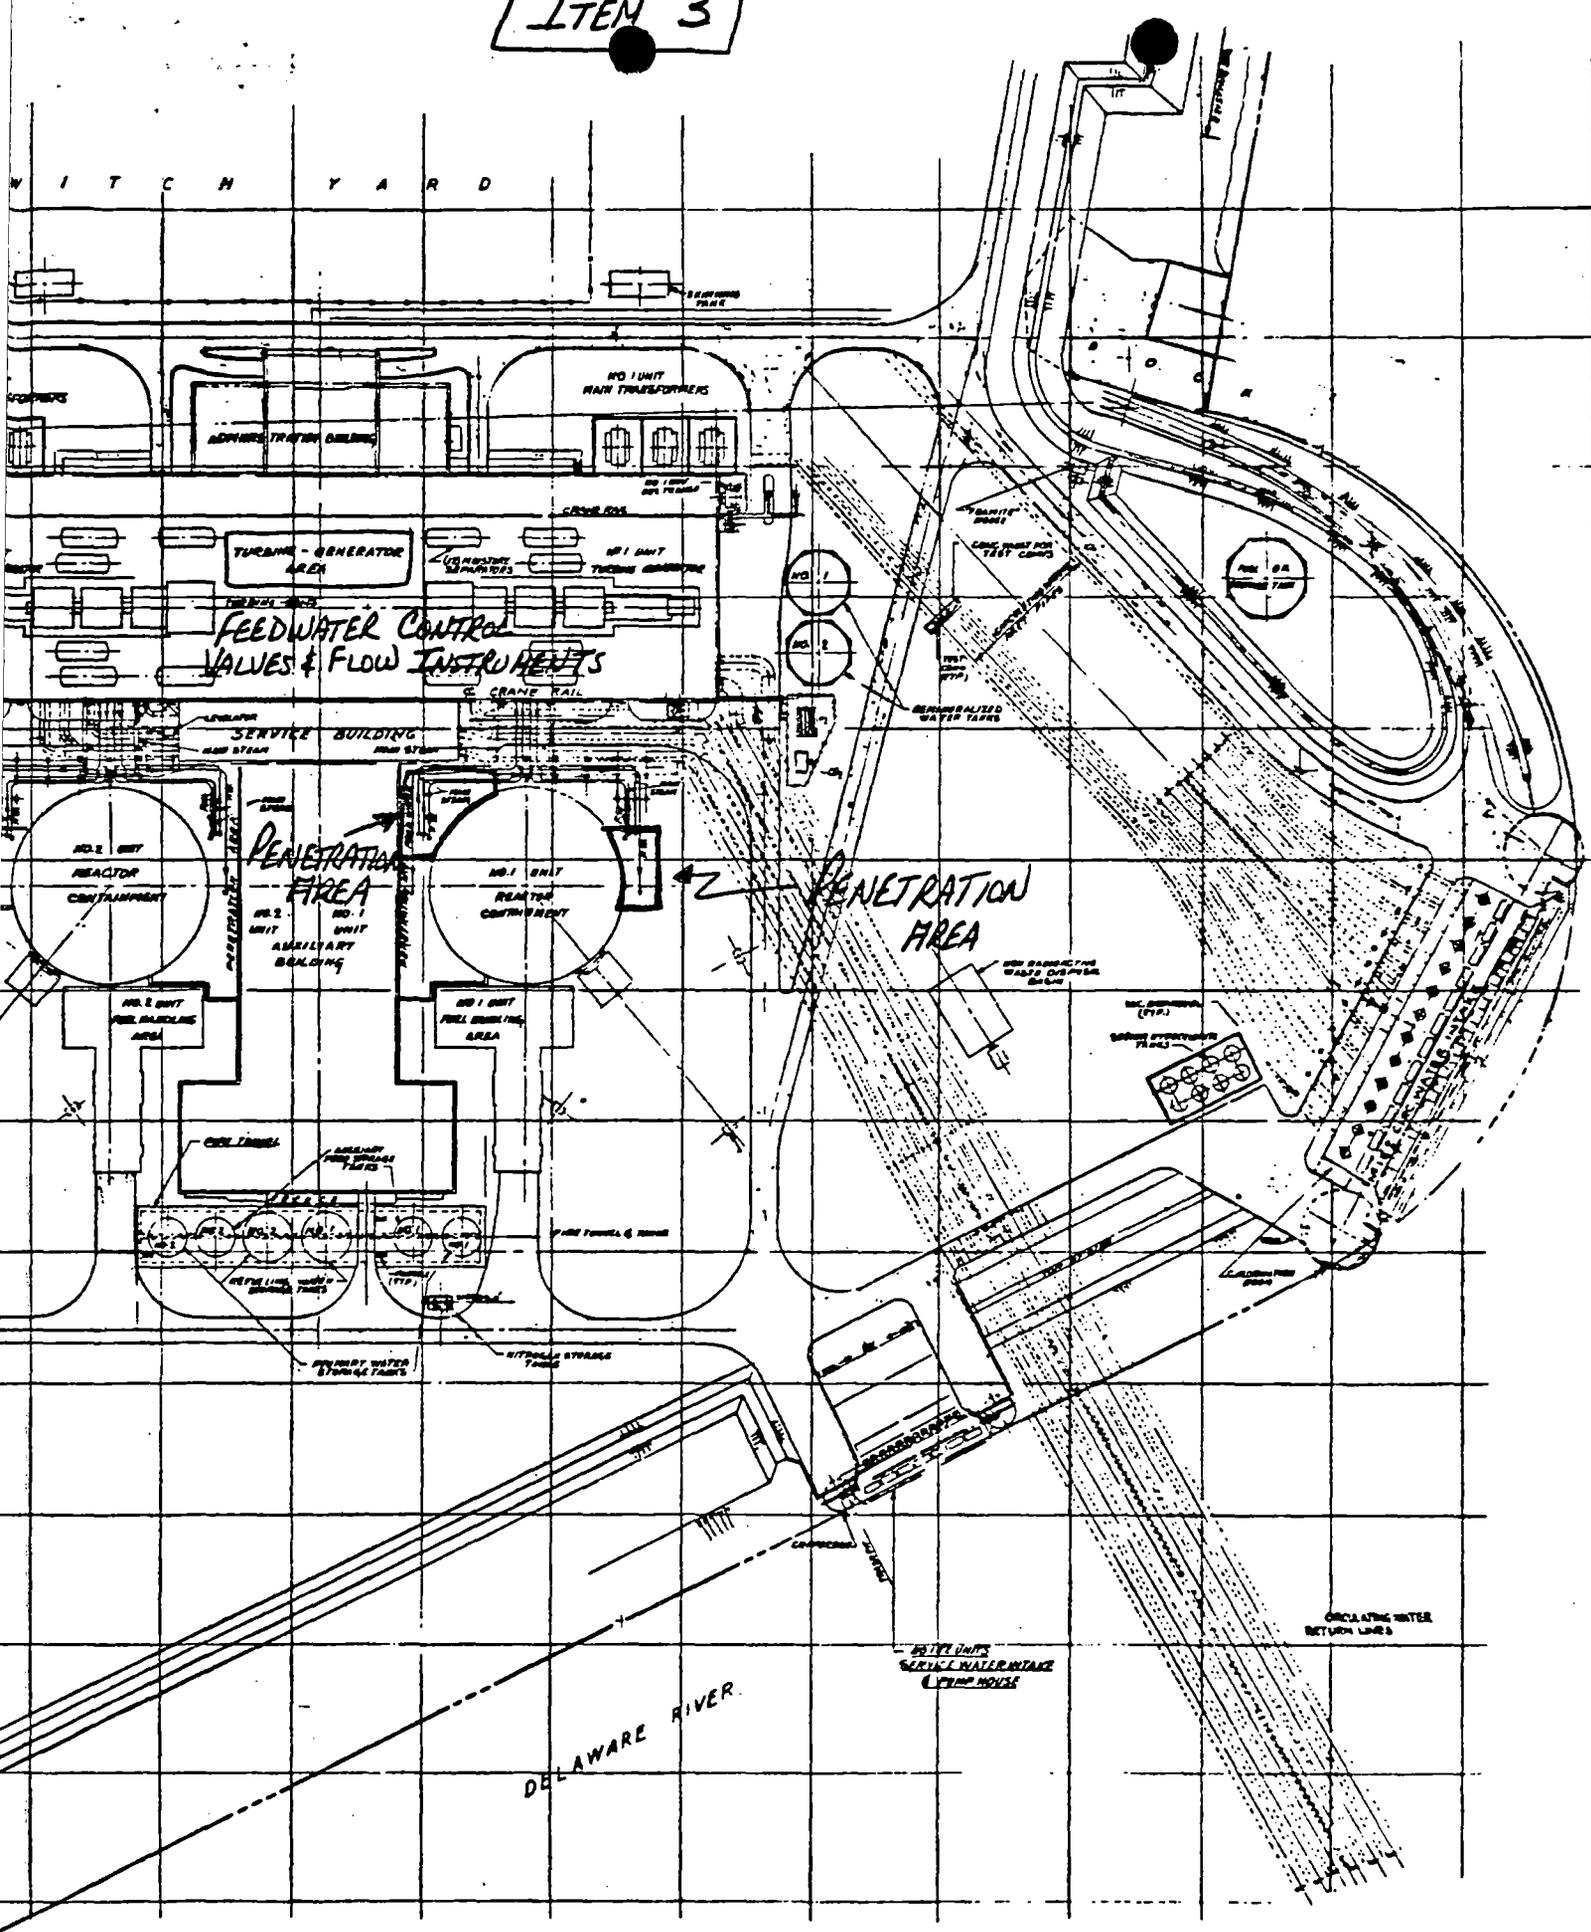
GENERAL PLOT PLAN

The postulated high energy line break for this potential interaction occurs in the mechanical penetration areas at the Salem plant (refer to attached figures). The main feedwater control system employs a three element control scheme. Steam generator level, steam flow and feedwater flow parameters are utilized for feedwater regulation. The main feedwater flow instrumentation and the main feedwater control valves are located in the Turbine Building which is not affected by the adverse environment from the postulated feedwater line rupture. The steam generator level and steam flow instrumentation is located in the containment which is also not subject to the adverse environment resulting from the break. In addition, the cabling for this equipment is not routed through the postulated break area.

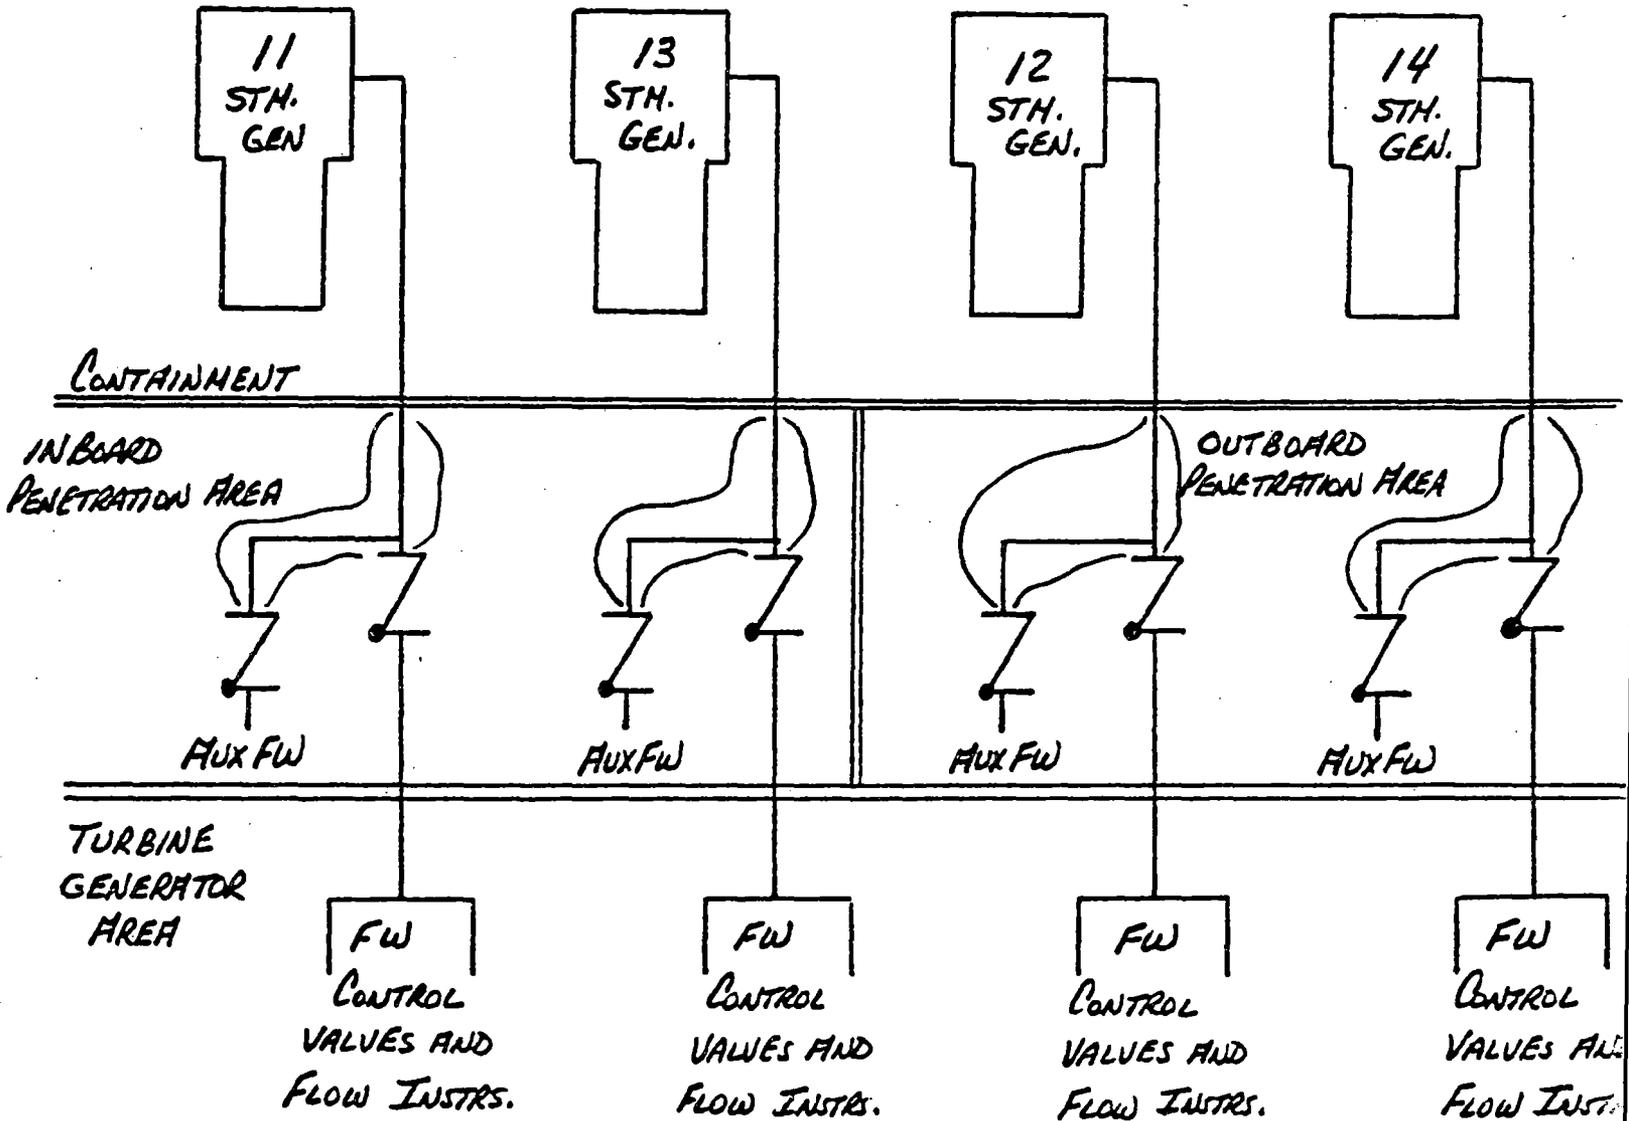
SIMPLIFIED MAIN FEEDWATER
DIAGRAM

POSTULATED BREAK LOCATION IN ANY ONE OF THE CIRCLED AREAS

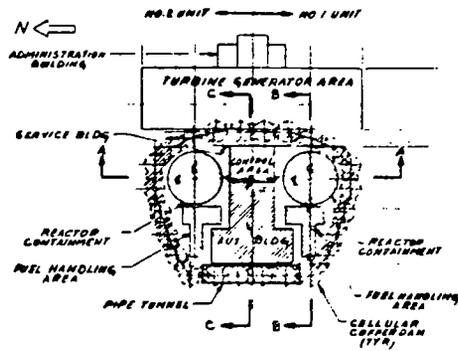
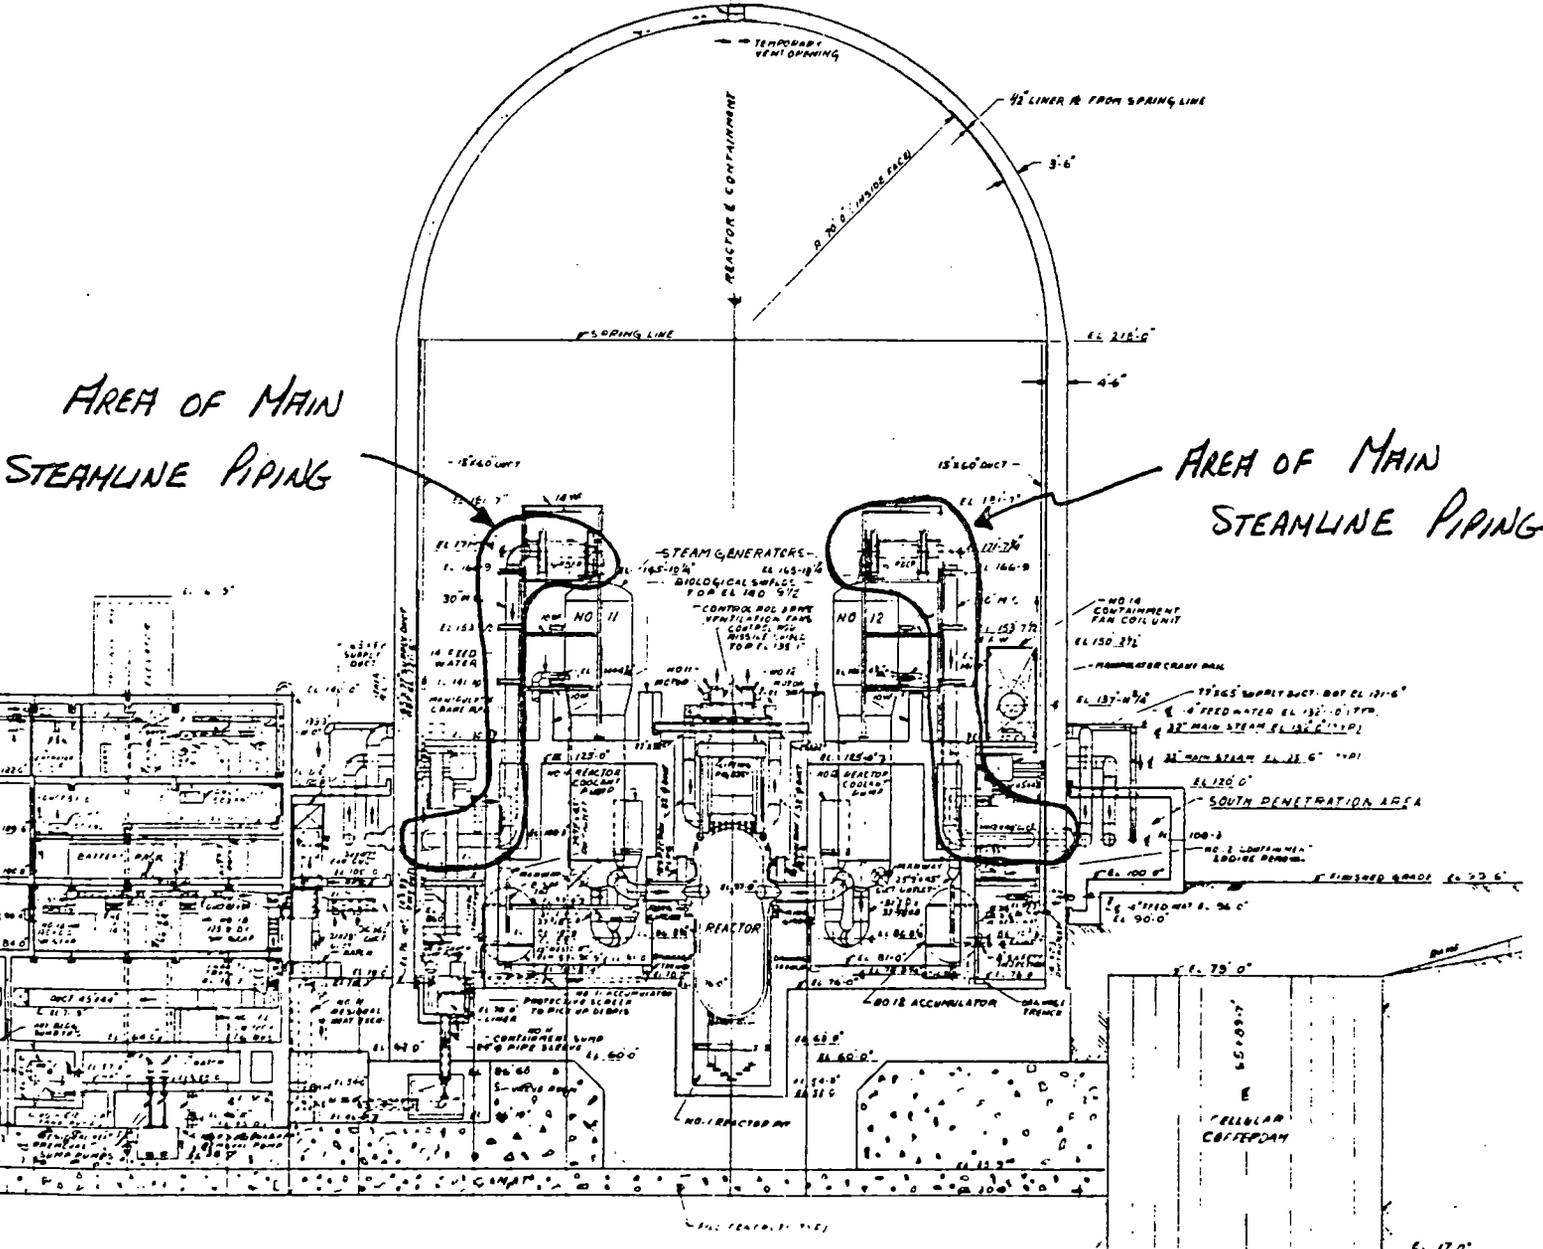
ITEM 4

The power range excore detectors at Salem are physically located in detector wells outside the reactor vessel on centerline with the reactor core (refer to attached figures). The location of the detectors preclude their immediate exposure to an adverse environment resulting from a main steam line break. The detector well is situated in such a fashion as to isolate it from the main containment environment. The equipment and concrete surrounding the detector wells will act as a thermal barrier to limit immediate environmental impact.
