Docket No. 50-272

UNITED STATES  
NUCLEAR REGULATORY COMMISSION  
OFFICE OF INSPECTION AND ENFORCEMENT  
WASHINGTON, D.C. 20555

October 17, 1979  
IE Bulletin No. 79-13  
Revision 2  
Page 1 of 5

CRACKING IN FEEDWATER SYSTEM PIPING

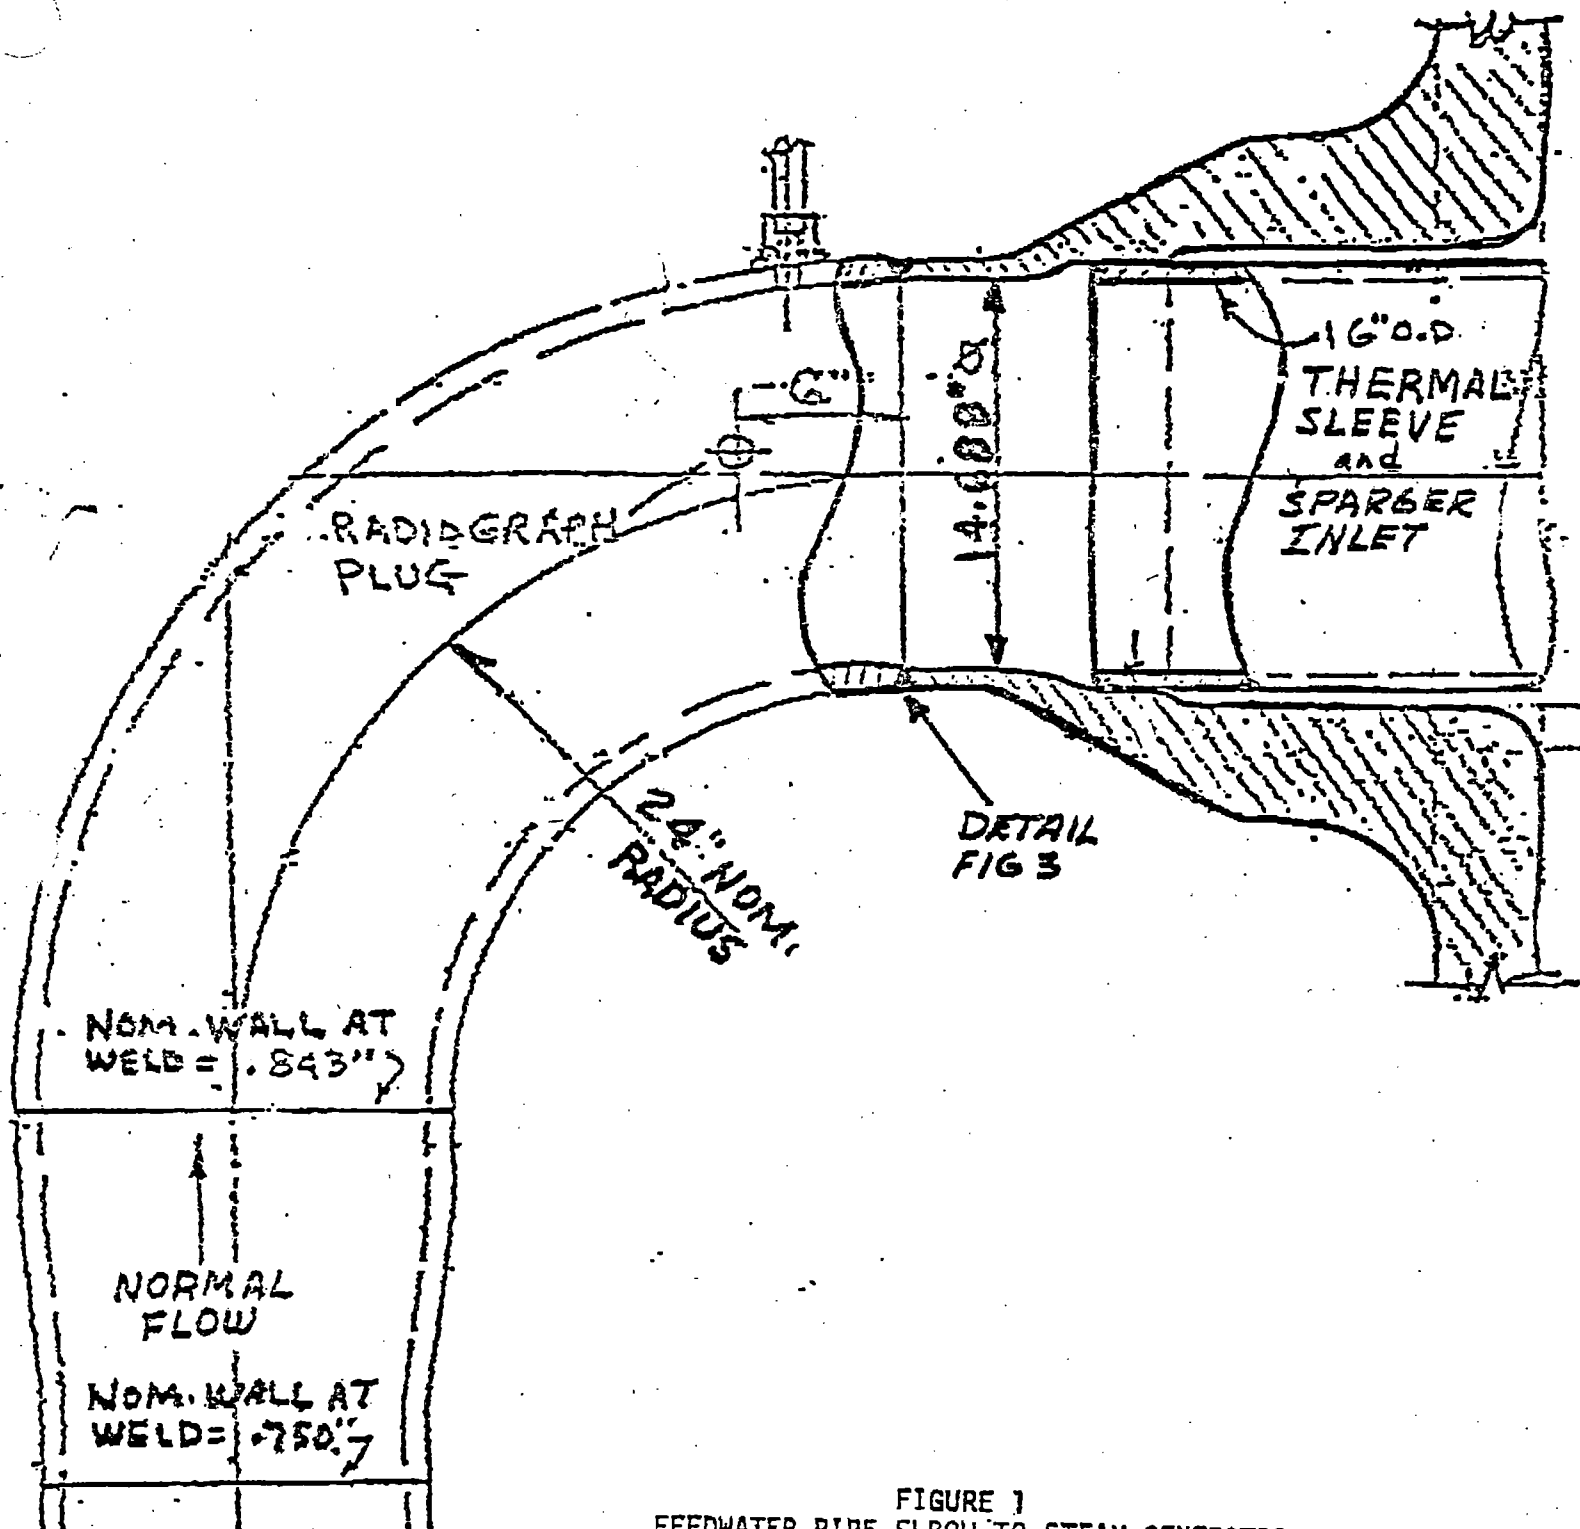
FIGURE 1  
FEEDWATER PIPE ELBOW TO STEAM GENERATOR  
NOZZLE INSTALLATION (DC COOK)

The feedwater nozzle-to-pipe configurations for D. C. Cook and for San Onofre are shown on the attached figures 1 and 2. A typical feedwater nozzle-to-pipe weld joint detail showing the principal crack locations for D. C. Cook and San Onofre are shown on the attached figure 3.

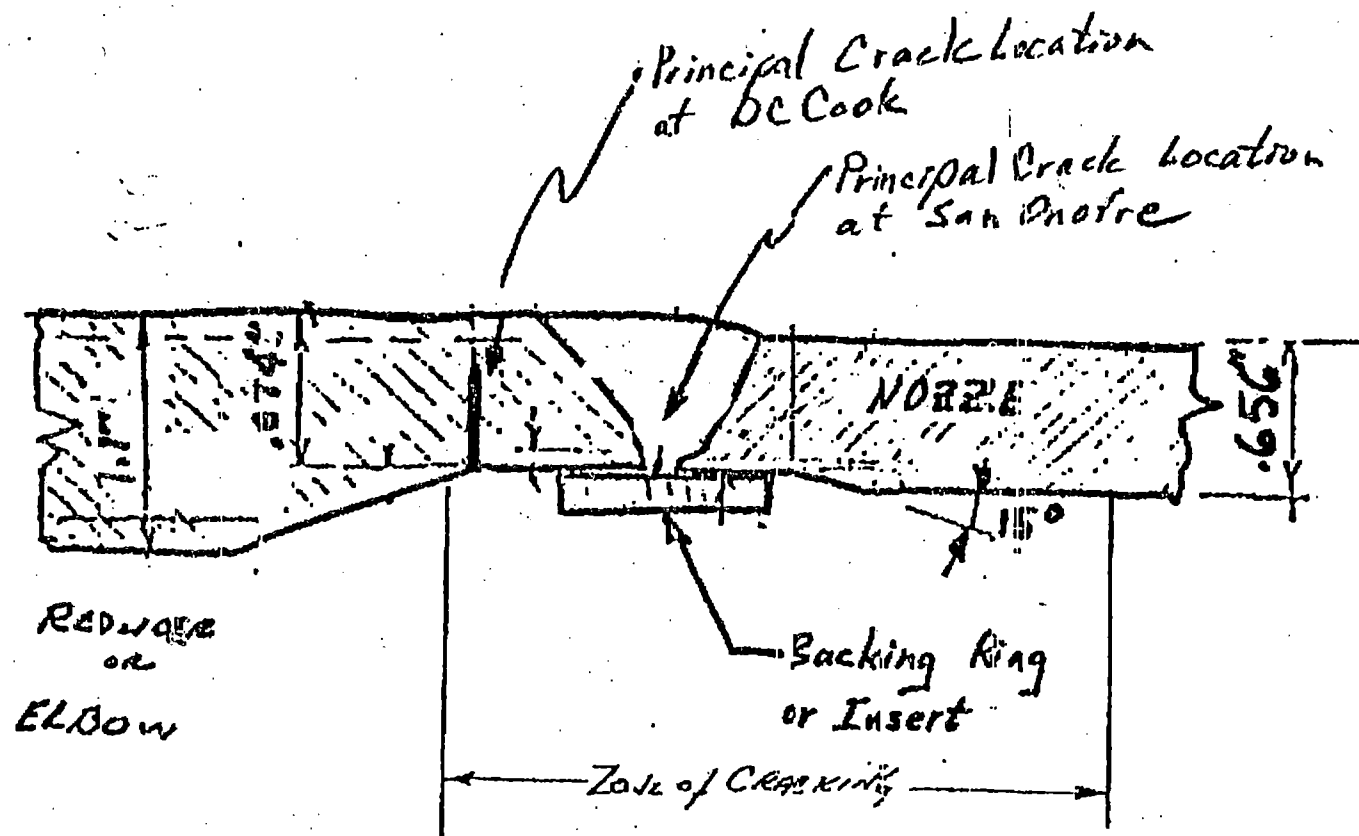
FIGURE 3  
TYPICAL FEEDWATER PIPE TO NOZZLE  
WELD JOINT DETAIL  
( 1 CE )

An extensive metallurgical investigation has been conducted by Westinghouse on a substantial number of cracked weldments removed from the above plants. Results of the metallurgical analysis lead to the conclusion that a corrosion fatigue phenomenon is the probable failure mechanism, except for the San Onofre piping which has been characterized as stress assisted corrosion.

- a. Perform radiographic examination, supplemented by ultrasonic examination as necessary to evaluate indications, of all feedwater nozzle-to-pipe welds and of adjacent pipe and nozzle areas (a distance equal to at least two wall thicknesses). Evaluation shall be in accordance with ASME Section III, Subsection NC, Article NC-5000. Radiography shall be performed to the 2T penetrameter sensitivity level, in lieu of Table NC-5111-1, with systems void of water.
