SUBJECT: TRANSMITTAL OF FINAL COOPER NUCLEAR STATION ACCIDENT
SEQUENCE PRECURSOR REPORT (LICENSEE EVENT
REPORT 298-2017-001-01)

FINAL ACCIDENT SEQUENCE PRECURSOR ANALYSIS

COOPER NUCLEAR STATION

CONCURRENT UNAVAILABILITIES—RESIDUAL HEAT
REMOVAL LOOP A, REACTOR CORE ISOLATION COOLING,
AND EMERGENCY STATION SERVICE TRANSFORMER
(LER 298-2017-001-01) - PRECURSOR

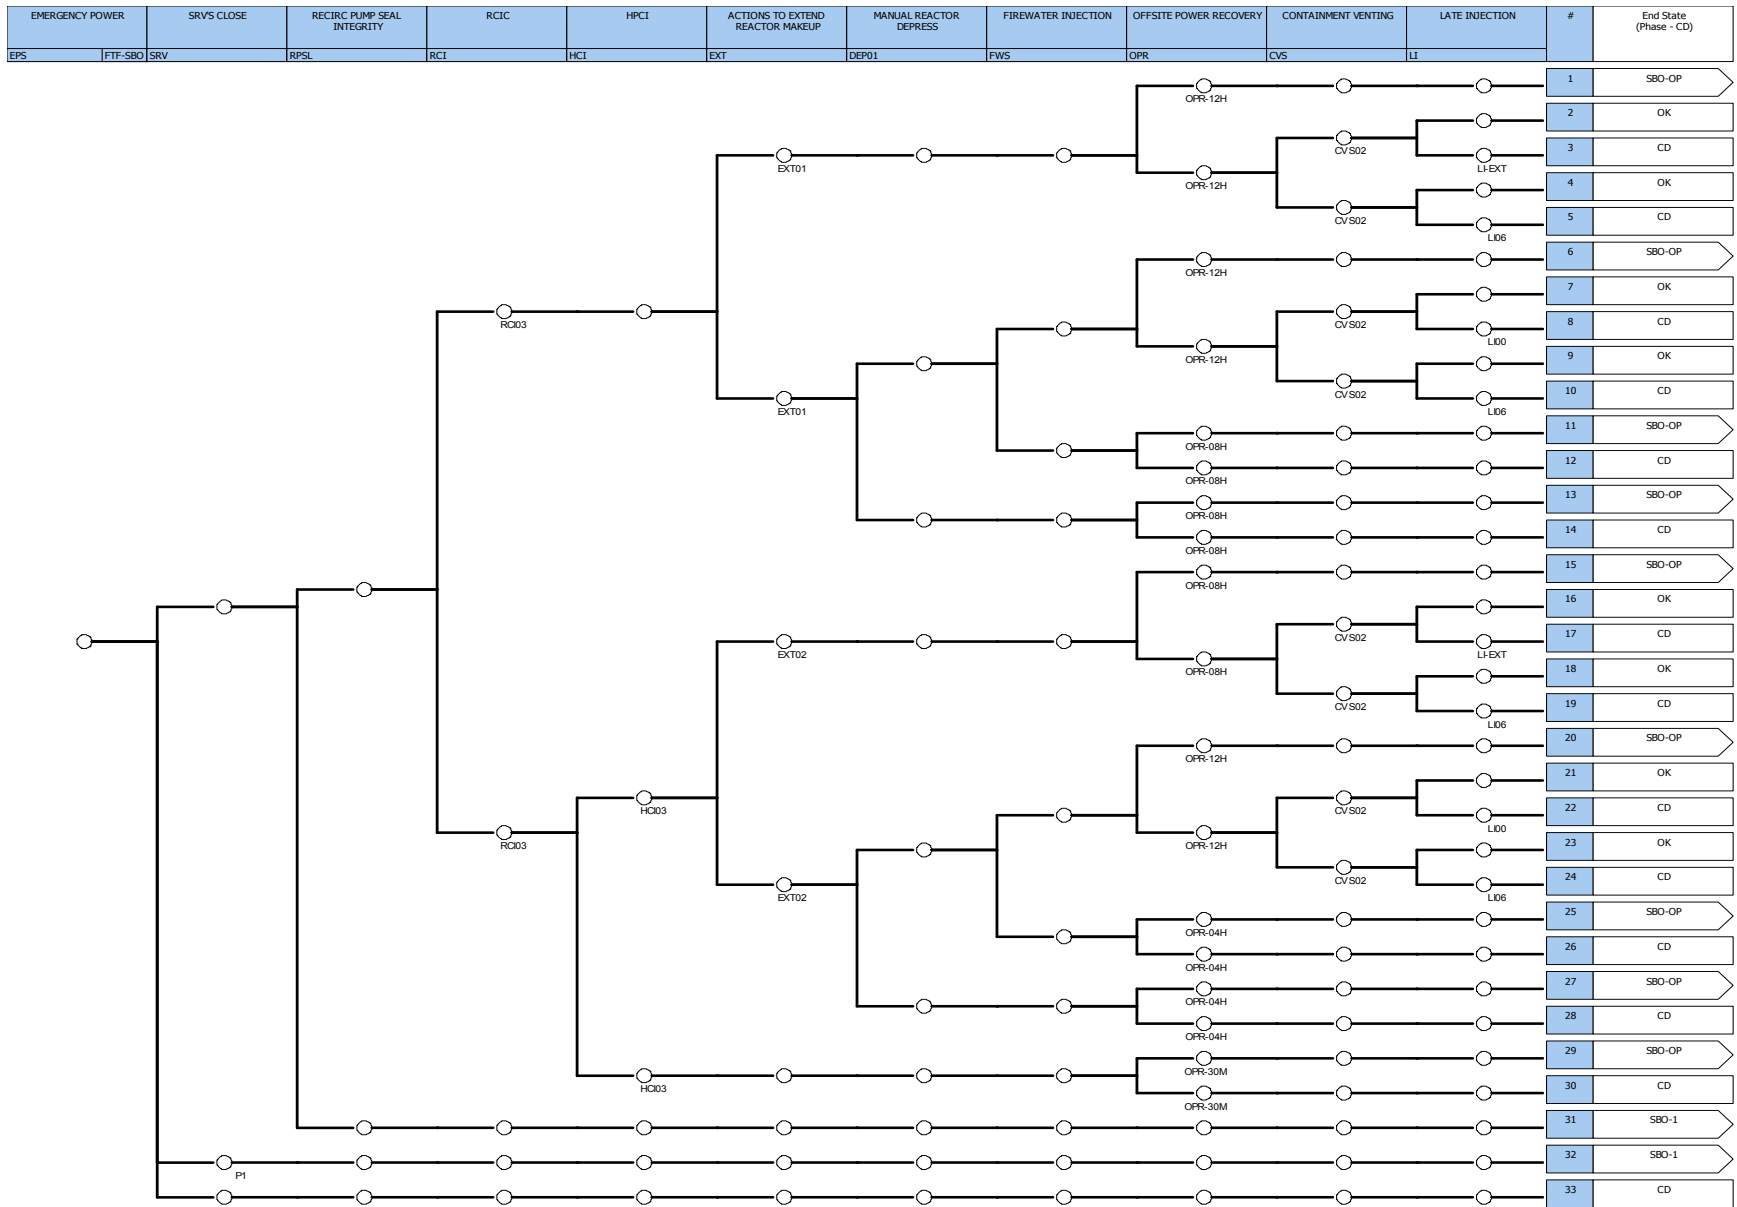
Figure A-3. Revised Cooper SBO Event Tree

Dominant Sequence. The dominant accident sequence is TRANS Sequence 74-37-28 (ΔCDP = 5.6×10^{-7}) that contributes approximately 10 percent of the total internal events ΔCDP. Figures A-1 through A-3 in [Appendix A](#) illustrate this sequence. The dominant sequences that contribute at least 1 percent of the total internal events CDDP are provided in the following table:

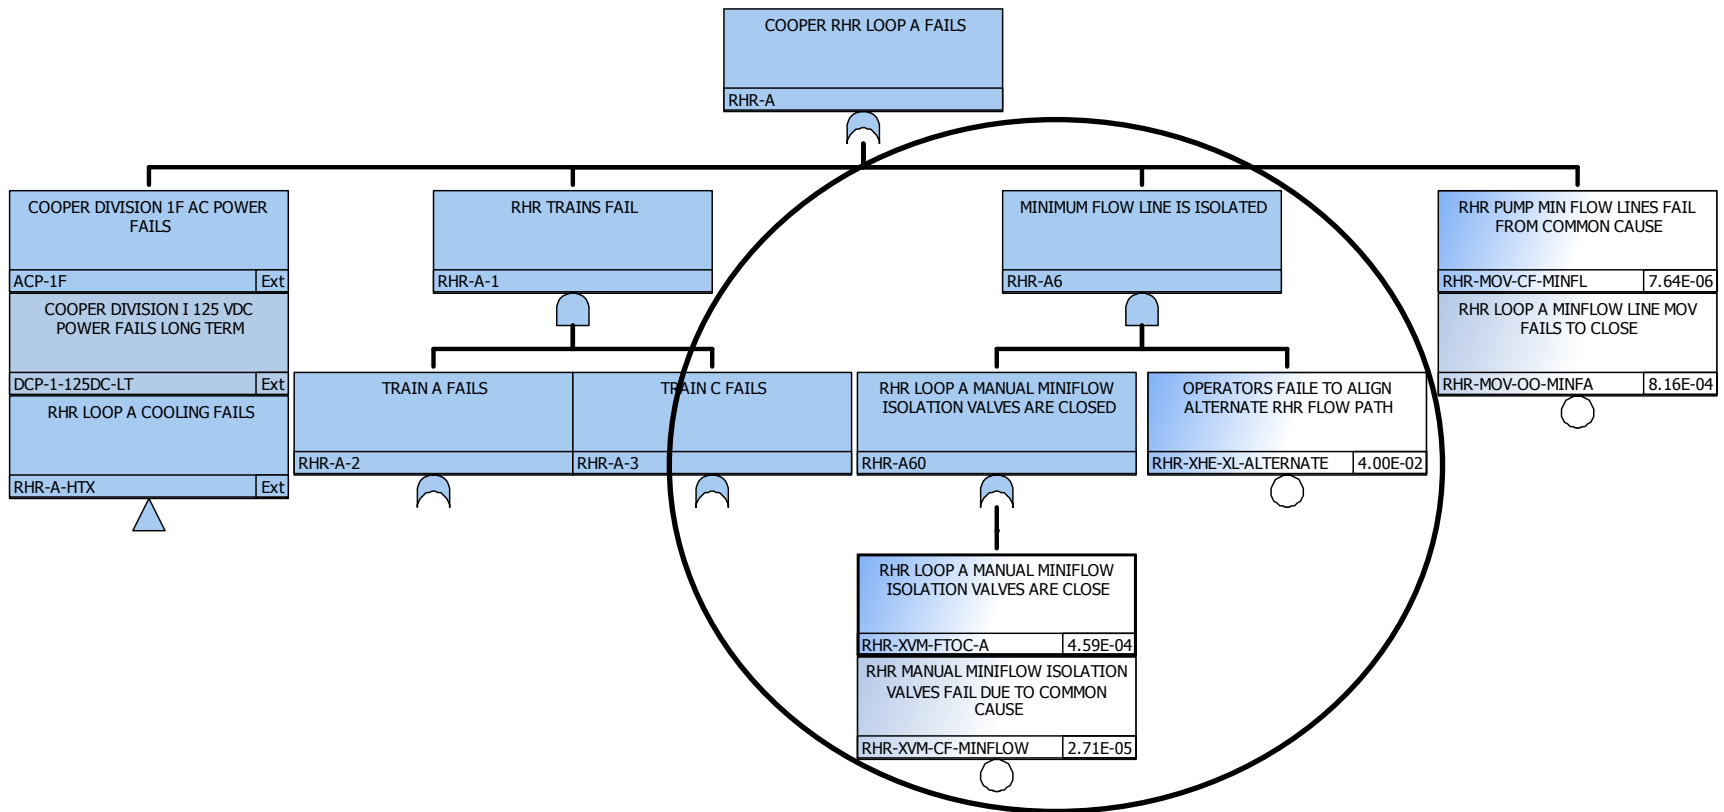
Figure B-1. Modified RHR-A Fault Tree

- Modifications were made to the applicable RHR fault trees. The RHR-A (*Cooper RHR loop A fails*) fault tree was modified to provide credit for operators aligning an alternate flow path (i.e., suppression pool cooling) and to account for potential common-cause failure (CCF) of the manual valves in the RHR minimum flow lines. A new 'AND' gate RHR-A6 (*minimum flow line is isolated*) was inserted under existing gate RHR-A (*Cooper RHR loop A fails*). Gate RHR-A60 (*RHR loop A miniflow isolation valves are closed*) was inserted under new 'AND' gate RHR-A6. Similar fault tree changes were made to the RHR-B (*Cooper RHR loop B fails*) fault tree. New basic events, RHR-XVM-FTOC-A (*RHR loop A miniflow isolation valves are closed*) and RHR-XVM-FTOC-B (*RHR loop B miniflow isolation valves are closed*), were inserted

under gates RHR-A60 and RHR-B60 (*RHR loop B miniflow isolation valves are closed*), respectively. The failure probabilities of these valves were set using template event ZT-AVM-FTOC (*manual valve fails to open*), which has a probability of 4.59×10^{-4} . A new basic event, RHR-XHE-XL-ALTERNATE (*operators fail to align alternate RHR flow path*), was inserted under gates RHR-A6 and RHR-B6. The failure probability of this basic event was set to 4.0×10^{-2} , per SPAR-H analysis described below, to provide for operator recovery credit to align an alternate RHR flow path. The RHR loop 'A' manual isolation valves for minimum flow that were incorrectly in the closed position were considered to be part of a common-cause component group (CCCG) with the similar valves in RHR loop 'B'.⁴ To create the CCF event, basic events RHR-XVM-FTOC-A and RHR-XVM-FTOC-B were used to create a new basic event, RHR-XVM-CF-MINFLW (*RHR manual miniflow isolation valves fail due to common-cause*), was inserted under gates RHR-A60 and RHR-B60 to account for potential CCF of the manual minimum flow isolation valves for loops 'A' and 'B'. The changes made in the RHR-A and RHR-B fault trees were made to the applicable SPC and low-pressure core injection (LPCI) fault trees. The revised RHR-A, RHR-B, SPC-A (*cooper RHR loop A fails*), SPC-B (*cooper RHR loop B fails*), LCI-A (*Cooper LPCI train A fails*), and LCI (*Cooper LPCI train B fails*) fault trees are provided in Figures B-1 through B-6 in [Appendix B](#).

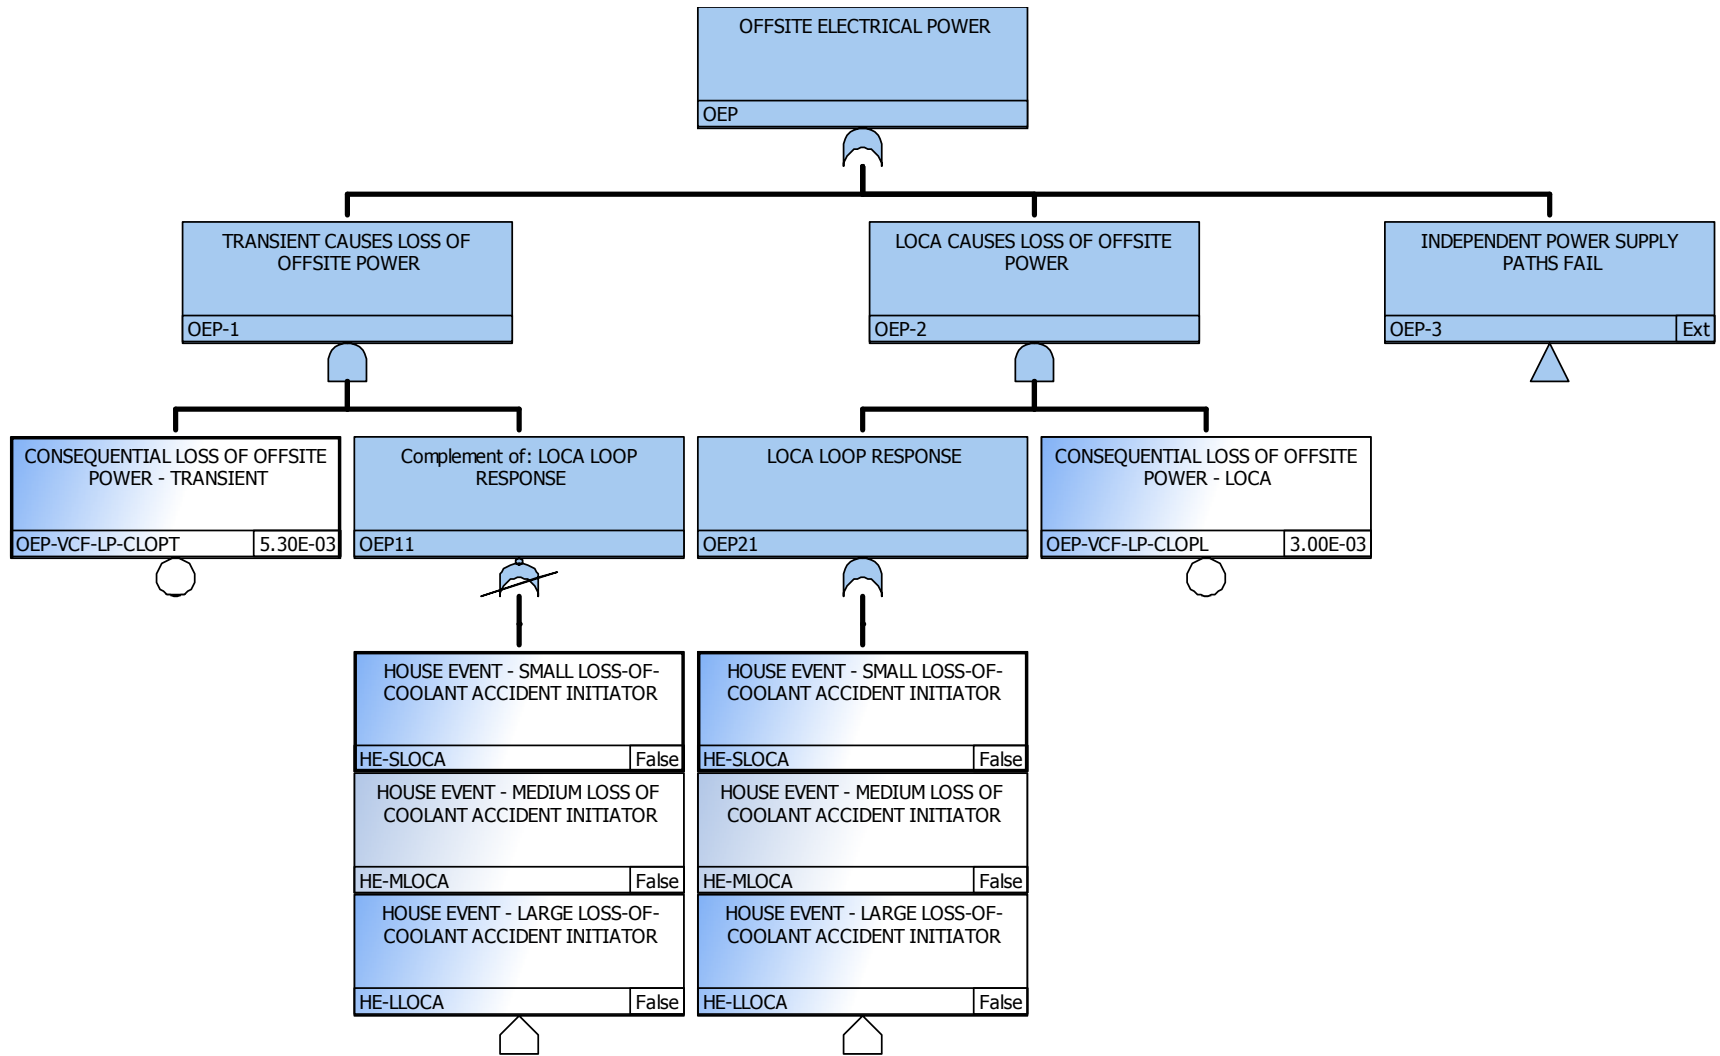
Figure B-7. Modified OEP Fault Tree

- Modifications were made to the ACP-1F-SWY (Cooper switchyard AC service to bus 1F), ACP-1G-SWY (Cooper switchyard AC service to bus 1G), OEP (offsite electrical power), OEP-3 (independent power supply paths fail), DGS (supplemental diesel generator faults), OPR (offsite power recovery), OPR-30M (offsite power recovery in 30 minutes), OPR-04H (offsite power recovery in 4 hours), OPR-08H (offsite power recovery in 8 hours), and OPR-12H (offsite power recovery in 12 hours) fault trees in a similar manner as in Attachment 2 in [IR 05000298/2017011](https://www.nrc.gov/reading-rm/doc-collections/ir/ir05000298/2017011). The revised ACP-1F-SWY,

ACP-1G-SWY, OEP, OEP-3, DGS and OPR fault trees are provided in Figures B-7 through B-12 in [Appendix B](#).

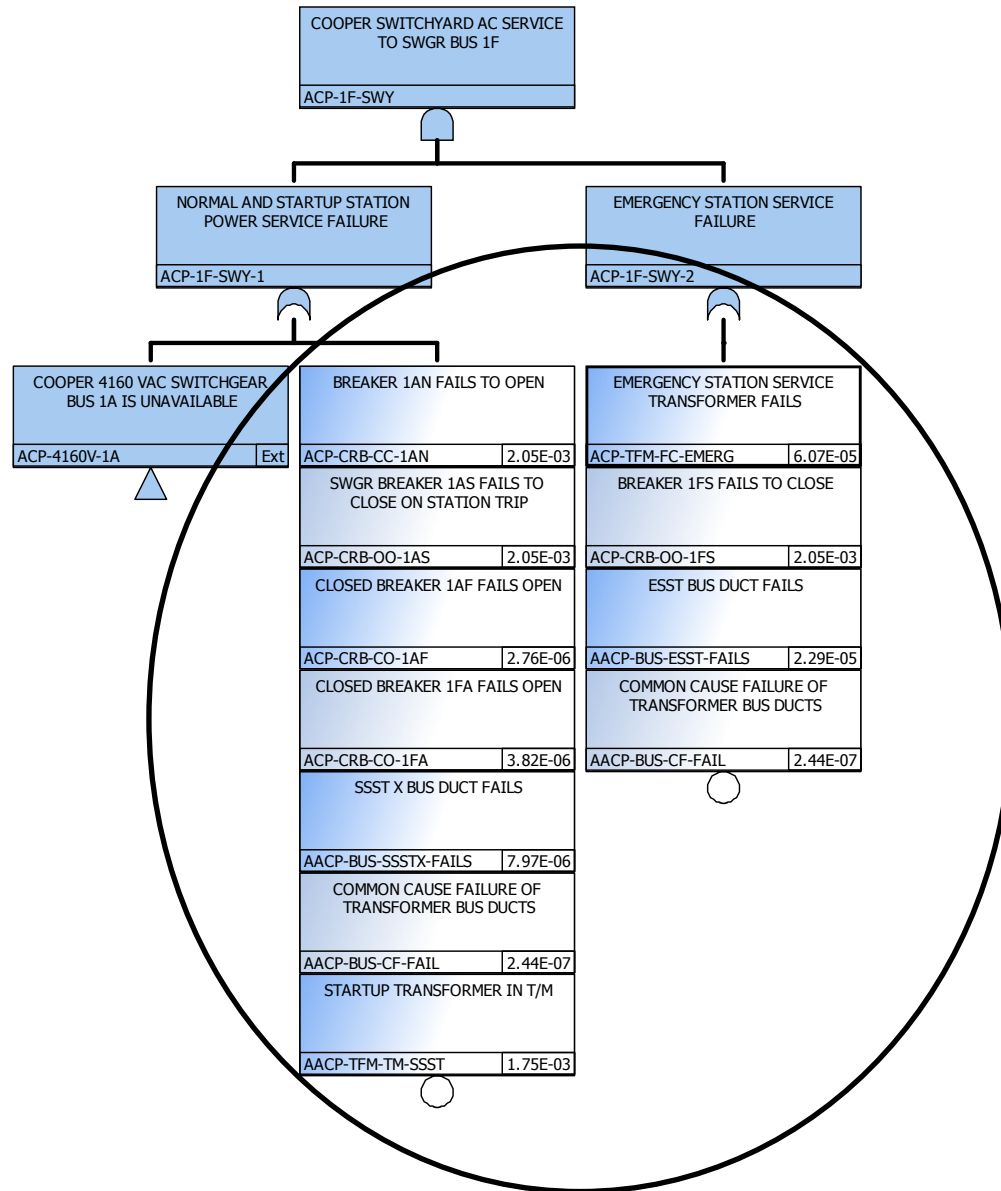
Figure B-8. Modified ACP-1F-SWY Fault Tree

- A new CCF basic event, AACP-BUS-CF-FAIL (*common-cause failure of transformer bus ducts*), representing the CCF of the ESST and SSST-X bus work was created. The common cause alpha factors, ZA-CCF-RATE-02A01 (*alpha factor 1 in group size 2 for component CCF with failure mode rate*) and ZA-CCF-RATE-02A02 (*alpha factor 2 in group size 2 for component CCF with failure mode rate*), were applied. These generic alpha factors for a CCG size of two are used because bus-work failure data is not explicitly collected and estimated for the SPAR models. This CCF basic event was inserted under existing 'OR' gates ACP-1F-SWY-1,

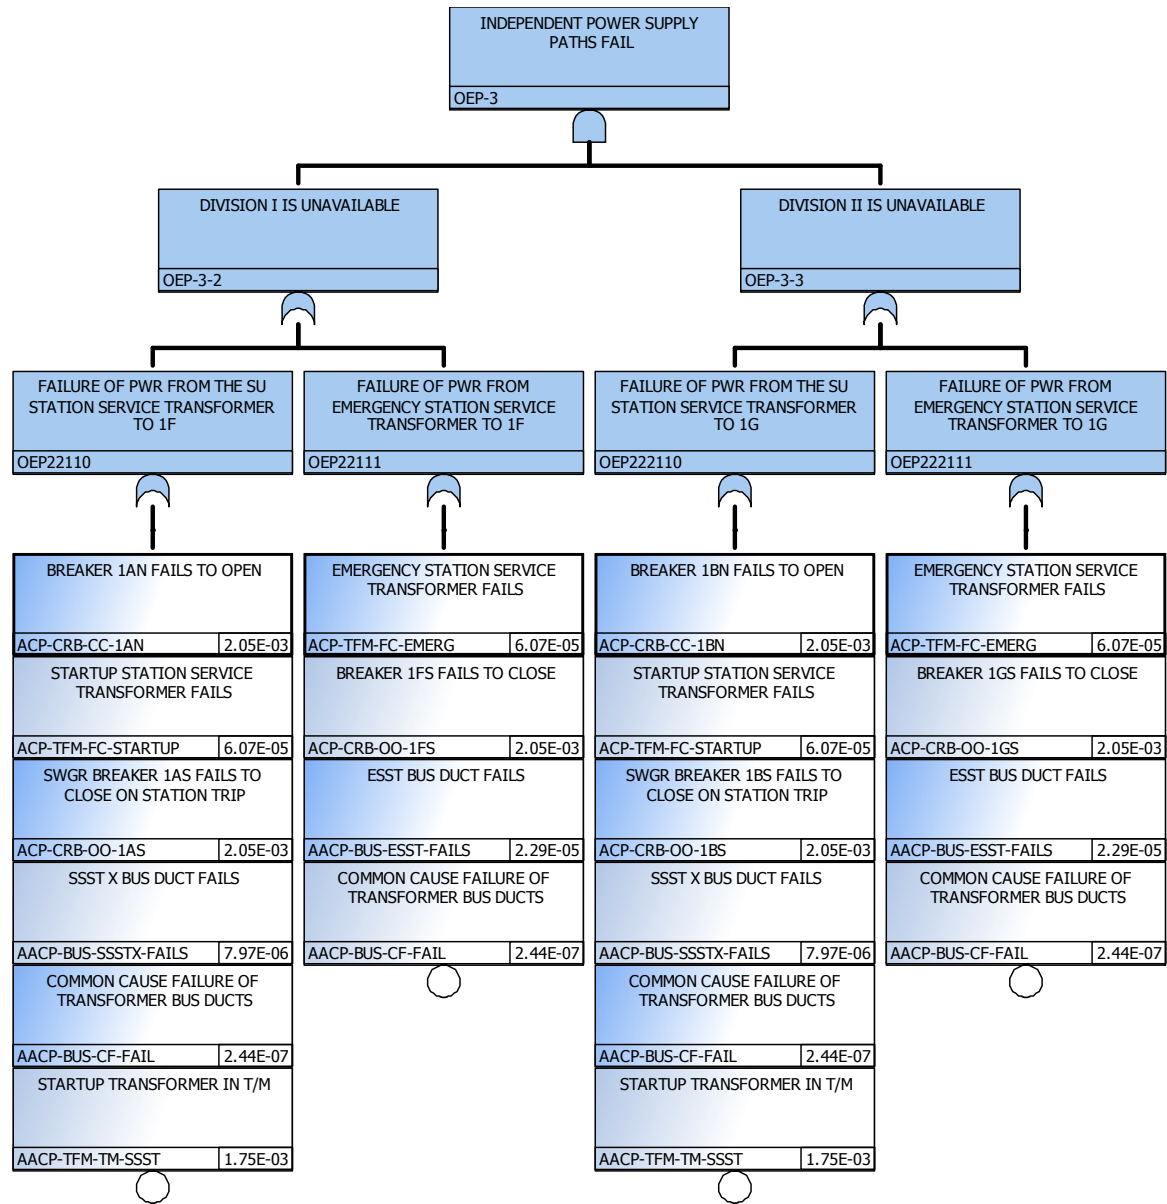
Figure B-10. Modified OEP-3 Fault Tree

- The OEP-3 fault tree was converted to transfer gate within the OEP fault tree.
- The nonsegregated bus work between the motor-operated disconnect associated with the ESST and electrical safety buses 1F and 1G is not included in the base SPAR model and is needed for this analysis. Therefore, new basic event AACP-BUS-ESST-FAILS (*ESST bus duct fails*) was created in the SPAR model using template ZT-BAC-LP (*AC bus fails to operate*). This basic event was added to the ACP-1F-SWY and ACP-1G-SWY fault trees under existing 'OR' gates ACP-1F-SWY-2 (*emergency station service failure*) and ACP-1G-SWY-2 (*emergency station service failure*). This basic event was also added to the OEP fault tree under existing 'OR' gates OEP22111 (*failure of power from ESST to 1F*) and OEP222111 (*failure of power from ESST to 1G*). Similarly, a new basic event, AACP-BUS-SSSTX-FAILS (*SSST-X bus duct fails*), representing the bus work from the X-winding of the SSST feeding the plant (which did not fail the SDG but was unavailable due to the failure of the ESST bus duct) was created using template ZT-BAC-LP and inserted under fault trees ACP-1F-SWY and ACP-1G-SWY as well under existing 'OR' gates OEP22110 (*failure of power from the startup station service transformer to 1F*) and OEP222110 (*failure of power from the startup station service transformer to 1G*) within the OEP-3 fault tree. In addition, basic event AACP-BUS-ESST-FAILS was inserted under the top gate of the DGS fault tree given the supplemental diesel generator would be unavailable given a bus duct failure.

ACP-1G-SWY-1, OEP22110, OEP222110, OEP22111, and OEP222111 within the OEP-3 fault tree.

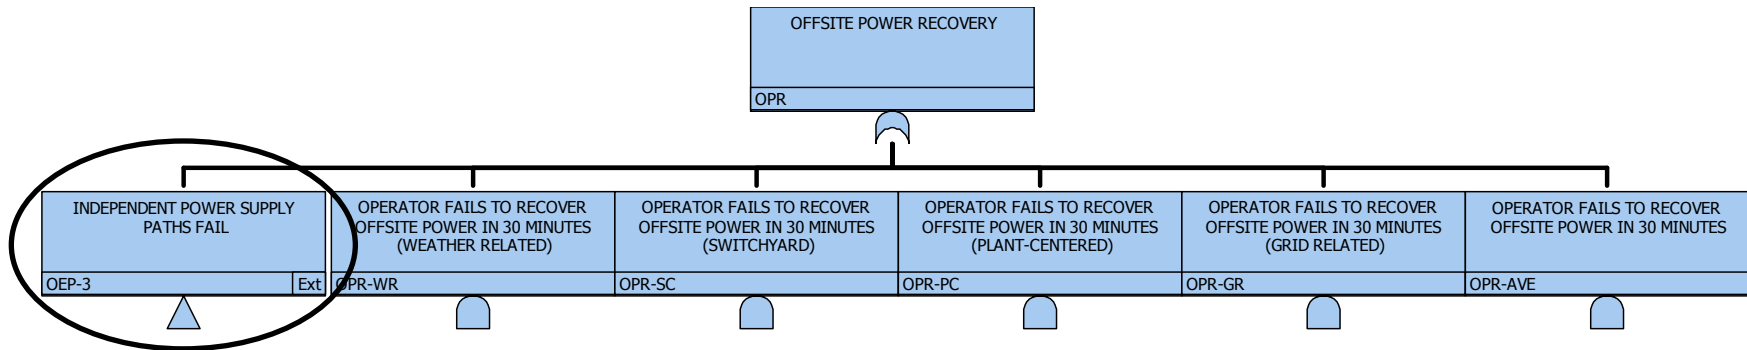
Figure B-12. Modified OPR Fault Tree (same change made for OPR-30M, OPR-04H, OPR-08H, and OPR-12H Fault Trees)

- The OEP-3 transfer tree was inserted under the existing top gate for the OPR-30M, OPR-04H, OPR-08H, and OPR-12H fault trees.
- In ASP analyses, recovery credit for EDG failures is limited to cases where event information supports credit for EDG recovery. Therefore, the DGR (diesel generator recovery) top event (including applicable event tree branching) was eliminated from the station blackout (SBO) event tree. The revised SBO event tree is shown in [Figure A-3](#).
- The basic event SPC-XHE-XL-NOREC (*late recovery of suppression pool cooling fails*) was set to TRUE. The base model probability of 0.5 is only used for benchmarking purposes.
