UNITED STATES
NUCLEAR REGULATORY COMMISSION
WASHINGTON, D. C. 20555

June 2, 1983

Your March 4, 1983 letter requested information and specific responses to questions concerning the events which occurred at the Salem Nuclear Generating Station, Unit 1, on February 22 and 25, 1983. The responses to your questions are enclosed.

Reactor Trip Breakers Failed To Open On RPS Trip Signal

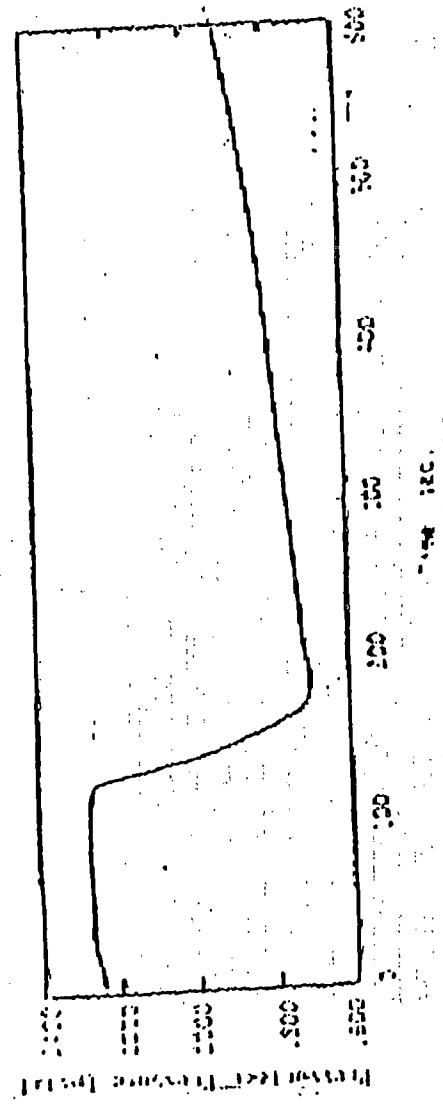
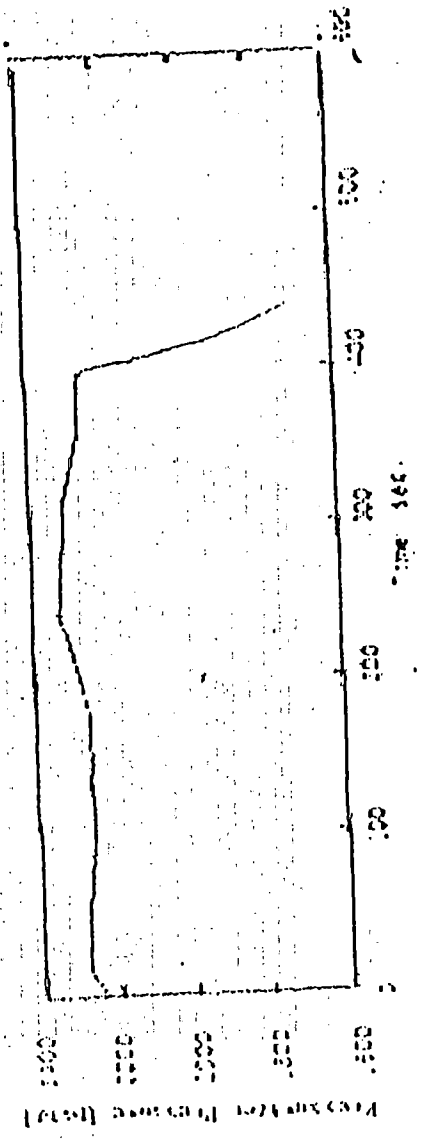
As in the previous case, the heatup of the primary coolant caused a turbine runback initiated by an Overpower Delta-T signal. The turbine load is reduced twice in 5% increments until the load is 90% of nominal load. Steam pressure starts to drop due to the boil off of water in the steam generators, generating a low steam pressure alarm. At this time primary pressure starts to increase and there is an surge into the pressurizer, causing both pressurizer high level and pressure trip alarms to be actuated. The steam generator tube bundle begins to uncover, causing a larger rate of increase in primary pressure and temperature. The pressurizer fills and the peak pressure reached is 3491 psia. Nuclear power has decreased at this point to about 30% of nominal due to the negative moderator temperature reactivity feedback. As the relief rate of water through the relief and safety valves increases, the primary system pressure starts to decrease and the safety and relief valves close about 30 seconds after the time of peak pressure. The operator trips the reactor manually at 333 seconds.

30 Seconds Delay Before TPO

300 Seconds Delay Before TPO

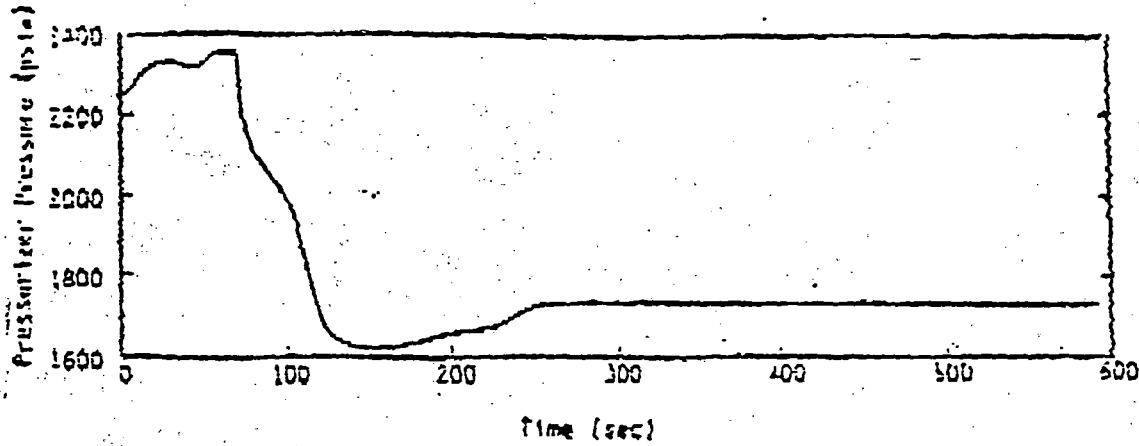
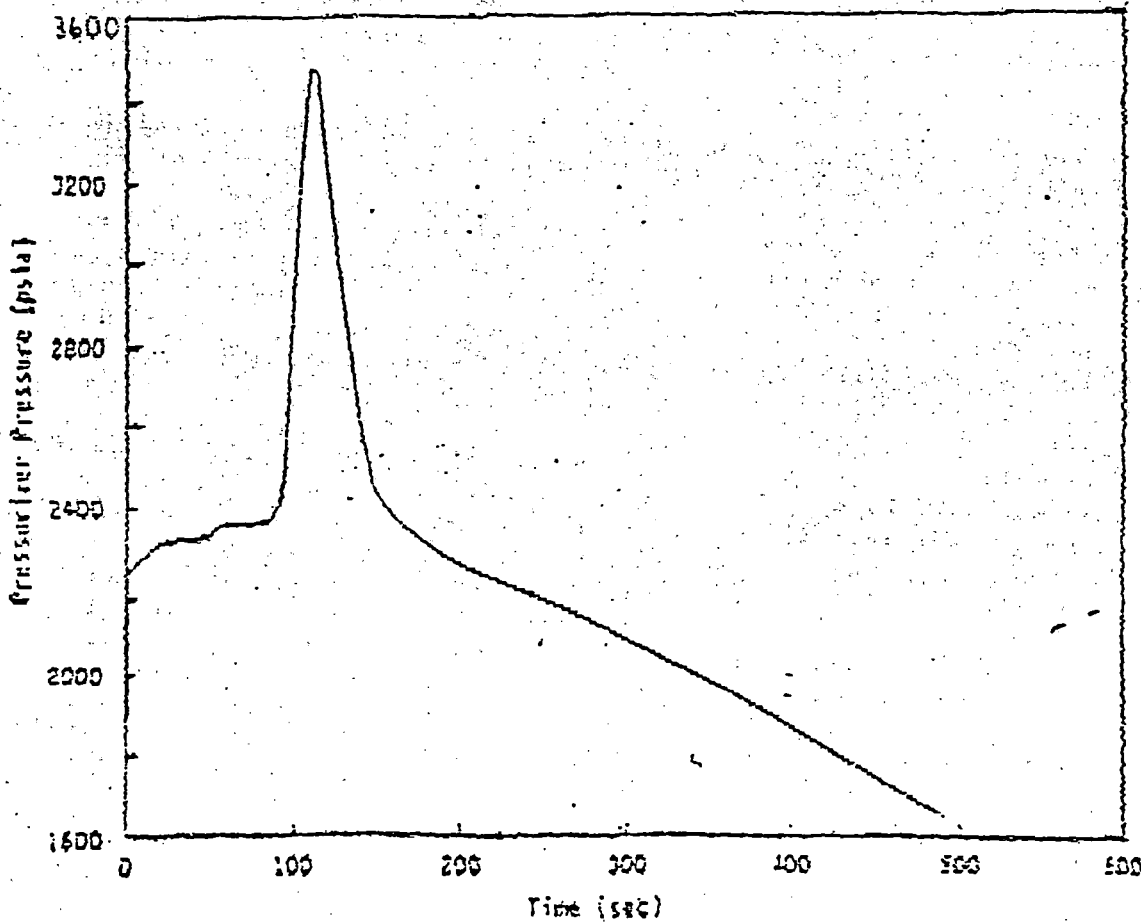
FIGURE 2

It should be noted that the core nuclear characteristics (a moderator reactivity coefficient of $-8 \text{ pcm}/^\circ\text{F}$) used are not representative of the actual core design for the Salem Plant. Previous AT&S analyses have shown the peak pressure to be a strong function of the coefficient and there is a 100 psi reduction for every 1 pcm decrease in the coefficient. The Salem core is designed to operate such that by the time the plant reached full power it would have a coefficient of $-10.5 \text{ pcm}/^\circ\text{F}$ or 2.5 pcm less than the coefficient in the study. This coefficient would be reduced even further by approximately $2 \text{ pcm}/^\circ\text{F}$ per month of operation (see Figure 3). The 10.5 pcm coefficient results in a peak pressure for the limiting case of five minute operator action of 3241 psia (a 250 psia reduction from 3491 psia) which is within the calculational band of the ASME Stress Level C limit. Therefore, the case represented in Figure 2 would not exceed the acceptance criteria.

Pressure Transient - Loss of All Main Feed Water

30 Seconds Delay Before Trip

300 Seconds Delay Before Trip

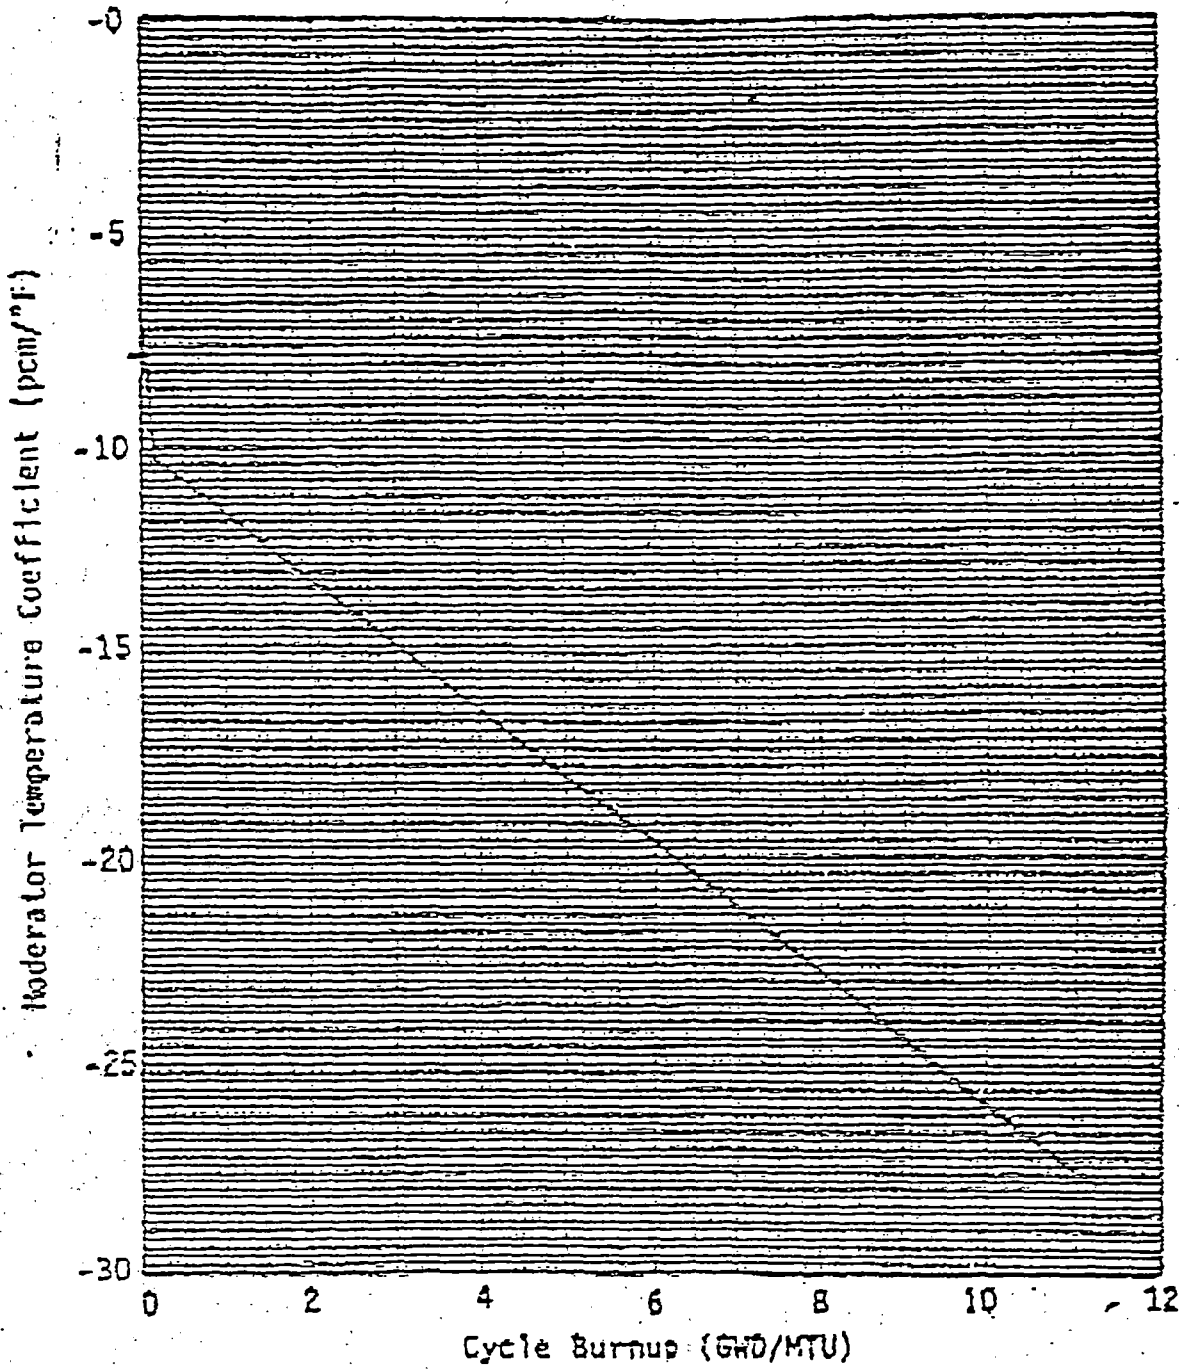
FIGURE 3

1. Initial normal full power operation at beginning of core life. This corresponds to the current condition of the Salem Plant and is also the limiting condition since the moderator temperature coefficient is at its least negative value. A value of $-8 \text{ pcm}/^\circ\text{F}$, which is valid for 95% of core life, was assumed.

MODERATOR TEMPERATURE COEFFICIENT DURING CYCLE 5
AT HFP, ARO, EQUILIBRIUM XENON CONDITIONS *
