Report No. AEOD/P301  
Date July 1983

Report  
on  
The Implications of the ATWS  
Events at the Salem Nuclear Power  
Plant on the NRC Program for  
Collection and Analysis of  
Operational Experience

Office for Analysis and Evaluation  
of Operational Data  
U.S. Nuclear Regulatory Commission

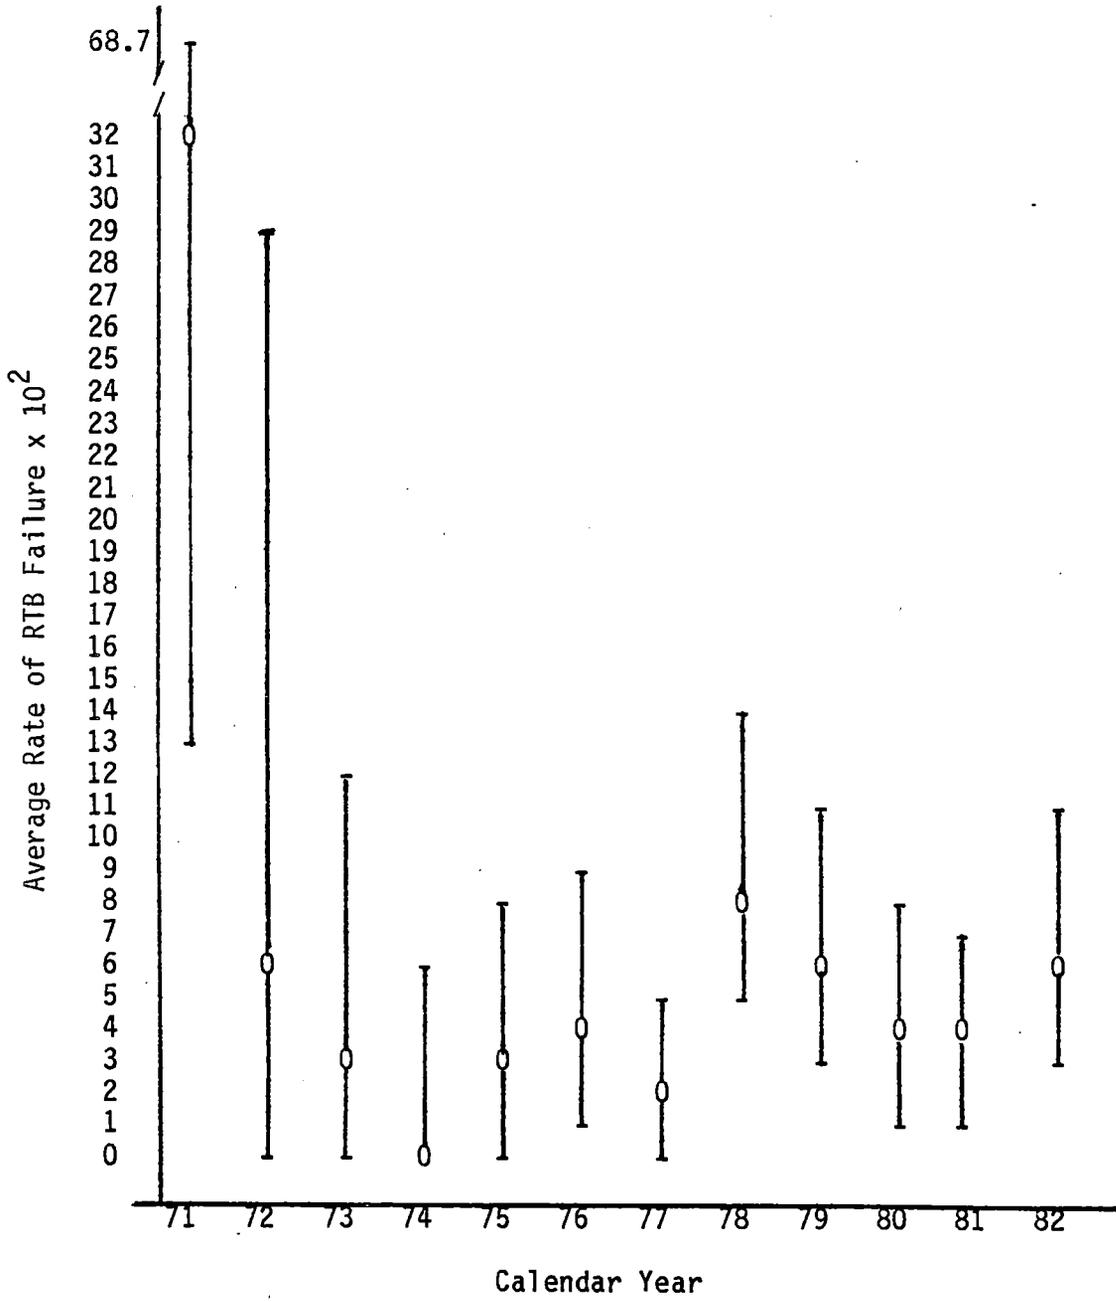
Average Rate of RTB Failure Versus Time

When the error bounds are taken into account, Figure 3.1 shows only one marginally significant "trend"; e.g., a shift upward in 1978 when looking at pairs of preceding/succeeding years, as an individual monitoring for short term indications would. A look at the entire time series shows that 1971 was significantly different from the years 1972-1982 taken as a group.

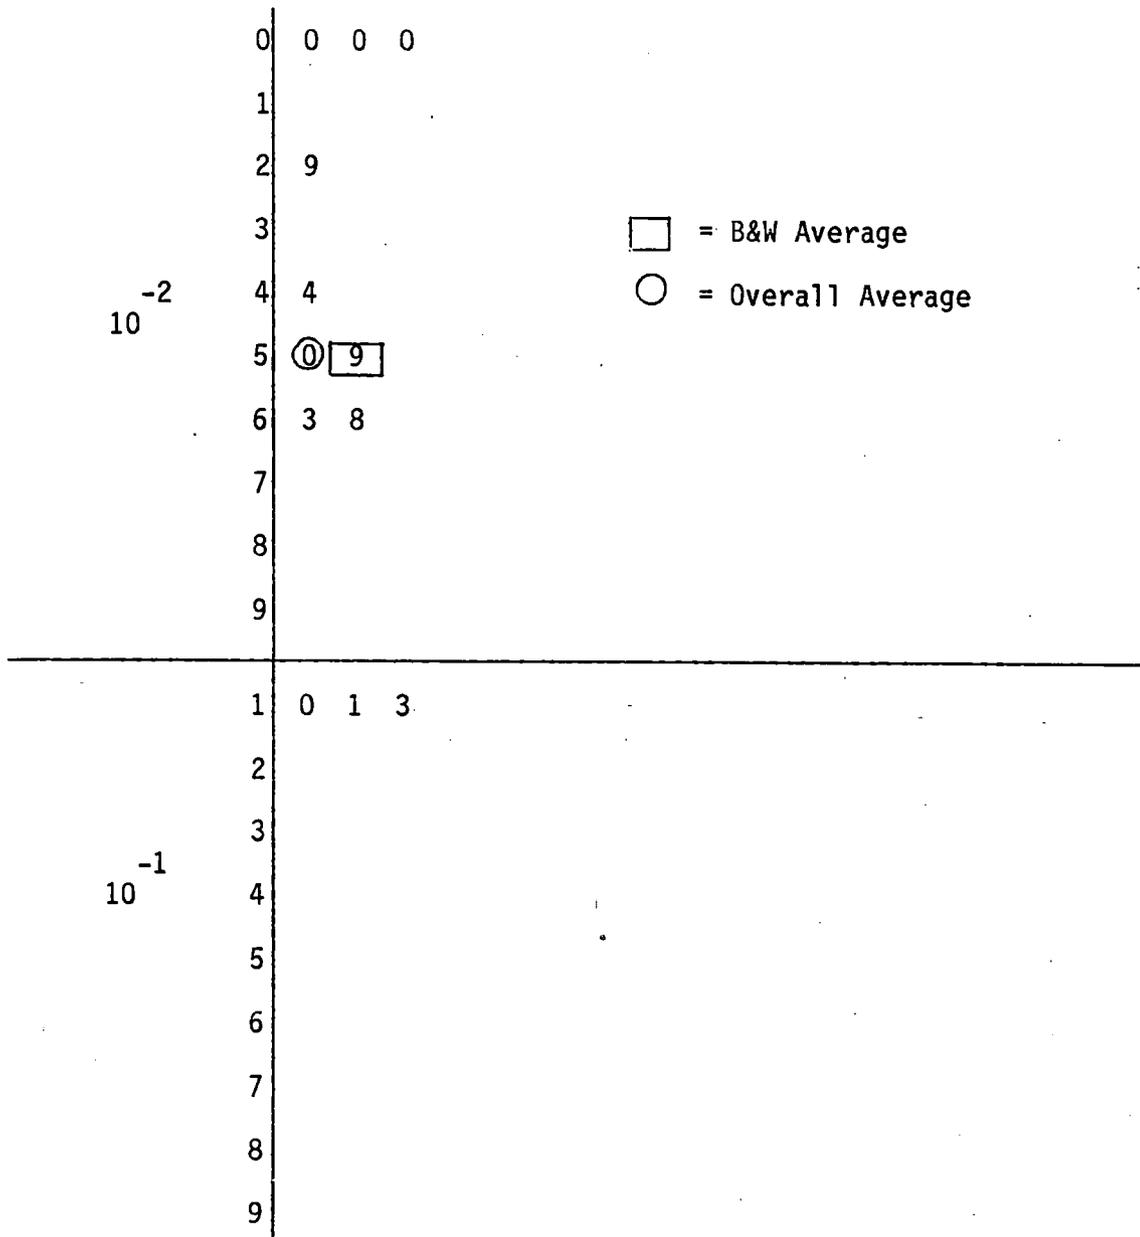
Figure G.1

RTB Failure Rate Per Breaker Year - B&W Plants

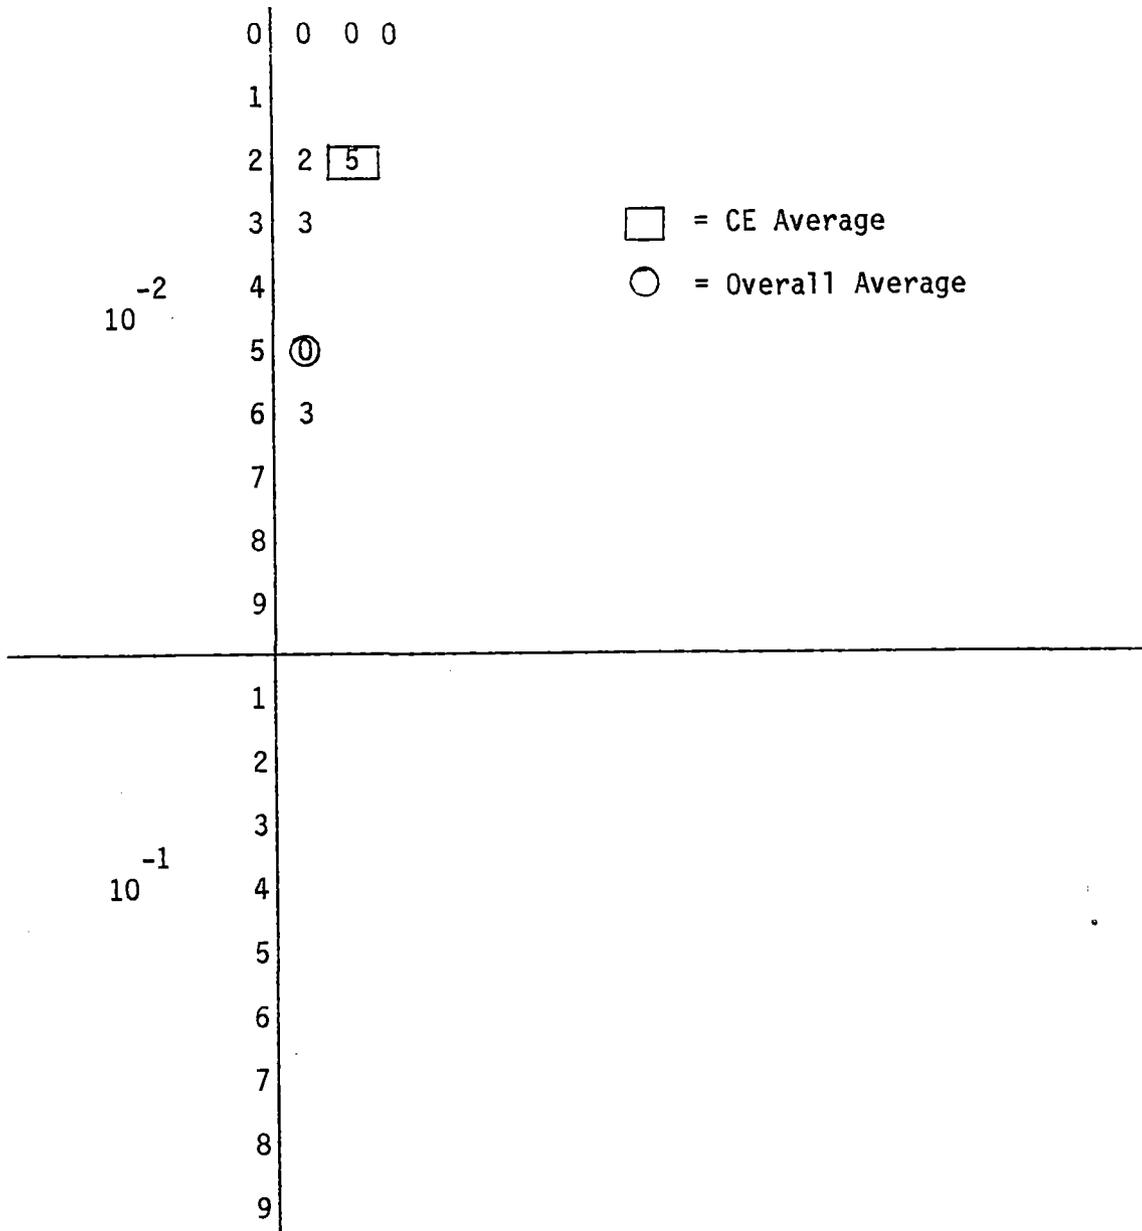
Figure G.3

RTB Failure Rate Per Breaker Year - CE Plants
