AEOD ENGINEERING EVALUATION REPORT*

UNIT: Salem 1 & 2
DOCKET NOS. 50-272, 50-311
LICENSEE: Public Service Electric and Gas Co.
NSSS/AE: Westinghouse/PSE&G

EE REPORT NO. AEOD/E319
DATE: August 15, 1983
EVALUATOR/CONTACT: E. V. Imbro

SUBJECT: BIOFOULING AT SALEM UNITS 1 AND 2

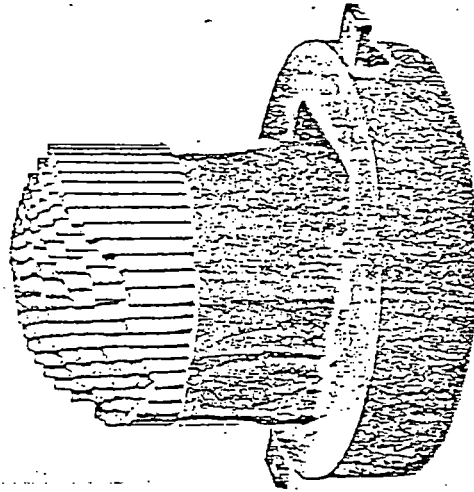
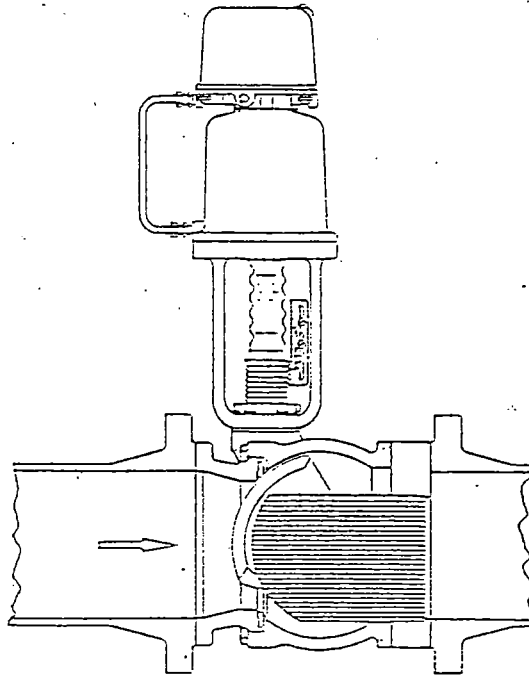
Figure 1

through the CFCUs to silt accumulation, it appears that these blockages may have been a result of shell impingement on the tube bundle. There is no way to differentiate between the causes of flow blockage unless the valve is disassembled. The licensee has determined that the tube bundles in these valve are not essential for cavitation control under the actual operating conditions and is considering removing them.
