AEOD TECHNICAL REVIEW REPORT*

UNIT: Salem 2 EE REPORT NO. AEOD/E509
DOCKET NO.: 50-311 DATE: July 25, 1985
LICENSEE: Public Service Electric and Gas Company EVALUATOR/CONTACT: R. Freeman
NSSS/AE: Westinghouse/Public Service Electric and Gas Company
SUBJECT: SALEM UNIT 2 DEPRESSURIZATION EVENT
EVENT DATE: July 25, 1984

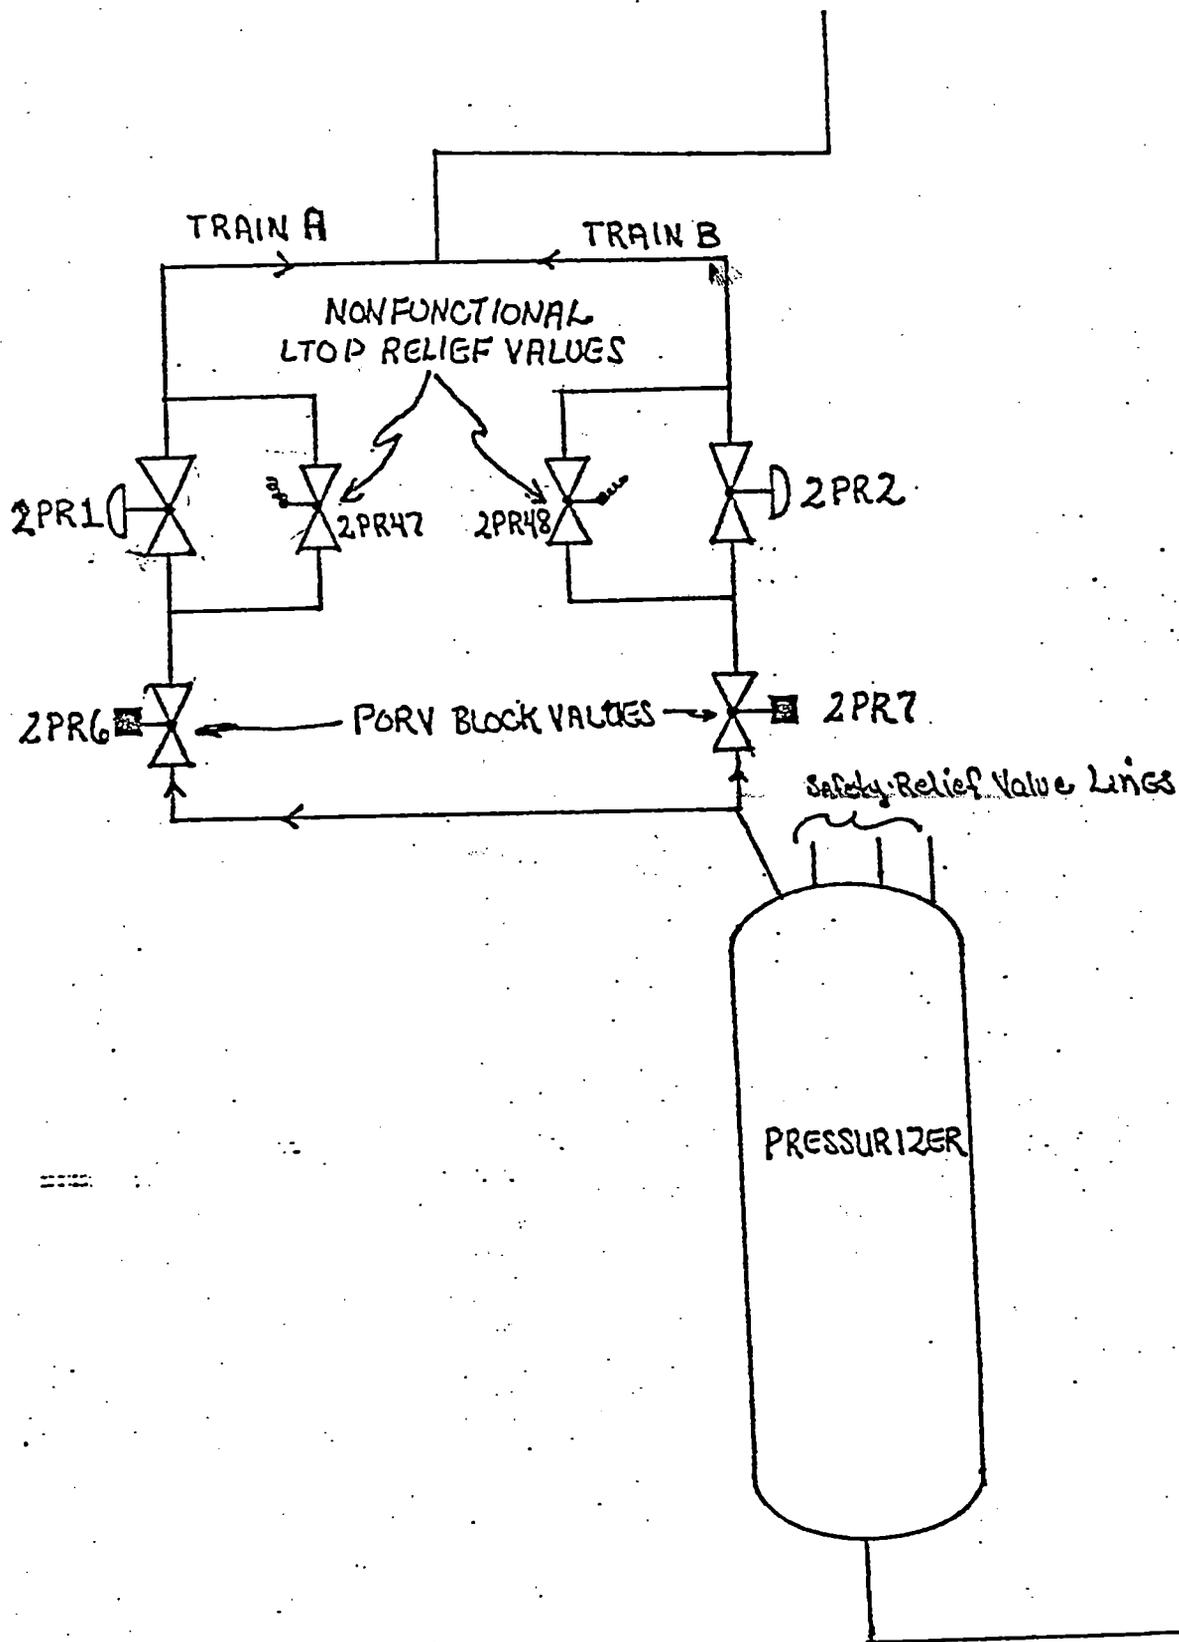
FIGURE 1.

Figure 1 shows a schematic of the Salem Unit 2 pressurizer overpressure protection system (POPS) relief system. As shown in the Figure, the Unit 2 design initially utilized two Maratta pilot-operated solenoid relief valves connected in parallel with the existing PORVs for overpressure protection at low temperature. The depressurization was caused by the inadvertent opening and failure to reseal of relief valve 2PR47 in train A when block valve 2PR6 was open. The reason for initially having a separate set of relief valves for plant low temperature overpressure protection was that Unit 2 did not have a safety-grade air system for the PORVs. Because of repeated problems with the indicating sensors on the solenoid valves, these valves were removed from service several months prior to the depressurization event by

Simplified Schematic of Salem Unit 2 POPS RELIEF SYSTEM

disconnecting the solenoid leads from their power sources. In addition, during the previous plant outage just prior to this event, additional maintenance was done on the solenoid valves to prevent leakage to the containment. The relief function of these valves was replaced by the PORVs after some modifications to the system. The "nonfunctional" LTOP valves were scheduled to be removed from the system during the next refueling outage.

Corrective actions taken by the licensee included removal of the "nonfunctional" Maratta LTOP relief valves and replacing them with welded plugs, fixing the broken wire in the PORV block valve Limitorque operator, increasing the closing torque switch setting from 1.5 to 2.5 (8000 pounds of thrust), and modifying the control circuitry on the PORV block valves to prevent valve reversal until after the valve has completed its stroke. Salem plant engineering is reviewing the other 27 identified valves with similar control circuitry in the ECCS.
