U.S. NUCLEAR REGULATORY COMMISSION

SYSTEMATIC ASSESSMENT OF LICENSEE PERFORMANCE

INSPECTION REPORT 50-272/85-99 AND 50-311/85-99

SALEM NUCLEAR GENERATING STATION

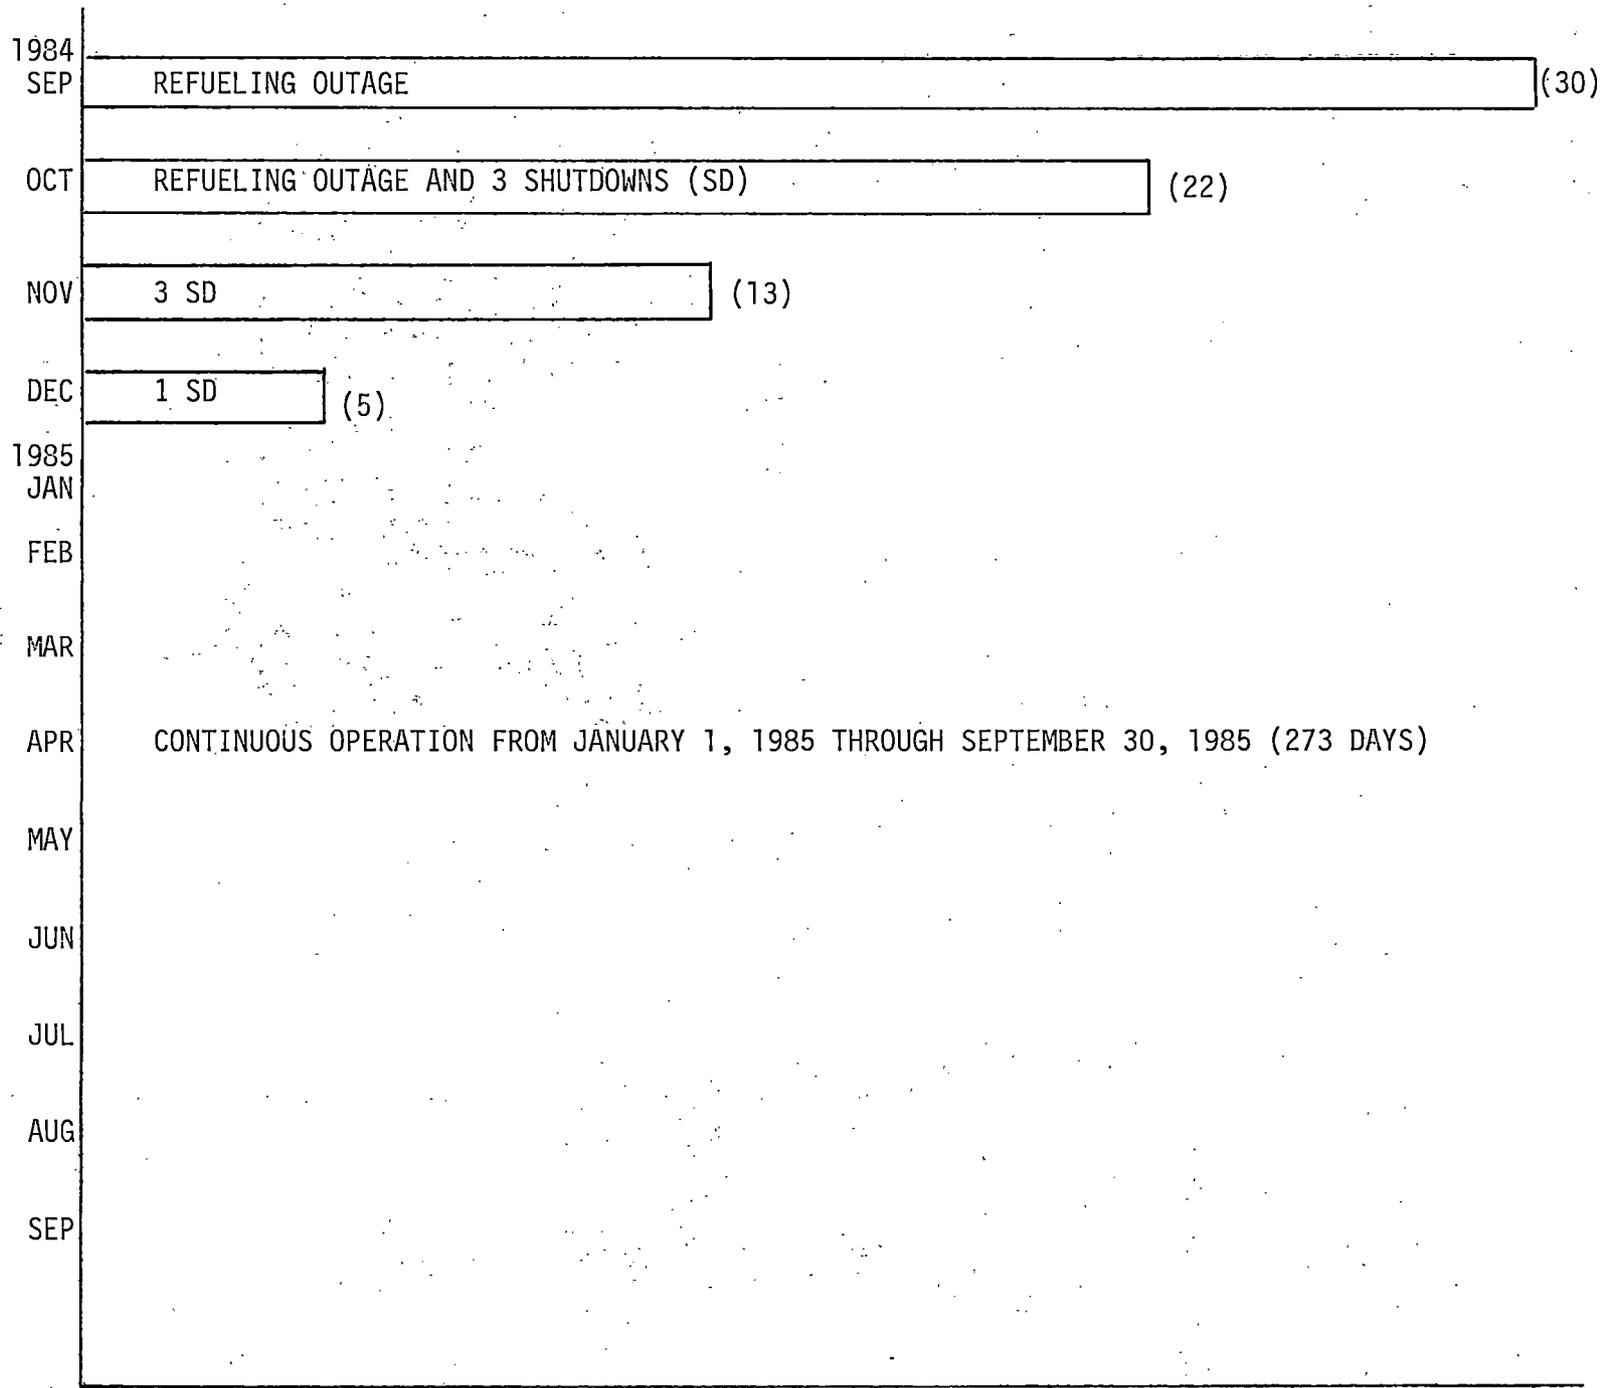
F1 - 1
 FIGURE 1
 NUMBER OF DAYS SHUTDOWN - UNIT 1

As noted in Figures 1 and 2, the trips occurred during short time durations within the thirteen month SALP rating period displaying the inconsistency of operation. Operations management attention is warranted to correct the cause of and to complete an already started investigation into the cause of and correction of the trips to reduce the total number.
