U.S. NUCLEAR REGULATORY COMMISSION  
REGION I

Report No. 50-311/86-29

Facility Name: Salem Nuclear Generating Station, Unit 2

Inspection Summary: Inspection on September 12-19, 1986 (Report No. 50-311/86-29)

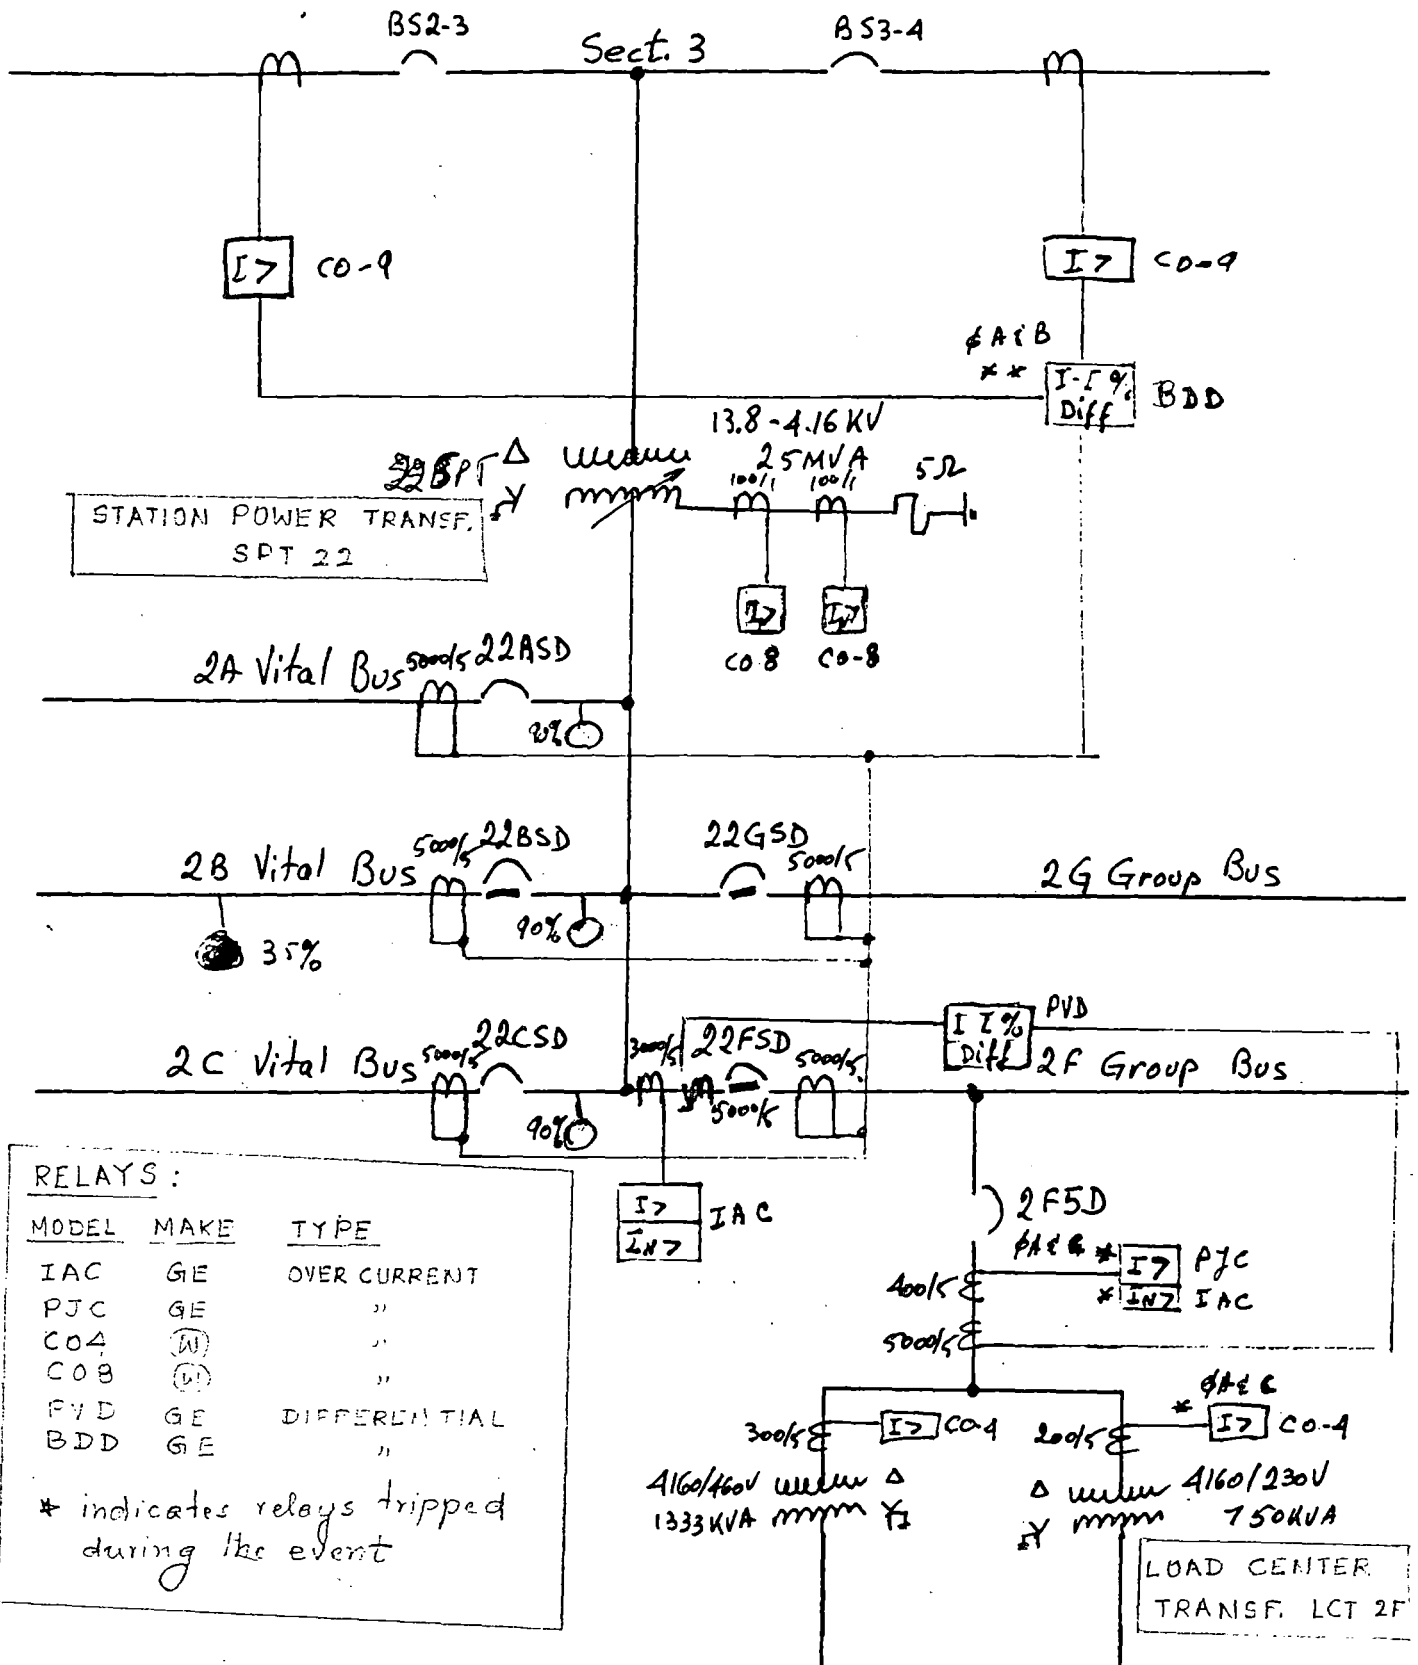
ATTACHMENT 2

Attachment 2 shows how the two transformers which faulted and initiated the event are connected to their buses and their associated relaying schemes. The two transformers include load center transformer LCT 2F (750 kVA, 4160/230 V, Delta/Wye, ITE make, dry type, self-cooled with provisions for fan cooling, 6.7 percent impedance at rated kVA) and station power transformer SPT 22 (25 MVA, 1.38/4.16 kV, Delta/Wye, Westinghouse make, Class OA/FA/FOA, 5.7 percent impedance at 15 MVA) Attachment 3 shows the detailed trip sequence of the protective relays which had tripped during the event to clear the faults.

Summarizing the relay trip sequence, the instantaneous overcurrent relays tripped the feeder breaker 2F5D and cleared the fault on LCT 2F. This happened almost instantaneously as was evidenced by not having any flags on the time overcurrent relays which are the backup protection for the instantaneous overcurrent relays. In normal circumstances, the instantaneous clearing of the fault on LCT 2F should not cause tripping of any upstream breakers as the relay settings are supposed to be well coordinated to clear the faults selectively. However, several upstream breakers around SPT 22 tripped. It was concluded by the licensee that this was because of an internal fault within SPT 22 which caused its differential protection relays to trip the breakers around it within a few cycles and was not because of any problem with improper coordination of relay settings. After the event, the relay settings and proper functioning of the affected breakers were verified to be correct by the licensee.

Fault on a 4160/230V transformer fed from 2F group bus (breaker position 2F5D)

Relay operation determined from the relay targets found by the Relay Department.

1. Phase A & C overcurrent protection on the high voltage side of the 4160/230V transformer. Indicating Instantaneous Trip unit (IIT). No time-delay unit targets were found.
2. Neutral overcurrent protection on the 4160V feeder (IAC Relay-Instantaneous).
3. Phase A & C Instantaneous overcurrent protection (Relay type PJC) on the 4160V feeder.

All these relays trip 2F5D circuit breaker. The PJC relays operate when the fault current is higher than 5760 amps.

2F group bus has overload protection, set very high both for current and time. However, if the 2F5D breaker should have not operated this protection would have cleared the 4160V group bus.

The transient data recorder tape indicates that 12 cycles later the bus breakers 22GSD, 22SD, and 22BSD tripped. Targets on phase A & B transformer differential protection were found.

- Oil and gas sample test and turns ratio test for SPT 22;
- Winding power factor and excitation tests for LCT 2F and SPT 22;
- Hi-Pot tests for 13 kV cables to and from SPT 22;
- Testing of the relays and breakers associated with LCT 2F and SPT 22 (see Attachment 2 of this report) to verify their function and proper relay coordination.
