U. S. NUCLEAR REGULATORY COMMISSION

Report Nos. 50-272/87-07 05000272-870312
50-311/87-08 05000311-870312

Facility Name: Salem Nuclear Generating Station - Units 1 and 2

Inspection Conducted: February 24, 1987 - March 23, 1987

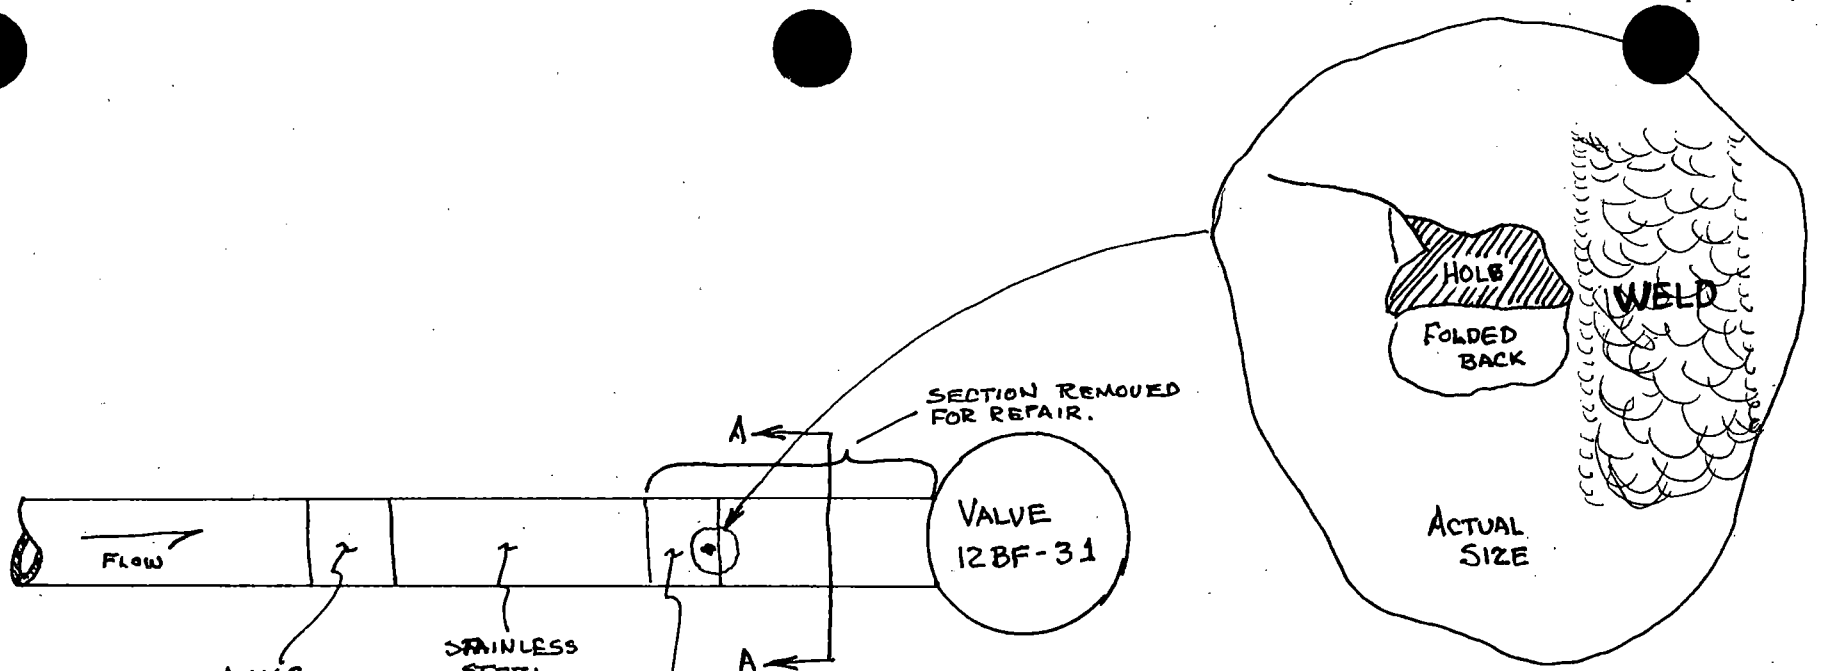
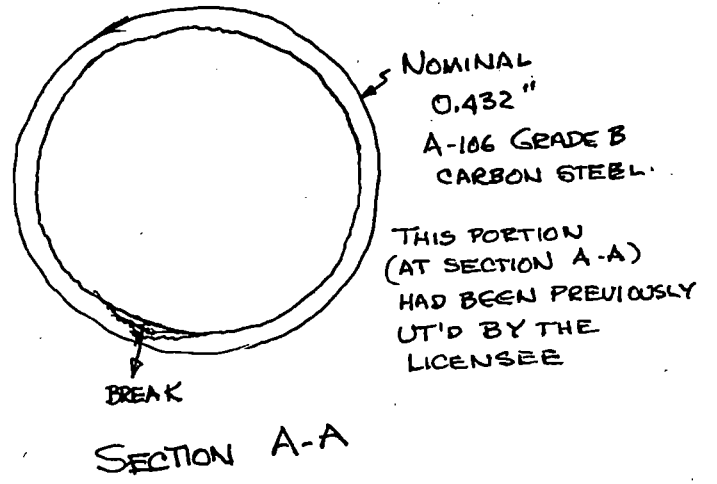
NOT TO SCALE
VIEWED FROM UNDER THE PIPE

During Unit 1 startup on March 16, 1987 at approximately 1:00 p.m., the licensee identified a leak on No. 12 steam generator feedpump (SGFP) recirculation line to the condenser. The leak resulted from a 1/2 inch by 1 inch hole in the piping near a carbon to carbon weld located between a stainless steel flow restricting orifice and valve 12BF31 (see Attachment 3 to this report). The piping is 6 inch A106 Grade B carbon steel with 0.432 inch nominal wall thickness. The break in the pipe occurred where erosion had thinned the pipe near the weld backing ring which protruded into the pipe. Although thinning in the recirculation piping had been identified previously by the licensee (discussed in Inspection Report 50-272/86-32; 50-311/86-36), the section between the carbon to carbon weld and carbon to stainless weld had not been inspected.

1. Cut out the section of pipe, as shown on attachment 3, for analysis to determine metallurgical root cause of the failure. The metallurgical laboratory's preliminary assessment of the cause was water impingement erosion as evidenced by flow disturbances indicated by swirl patterns observed through an etching technique.

4. Qualified a welding procedure for A106 carbon to 410 stainless steel.
5. Welded in new A106 piping as shown on attachment 3. The inspector noted that the backing ring technique was not used because the licensee believed that the backing ring of the previous weld protruding into the piping may have contributed to the thinning.
