U. S. NUCLEAR REGULATORY COMMISSION
REGION I

Docket and Report Nos. 50-272/88-02
50-311/88-02 Licensee Nos.: DPR-70
DPR-75

Facility: Salem Nuclear Generating Station,
Units 1 and 2

Dates: January 4-7, 1988

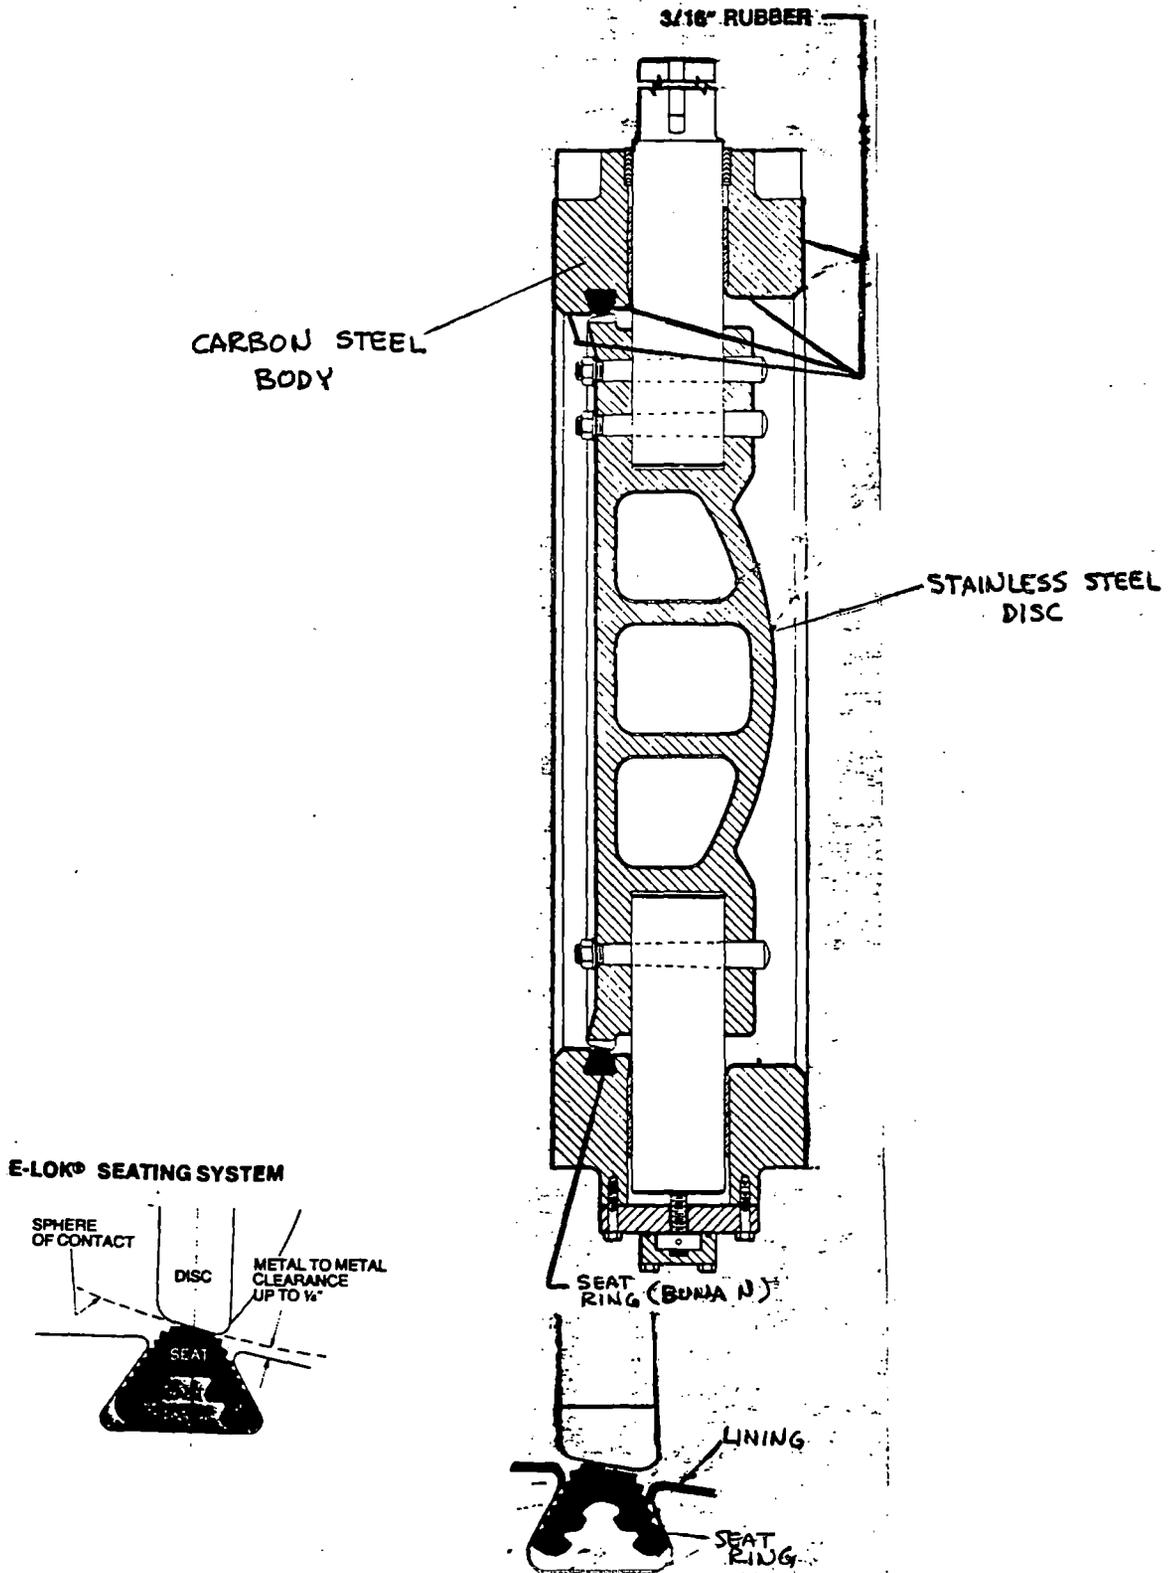
FIGURE 3
PRATT VALVE DETAILS

The service water isolation valves which failed in this event are Pratt Company 30-inch, 150 pound Triton Model XR70, wafer type butterfly valves with rubber seat rings and a separate rubber lining. The valves have H4BC Limitorque operators with SMB motors. There are seven valves of this type installed in the Unit 1 service water bays and 7 in Unit 2 bays (including several 24" valves with H3BC operators). The valves are fabricated to ASME Class 3 requirements.

The inspector observed the failed 13SW20 valve that was removed after the event. This valve was replaced with a new Pratt valve of the same internal design. Observation of the removed valve was made from the downstream side with the valve disc approximately 5 degrees open. The seat ring was out of the body seat groove between the one and four o'clock positions. The seat ring was not broken circumferentially, and the seating surface area was not damaged. The dislodged portion of the ring, however, was ragged on the rear surfaces that retained the ring in the body. The seat material was noted to be very hard, and there was little evidence of any epoxy on the back of the ring.

The body groove that retains the seat ring was significantly eroded on both the upstream and downstream sides where the ring was out. The rubber body liner was completely gone in over 50% of the wetted body surface, and the body was badly corroded. Corrosion and missing liner material were also evident at the seat-to-liner joint locations around the viewable seat ring circumference. The seat liner material that still remained was resilient. The valve disc, a stainless steel material, was in excellent condition.

The failed 13SW20 valve had been reworked in August 1984 due to excessive corrosion. The seat retaining groove and body were weld repaired, remachined, and a new seat ring was installed. The body was rubber lined at that time. Observations made during January 4-7, 1988 of the failed 13SW20 valve were that severe corrosion and removal of the seat groove had occurred again. The corrosion problems have been attributed to brackish Delaware River Bay water conditions, which erode and corrode the carbon steel body at locations where the liner is torn or has a hole.
