April 28, 1988
NLR-N88060

**RESPONSE TO NOTICE OF VIOLATION
FIRE PROTECTION REQUIREMENTS
SALEM GENERATING STATION - UNIT NO. 2
DOCKET NO. 50-311**

REPLY TO NOTICE OF VIOLATION AND
PROPOSED IMPOSITION OF CIVIL PENALTY
NRC INSPECTION REPORT NO. 50-311/87-29
PUBLIC SERVICE ELECTRIC AND GAS COMPANY
SALEM GENERATING STATION - UNIT NO. 2

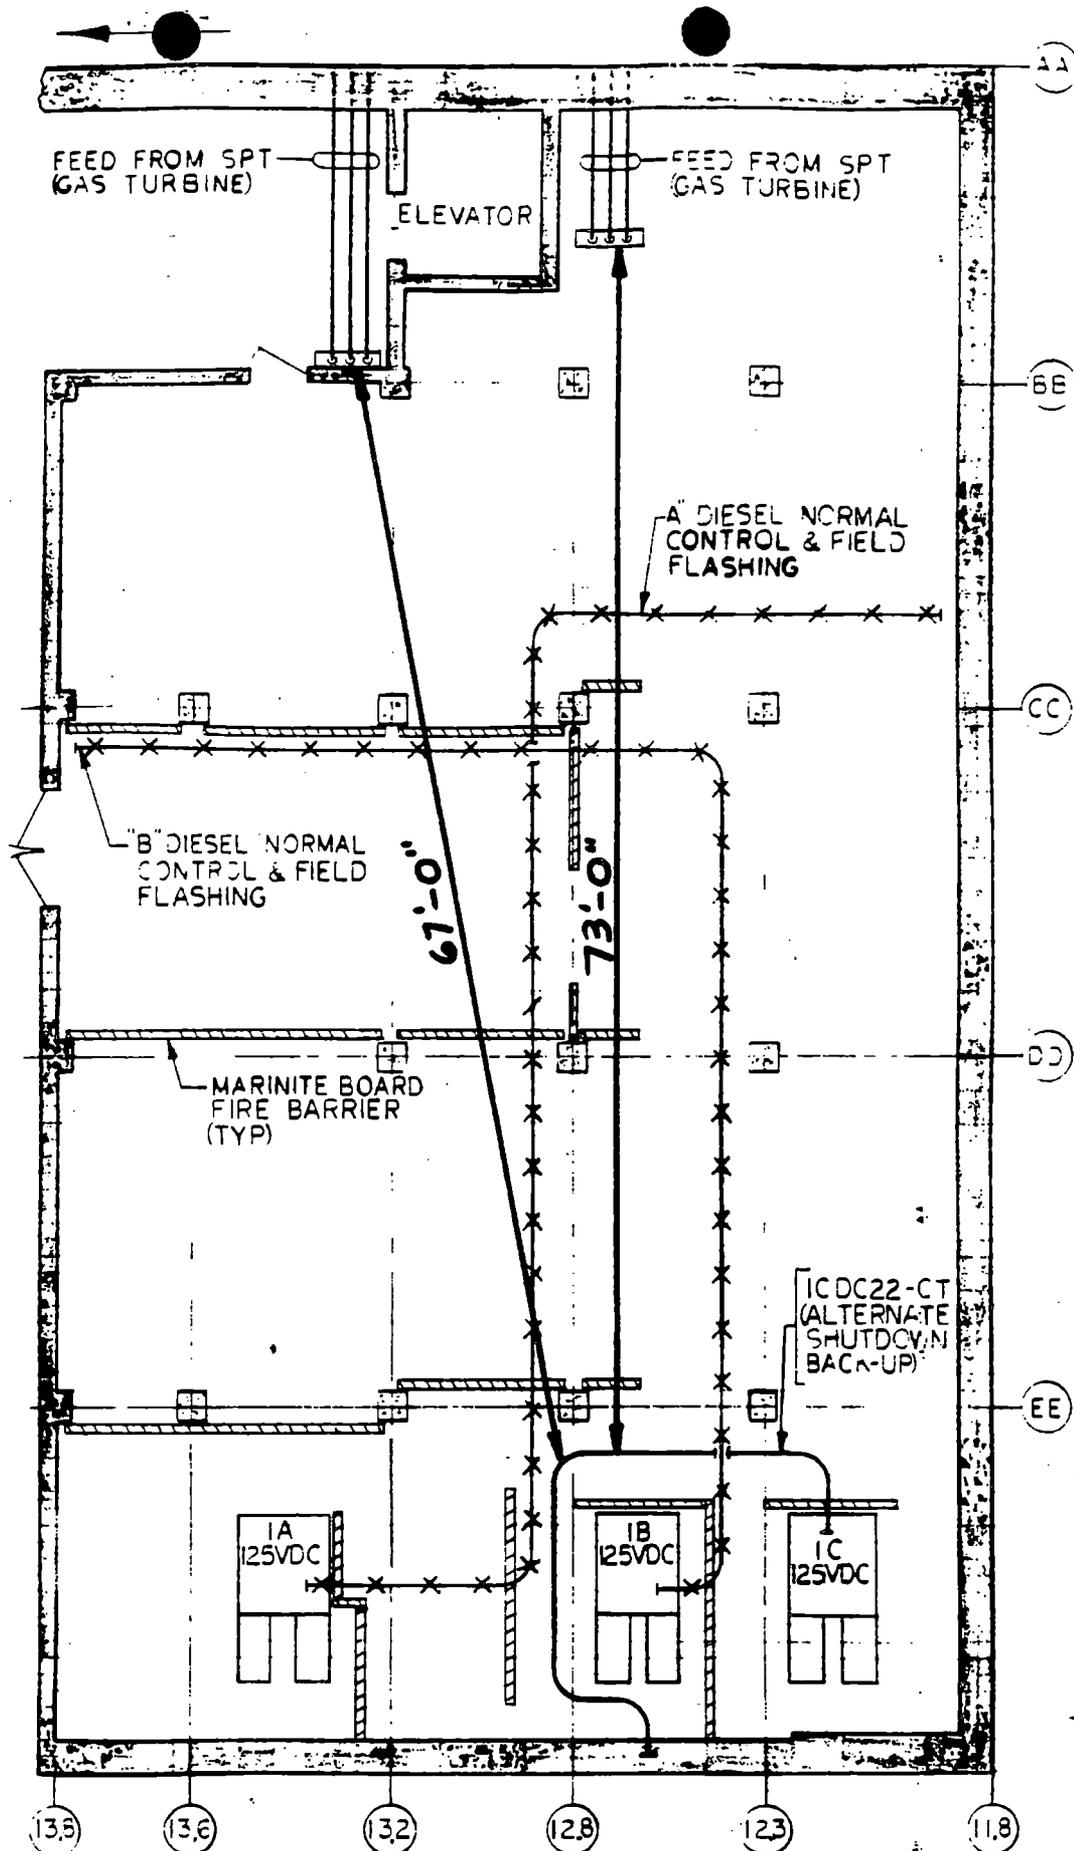
NO. 1 UNIT CONTROL AREA
EL. 84'-0"

The cables supplying normal power to the "A" and "B" Distribution Cabinets are routed in fire wrapped conduit (see attached sketches). The cable supplying normal power to the "C" Distribution Cabinet is not fire protected (not shown). In addition, cable CDC22-CT is routed in the ceiling area of the Switchgear Room and is also not fire protected.

If a fire is postulated at the location of the "B" 125V Vital Switchgear, the "B" Diesel Generator would be rendered inoperable due to the loss of field flashing and control power. This fire could also impact the unprotected CDC22-CT cable. If the fire is postulated to spread beyond the boundary of the marinite wall surrounding the "B" Switchgear, it is possible to cause damage to the normal "C" 125V DC feed. Therefore, only the "A" D/G would remain operable. Safe shutdown during loss of offsite power conditions requires two D/Gs to be operable.

The CDC22-CT cable will be re-routed in accordance with 10CFR 50 Appendix R criteria. The Unit 1 cable re-route will be
